Release Notification

Site Name **Kimbeto Wash Unit 2309-19K WRF**	Site Type **pipeline ROW**
Date Release Discovered **2/23/2021**	API# *(if applicable)* **NA**

May 17, 2021 Project #21016-0001

RE: Brine Water Release Closure Report at Kimberto Wash, San Juan County, New Mexico

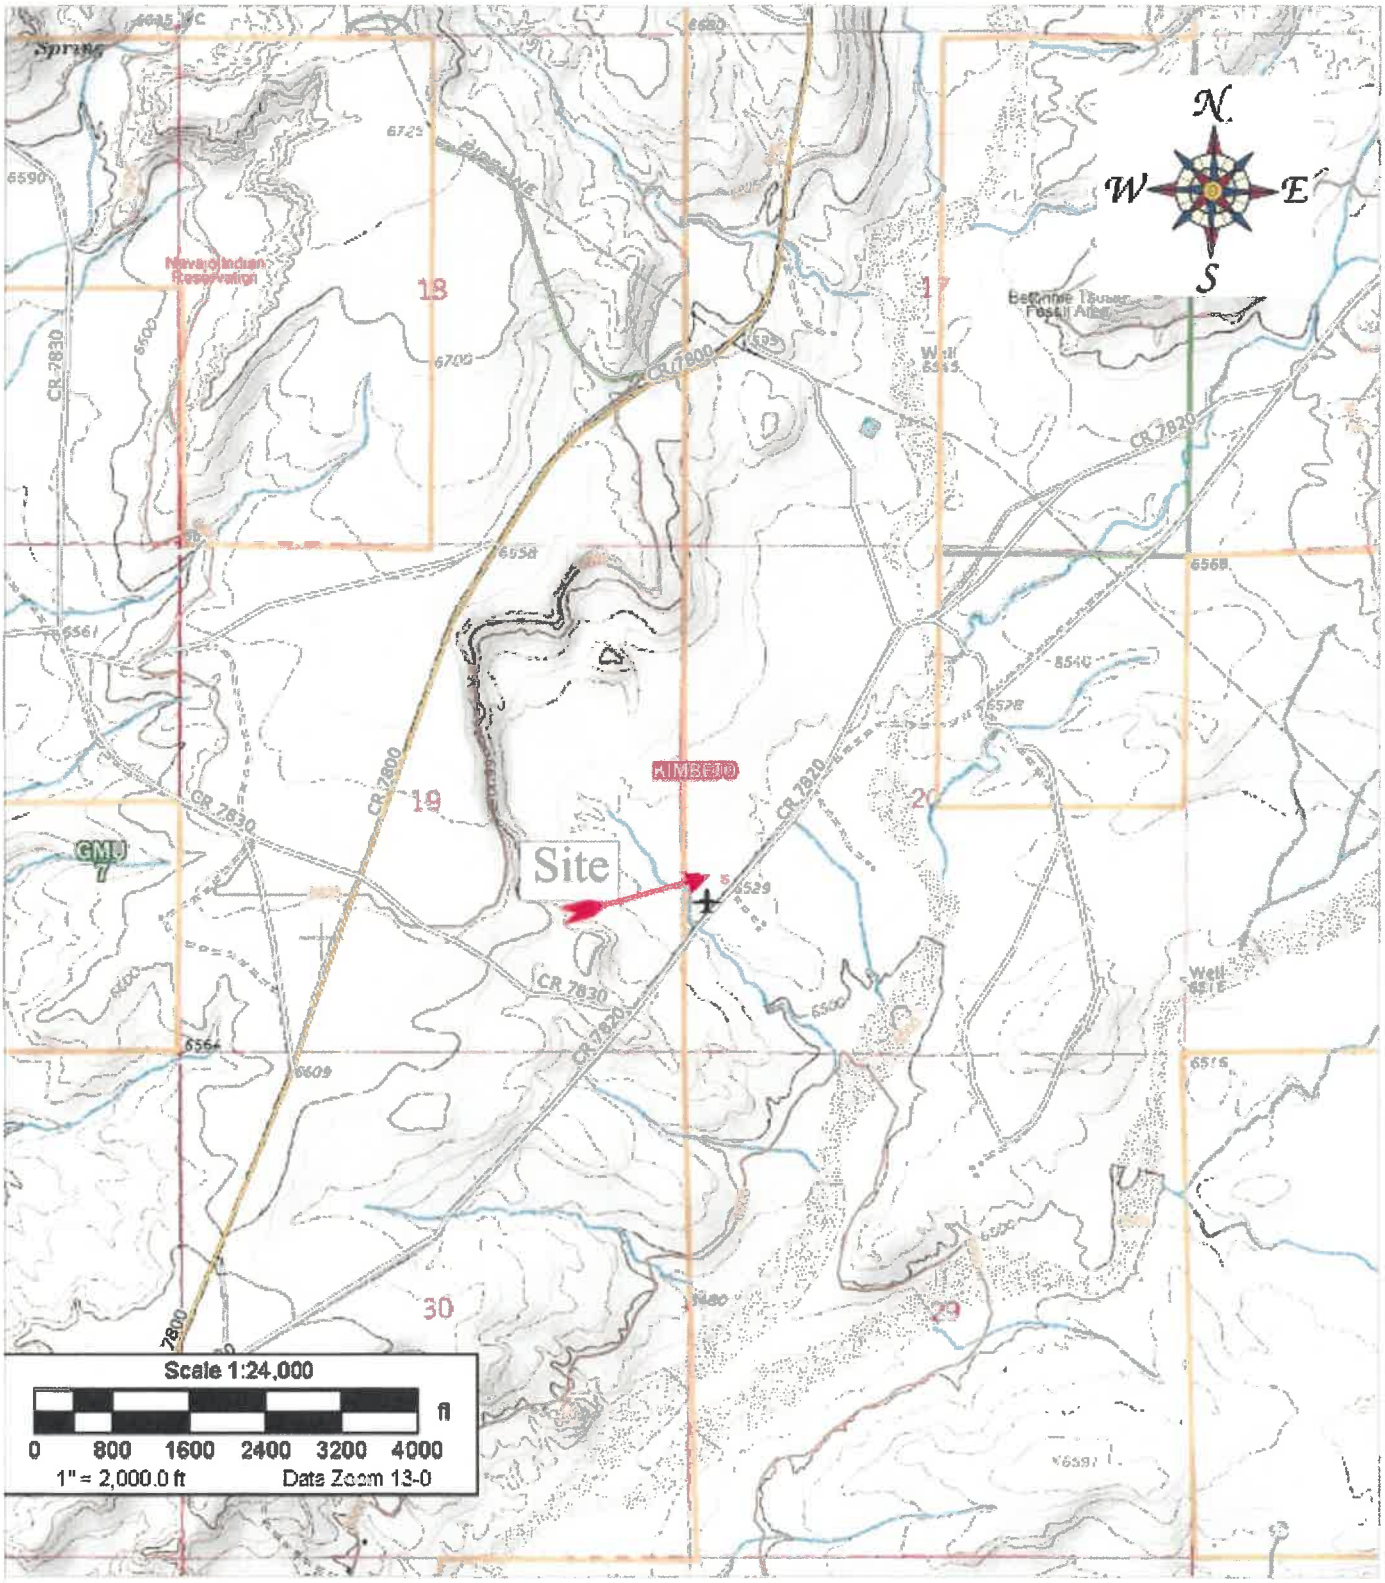
Figure 1, *Vicinity Map*

Envirotech, Inc. (Envirotech) of Farmington, New Mexico, was retained by Tetra Technologies (TetraTech) to complete remediation activities for a brine water release that occurred at in Kimberto Wash located in Section 20, Township 23 North, Range 9 West, San Juan County, New Mexico; see enclosed **Figure 1, *Vicinity Map.***

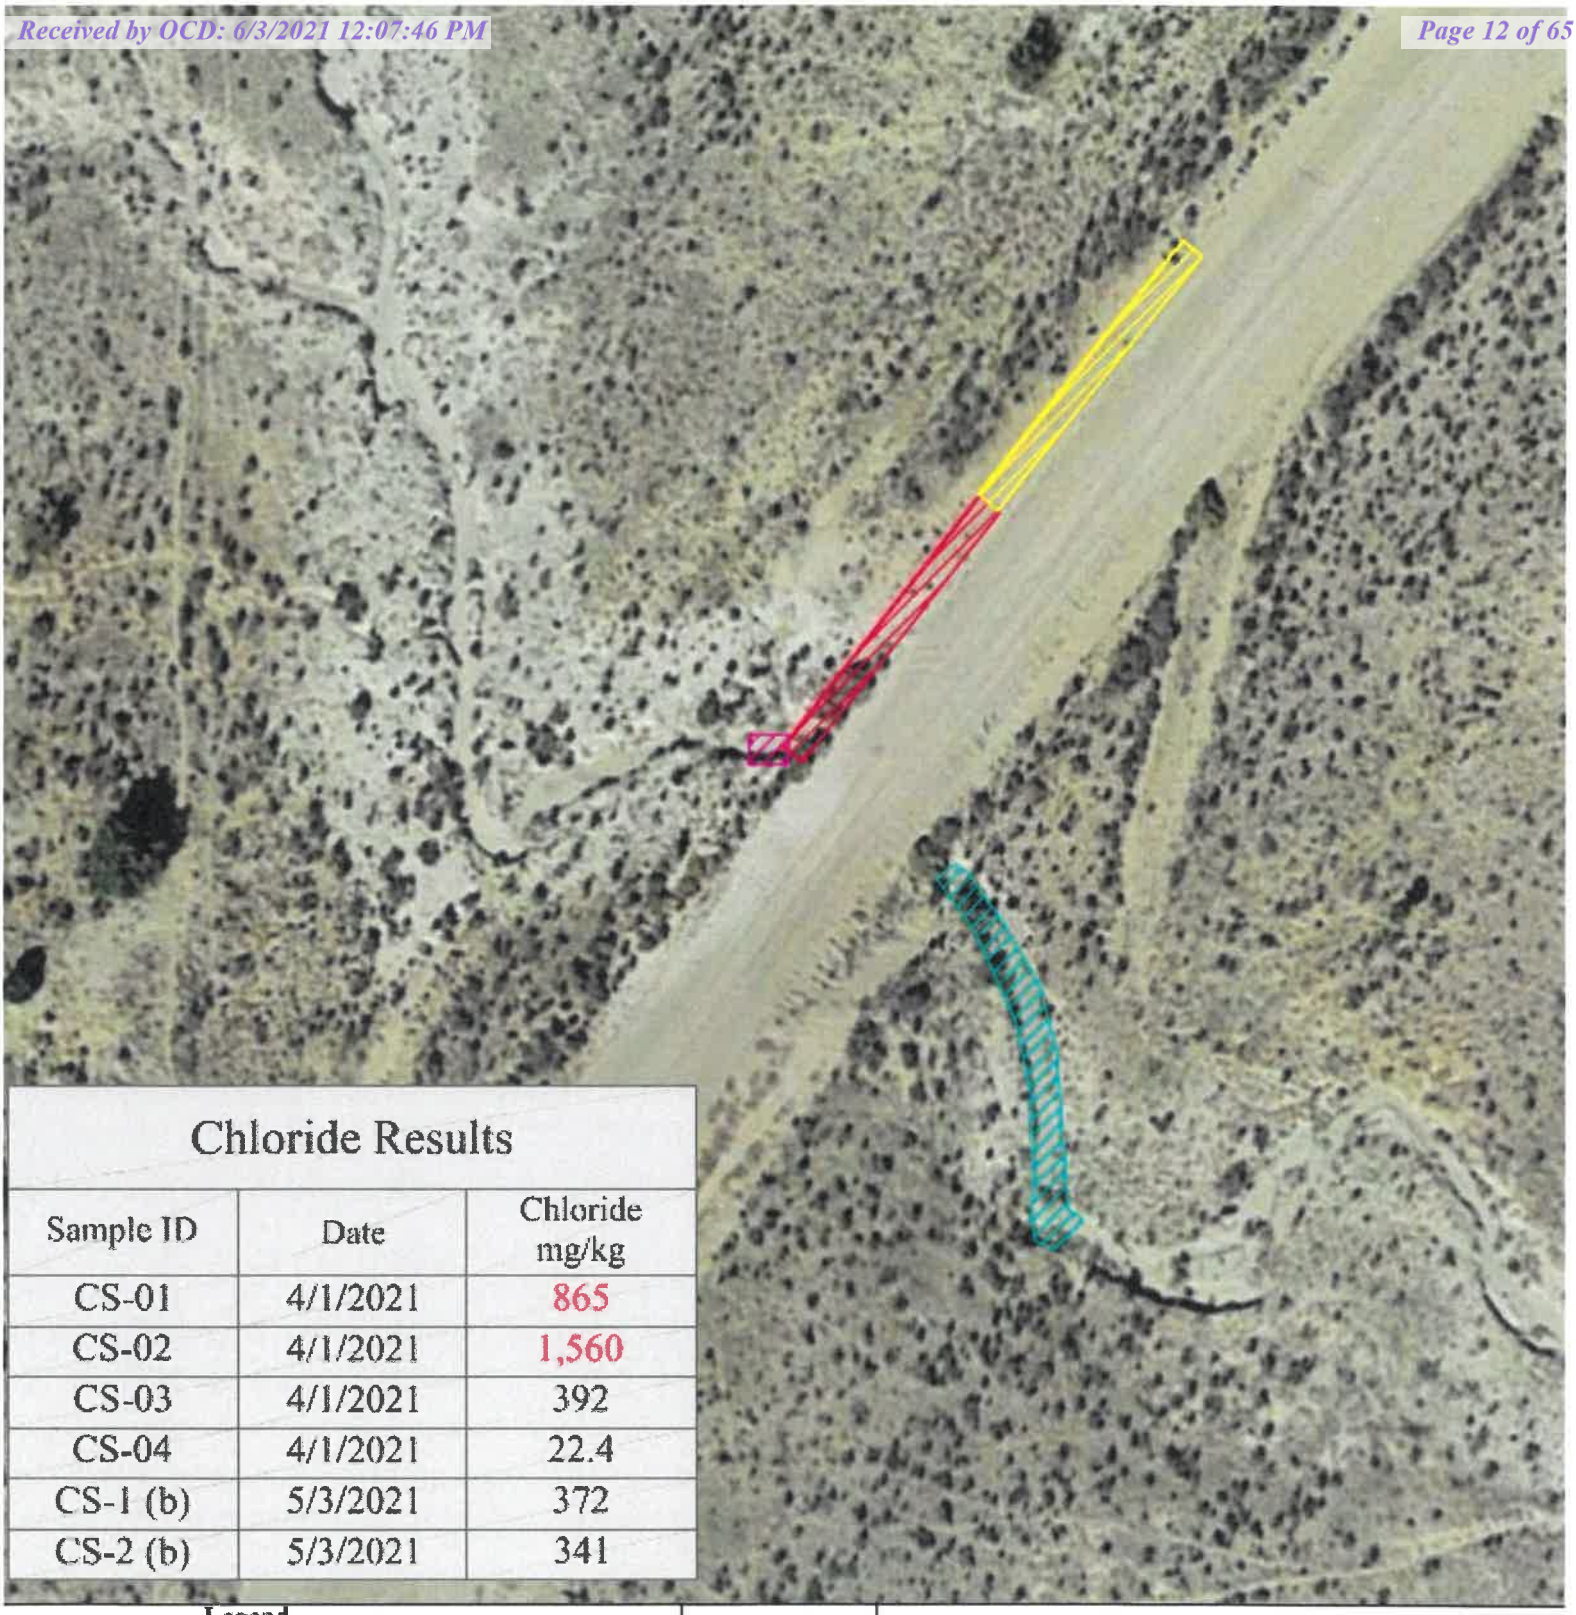
Figure 2, Site Map

Utilizing a mini excavator, the contaminated soil was excavated along the release flow path. The final extents of the excavation measured approximately 170 feet long with a width ranging from 1.5 feet to 3 feet, and a depth ranging from 1 to 6 inches. Remediation activities are documented in the enclosed **Figure 2, *Site Map*** and **Appendix B, *Photography Log***.

Sample ID	Date	Chloride mg/kg
CS-01	4/1/2021	865
CS-02	4/1/2021	1,560
CS-03	4/1/2021	392
CS-04	4/1/2021	22.4
CS-1 (b)	5/3/2021	372
CS-2 (b)	5/3/2021	341

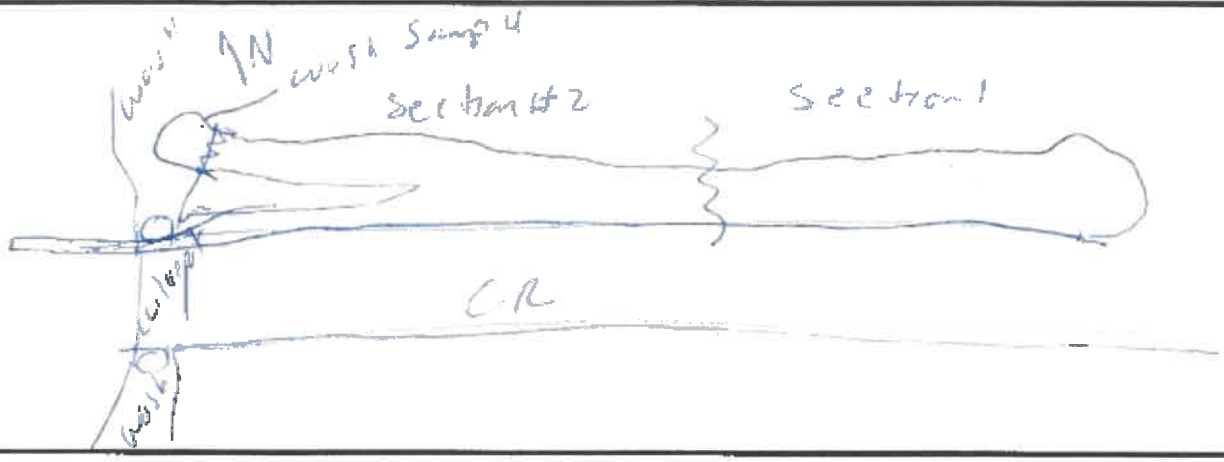
SITE PERIMETER: *Draw a schematic of the spill site. Attach photos and other diagrams as needed.*

Brian Thompson w/ Tetra on site to

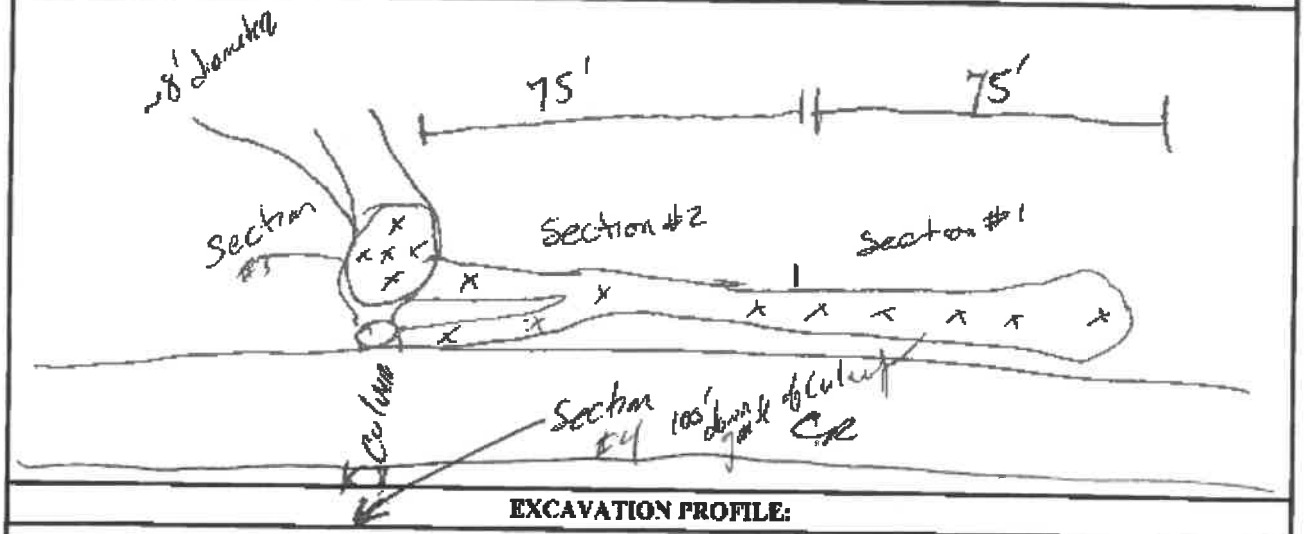
SPILL PERIMETER: *Draw a schematic of the spill site. Attach photos and other diagrams as needed.*

Cause of Release: Leakin water line Material Released: Brine water Amt. Released:

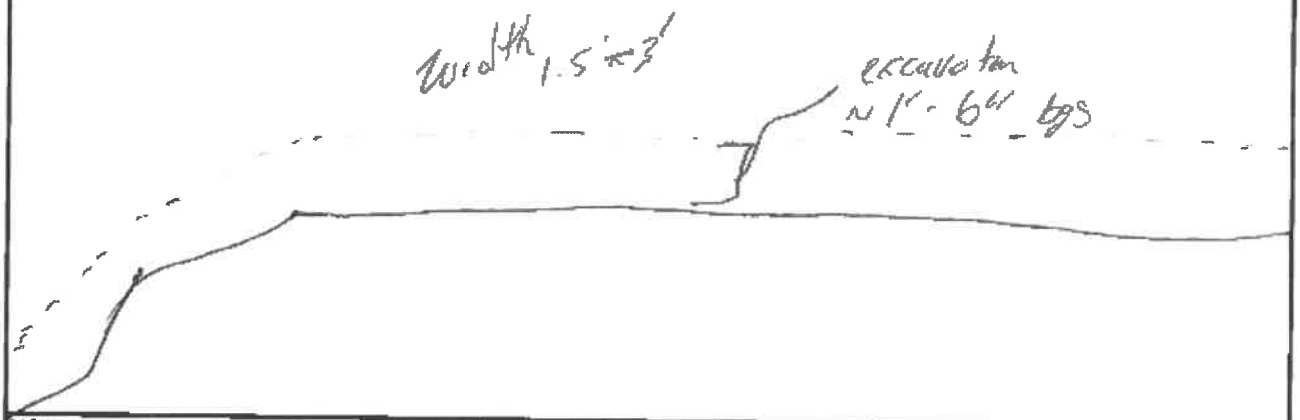
EXCAVATION PROFILE:

NOTES: all Samples 5pt composite

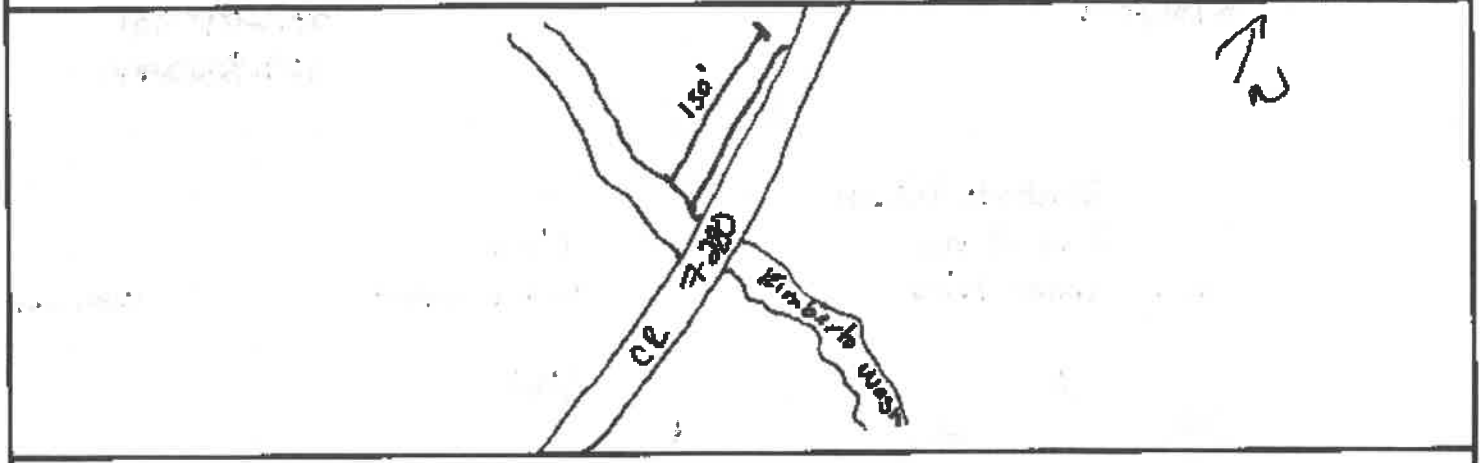
SITE PERIMETER: *Draw a schematic of the spill site. Attach photos and other diagrams as needed.*

LOCATION: Name: Kimbeto Wash Well #: — API: —
County: San Juan State: NM HWY-MM:
Cause of Release: leaking water line Material Released: brine water Amt. Released: Unknown
QUAD/UNIT: SEC: TWP: RNG: PM:
Spill Located Approximately: 0 FT. FROM ROW
Excavation Approx: 150 FT. X 2 FT. X 1 FT. Volume (cy/tons):
Disposal Facility: LF
Land Use: ROW Land Owner:
REGULATORY AGENCY: NMOCD TPH CLOSURE STD:
ADDITIONAL CLOSURE REQUIREMENTS:

Took pics + measured ex. 9.915
