April 14, 2022 Vertex Project #: 22E-00496

Spill Closure Report: RDX Federal 9 #005
Section 09, Township 26 South, Range 30 East
County: Eddy
API: 30-015-41630
Incident Report: nAPP2204537247

Prepared For: WPX Energy Permian, LLC
5315 Buena Vista Drive
Carlsbad, New Mexico 88220

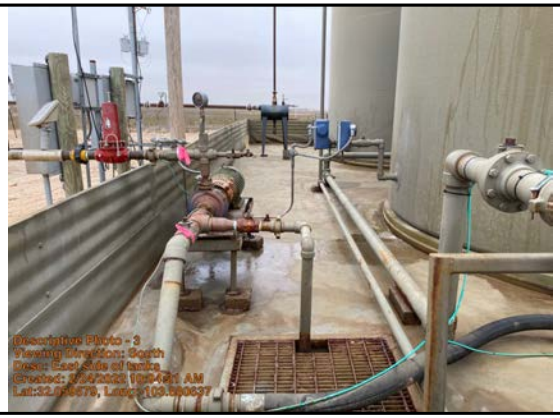
Between tanks

Viewing Direction: South
