July 11, 2022

Re: Second Quarter 2022 – SVE System Update
Lambe #2C
San Juan County, New Mexico
Hilcorp Energy Company
NMOCD Incident Number: NVF1836050592
Ensolum Project No. 07A1988008

PROJECT PHOTOGRAPHS
Lambe #2C
San Juan County, New Mexico
Hilcorp Energy Company

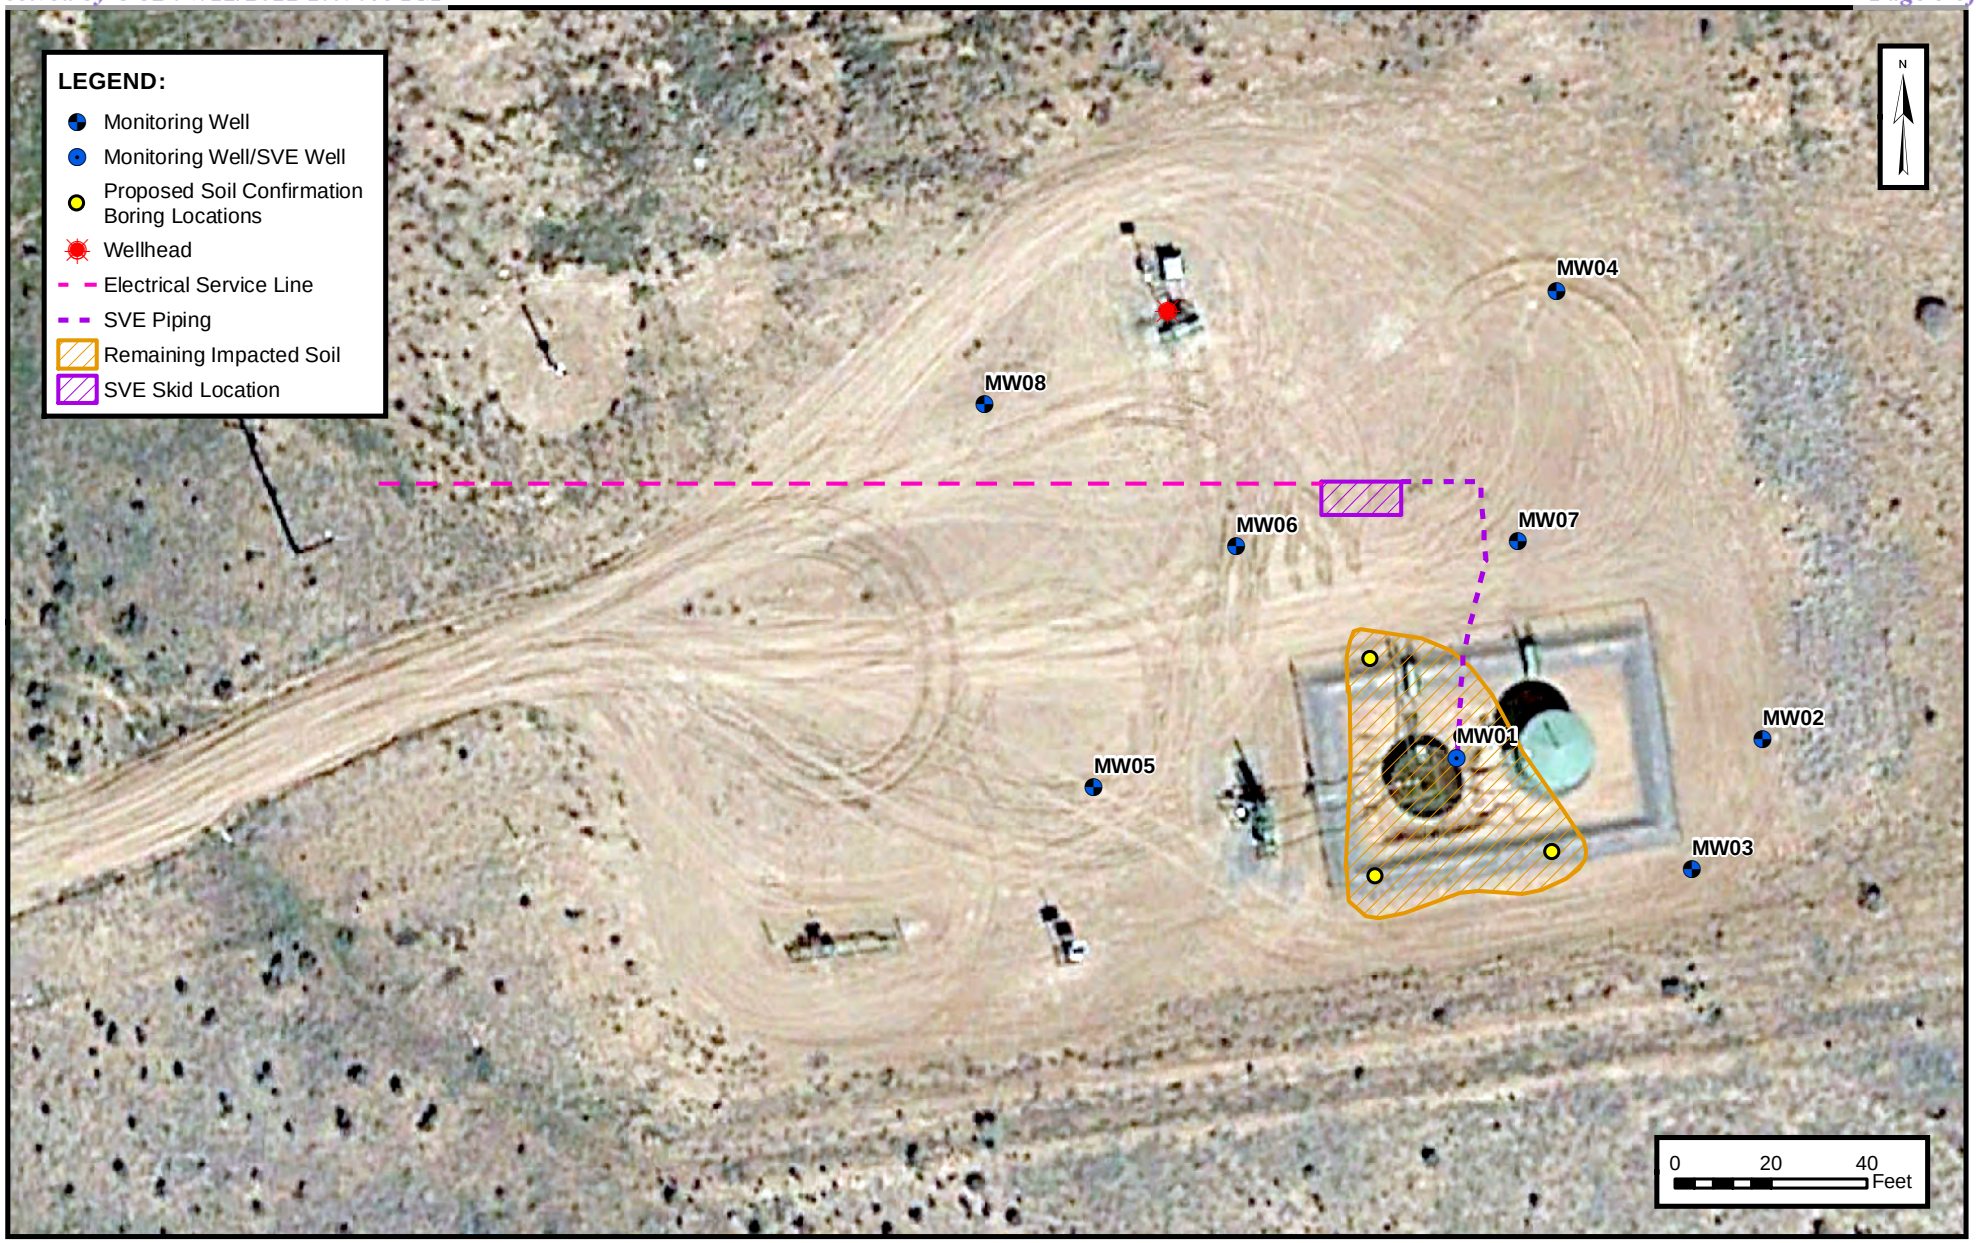
FIGURE

The current SVE system was installed at the Site in September 2021, with operation beginning on September 24, 2021. The SVE system is configured so vacuum is being applied to well MW01 (shown on Figure 2). SVE well MW01 is screened across the impacted soil interval from approximately 20 feet to 35 feet below ground surface (bgs). The SVE system consists of a 1 horsepower Atlantic Blower model AB-202/1 regenerative blower capable of producing 50 standard cubic feet per minute (scfm) flow and 30 inches of water column (IWC) vacuum. The layout of the SVE system and piping is shown on Figure 2.

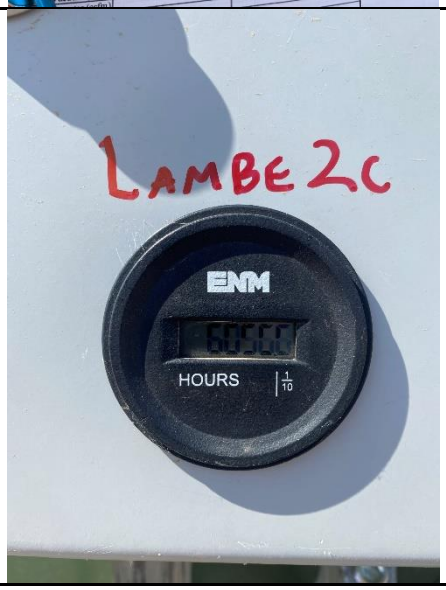
Photograph 1 Runtime meter taken on April 4, 2022 at 12:36 PM Hours = 4,362.3	
Photograph 2 Runtime meter taken on June 16, 2022 at 10:05 AM Hours = 6,096.8
