RE: *Incident Closure Request*
NTO1423253772-VACUUM GLORIETTA WEST UNIT 118
1RP-3260- Lea County, New Mexico
NTO1423253772 @ 30-025-31129

Re: Vacuum Glorieta West Unit #118
Site Closure Report
NMOCD Case No. 1RP-3260
Lea County, New Mexico

- Vacuum Glorieta West Unit #118 - Site Closure Report

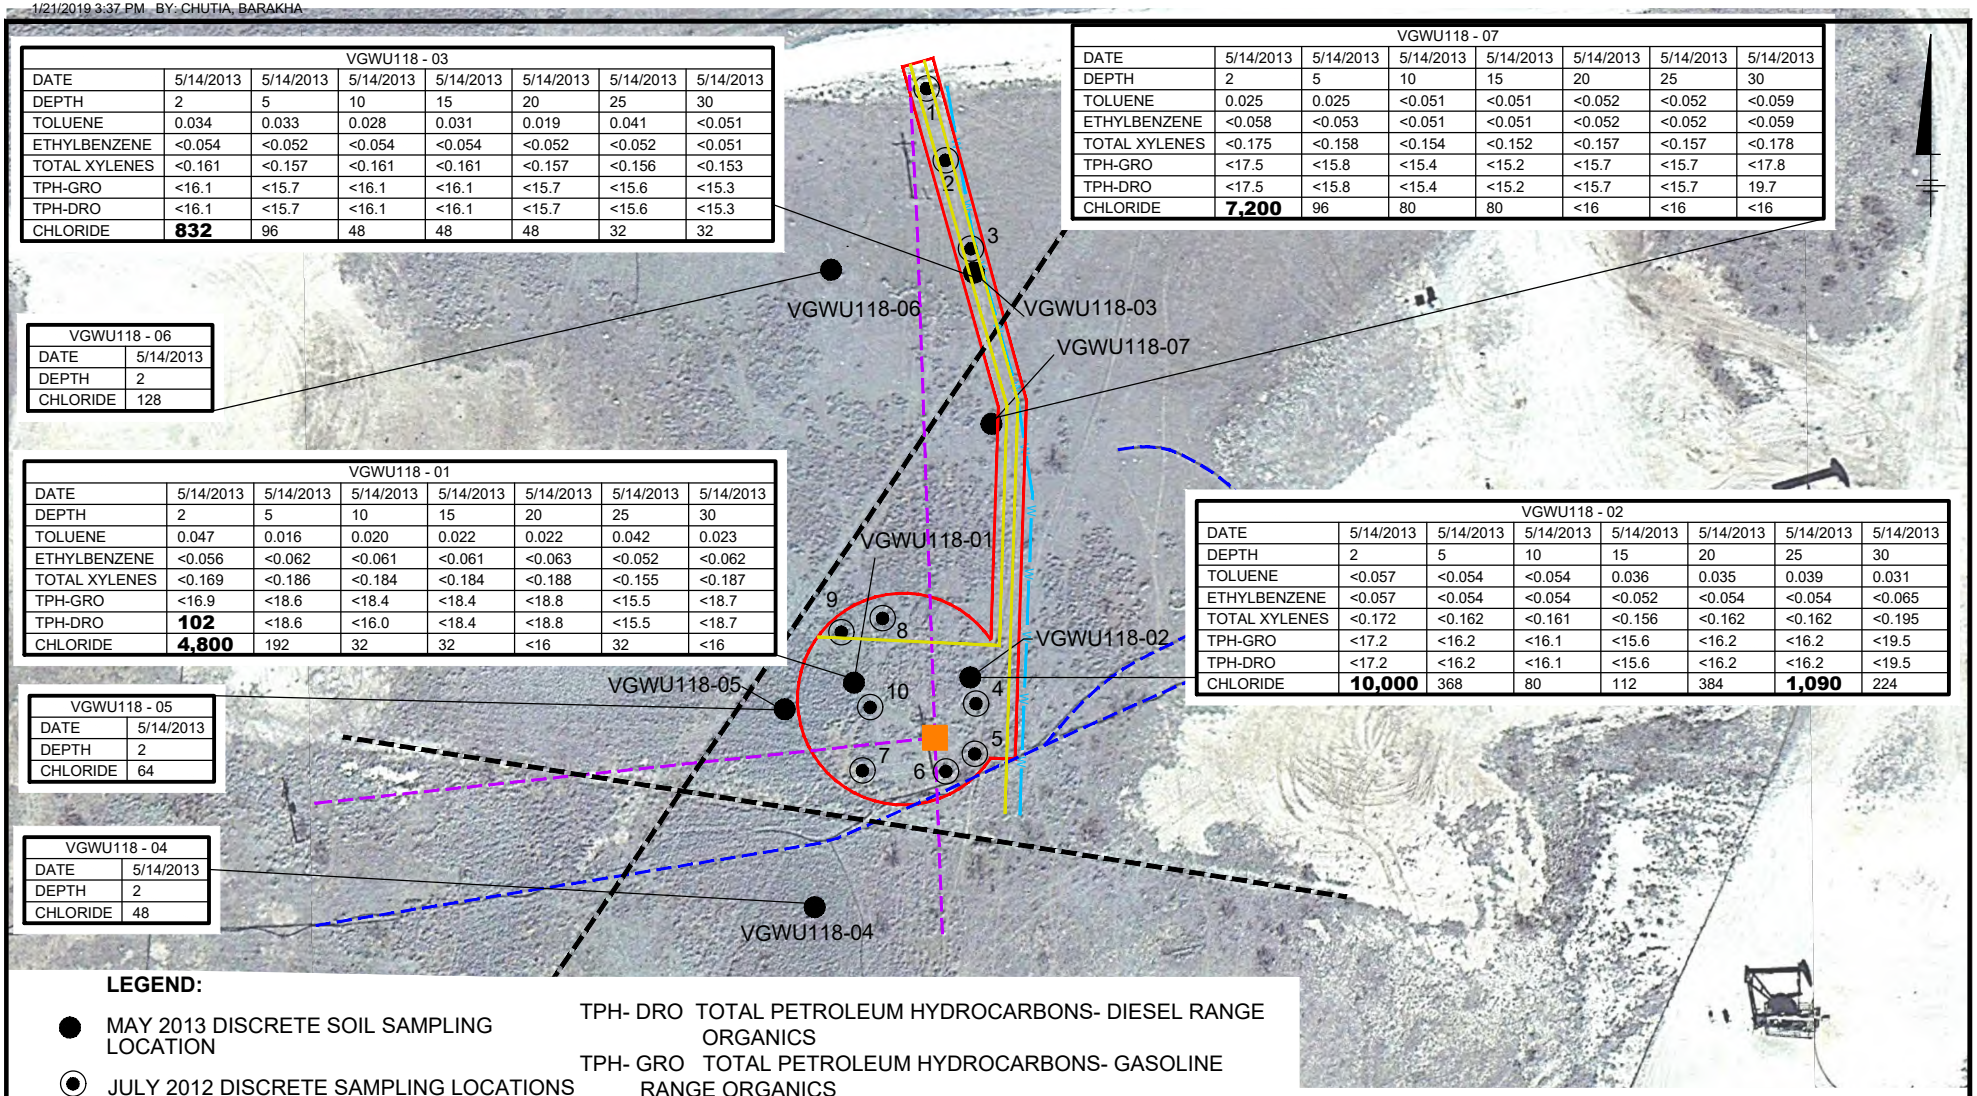
VGWU118 - 05	
DATE	5/14/2013
DEPTH	2
CHLORIDE	64

VGWU118 - 04	
DATE	5/14/2013
DEPTH	2
CHLORIDE	48

- MAY 2013 DISCRETE SOIL SAMPLING LOCATION
- JULY 2012 DISCRETE SAMPLING LOCATIONS
- POTENTIAL UNDERGROUND UTILITY LINE NOT DETECTED BY THIRD PARTY SURVEYOR
- ABOVE GROUND UTILITY LINE
- OVERHEAD UTILITY LINE
- IDENTIFIED BURIED LINE
- WATER LINE
- APPROXIMATE EXTENT OF SPILL
- UTILITY INTERSECTION

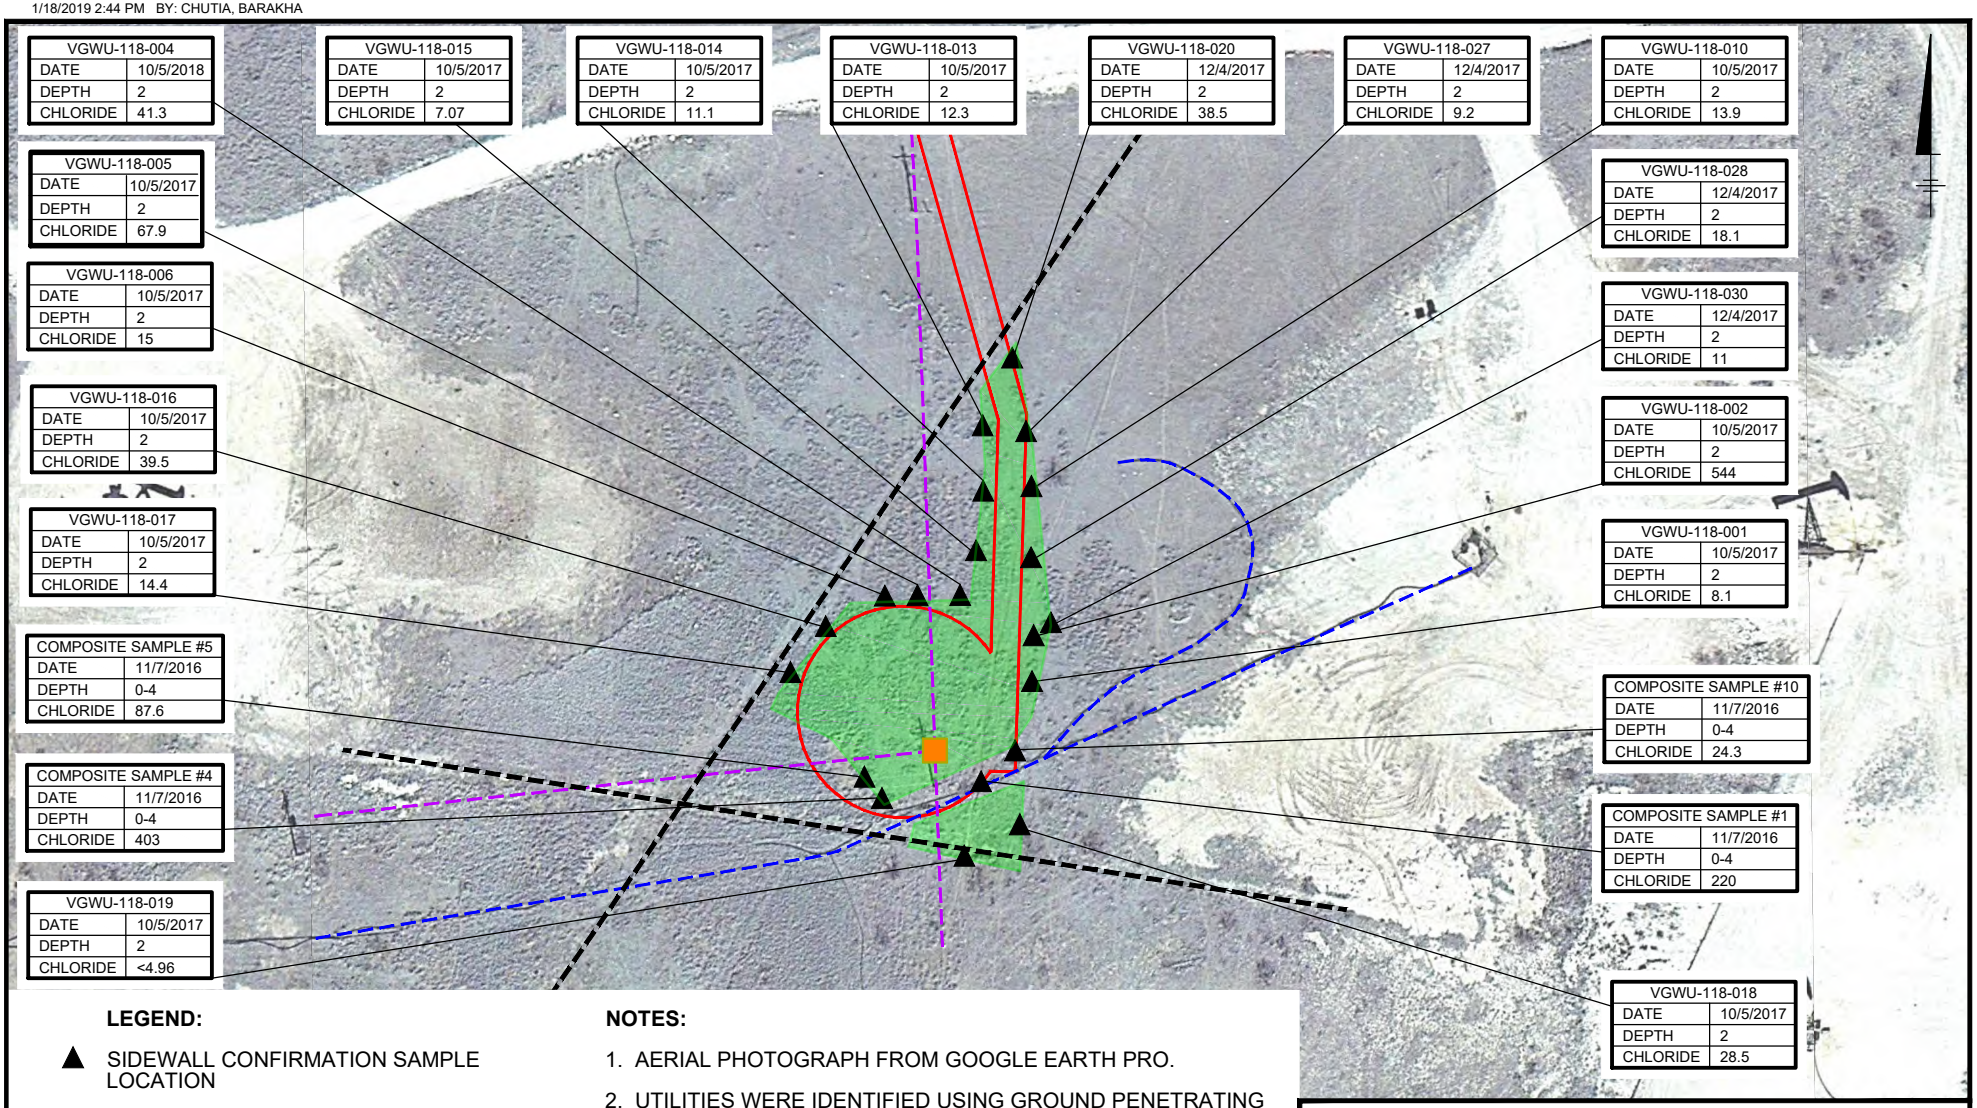
FIGURE 3

- SIDEWALL CONFIRMATION SAMPLE LOCATION
- POTENTIAL UNDERGROUND UTILITY LINE NOT DETECTED BY THIRD PARTY SURVEYOR
- ABOVE GROUND UTILITY LINE
- OVERHEAD UTILITY LINE
- APPROXIMATE EXTENT OF SPILL
- EXCAVATION AREA
- UTILITY INTERSECTION

Following completion of the excavation, a liner was installed within the limits of each excavation footprint and clean fill was used to backfill the excavated areas. Following backfill, the surface was graded, broken up, seeded, and watered to promote revegetation Upon receiving laboratory confirmation, the excavated soil was transported offsite to Sundance Services for disposal in accordance with state and federal regulations.
