RE: *Incident Deferral Request*
NJXK1530333917
CENTRAL VACUUM UNIT #266
1RP-3948 - Lea County, New Mexico

2017 Soil Assessment Report

Central Vacuum Unit No. 266
Buckeye, New Mexico
RP-3948

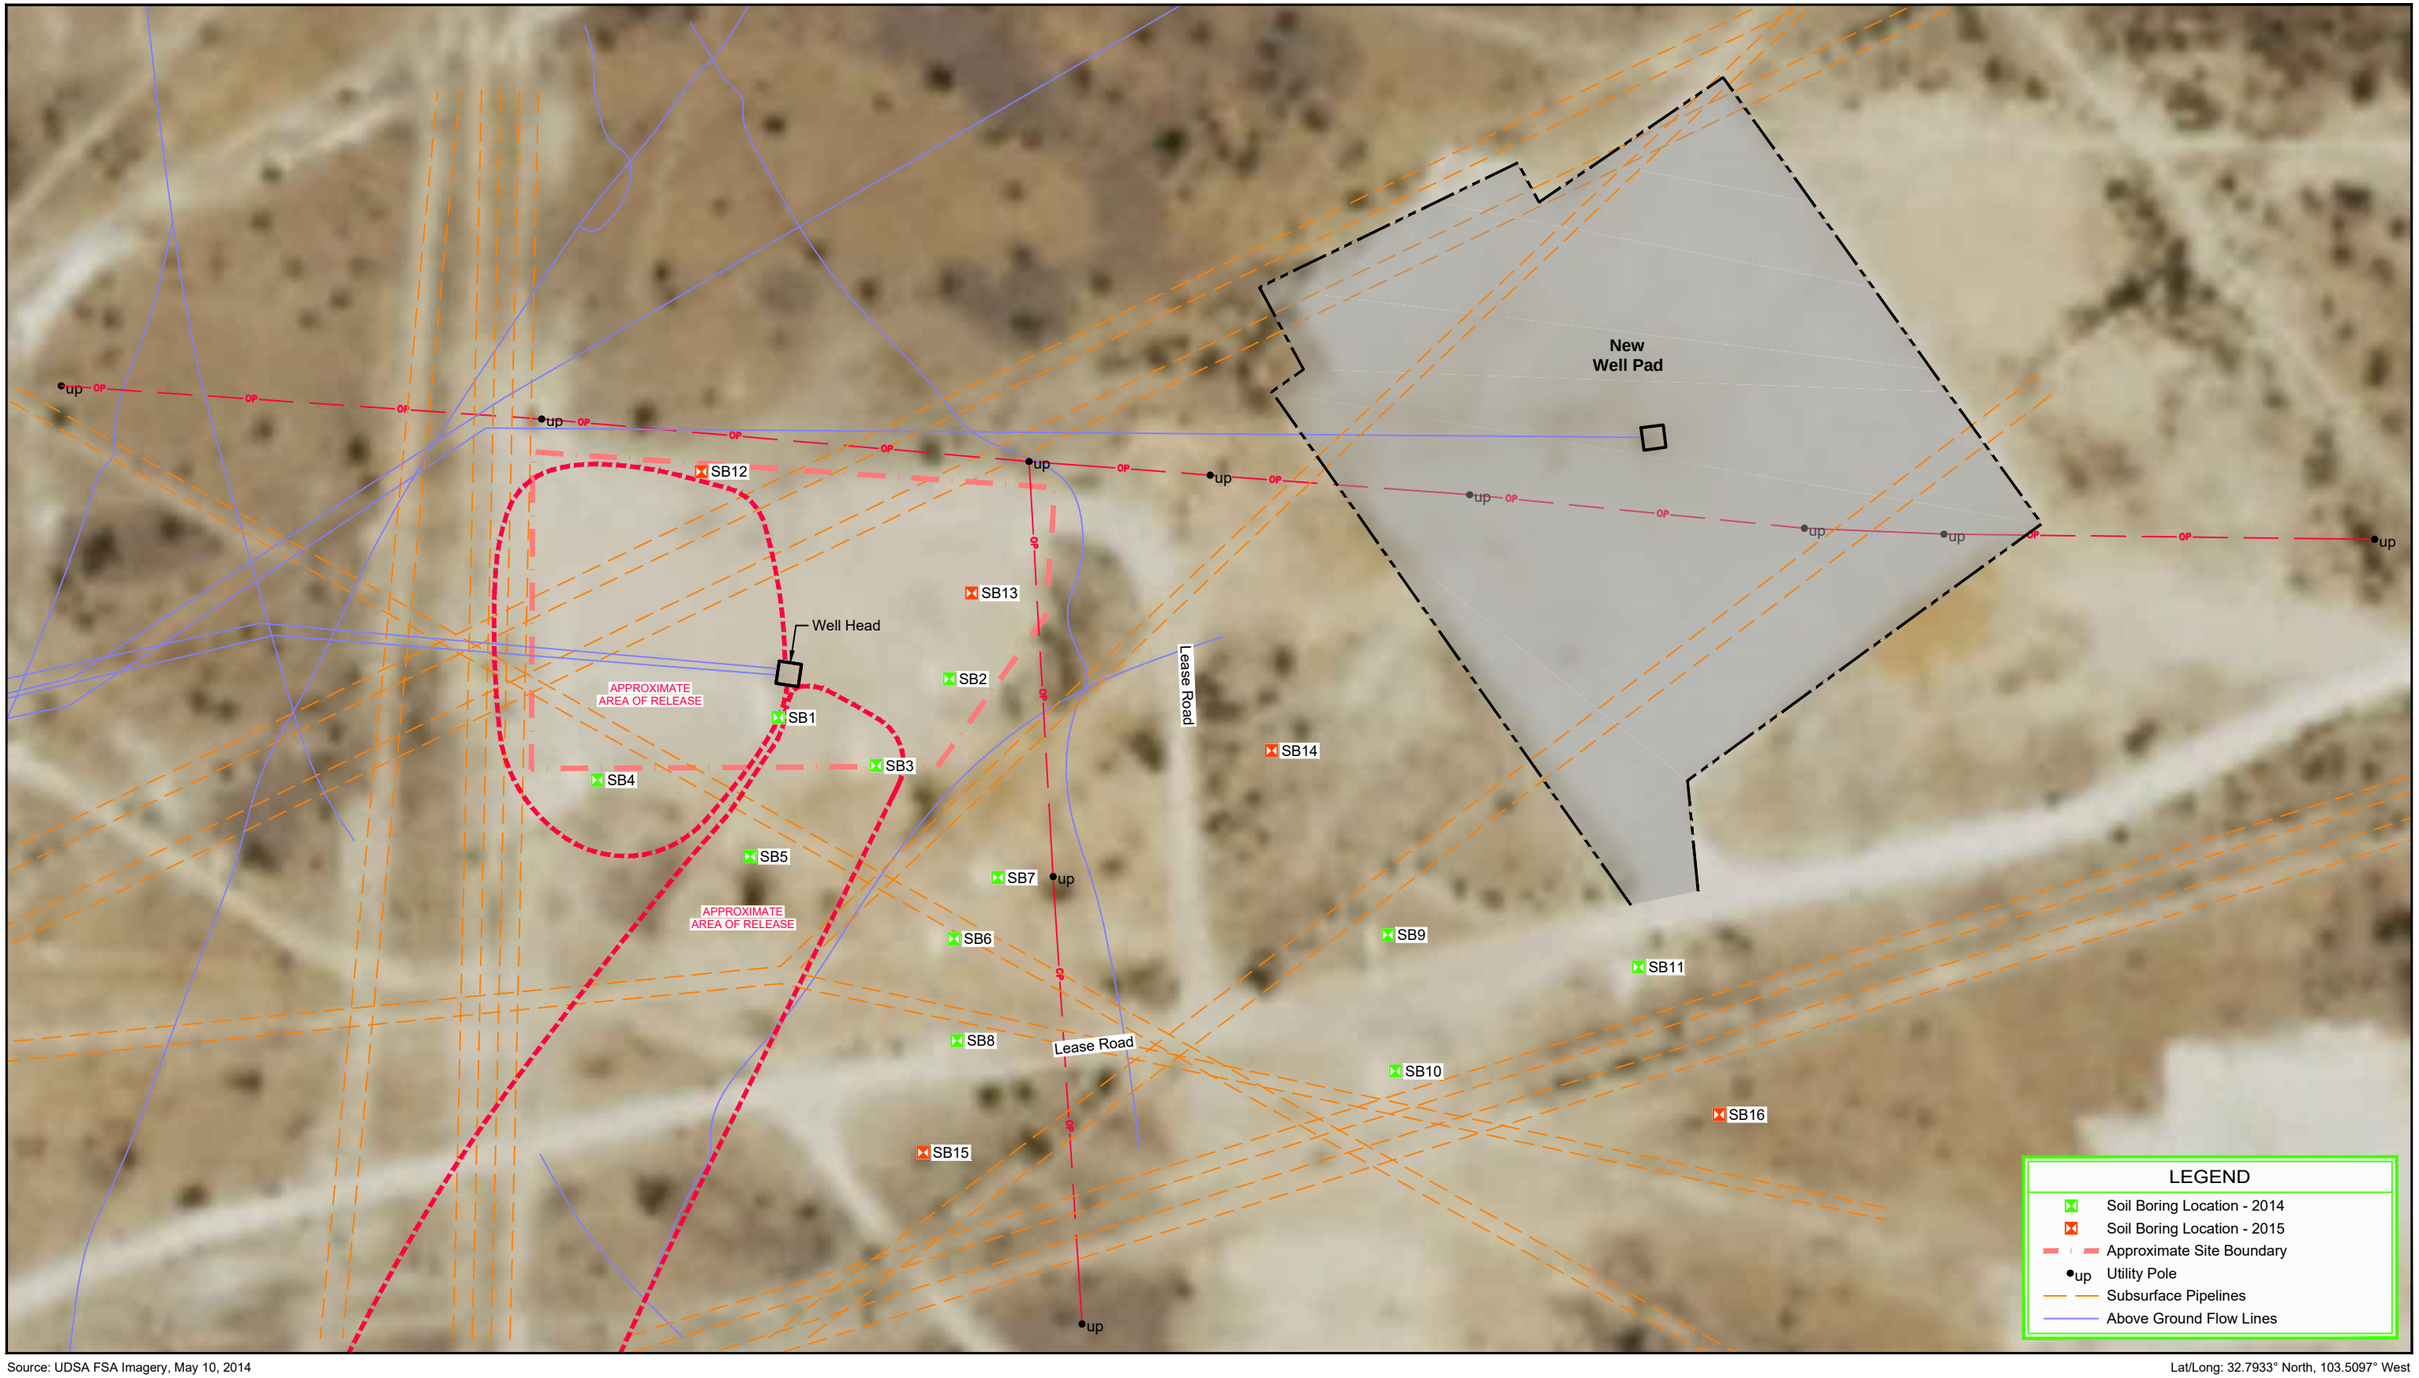
In 2014, Chevron contracted GHD to perform a comprehensive soil assessment at the Site by implementing a soil boring program. A Site visit was performed on April 8, 2014 by GHD. During the Site visit, boring locations were flagged for utility locating purposes. In addition, the Site was walked to observe Site features; which included oversight of a geophysical Site survey by way of ground penetrating radar (GPR) to assess the presence of subsurface utility hazards. Multiple surface and subsurface hazards were identified at the Site. A Site details and utility map is presented as Figure 2.

Two areas observed to be lacking natural vegetation both in the field and on aerial photography (Figure 2 and Figure 3) exhibited elevated and peak responses ranging from approximately 40 to 200 mS/m. Due to the lack of natural vegetation, the elevated EM responses, and previously collected analytical soil data from near or within the areas, it is assumed that these areas are likely former pits associated with oil and gas production.

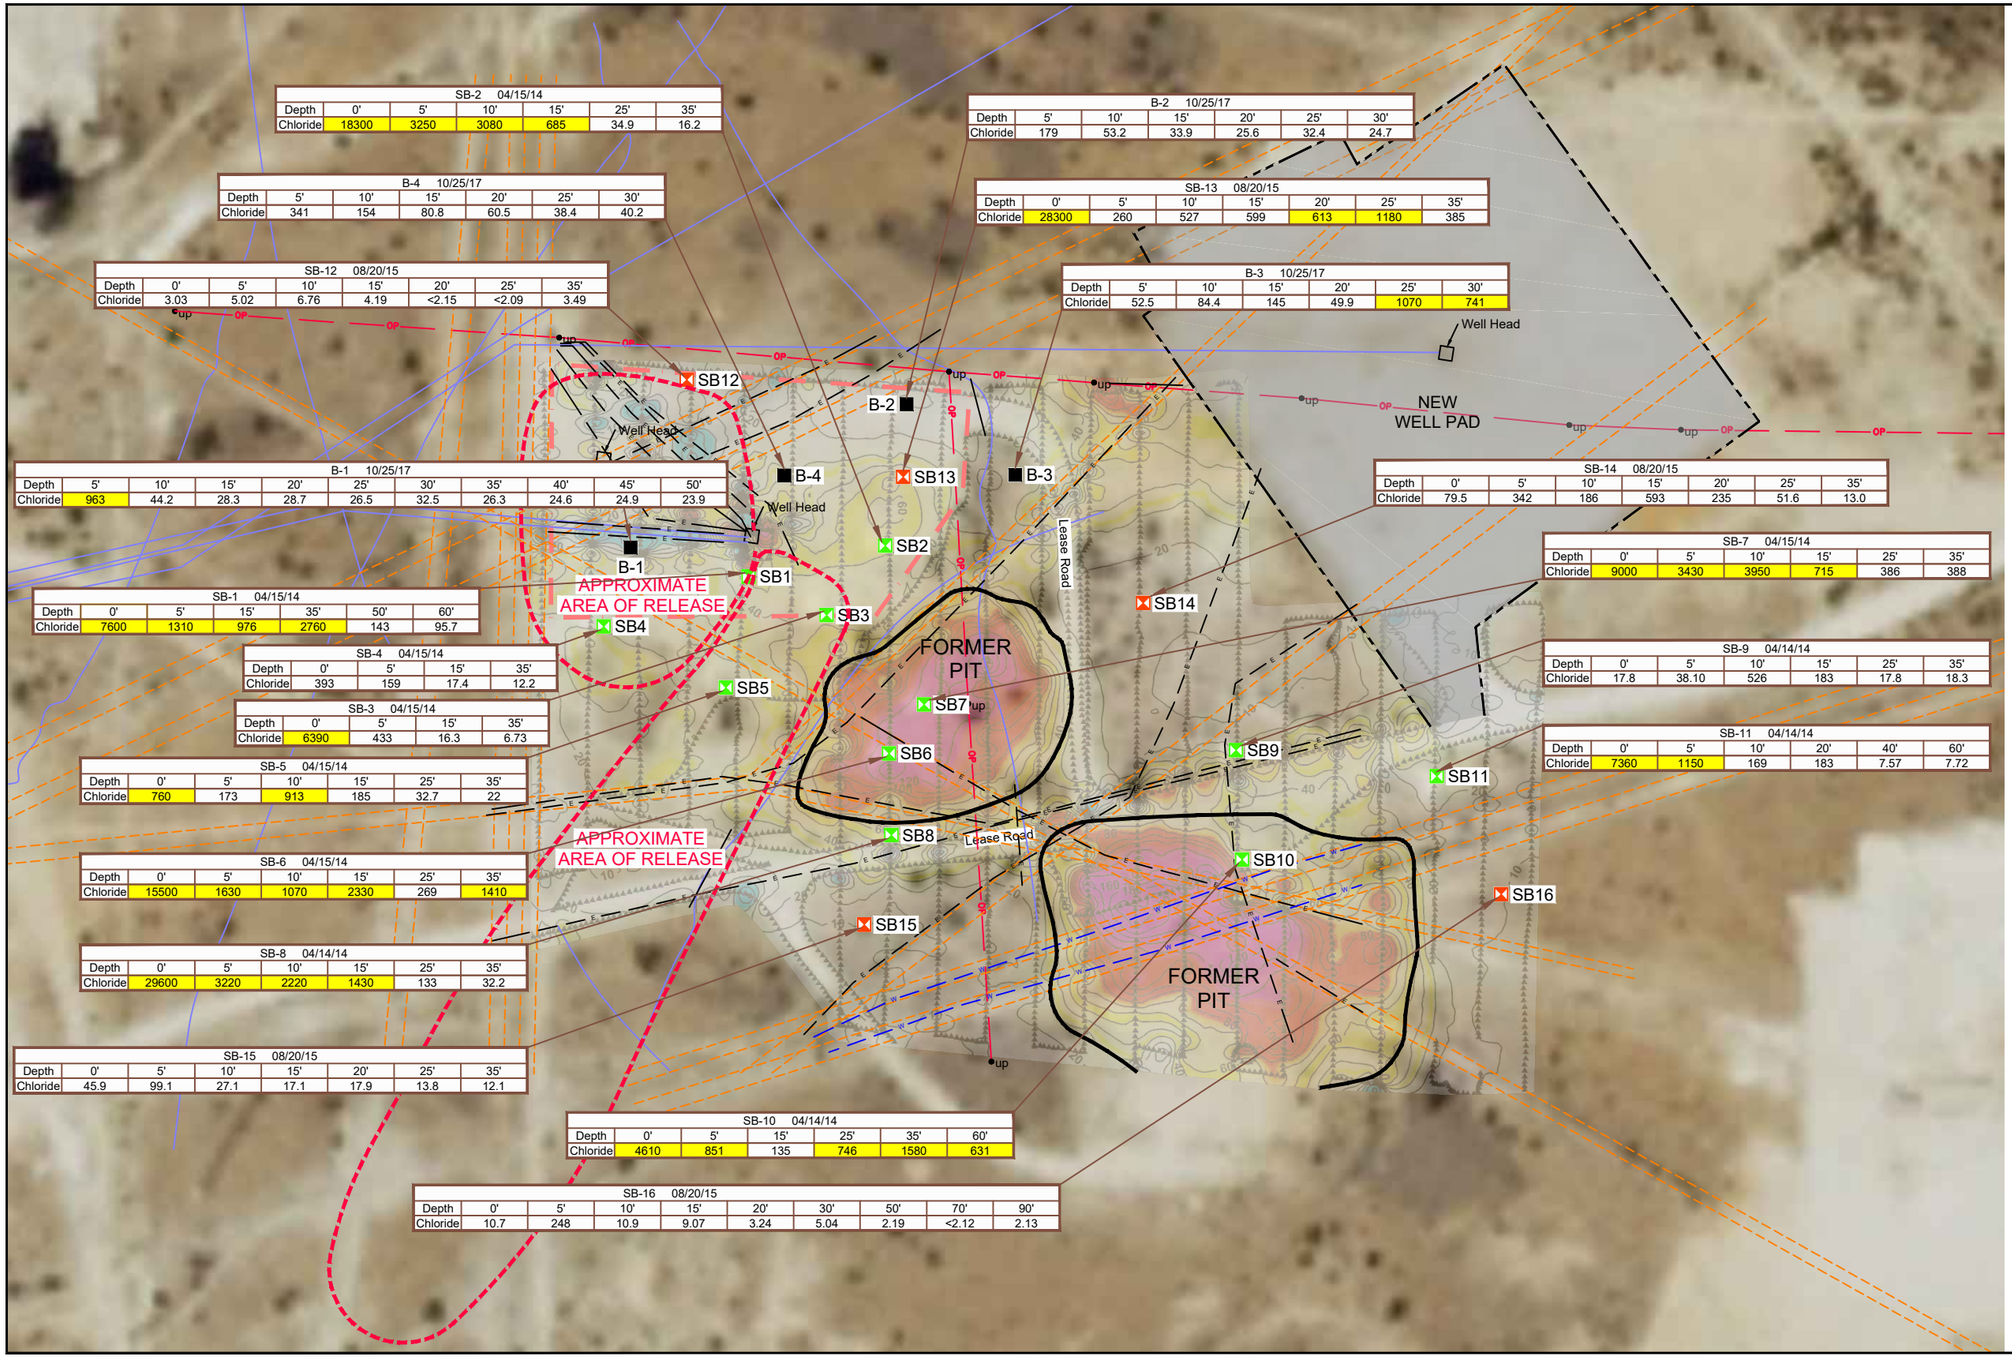
Drill cuttings were used for logging the soil type in each of the locations. Boring locations are shown on Figure 3. Soil observed during drilling activities consisted primarily of silty sands with secondary cementation (caliche). Boring logs are included as Appendix C.
