Closure Report
Honey Graham State Com 002H
Incident #: NAPP212389552
Eddy County, New Mexico
Unit C Sec 29 T26S R28E
32.020690°, -104.112098°

Produced Water Release
Point of Release: Hole in flowline
Release Date: 08.08.21
Volume Released: 7 barrels of Produced Water
Volume Recovered: 7 barrels of Produced Water

Re: Closure Report
Honey Graham State Com 002H
Concho Operating, LLC
Incident ID NAPP213839552
Site Location: Unit C, S29, T26S, R28E
(Lat 32.020690º, Long -104.112098º)
Eddy County, New Mexico

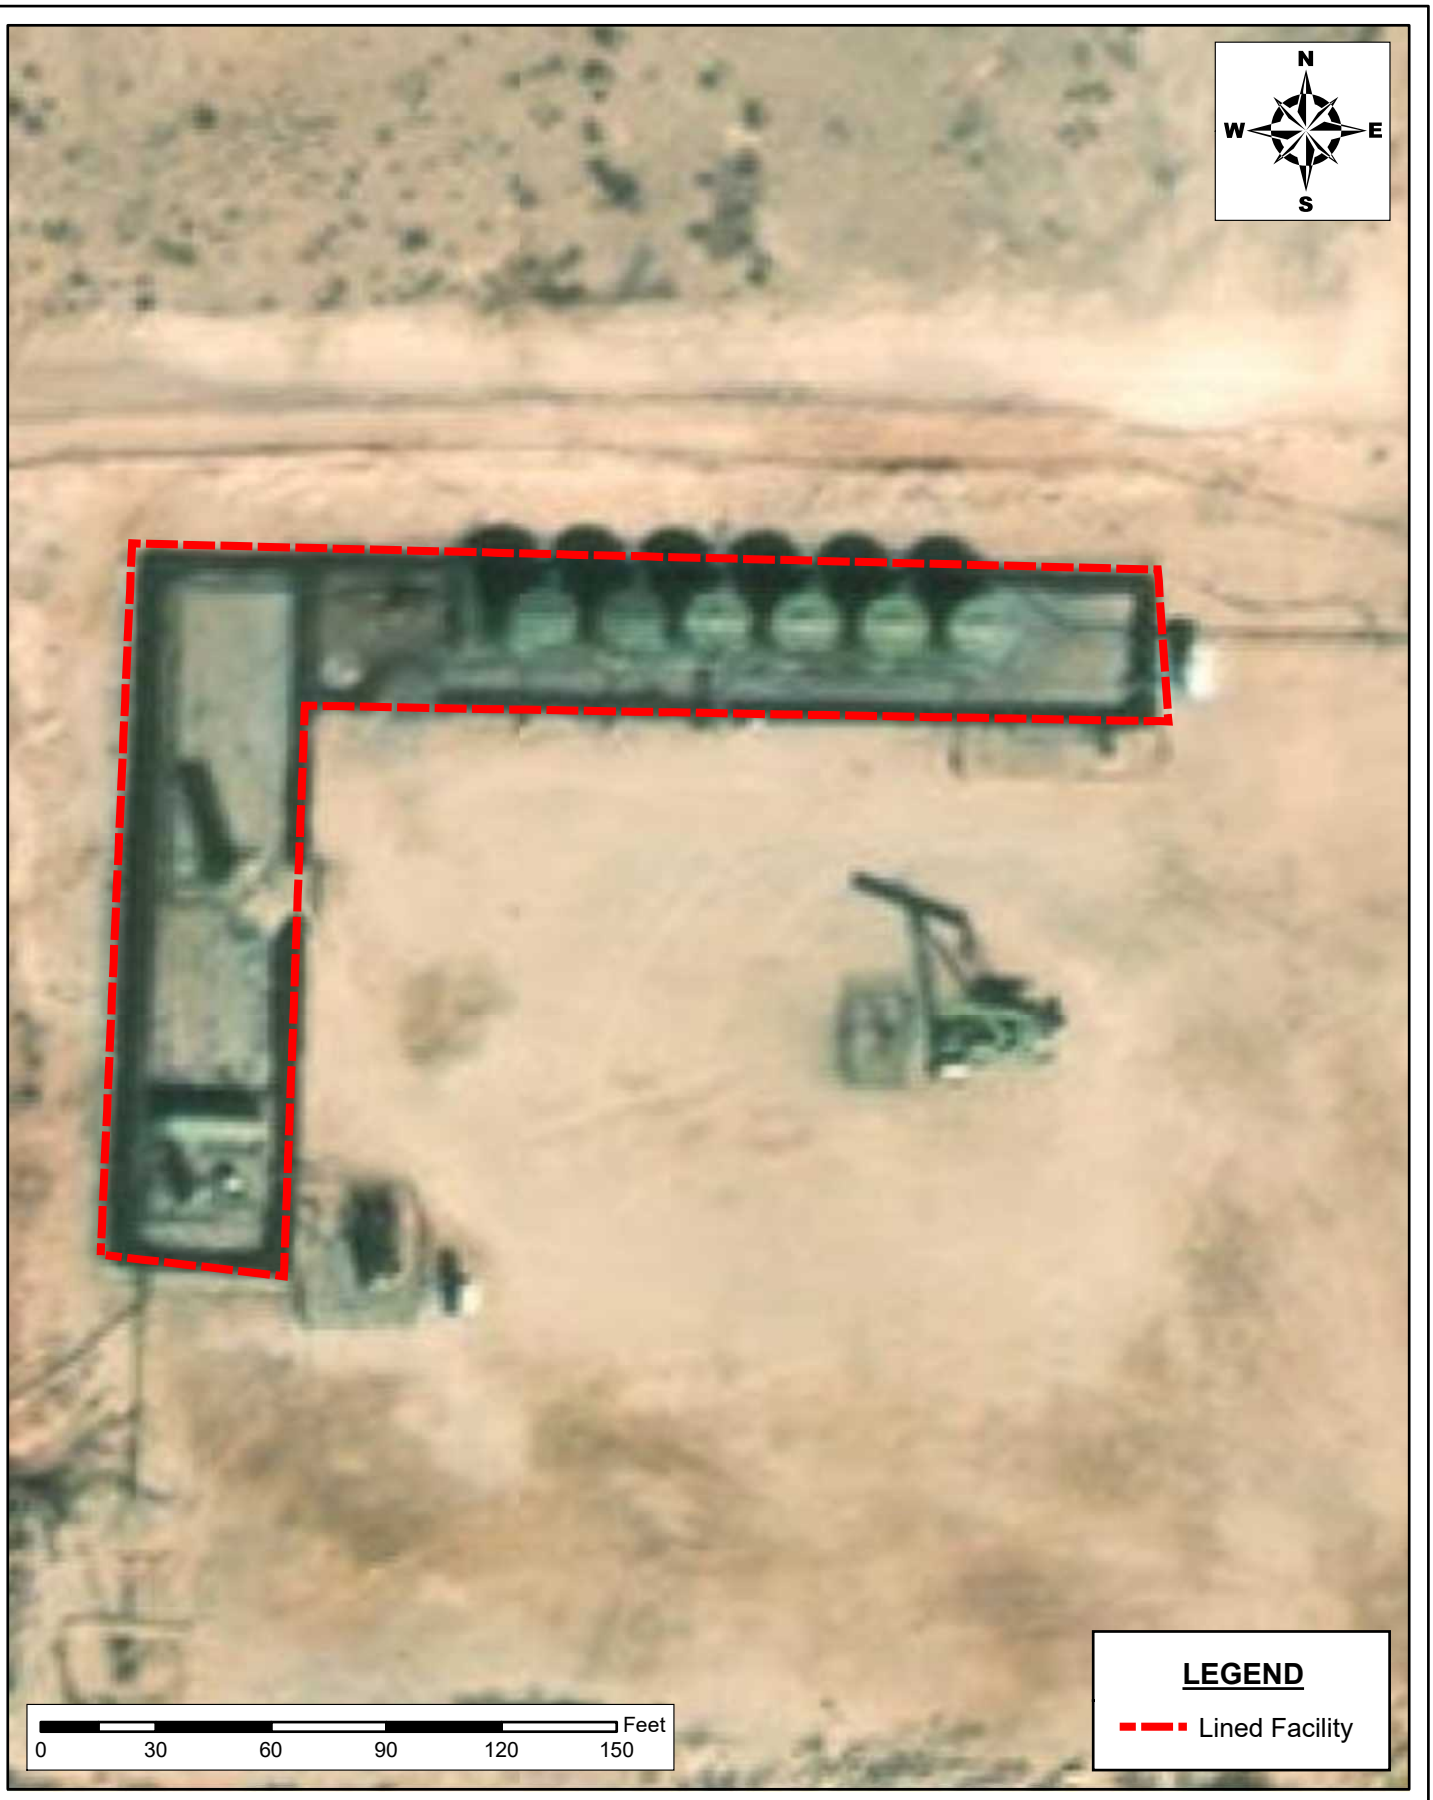
DRAWING NUMBER:
FIGURE 3
SHEET NUMBER:
1 of 1

Based on the initial C-141 obtained from the New Mexico Oil Conservation Division (NMOCD), the release was discovered on August 8, 2021, due to a hole developing on a flowline. It resulted in approximately 7 barrels of produced water and 7 barrels of produced water recovered. See figure 3. The initial C-141 form is attached in Appendix B.
