LT Environmental, Inc.
3300 North "A" Street
Building 1, Unit 103
Midland, Texas 79705
432.704.5178

October 4, 2019

RE: Closure Request
Big Eddy Unit #74 Tank Battery
Remediation Permit Numbers 2RP-2664 and 2RP-3213
Eddy County, New Mexico

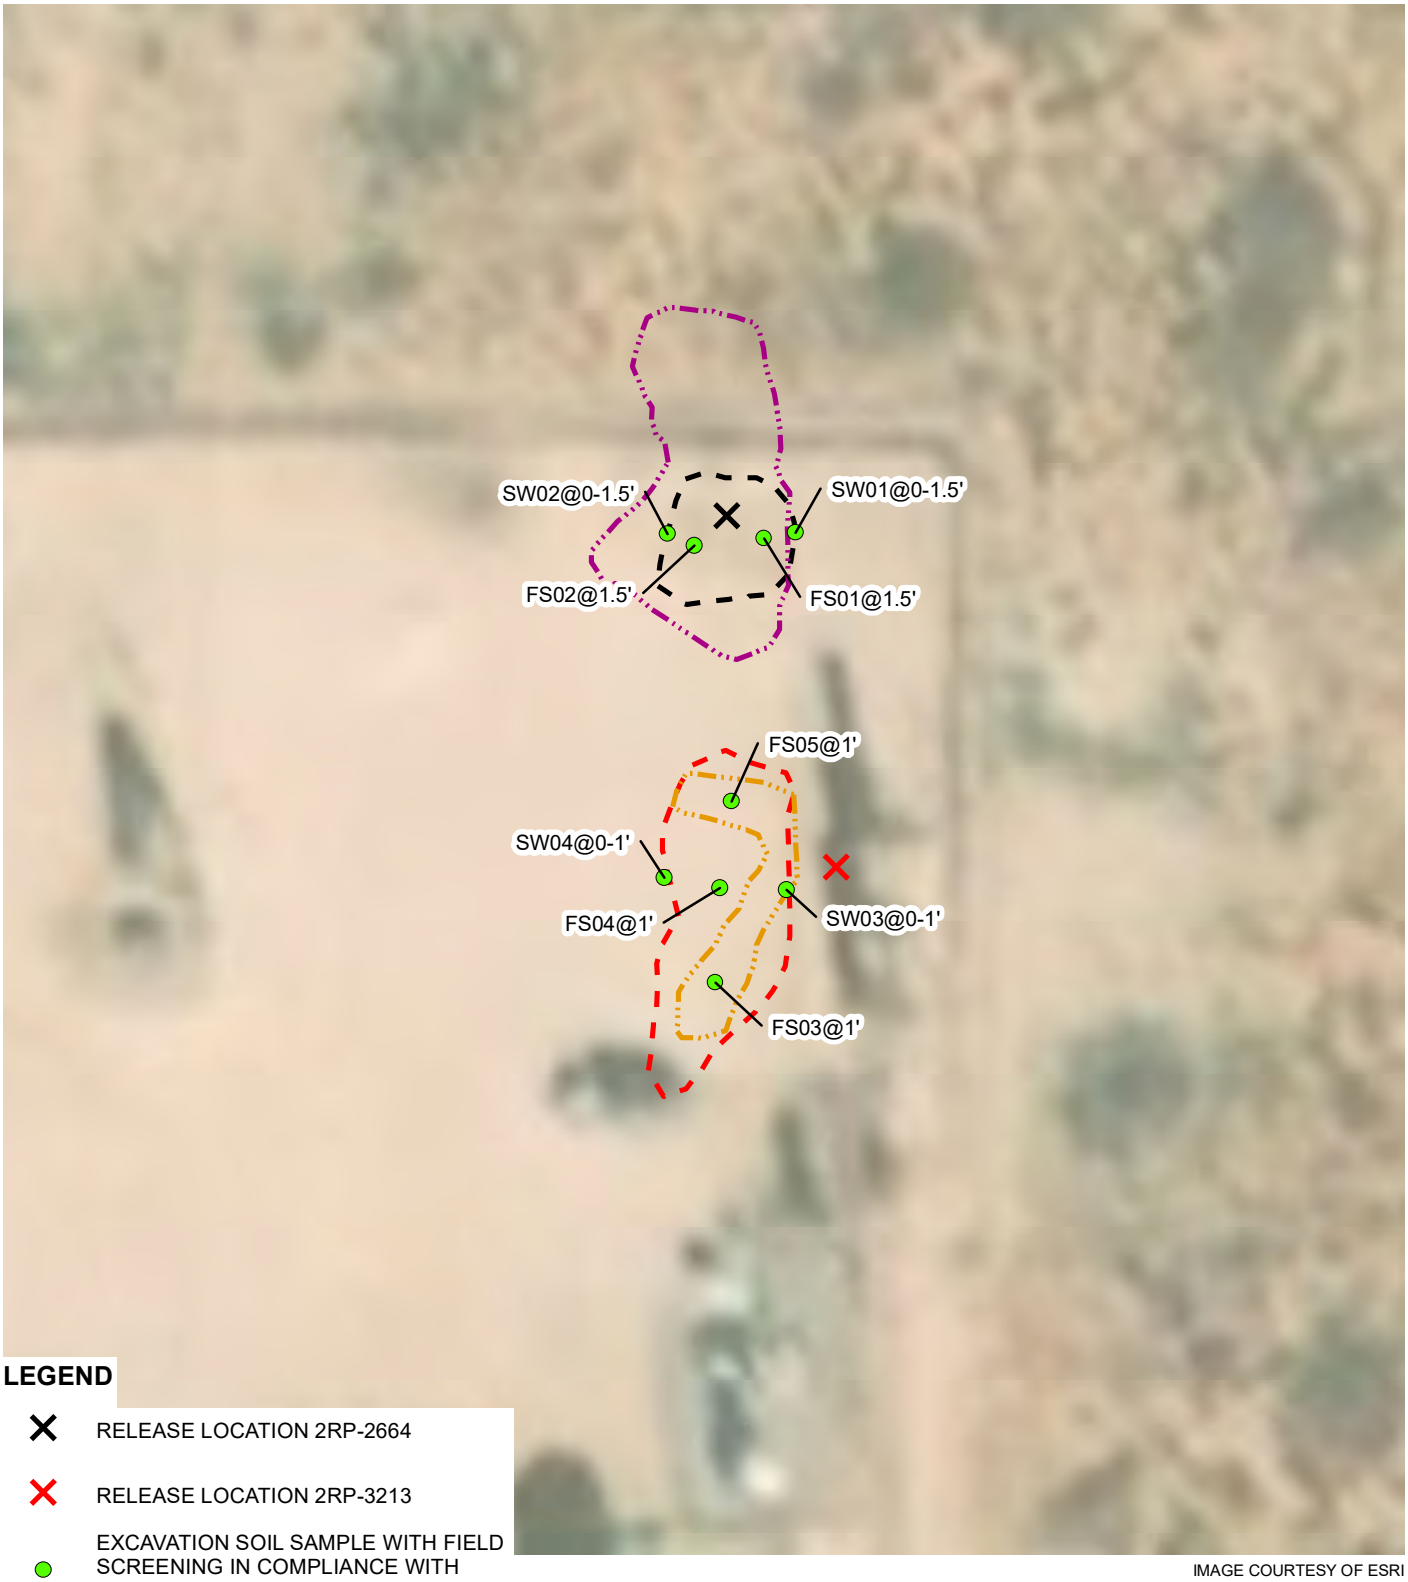
FIGURE 2
EXCAVATION SOIL SAMPLE LOCATIONS
BIG EDDY UNIT #74 TANK BATTERY
UNIT B SEC 25 T21S R28E
EDDY COUNTY, NEW MEXICO
XTO ENERGY, INC.

On June 14, 2019, LTE personnel inspected the Site to evaluate the release extents based on information provided on the Form C141s and visual observations. Surficial staining was observed in the release areas on the well pad. The release extents were mapped utilizing a handheld Global Positing System (GPS) unit and are depicted on Figure 2.

Initial response efforts and excavation of impacted soil have mitigated impacts at this Site. XTO requests no further action for RP Numbers 2RP-2664 and 2RP-3213. XTO will backfill the excavations with material purchased locally and recontour the Site to match pre-existing site conditions. An updated NMOCD Form C-141 for each release is included in Attachment 1.

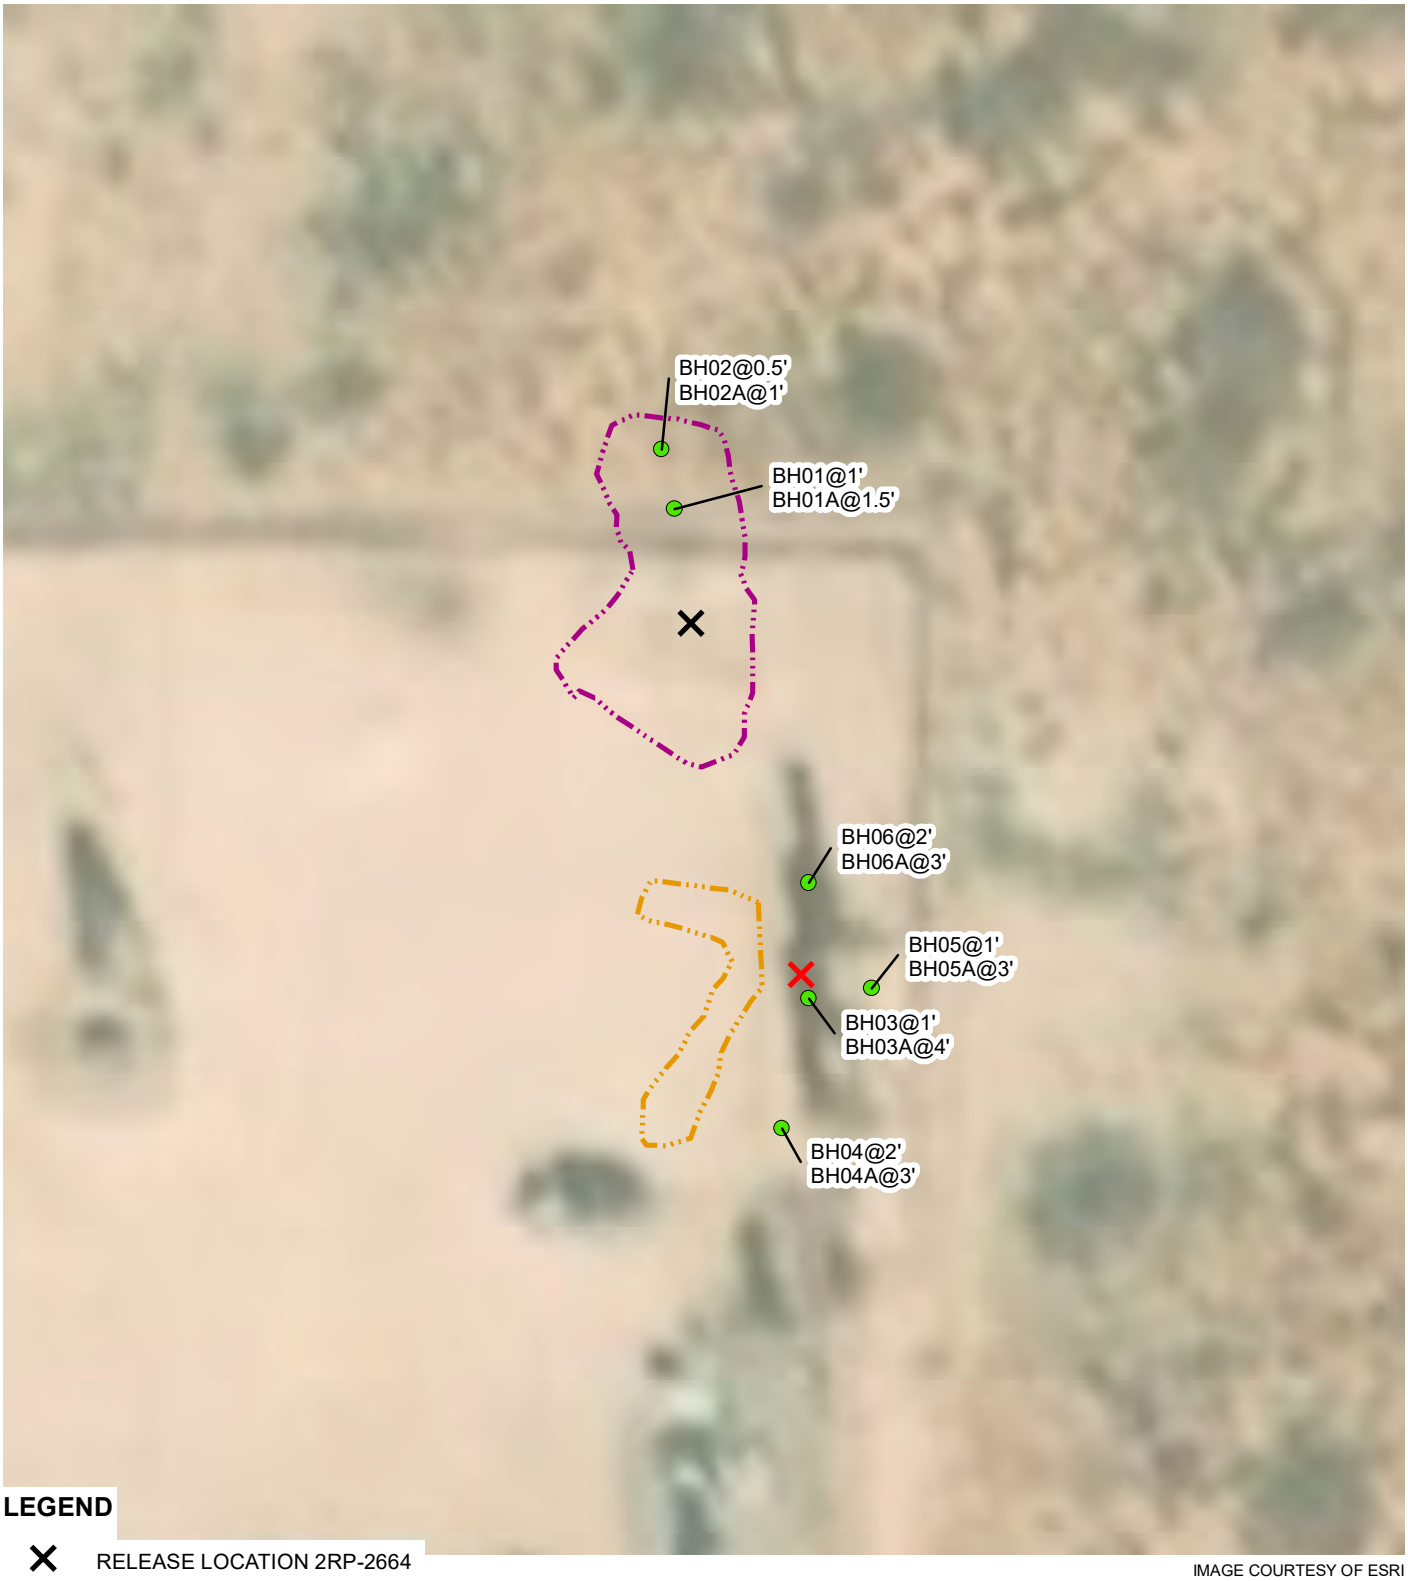
- RELEASE LOCATION 2RP-2664
- RELEASE LOCATION 2RP-3213
- DELINEATION SOIL SAMPLE IN COMPLIANCE WITH APPLICABLE CLOSURE CRITERIA
- RELEASE EXTENT 2RP-2664
- RELEASE EXTENT 2RP-3213
