TETRA TECH

January 31, 2022

Re: Release Characterization and Closure Request
ConocoPhillips
Heritage Concho
RJ Unit 119 Release
Unit Letter P & O, Section 27, Township 17 South, Range 29 East
Eddy County, New Mexico
Incident ID# NMLB1022356827
2RP-426

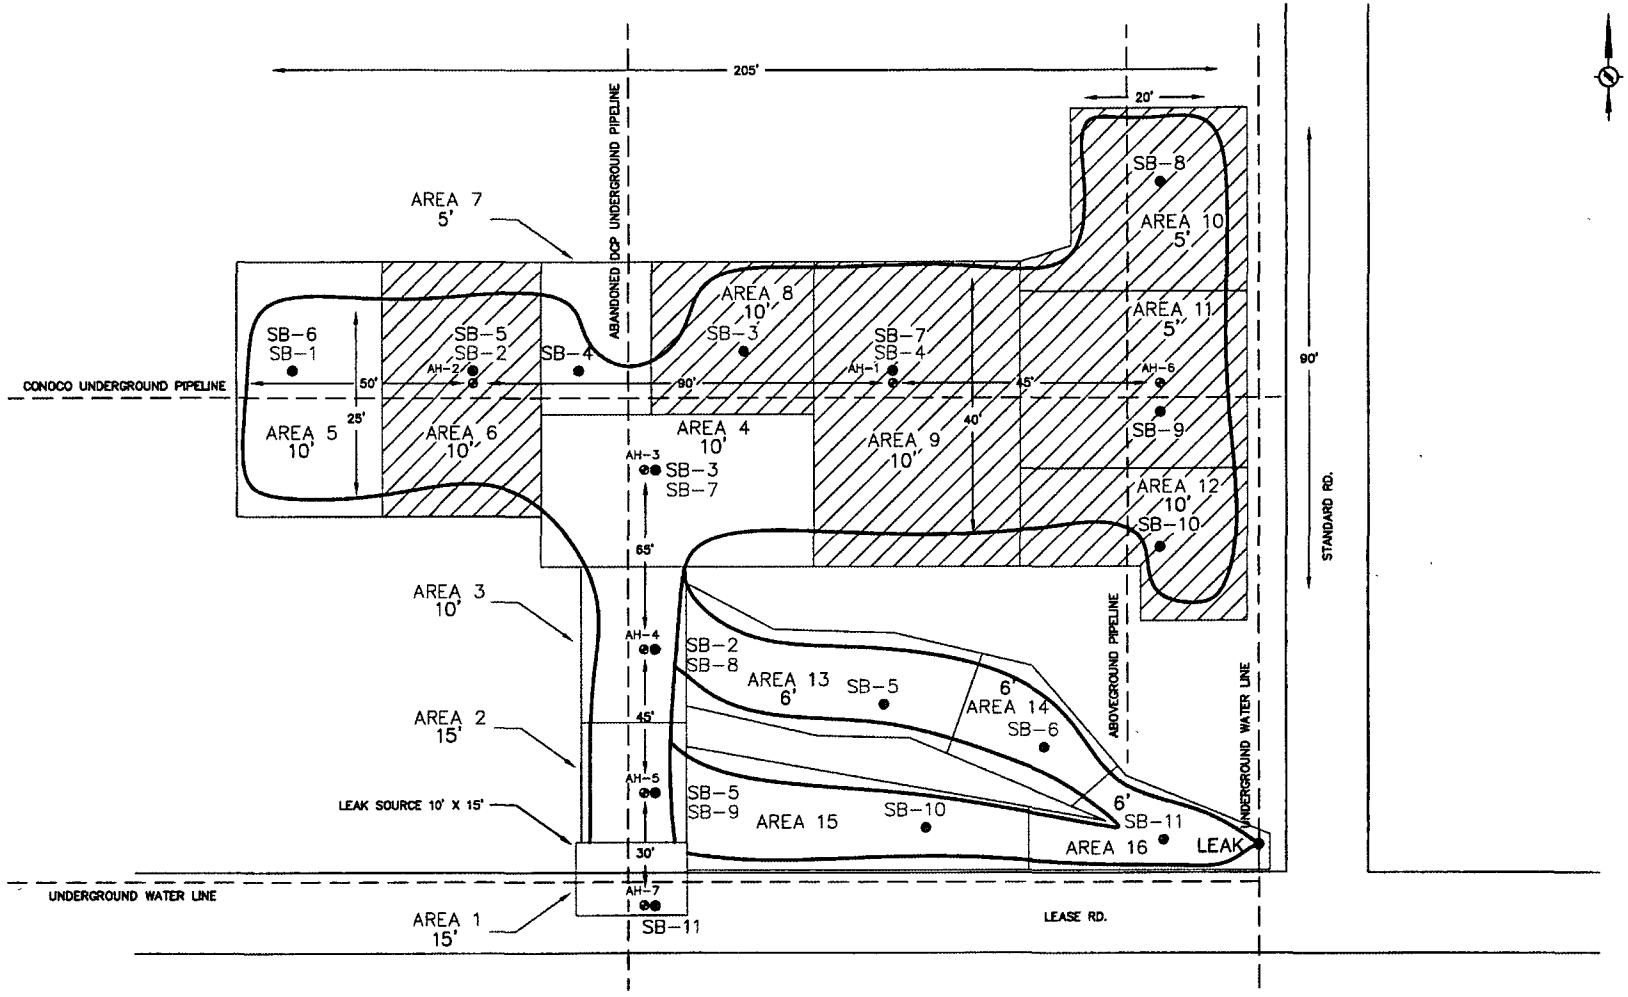
RJU #119 & #110 (#121)
INJECTION LINE LEAK

Propose Excavation Depths

Propose Liner Installation

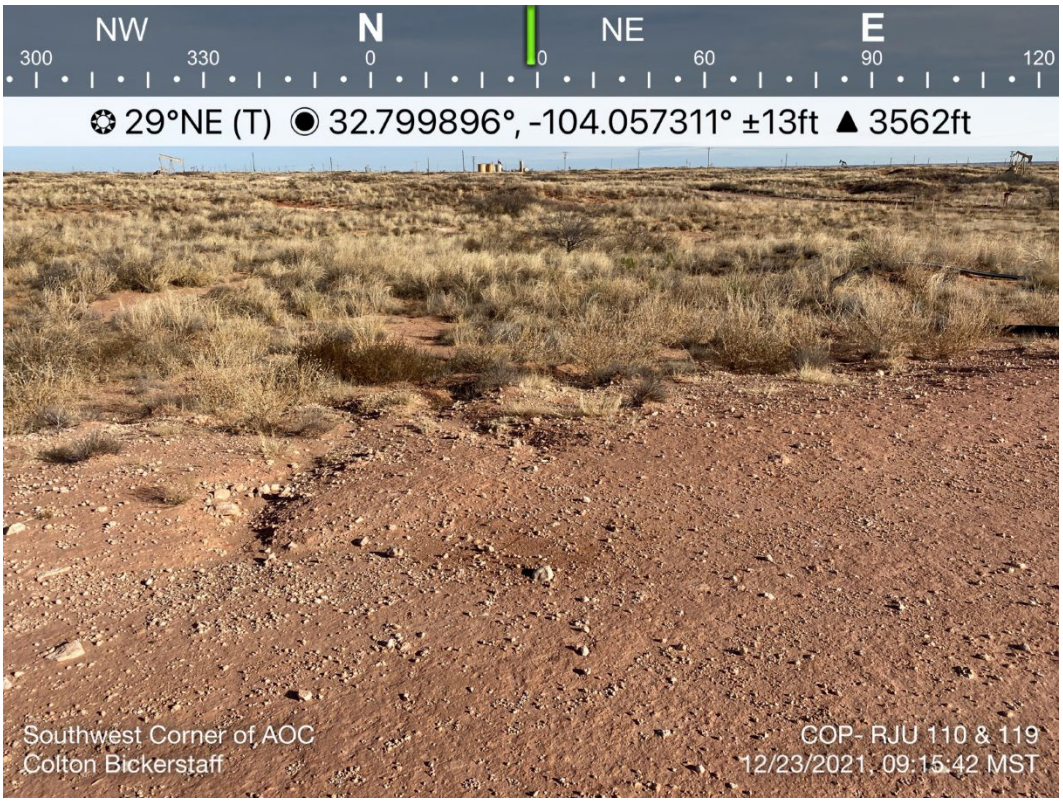
TETRA TECH, INC. PROJECT NO. 212C-MD-02619	DESCRIPTION	View north-northeast of southwest corner of visual inspection area from lease pad.	1
	SITE NAME	ConocoPhillips: RJ Units 110 & 119 Site Visit	12/23/2021

TETRA TECH, INC. PROJECT NO. 212C-MD-02619	DESCRIPTION	View south-southwest of northeast corner of visual inspection area from lease road.	2
	SITE NAME	ConocoPhillips: RJ Units 110 & 119 Site Visit	12/23/2021

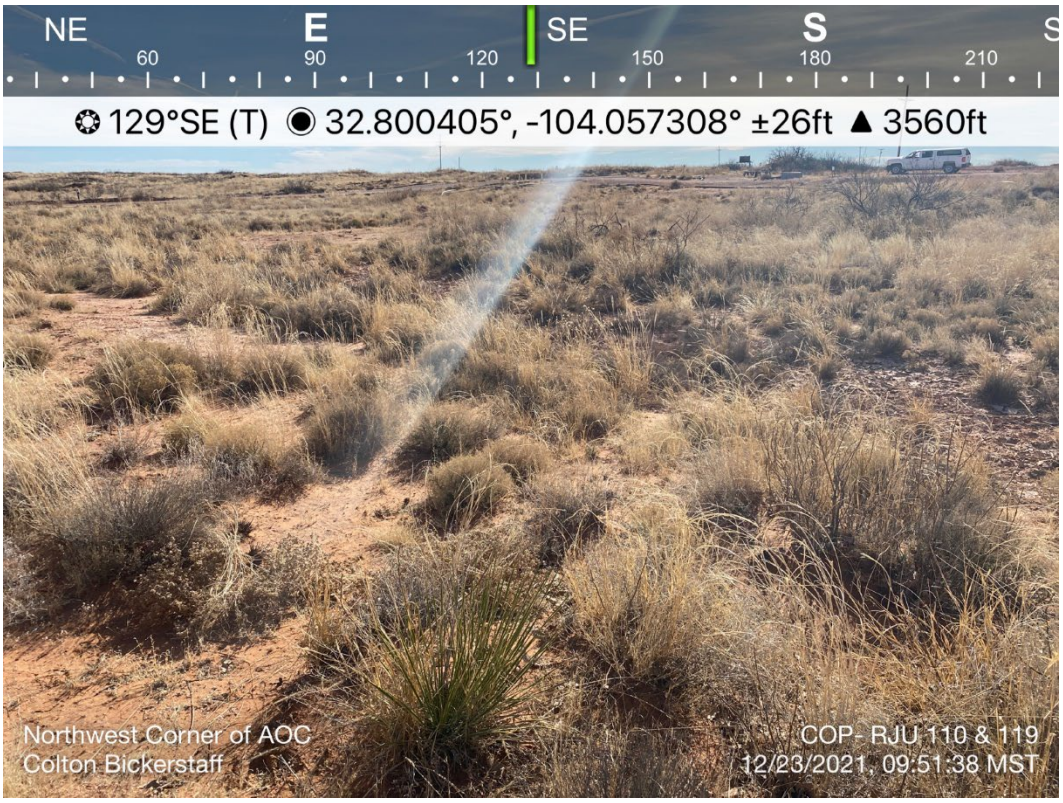
TETRA TECH, INC. PROJECT NO. 212C-MD-02619	DESCRIPTION	View southeast of northwest corner of visual inspection area.	3
	SITE NAME	ConocoPhillips: RJ Units 110 & 119 Site Visit	12/23/2021

TETRA TECH, INC. PROJECT NO. 212C-MD-02619	DESCRIPTION	View south of surface flowlines along eastern boundary of visual inspection area.	4
	SITE NAME	ConocoPhillips: RJ Units 110 & 119 Site Visit	12/23/2021

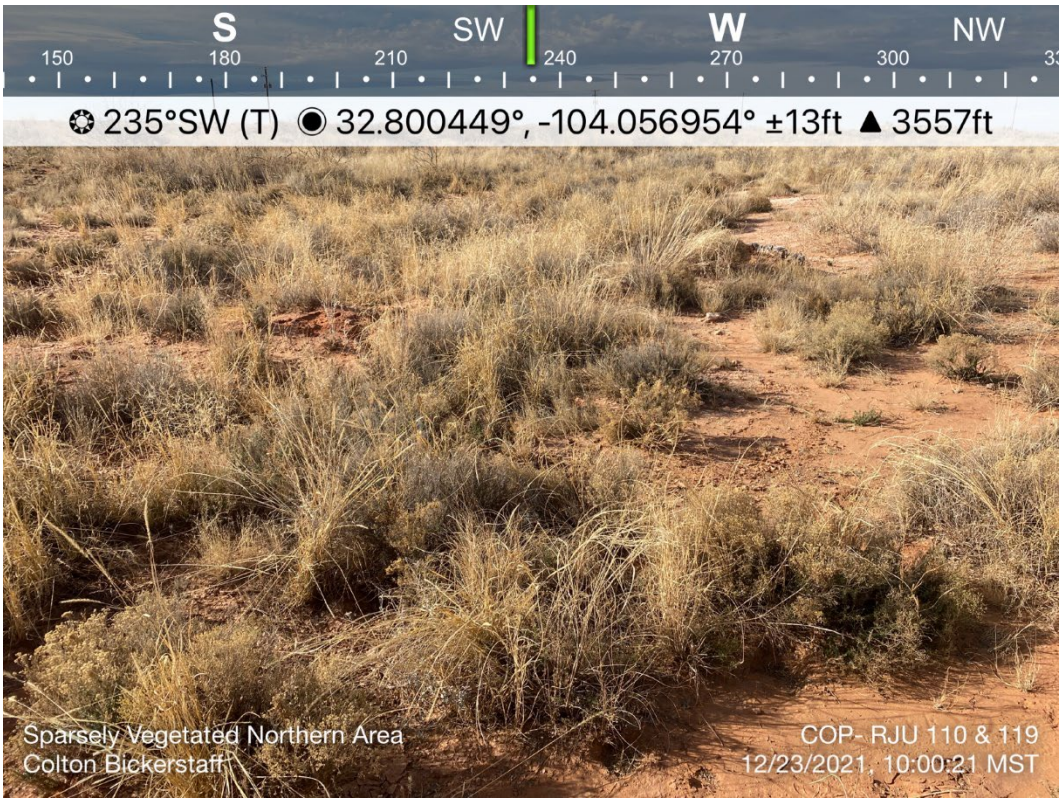
TETRA TECH, INC. PROJECT NO. 212C-MD-02619	DESCRIPTION	View southwest of northern portion of the visual inspection area.	5
	SITE NAME	ConocoPhillips: RJ Units 110 & 119 Site Visit	12/23/2021

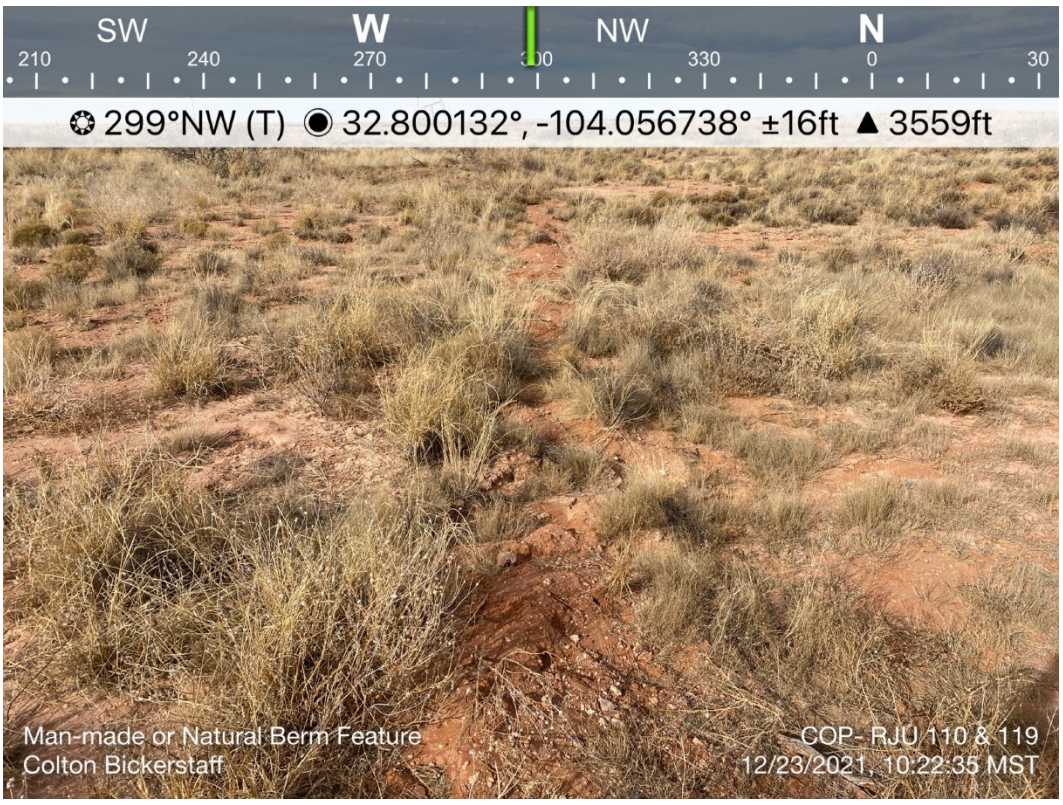
TETRA TECH, INC. PROJECT NO. 212C-MD-02619	DESCRIPTION	View northwest of vegetation and berm feature in visual inspection area.	6
	SITE NAME	ConocoPhillips: RJ Units 110 & 119 Site Visit	12/23/2021
