February 11, 2019

RE: Closure Request
Palmillo State #1 Flow Line
Remediation Permit Number 2RP-2849
Eddy County, New Mexico

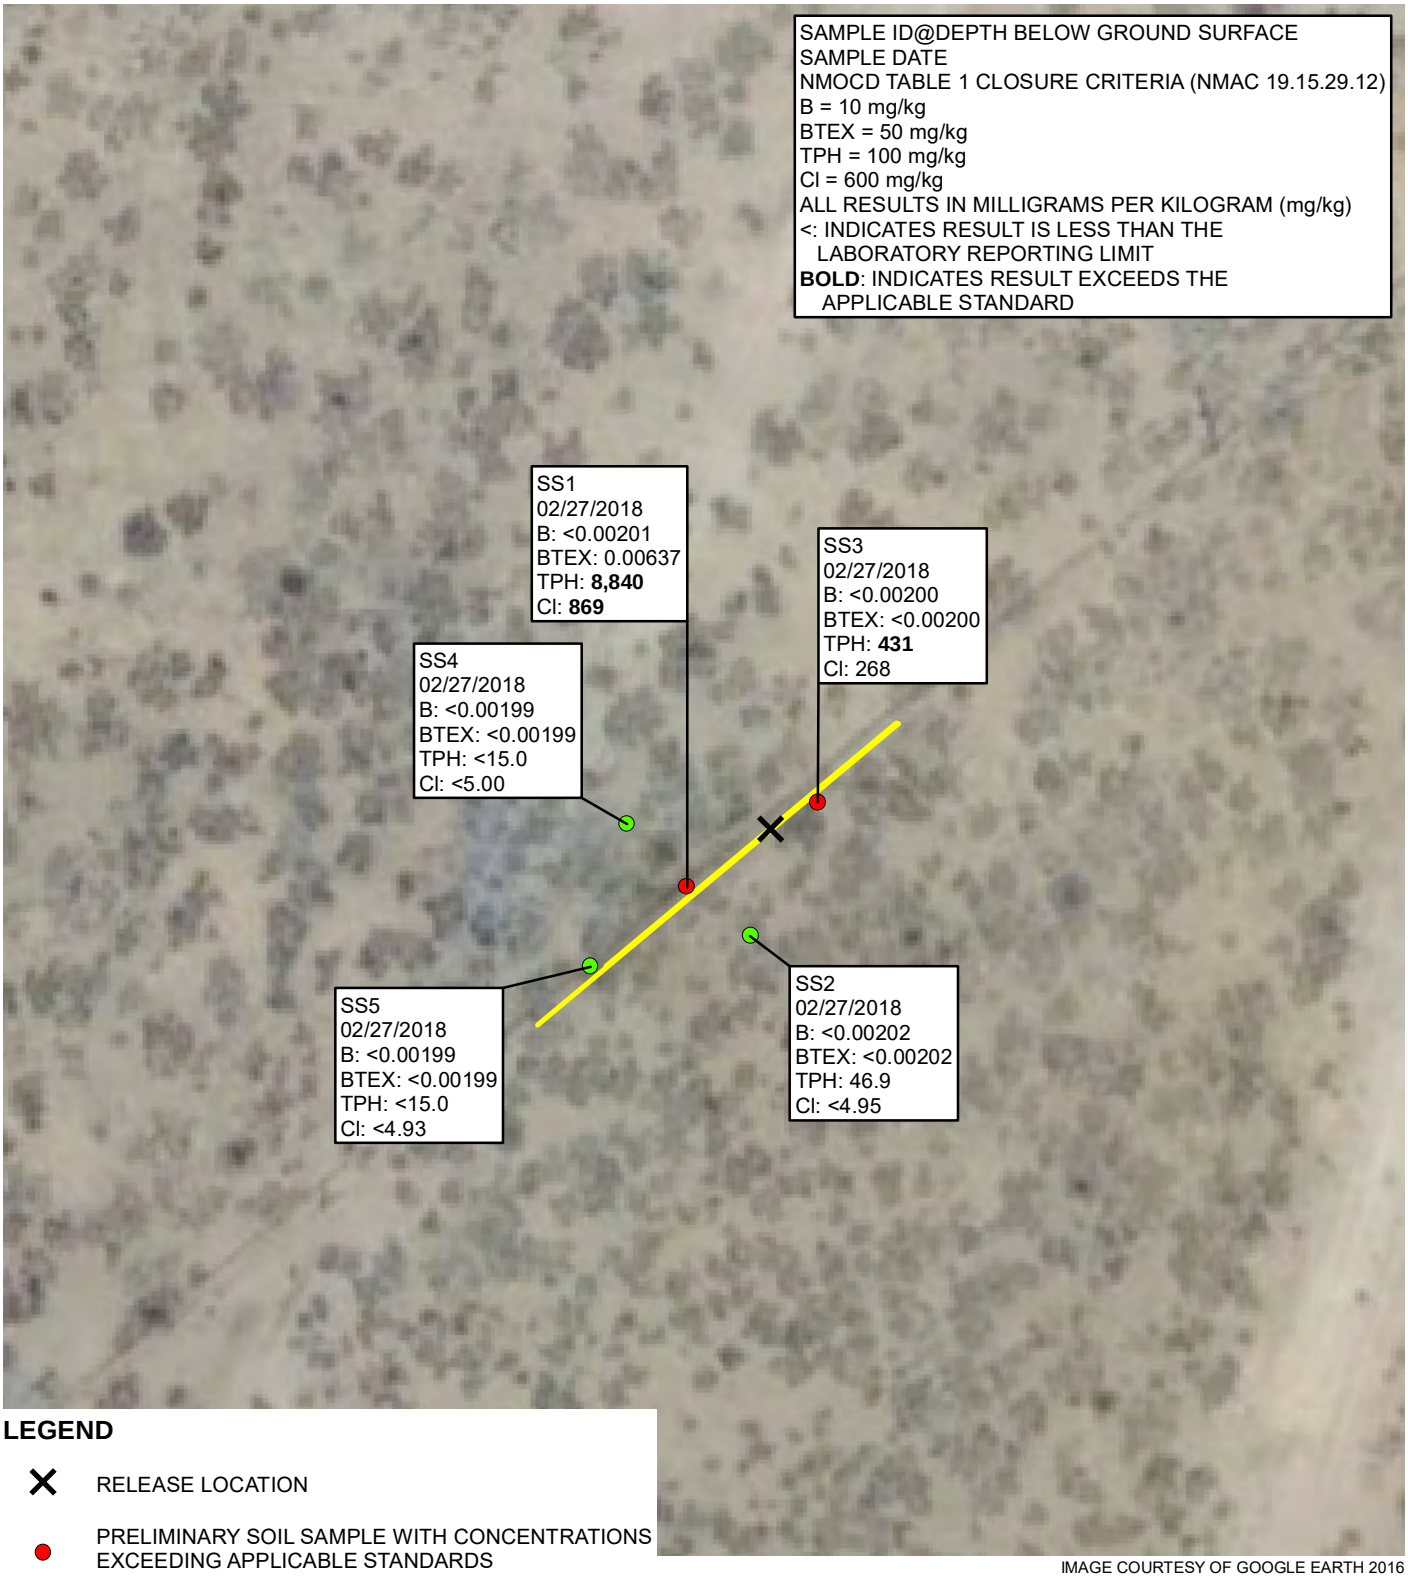
FIGURE 2
PRELIMINARY SOIL SAMPLE LOCATIONS
PALMILLO STATE #1 FLOW LINE
UNIT J SEC 1 T19S R28E
EDDY COUNTY, NEW MEXICO
XTO ENERGY, INC.

Laboratory analytical results indicated that soil samples SS1 and SS3 exceeded the NMOCD Table 1 closure criteria for TPH and soil sample SS1 exceeded the NMOCD Table 1 closure criteria for chloride. Laboratory analytical results indicated that soil samples SS2, SS4, and SS5 were compliant with the NMOCD Table 1 closure criteria for BTEX, TPH, and chloride. Laboratory analytical results are presented on Figure 2 and summarized in Table 1, and the laboratory analytical report is included in Attachment 2. Based on the soil sample laboratory results, excavation of impacted soil was required.

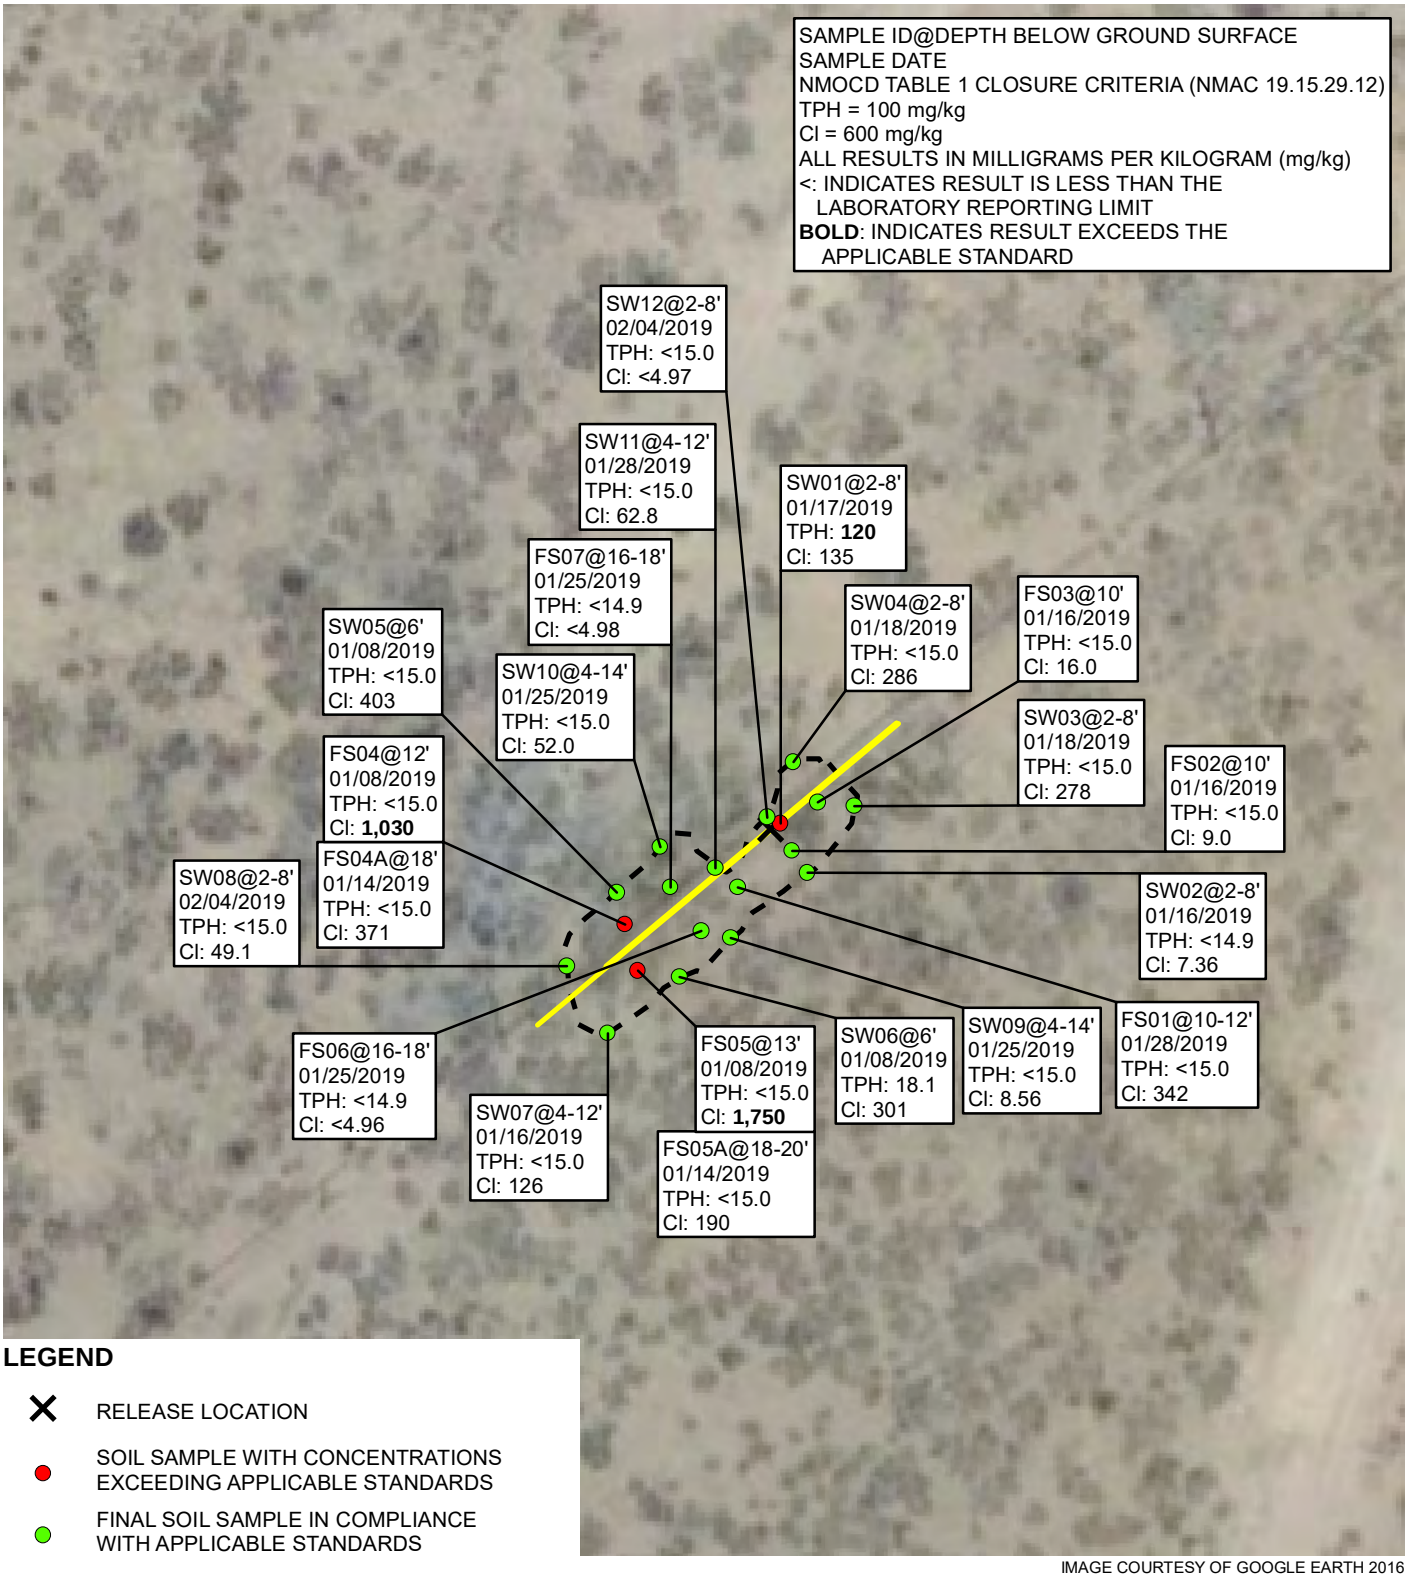
During January and February 2019, LTE personnel returned to the Site to oversee excavation of impacted soil as indicated by visual staining, field screening, and laboratory analytical results exceeding the NMOCD Table 1 closure criteria in preliminary soil samples SS1 and SS3. To delineate hydrocarbon and chloride impacts to soil and direct excavation activities, LTE screened soil samples using a PID and Hach® chloride QuanTab® test strips. Following removal of impacted soil, LTE collected soil samples from the sidewalls and floor of the excavation. The excavation soil samples were collected as 5-point composite samples to comply with 19.15.29 NMAC, dated August 14, 2018. Composite soil samples SW01 through SW12 were collected from the sidewalls of the excavation from depths of 2 feet to 12 feet bgs. Composite soil samples FS01 through FS07 were collected from the floor of the excavation from depths of 10 feet to 20 feet bgs. The 5-point composite sample were collected by depositing 5 aliquots of soil into a 1-gallon, resealable plastic bag and homogenizing the samples by thoroughly mixing. The soil samples were collected, handled, and analyzed as described above and submitted to Xenco in Midland, Texas. The soil sample locations are depicted on Figure 3.
