LT Environmental, Inc.
3300 North "A" Street, Building 1, Unit 103
Midland, Texas 79705
432.704.5178

October 22, 2018

RE: Closure Request
Big Eddy Unit #158
Remediation Permit Number 2RP-2631 and 2RP-2662
Eddy County, New Mexico

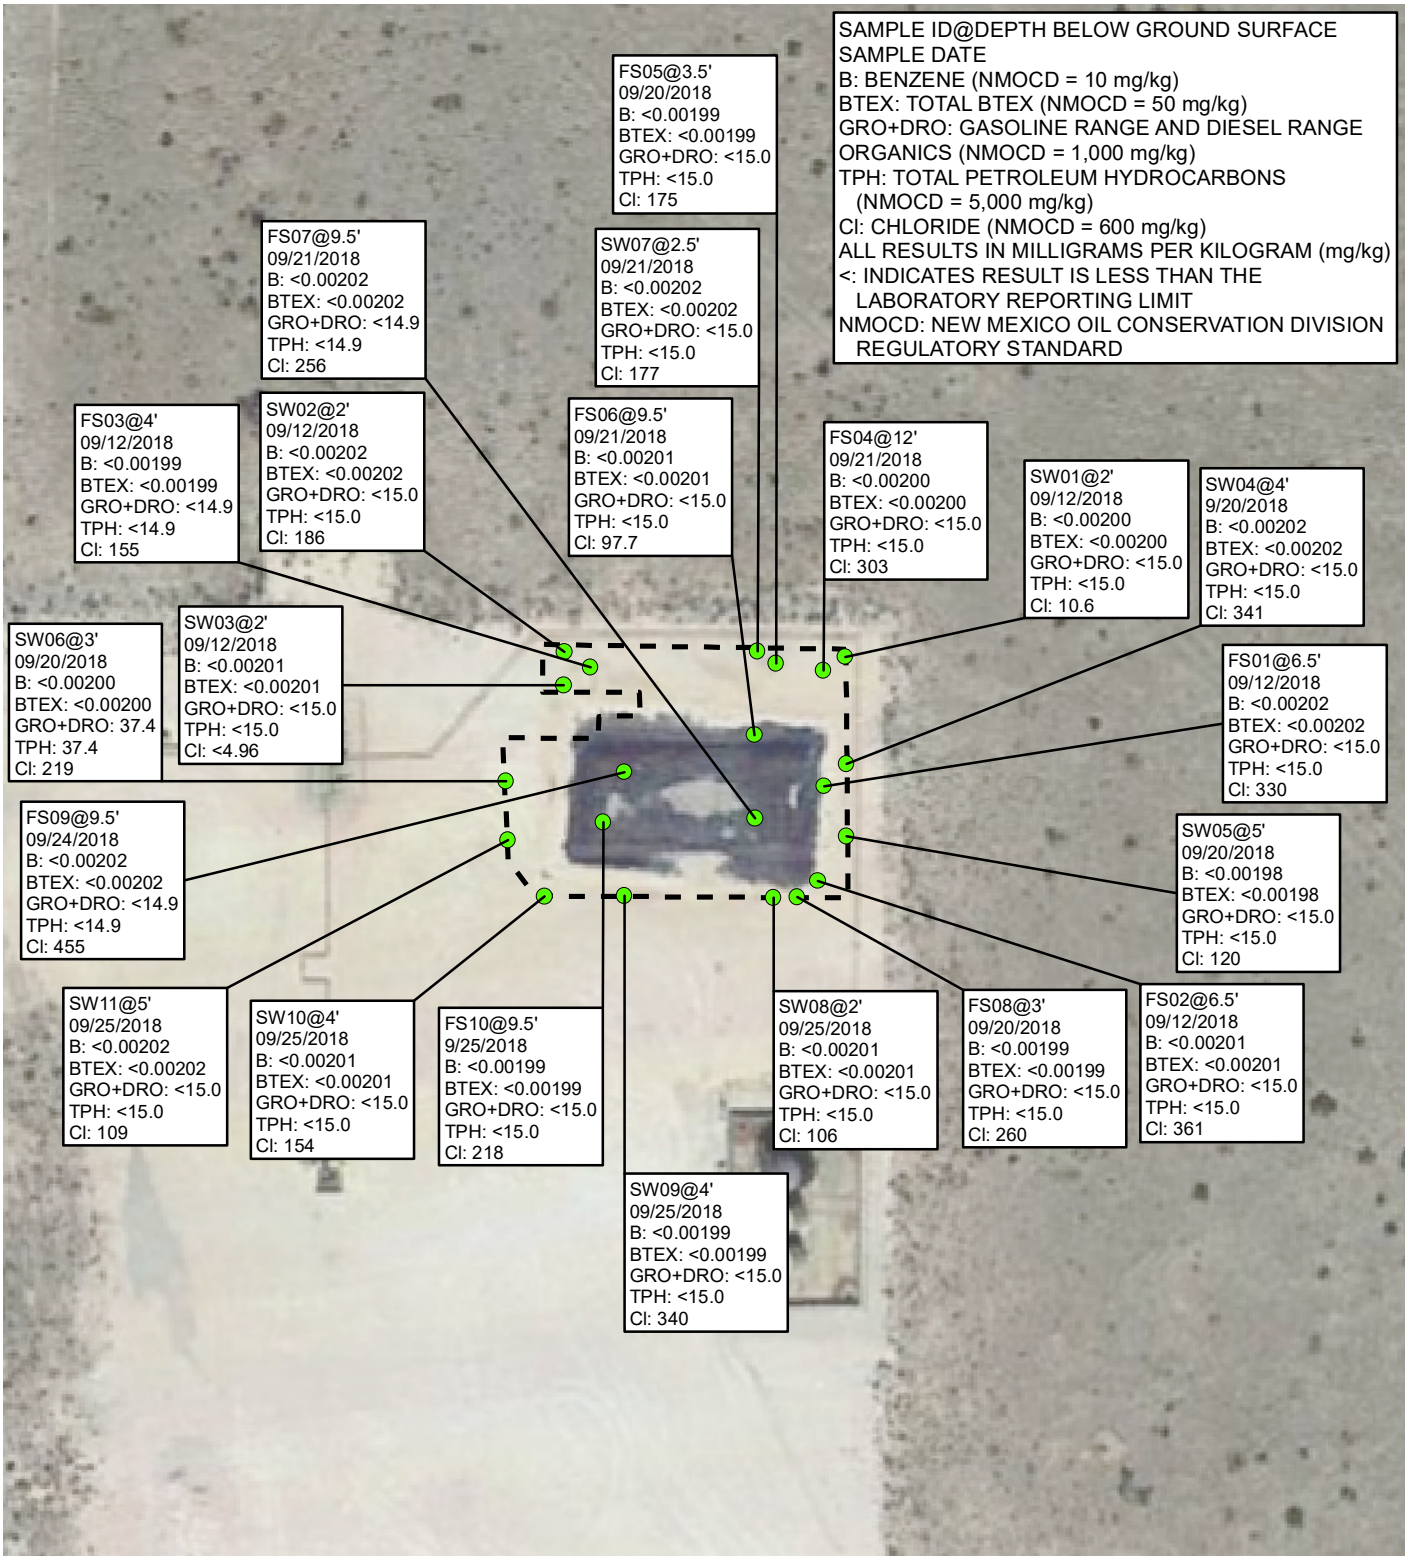
During September 2018, LTE personnel were at the Site to oversee excavation of impacted soil as indicated by visual staining, field screening, and descriptions on the NMOCD Form C-141s. To delineate hydrocarbon and chloride impacts to soil and direct excavation activities, LTE screened soil using a photo-ionization detector and Hach® chloride QuanTab® test strips. Excavation activities commenced on September 5, 2018, and concluded on September 25, 2018. Impacted soil was mechanically excavated from the release area to depths ranging from 3 feet to 12 feet bgs.
