CONCHO

Closure Report
MC Federal #003
API#: 30-025-34773
RP#: 1RP-4793
DOR: August 14, 2017
Unit Letter F, Section 21, Township 17 South, Range 32 East
Lea County, New Mexico

MC FEDERAL #003

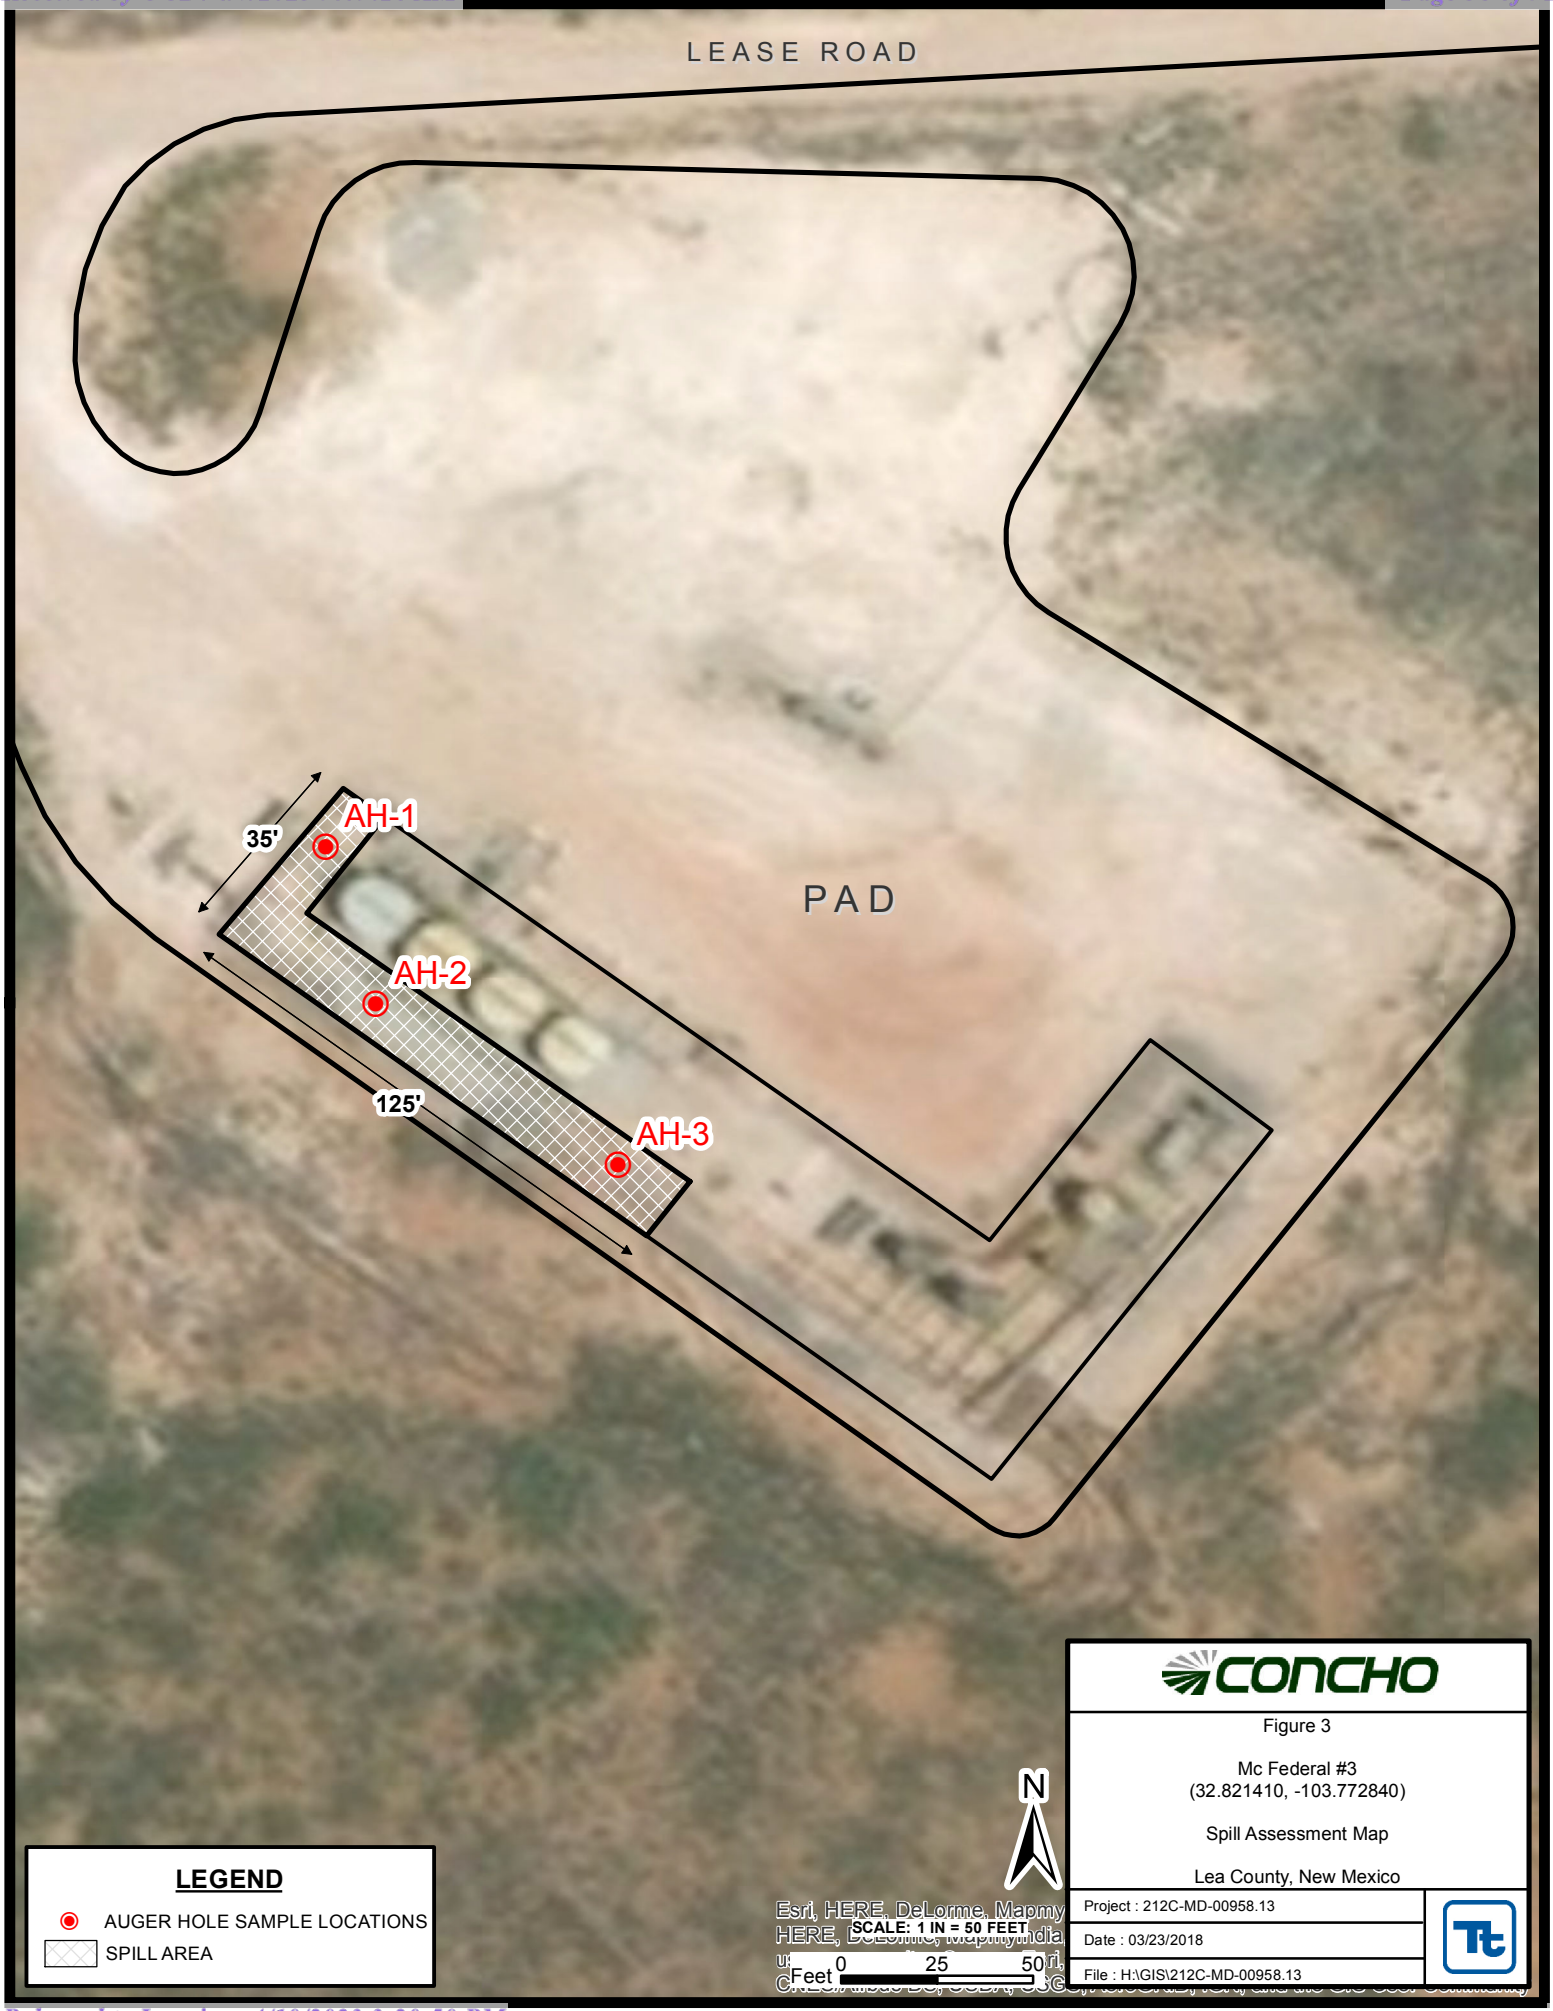
According to the State of New Mexico C-141 Initial Report, the leak was discovered on August 14, 2017, and released approximately fifteen (15) barrels of oil due to a hammer union failure on a divert line. A vacuum truck was used to remove all freestanding fluids, recovering approximately teen (10) barrels of oil. The release was contained inside the bermed facility and impacted an area measuring approximately 125' x 35'. The initial C-141 Form is included in Appendix A.

LEASE ROAD
PAD
AH-1
AH-2
AH-3
35'
125'
N
LEGEND
AUGER HOLE SAMPLE LOCATIONS
SPILL AREA
SCALE: 1 IN = 50 FEET
0
25
50
Feet
Esri, HERE, DeLorme, Mapmy
HERE, DeLorme, MapmyIndia
CONCHO
Figure 3
Mc Federal #3
(32.821410, -103.772840)
Spill Assessment Map
Lea County, New Mexico
Project : 212C-MD-00958.13
Date : 03/23/2018
File : H:\GIS\212C-MD-00958.13

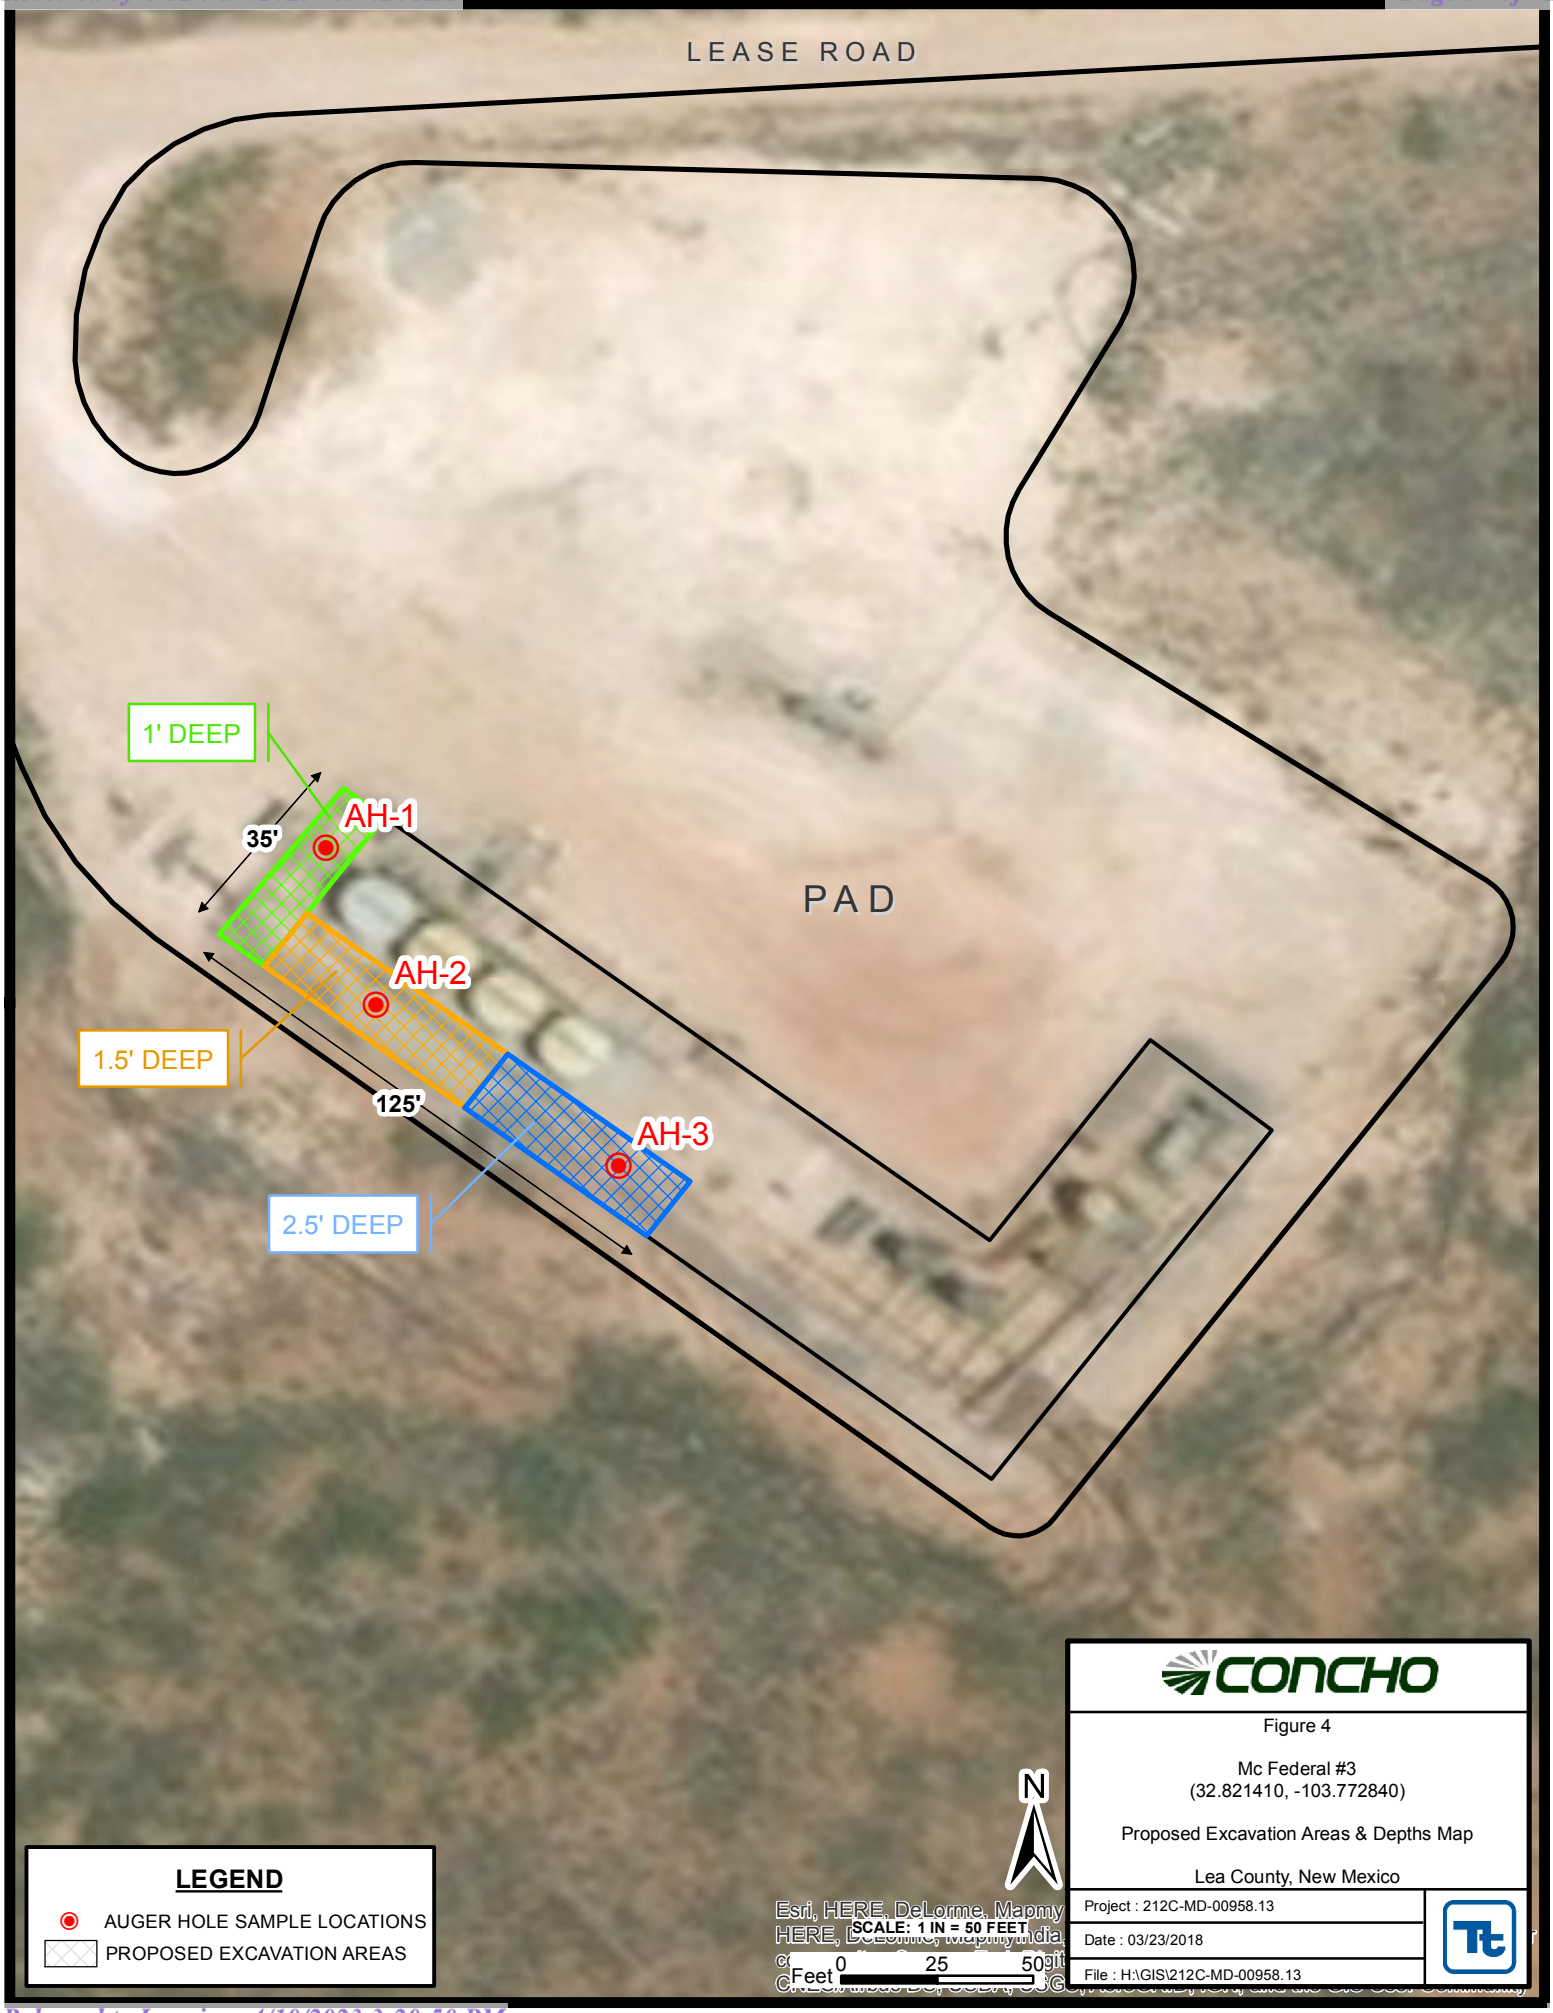
LEASE ROAD
PAD
1' DEEP
AH-1
35'
AH-2
1.5' DEEP
125'
AH-3
2.5' DEEP
LEGEND
AUGER HOLE SAMPLE LOCATIONS
PROPOSED EXCAVATION AREAS
N
SCALE: 1 IN = 50 FEET
0 25 50
Feet
Esri, HERE, DeLorme, Mapmy
CONCHO
Figure 4
Mc Federal #3
(32.821410, -103.772840)
Proposed Excavation Areas & Depths Map
Lea County, New Mexico
Project : 212C-MD-00958.13
Date : 03/23/2018
File : H:\GIS\212C-MD-00958.13

- The impacted area of AH-1 was excavated to a depth of one (1) foot below ground surface (bgs).
- The impacted area of AH-2 was excavated to a depth of one and one-half (1.5) feet bgs.
- The impacted area of AH-3 was excavated to a depth of two and one-half (2.5) feet bgs.
- On January 17, 2019, confirmation samples were collected from the floor and sidewalls of the excavation and analyzed for benzene, toluene, ethylbenzene and xylene (BTEX) by EPA Method 8021B, total petroleum hydrocarbons (TPH) by EPA Method 8015 modified and chloride SM4500 Cl B. Sidewall sample North-2 and East-1 exhibited elevated concentrations of chlorides and TPH respectively.
- All of the excavated material was hauled to an NMOCD approved solid waste disposal facility.
- The excavation was backfilled with clean "like" material and contoured to match the surrounding terrain.
