Re: Vacuum Glorieta West Unit Tank Battery Sites
Deferral Request Report
NMOCD Case No. 1RP-2861 and 3293
Lea County, New Mexico

2019 SITE DEFERRAL REPORT

Vacuum Glorieta West Unit Tank Battery Sites
Lea County, New Mexico

OGRID No. 4323
Case No. 1RP-2861 and 3293

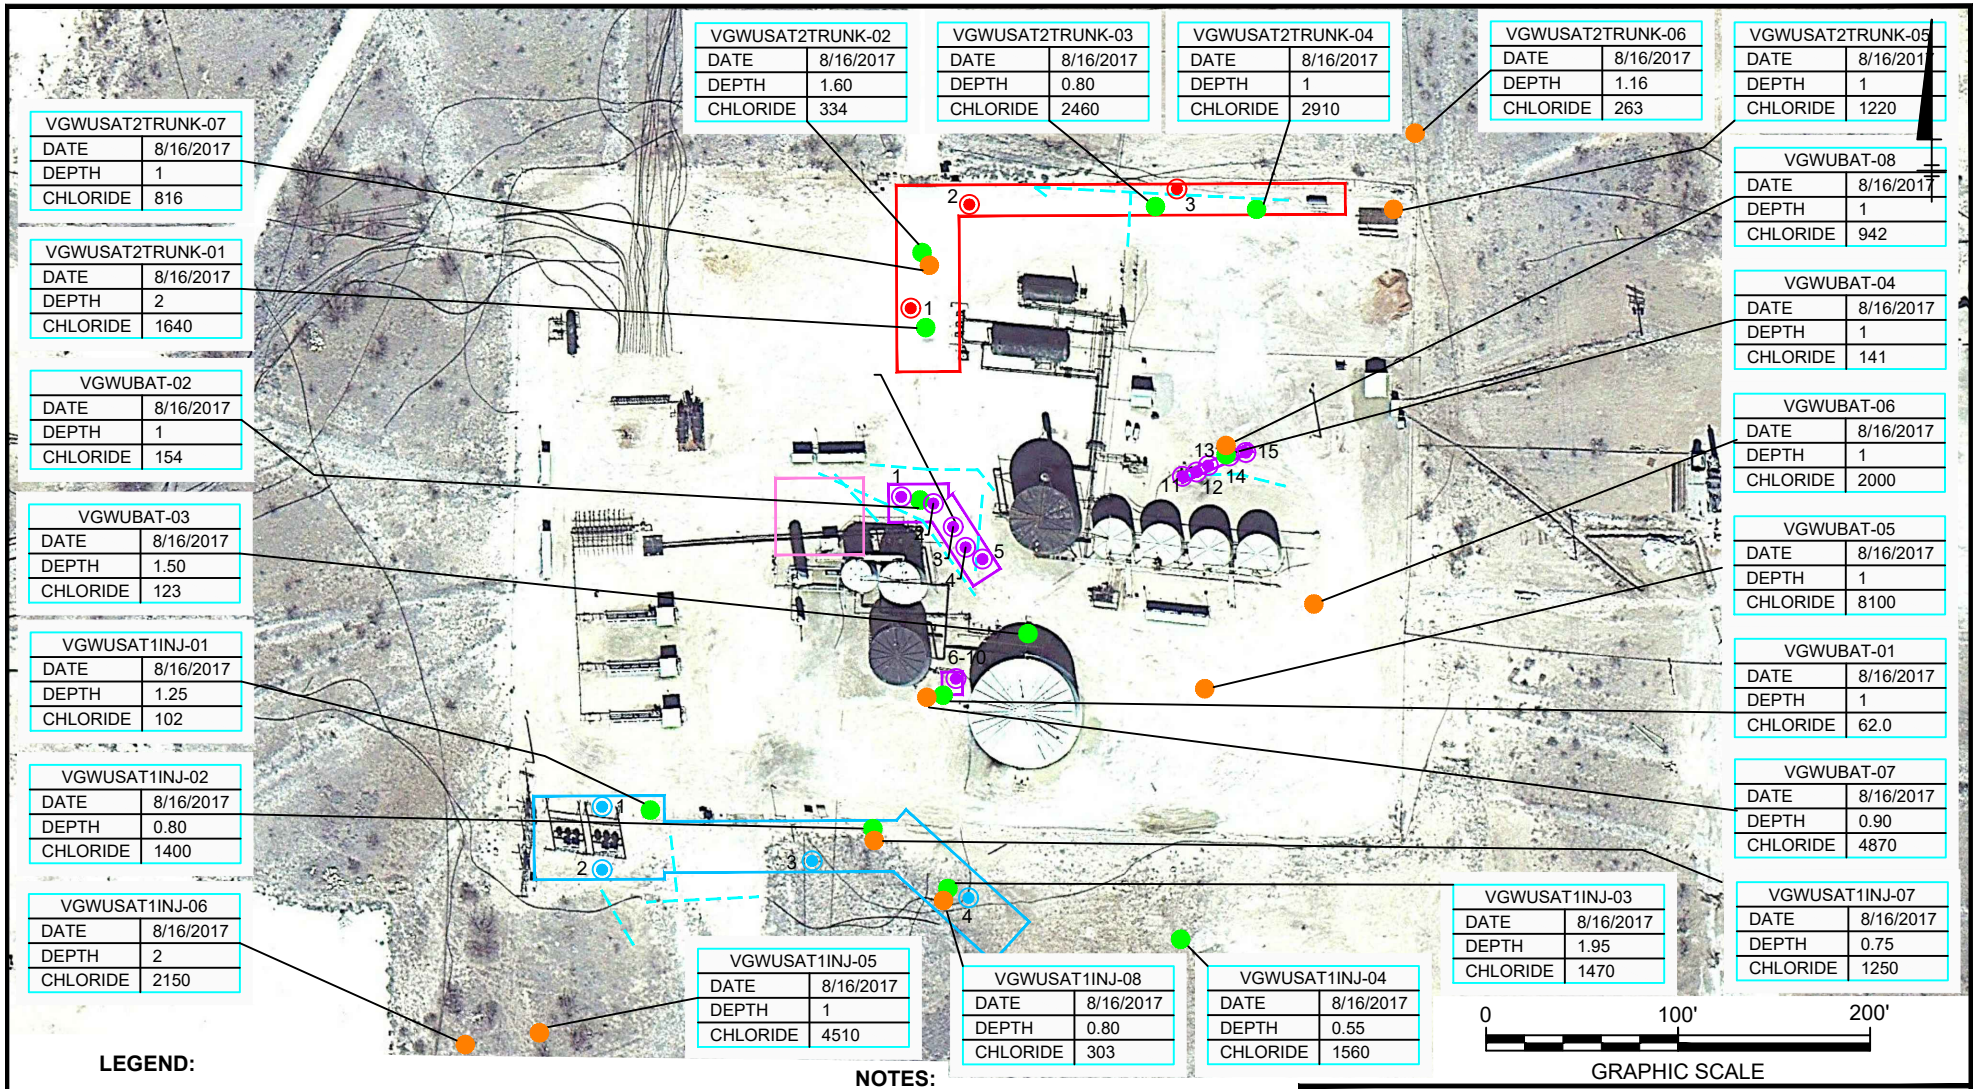
FIGURE
2

Additional soil assessment activities were conducted on August 16, 2017. Twenty-three surface soil samples were collected within the VGWU Tank Battery Sites shown on **Figure 2**, as follows:

Soil sample depths ranged from 0.55-ft to 2 ft bgs. Sample locations are shown on **Figure 2** and sample methodology is described further in **Appendix D**. Soil samples were placed in laboratory-supplied containers and submitted under appropriate chain of custody protocols to Xenco Laboratories (Xenco) in Midland, TX for analysis of chloride by USEPA Method 300/300.1. Laboratory analytical results with chain of custody documentation are provided in **Appendix C**.

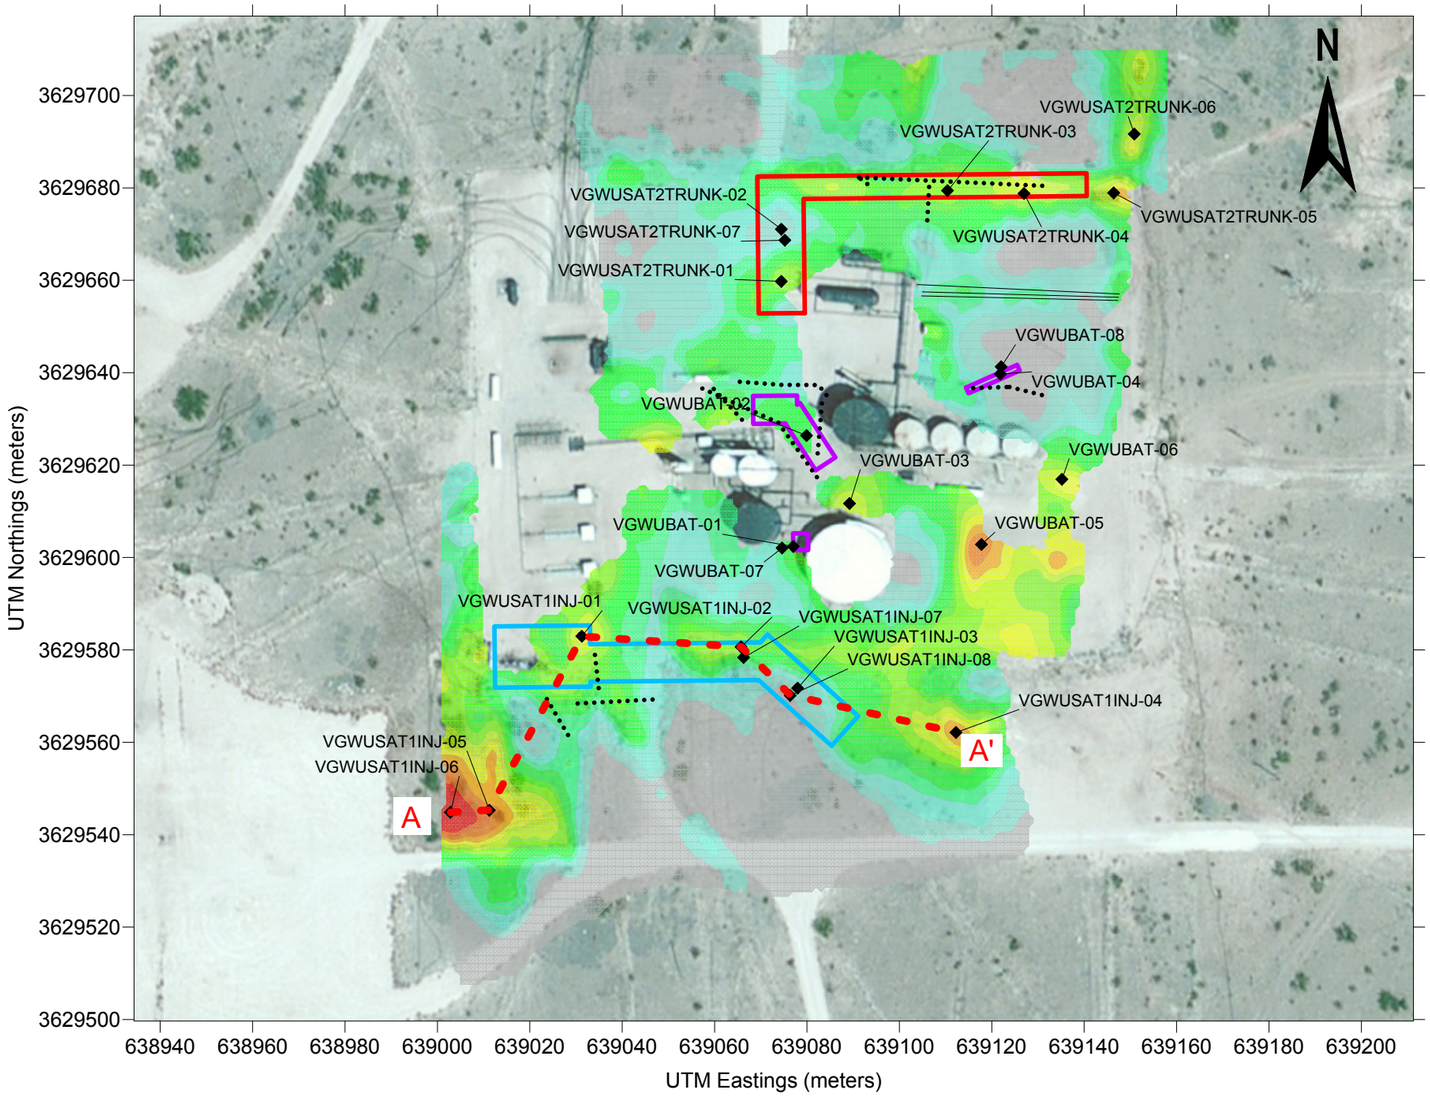
FIGURE 3

The color scale used in **Figures 3** through **6** is designed to visually portray the deviation from the background EC conditions, which are in the gray to blue green range. In contrast, anomalous areas of high EC are shown in upper portion of the color scale, from green to yellow to red, progressively indicating higher EC, which is generally assumed to reflect proportionately higher TDS pore fluids (produced water influence) or conductive metallic features (Site structure or subsurface utilities). Anomaly intensity and physical dimensions typically reveal whether the anomalies are due to pore fluid chemistry or metallic objects. Note that the data output for the GEM-2 model profile presented in **Figure 6** is in units of electrical resistivity (ohm-meters) which is the inverse quantity of electrical conductivity measured in millisiemens per meter (mS/m). A corresponding color scale is used in **Figure 6** to depict areas of low electrical resistivity in the A-A' profile with warm colors (yellow to red) that correlate to areas of high EC in the contour maps.

It should be noted that the locations of the significantly high EC values generally are in close proximity to metallic Site features such as above ground storage tanks, associated conveyance piping, perimeter fencing, and utilities. These metallic utilities may interfere with EC data quality and/or exaggerate the magnitude and spatial extent of anomalously high EC zones. An example of data interference attributed to metallic Site features is labeled in the **Figure 6** A-A' profile, from approximately 230 ft to 265 ft from the beginning of the profile where a resistivity data artifact is produced. Furthermore, anomalously high EC features that display a linear pattern may suggest the dispersion of produced water impacts along underground utilities/pipelines.

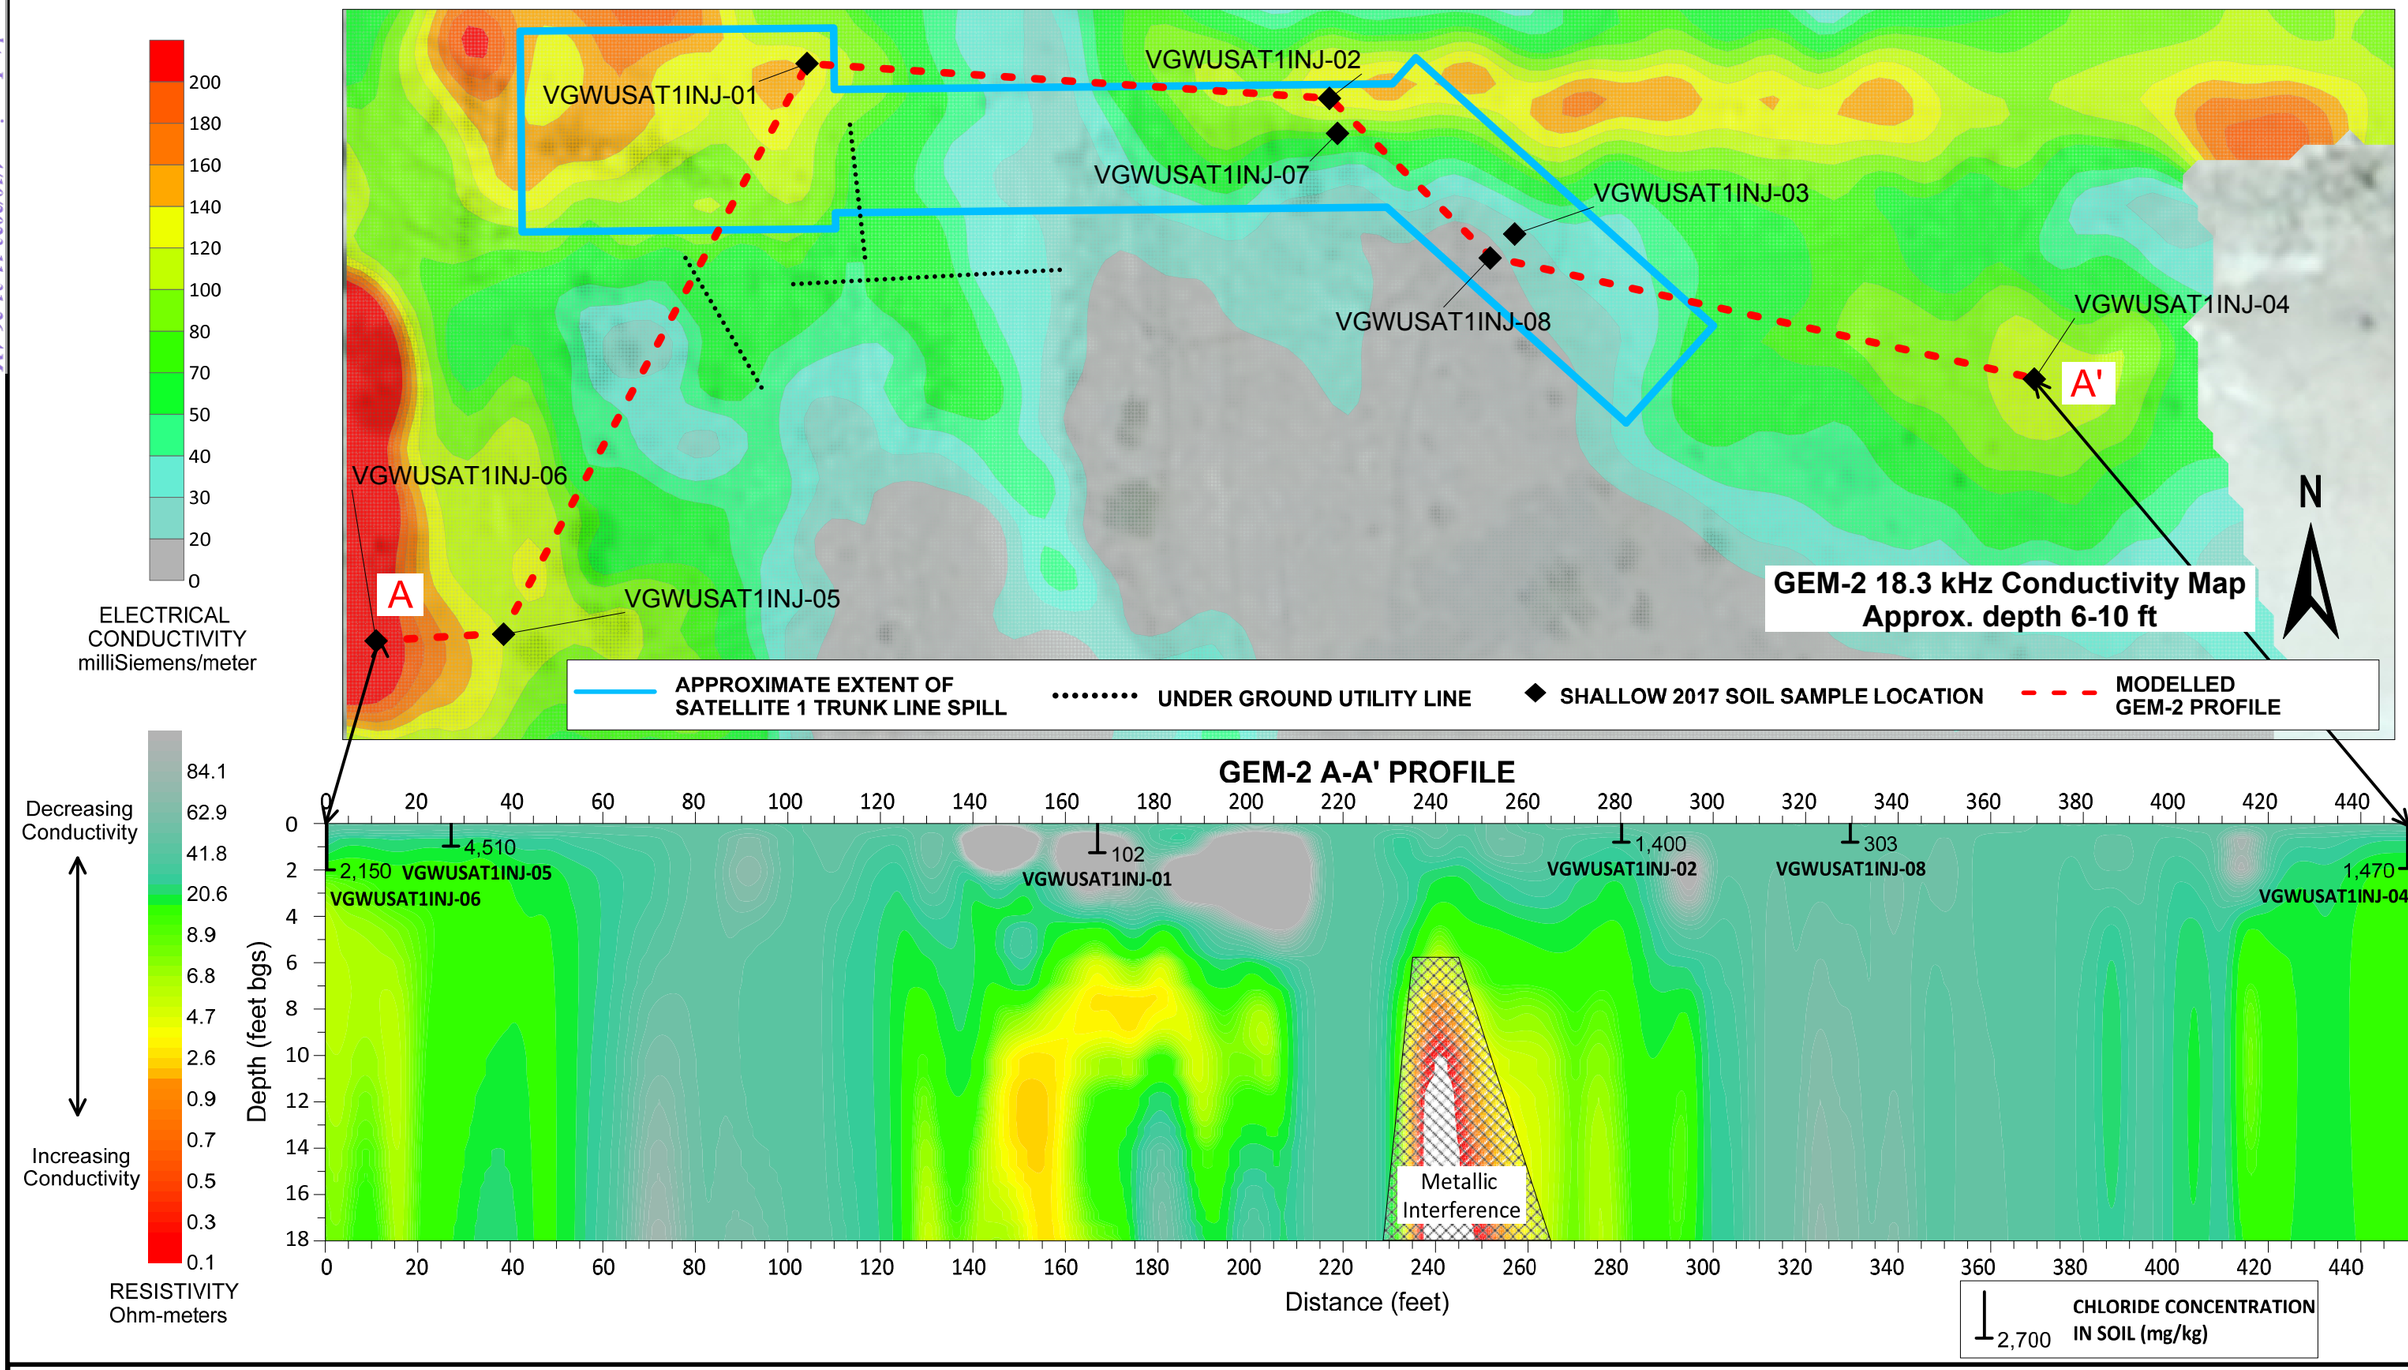
FIGURE 6

MODELLED GEM-2 PROFILE - SECTION A-A'
