Amended Remediation Summary and Soil Closure Request

H.L. Brown Operating, LLC
Fed Com 27 001
Roosevelt County, New Mexico
Unit Letter A, Section 5, Township 8 South, Range 37 East
Latitude 33.681821 North, Longitude 103.147614 West
NMOCD Reference No. nAPP2227229728

Etech Environmental & Safety Solutions, Inc.
2617 W. Marland
Hobbs, New Mexico 88240

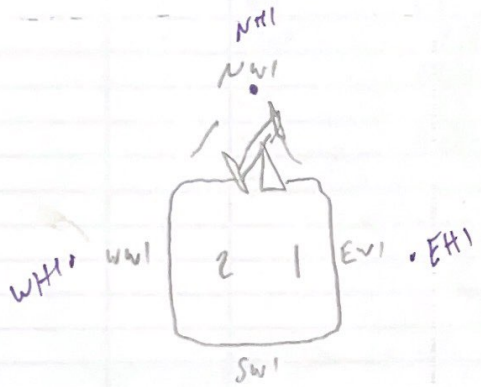
Site Diagram

~Length: 20 ~Width: 18 ~Area: 360 sq ft ~Depth: 1'
