Re: Status Report – 1st Quarter 2023
San Juan 28-7 Unit 183M
Rio Arriba County, New Mexico
OCD Incident No. NCS1901627746

On behalf of Hilcorp Energy Company (Hilcorp), Timberwolf Environmental, LLC (Timberwolf) presents this report to document remedial activities conducted during the 1st quarter of 2023 (1Q23) at the San Juan 28-7 Unit 183M (Site).

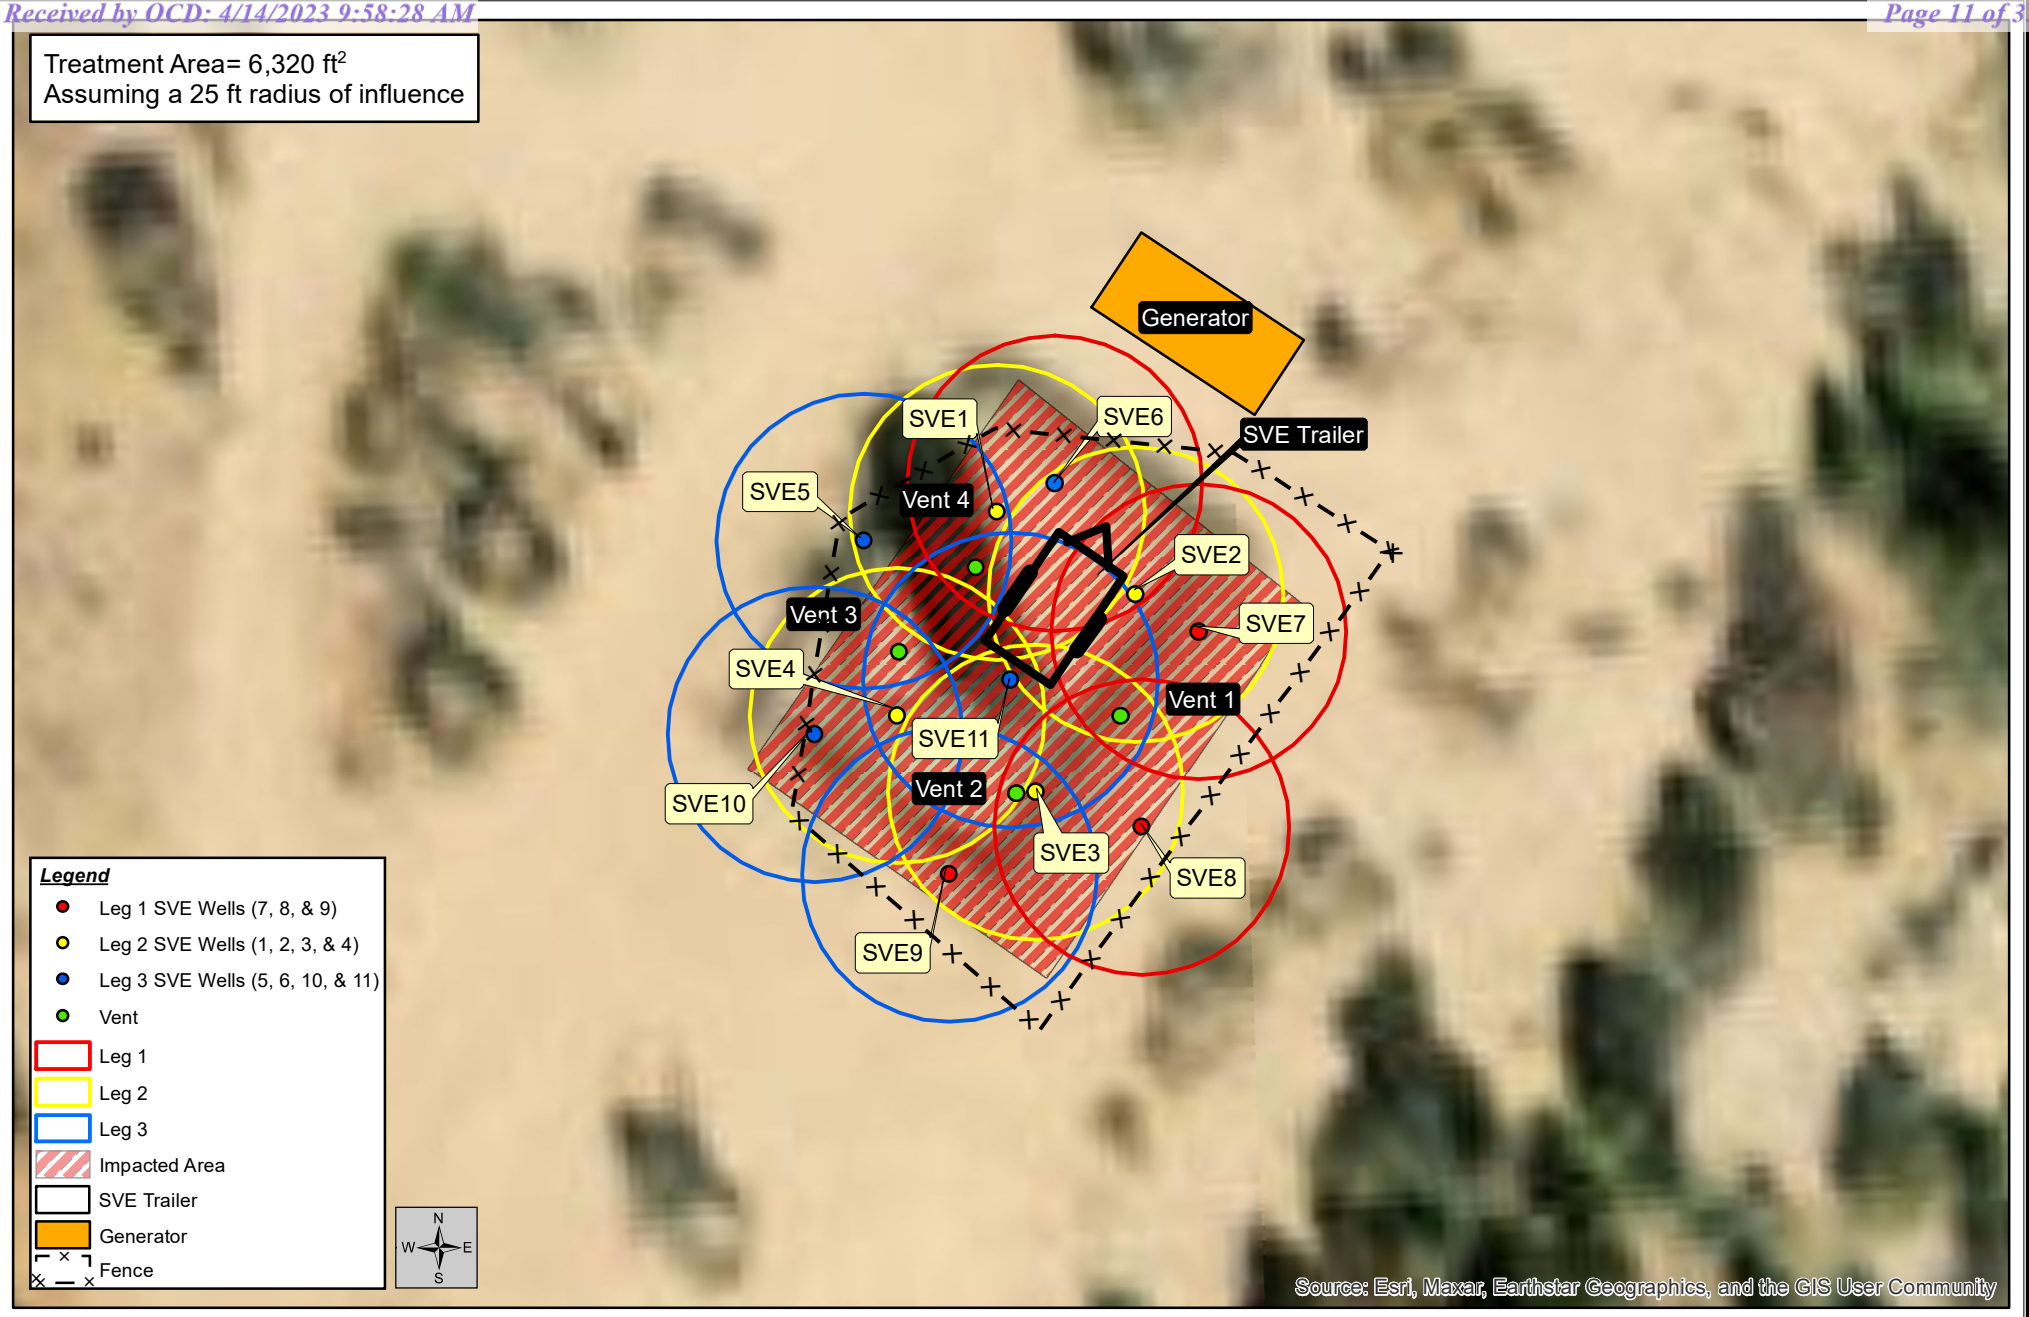
Figure 4
SVE System Overview

The SVE system creates a treatment field of approximately 0.15 acres and treats soil to a depth of approximately 30 ft bgs for a total volume of approximately 7,021 cubic yards of soil. The SVE wells, measured radius of influence of 25 ft, and leg configurations are shown in Figure 4.
