TETRA TECH

May 1, 2023

Re: Release Characterization and Remediation Work Plan
Maverick Natural Resources
EVGSAU 2418-001 Flowline Leak
Unit Letter P, Section 24, Township 17 South, Range 34 East
Lea County, New Mexico
Incident ID# nAPP2310153358

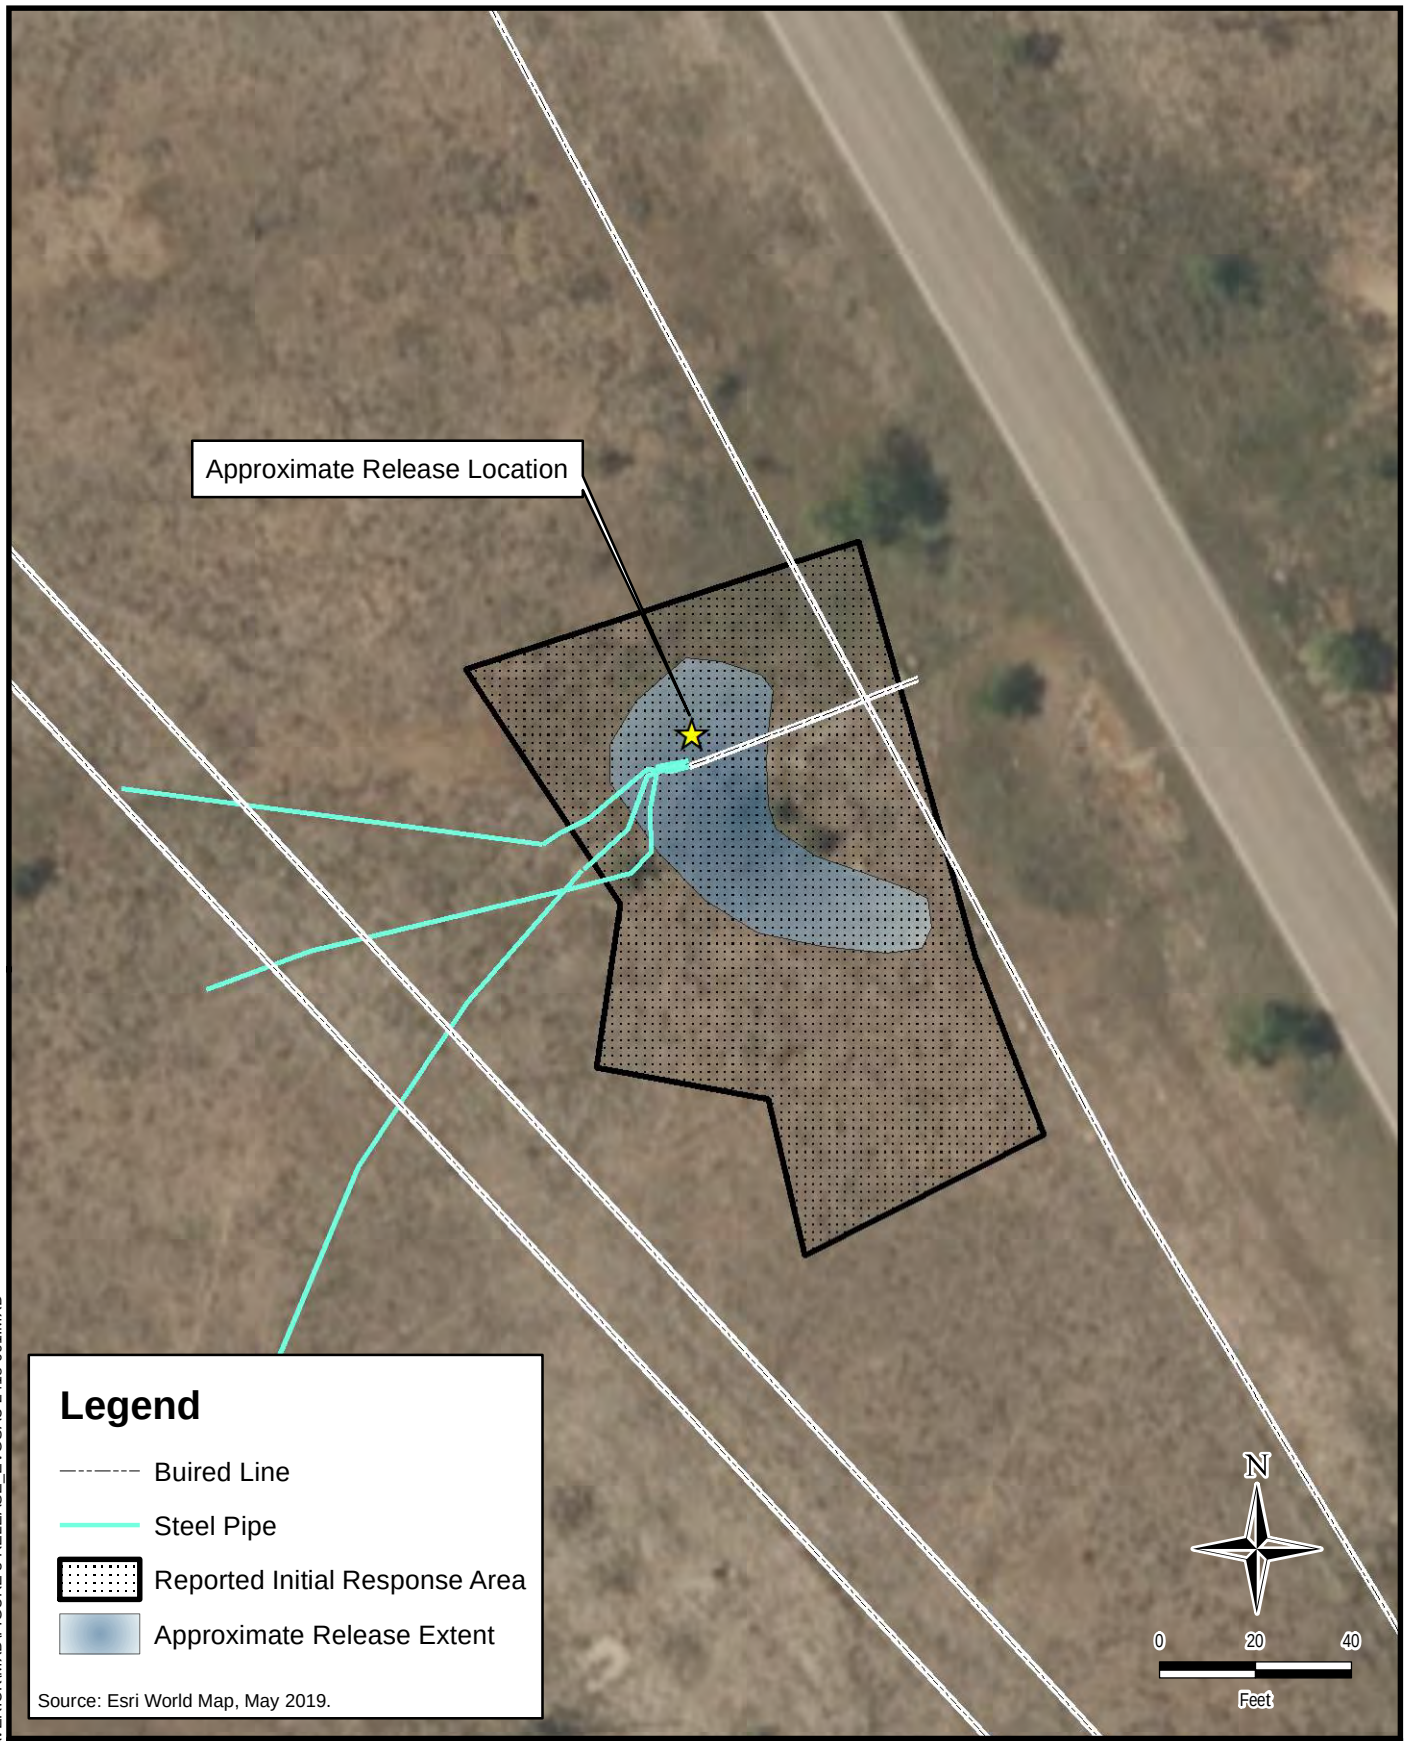
Figure No.
3

The release occurred due to internal corrosion of a surface production flow line consisting of an approximately 1,750 square foot area in open pasture, as shown in **Figure 3**. According to site records, initial response actions were taken by Maverick at the release site on March 8, 2023. Maverick responded to the site and made an initial excavation/scrape of approximately the top 6 inches of impacted material. The scraped material was sent to R360 for disposal. Confirmation samples were not collected during the initial response activities. Tetra Tech conducted a visual site inspection on March 16, 2023, to document the release and initial scrape area. The area encompassing this initial scrape was approximately 4,000 square feet as shown in **Figure 3**.

EVGSAU 2418-001 **FLOWLINE** RELEASE
APPROXIMATE RELEASE EXTENT AND SITE FEATURES

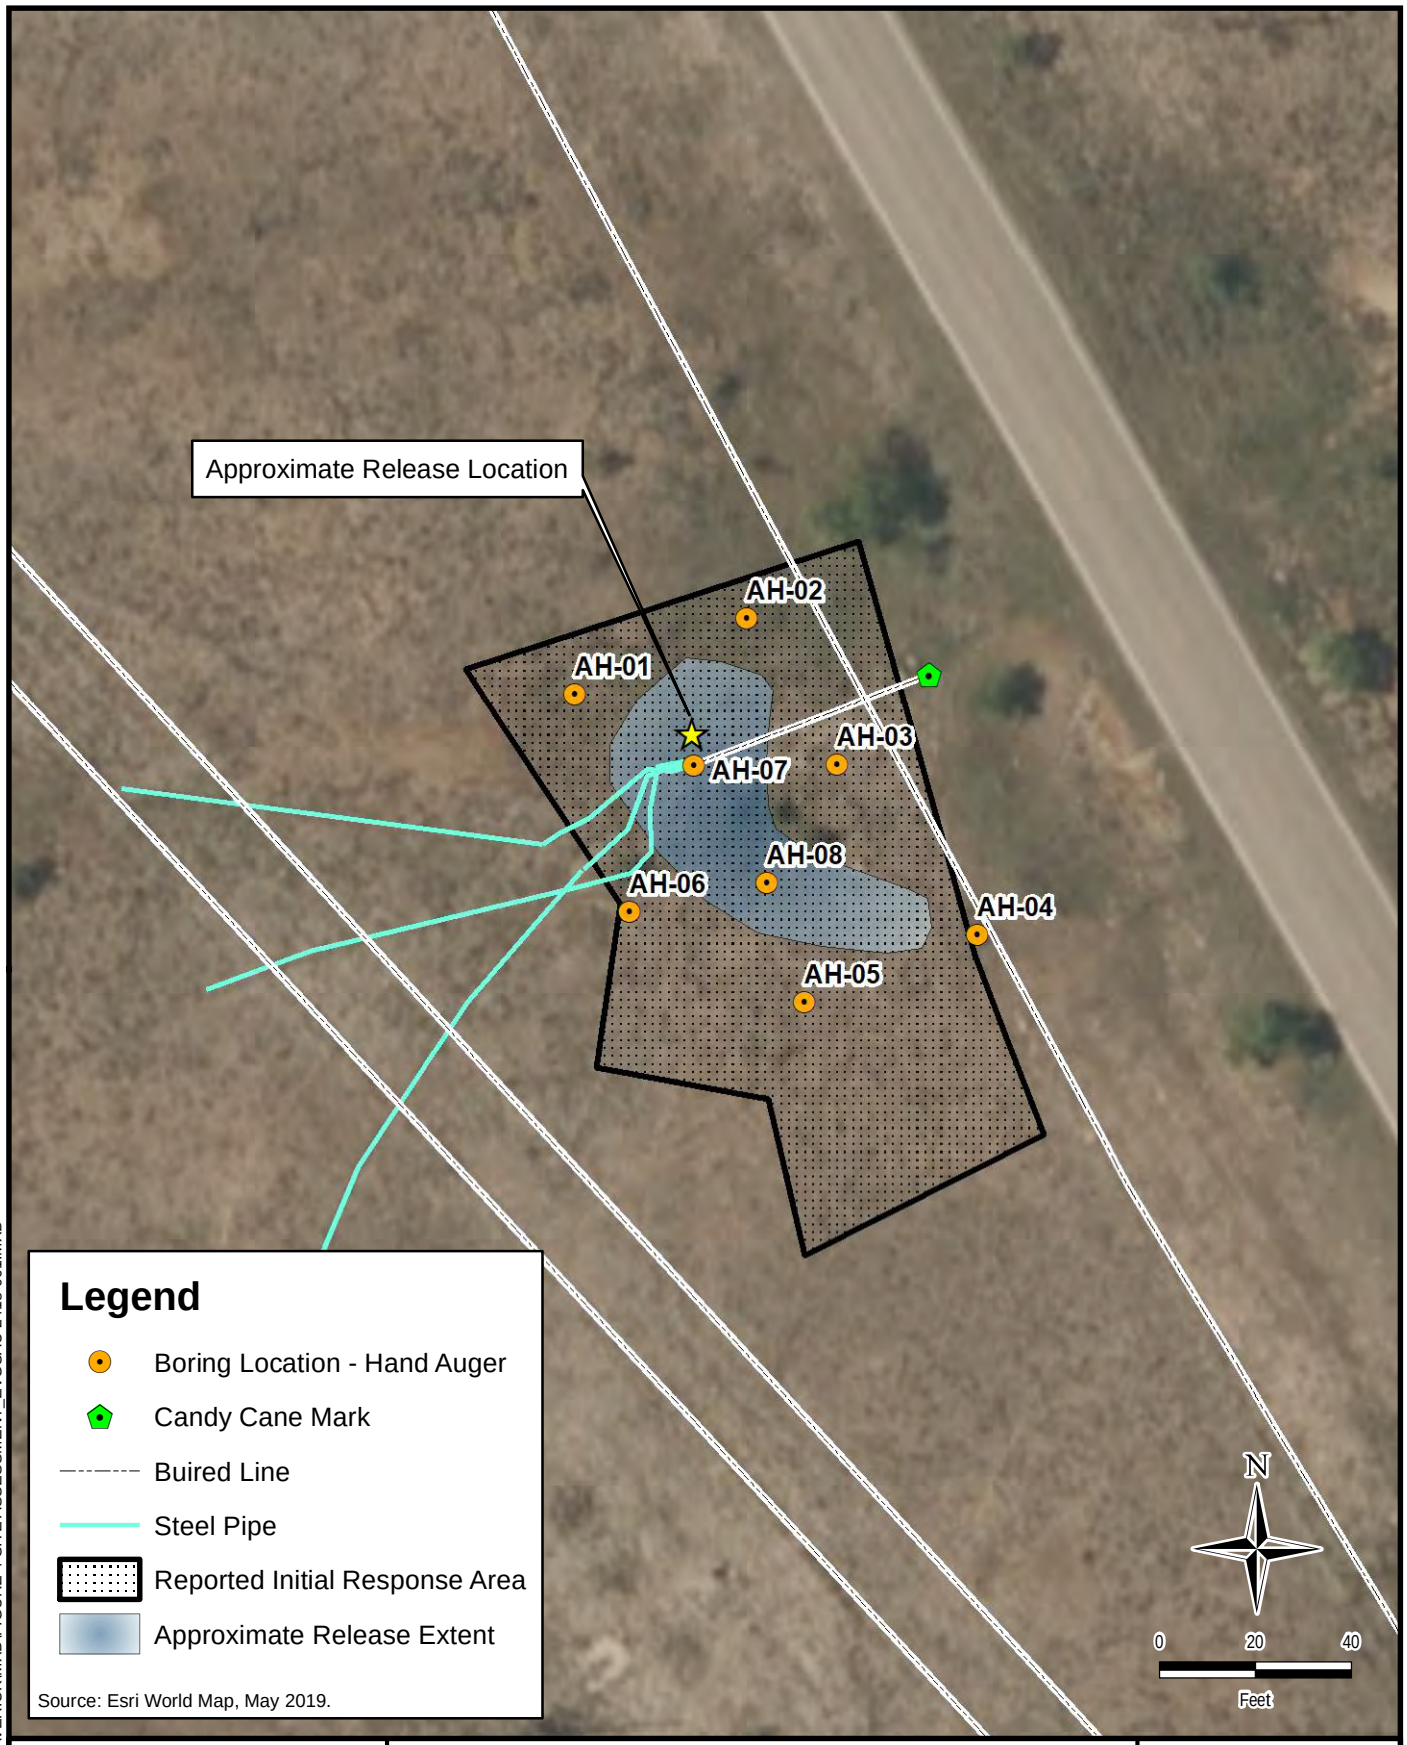
Figure No.
4

below ground surface to horizontally delineate the release. One additional sample was taken at 1-2 feet bgs at AH-1. Hand auger refusal was encountered between 1 and 2 feet bgs due to hardpan soil material. Two additional hand auger borings, AH-7 and AH-8 were installed 0-1 feet bgs in the center of the release area. Boring locations are presented in **Figure 4**.

Results from the April 6, 2023 soil sampling event are summarized in **Table 1**. The analytical reported concentrations of chloride, TPH, and BTEX as less than RRALs and Reclamation Requirements in samples AH-1 through AH-6. Sample AH-7 reported concentrations of chloride as greater than RRALs and Reclamation Requirements, and AH-8 reported concentrations of BTEX and TPH as greater than RRALs and Reclamation Requirements. Photographic documentation of Site conditions at the time of the assessment is presented in **Attachment 4**.

EVGSAU 2418-001 **FLOWLINE** RELEASE
SITE ASSESSMENT MAP

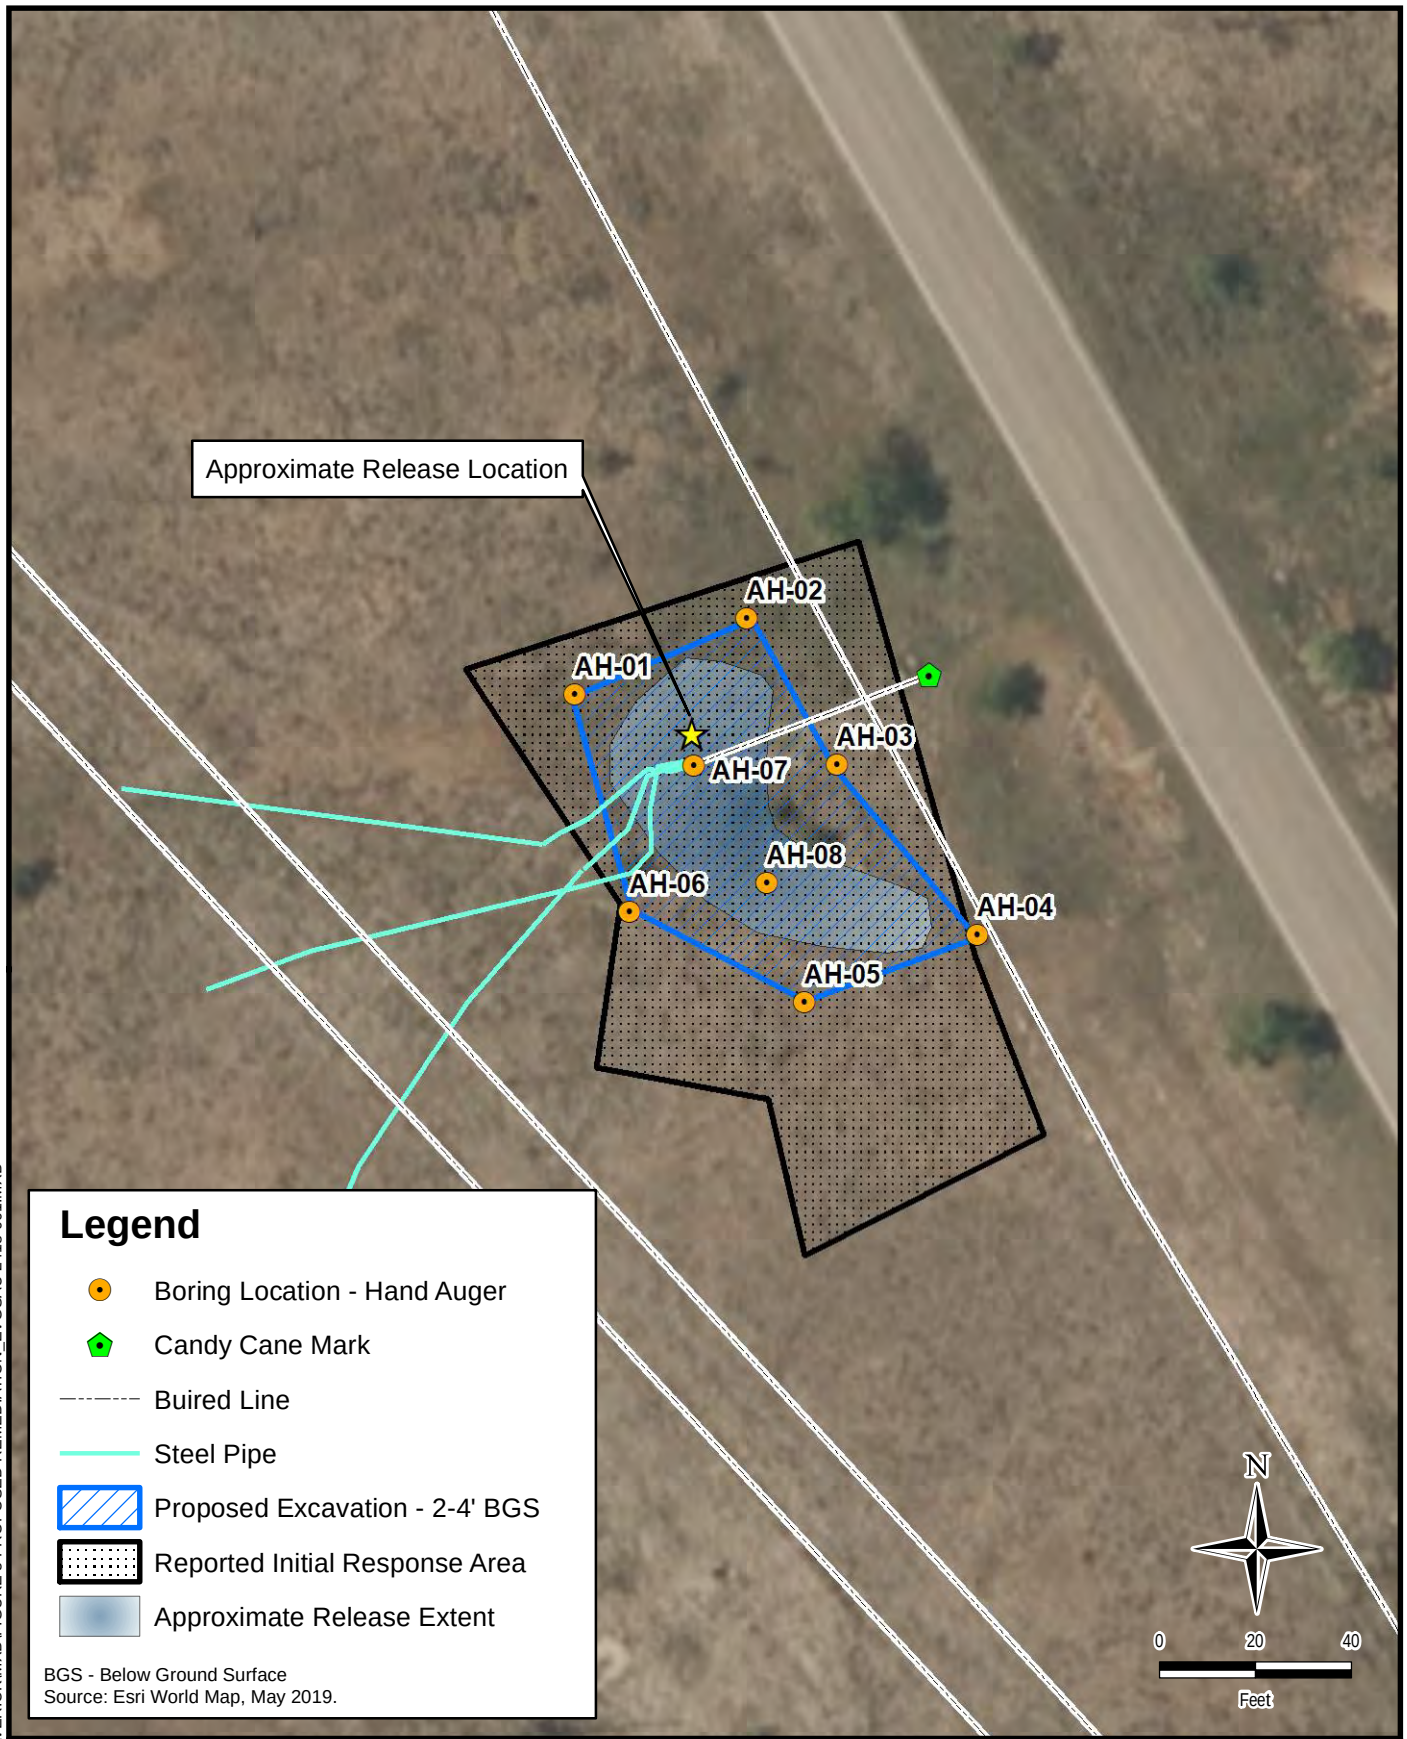
Figure No.
5

EVGSAU 2418-001 **FLOWLINE** RELEASE
PROPOSED REMEDIATION EXTENT

Based on the analytical results from the assessment, Maverick proposes to remove the impacted material within the release extent as shown in **Figure 5**. Impacted soils will be excavated using heavy equipment (backhoes, hoe rams, and track hoes) to an approximate depth of 2 to 4 feet below the surrounding surface until representative samples from the excavation sidewalls and the floor of the excavation report concentrations of constituents as less than Site RRALs and Reclamation Requirements. Heavy equipment will come no more than two feet from any pressurized lines. Impacted soils within the vicinity of the surface and subsurface lines which intersect the release footprint will be excavated with hydro-vac excavation or dug by hand to the maximum extent practicable.

Excavated soils will be transported offsite and disposed of at an NMOCD-approved or permitted facility. Confirmation floor and sidewall samples will be collected for verification of remedial activities and analyzed for TPH, BTEX, and chloride. Once analytical results are received, NMOCD will be notified, and the excavation will then be backfilled with clean material to surface grade. The estimated volume of material to be remediated is between 275 to 550 cubic yards.

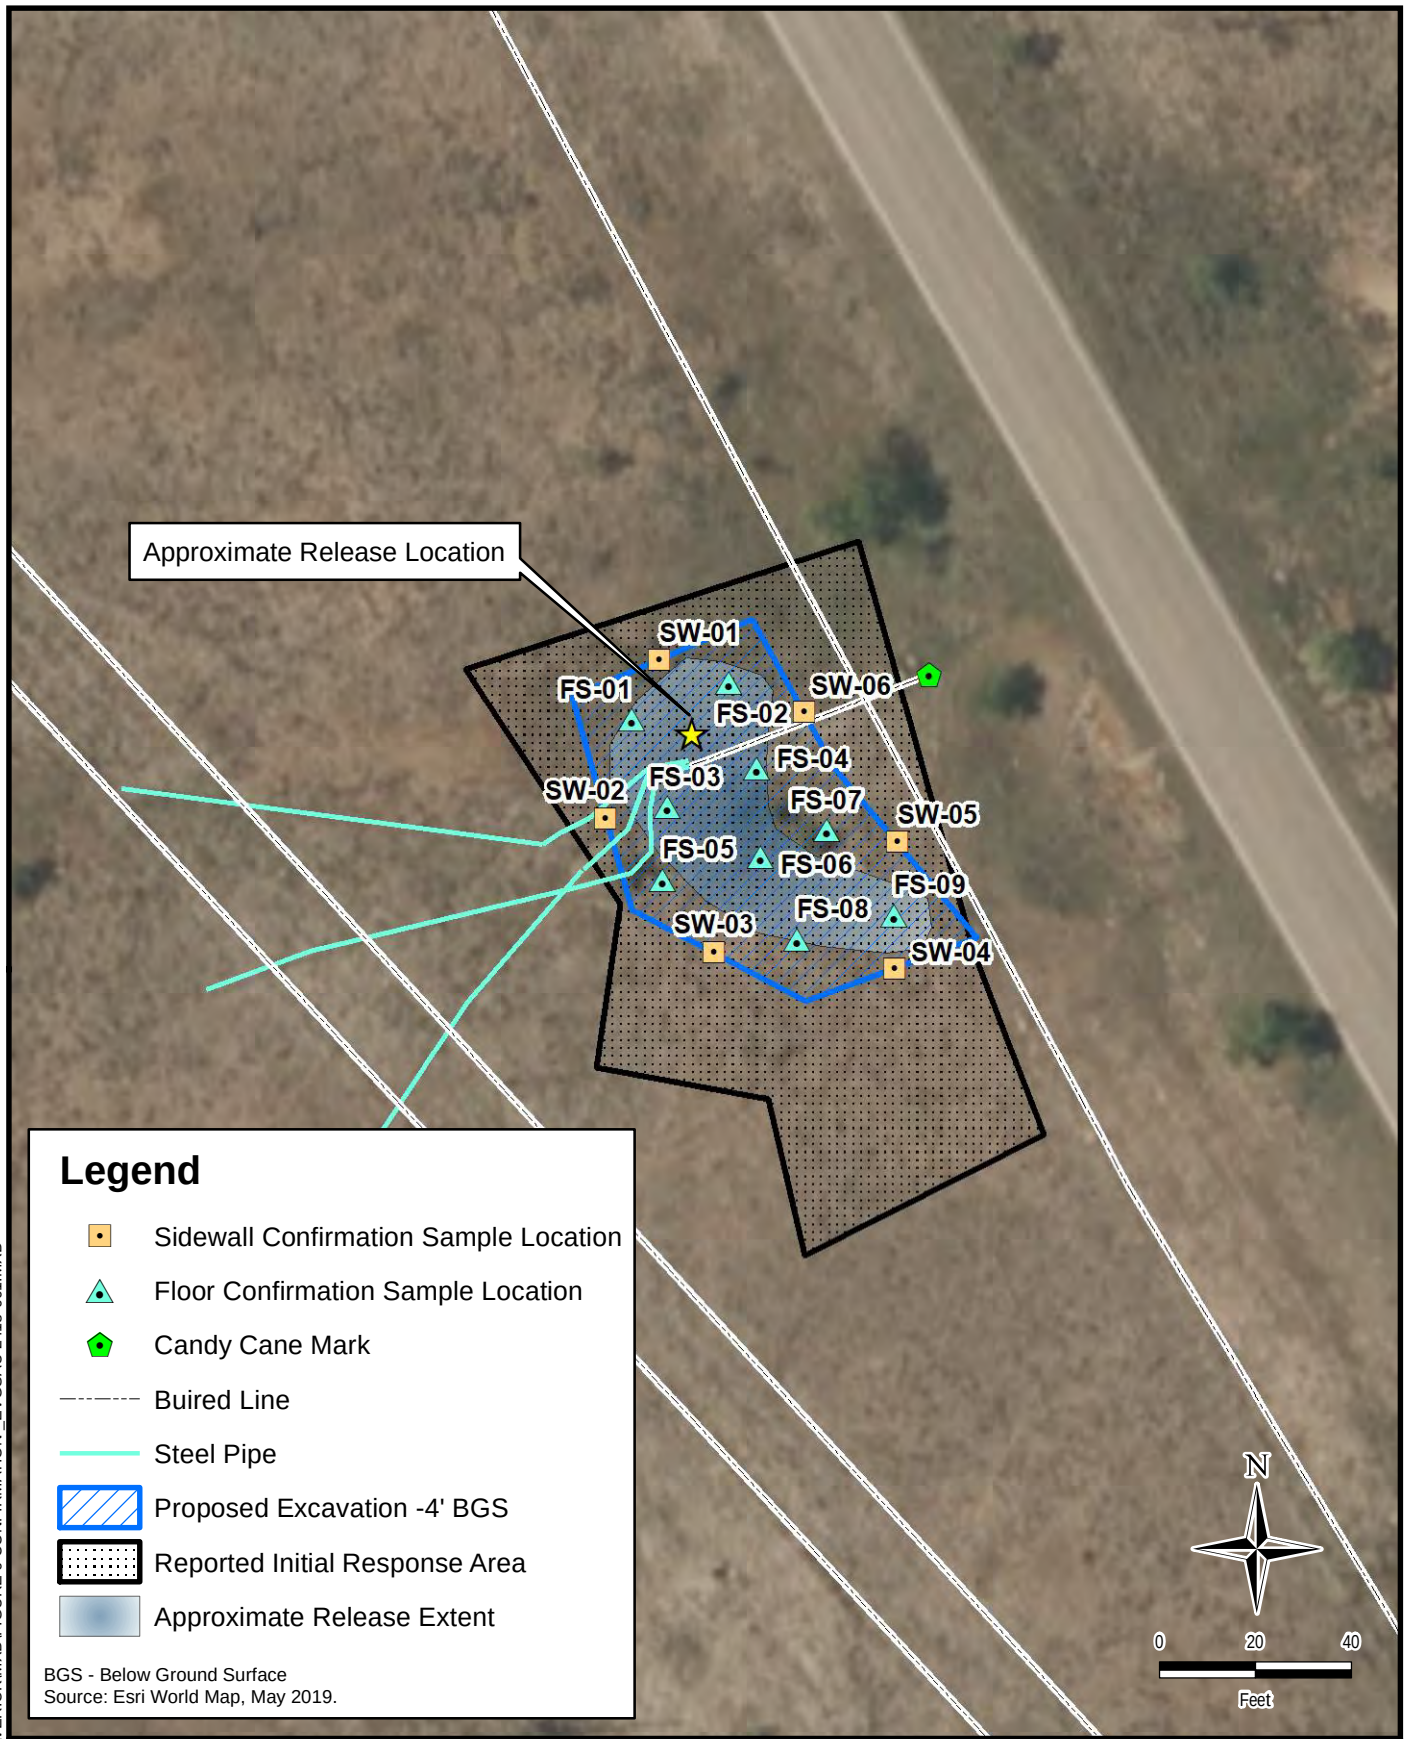
Figure No.
6

EVGSAU 2418-001 **FLOWLINE** RELEASE
CONFIRMATION SAMPLING PLAN

In accordance with 19.15.29.12(D)(1)(b) NMAC, Maverick proposes the following alternative confirmation sampling plan to adhere to NMOCD requirements. The proposed confirmation sample locations are depicted in **Figure 6**. Nine (9) confirmation floor samples and six (6) confirmation sidewall samples are proposed for verification of remedial activities. The proposed excavation encompasses a surface area of approximately 3600 square feet.

These confirmation sidewall samples will be representative of approximately 200 square feet each and floor samples will be representative of no more than approximately 500 square feet of the excavated area. Confirmation samples will be submitted to Cardinal Laboratory for analysis of TPH (Method 8015 modified), BTEX (Method 8260B), and chloride (EPA SM4500Cl-B). Once results are received, NMOCD will be notified, and the excavation will then be backfilled with clean material to surface grade.
