****** LIQUID SPILLS - VOLUME CALCULATIONS ******

Location of spill: VACUUM GLORIETTA WEST UNIT #85 (32.7902031, -103.5205383) **Date of Spill:** 8/29/2012

Release Notification and Corrective Action

On 8/29/2012, Chevron reported a release at the Vacuum Glorietta West Unit #85. The release was caused when a flowline leaked due to carbonic acid eating the line during maintenance. Approximately 5,247 sqft. of the Pasture was found to be damp upon initial inspection.

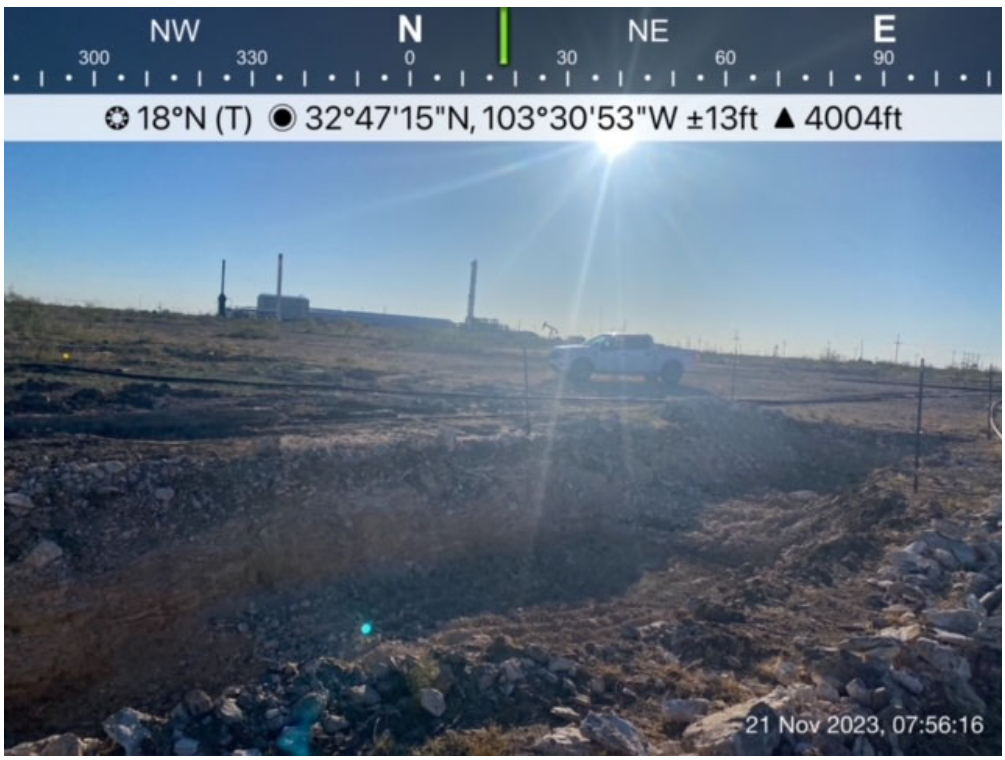
Excavation

Pasture:
