State of New Mexico
Energy Minerals and Natural Resources Department

Release Notification

COG Operating LLC
Roy Batty Fed Com #3H
Lea County, New Mexico

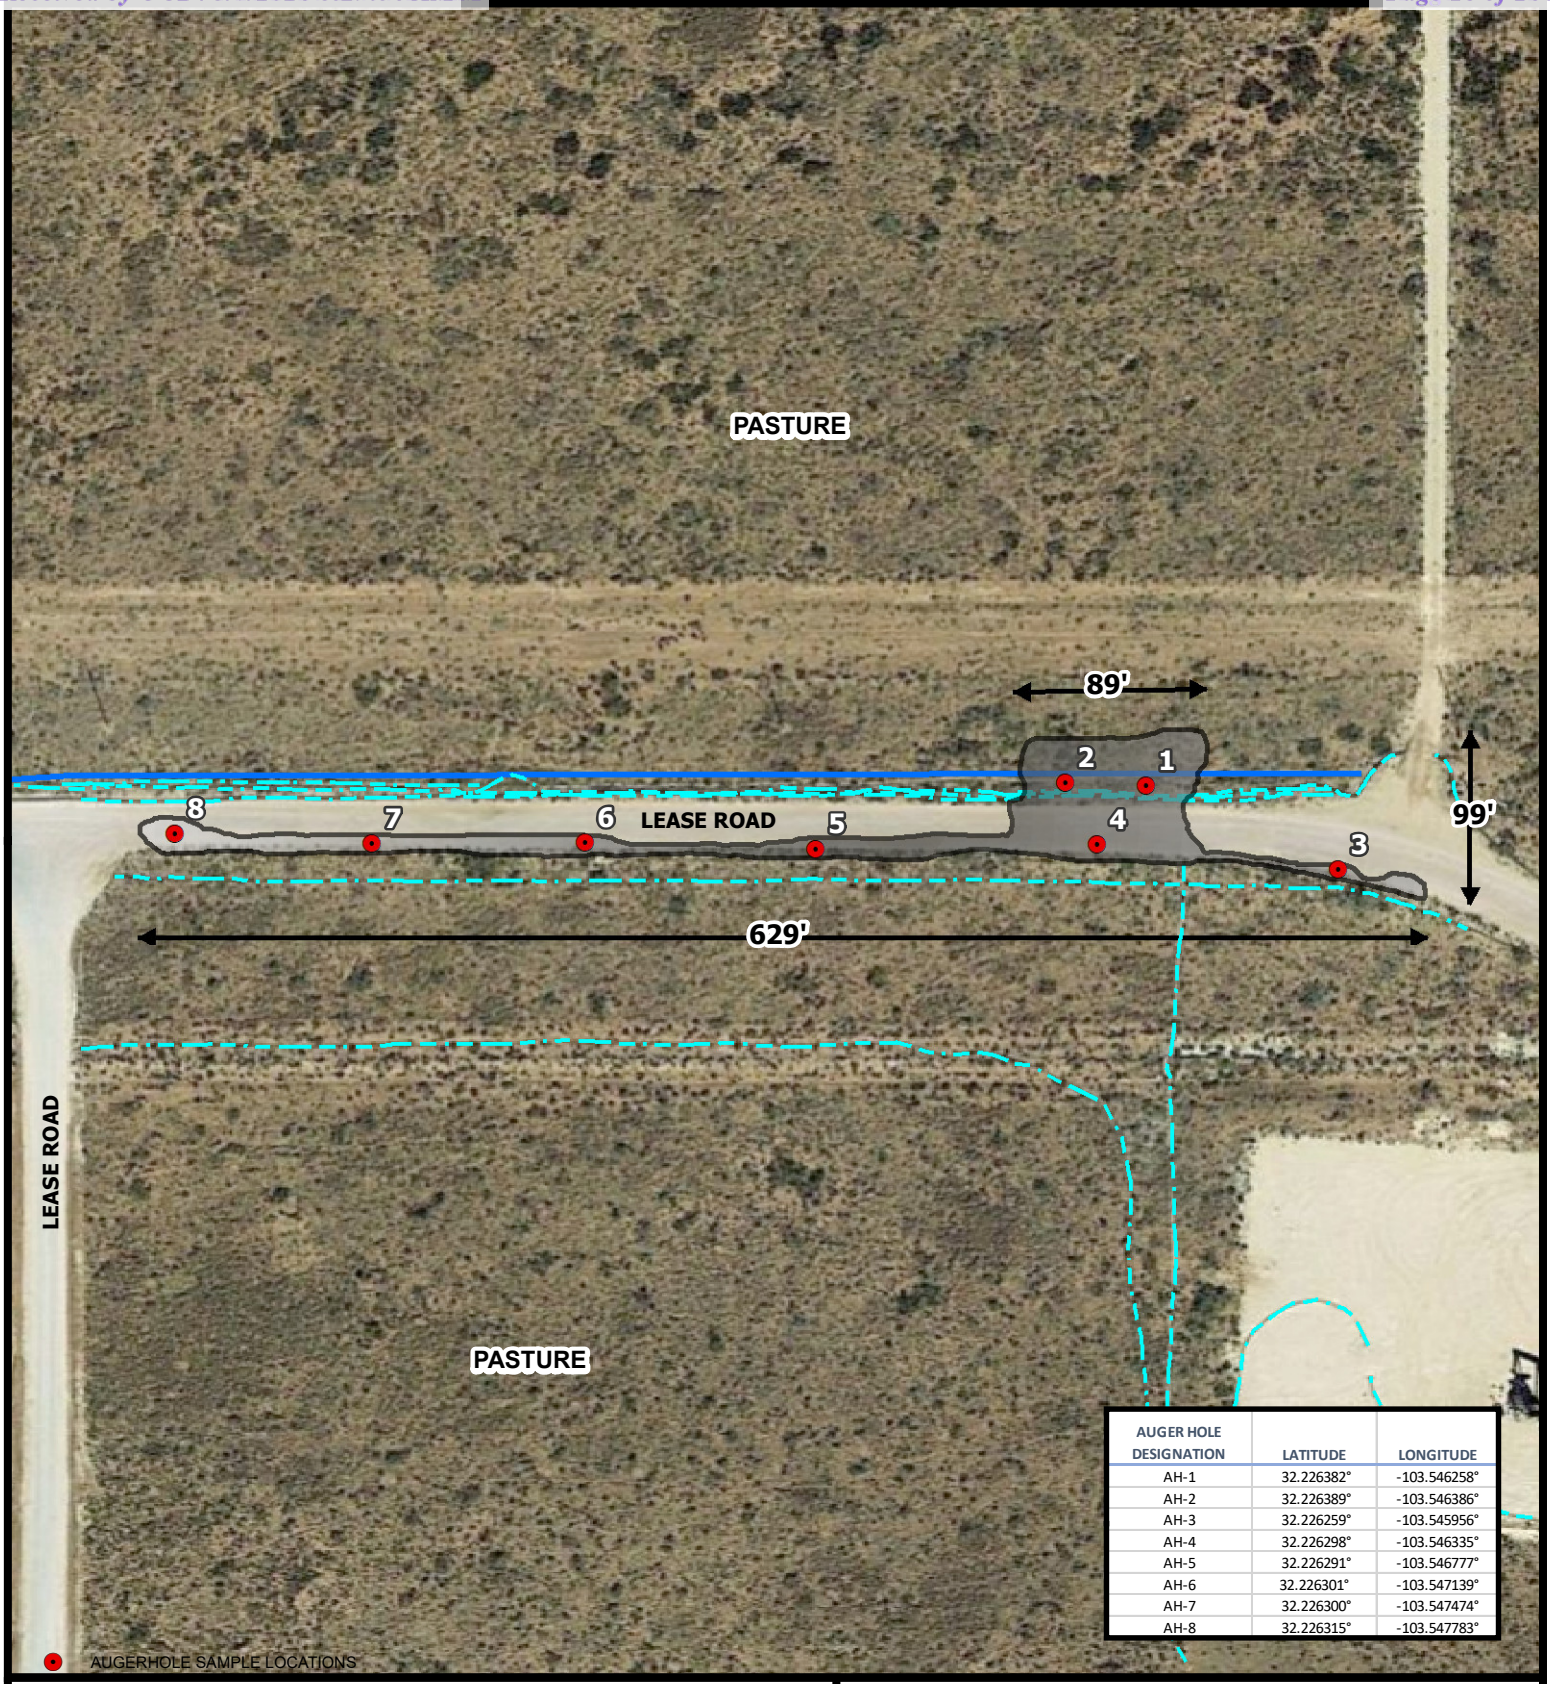
FIGURE 3

AUGERHOLE SAMPLE LOCATIONS

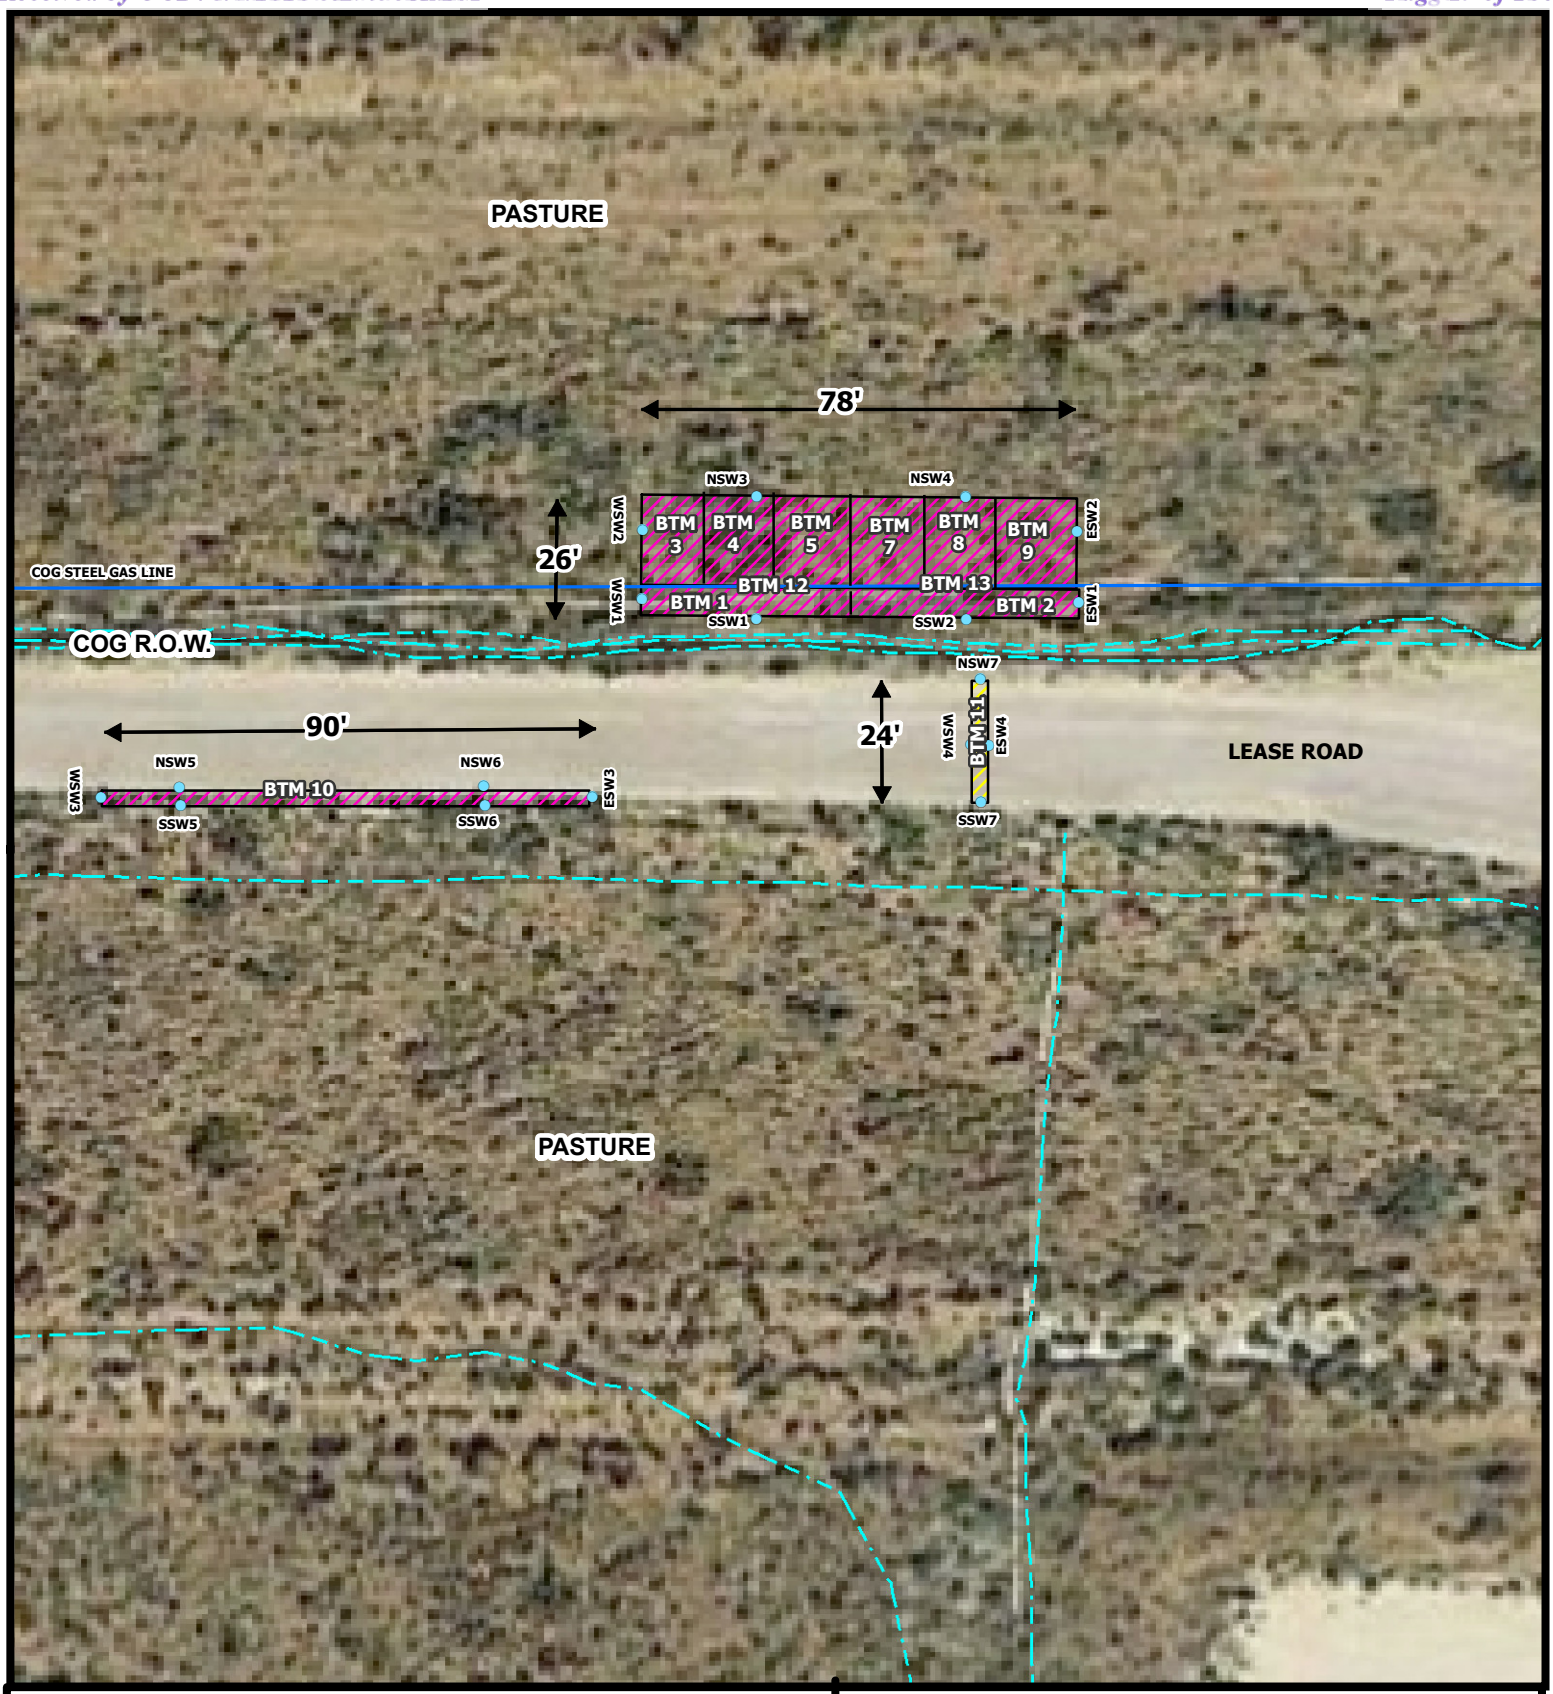
BTM BOTTOM HOLES
SIDE WALL SAMPLE LOCATIONS
STEEL PIPE
6"' EXCAVATED DEPTH
4.5' EXCAVATED DEPTH
FLOWLINE

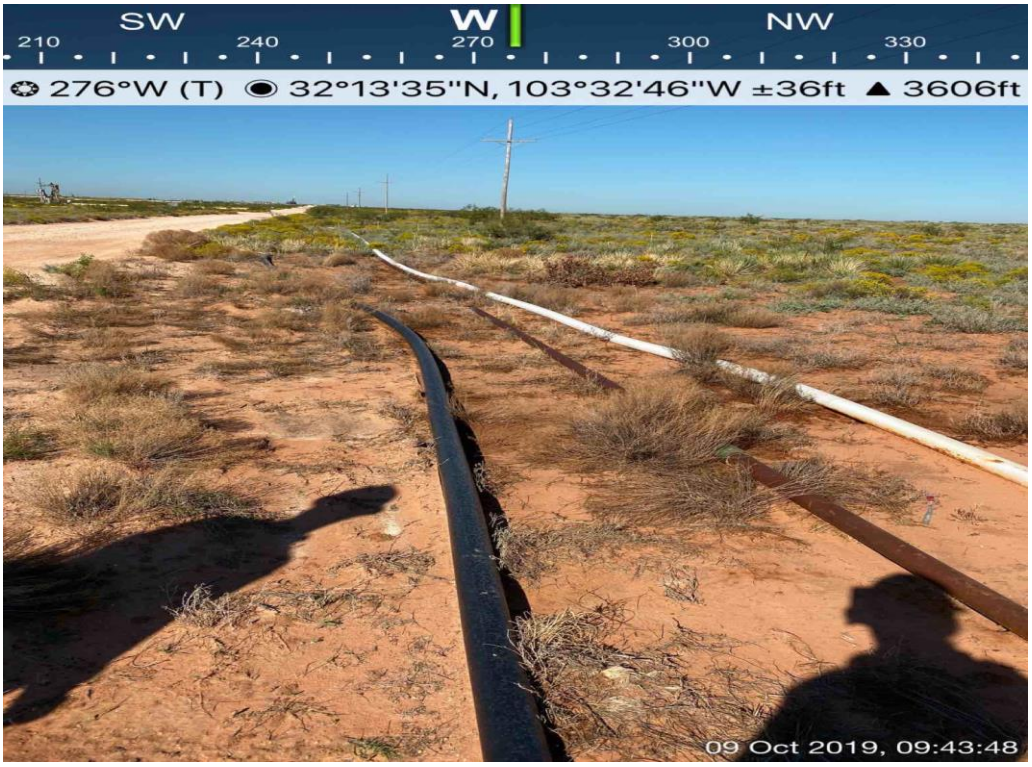
View West –Areas of AH-1 and AH-2

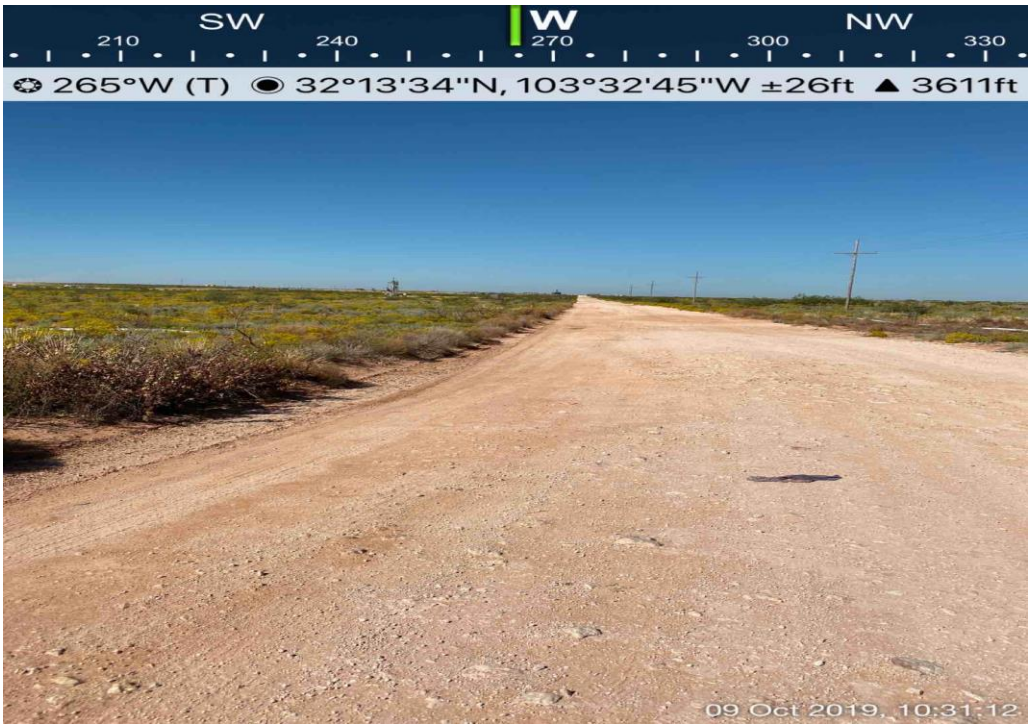
View West –Areas of AH-3 through AH-8

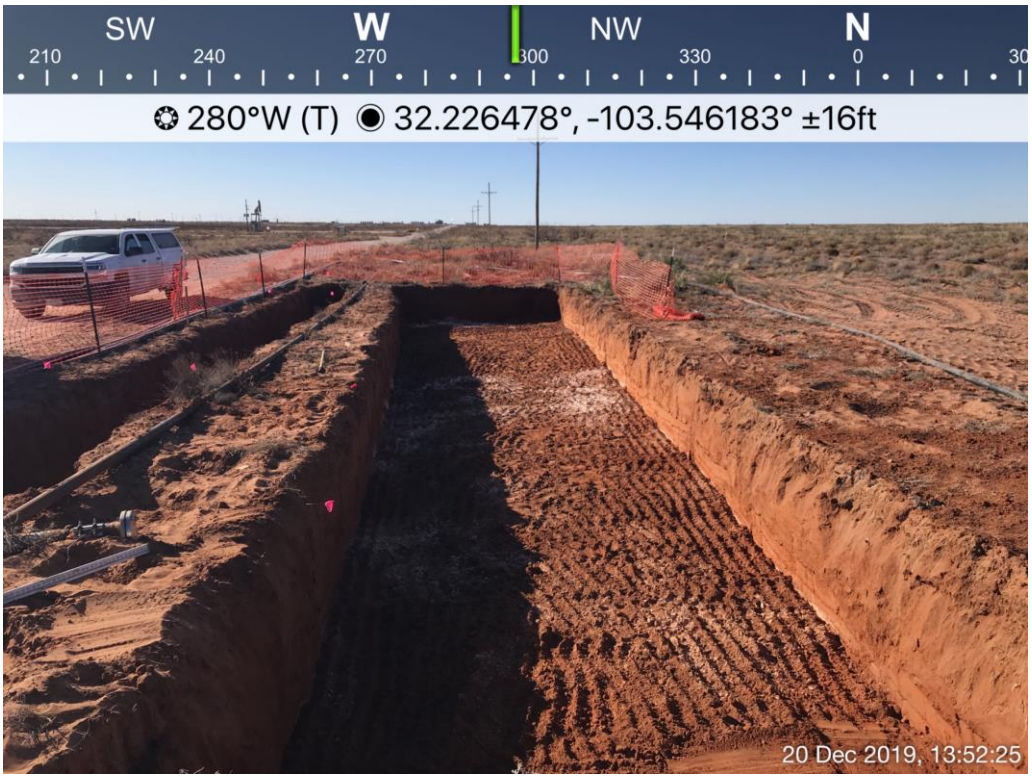
View West – Excavated Areas of AH-1 and AH-2

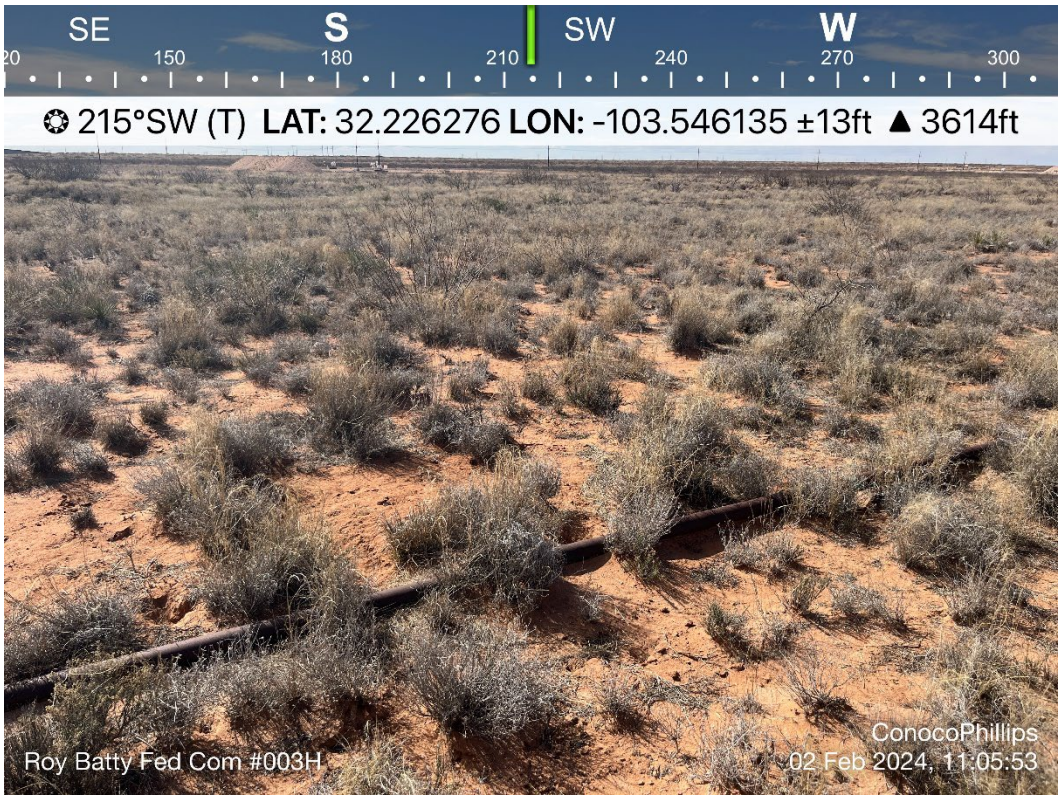
TETRA TECH, INC. PROJECT NO. 212C-MD-03244	DESCRIPTION	View north of approximate release area. Surface and steel polyline.	1
	SITE NAME	Roy Batty Federal Com #003H Release	2/2/2024

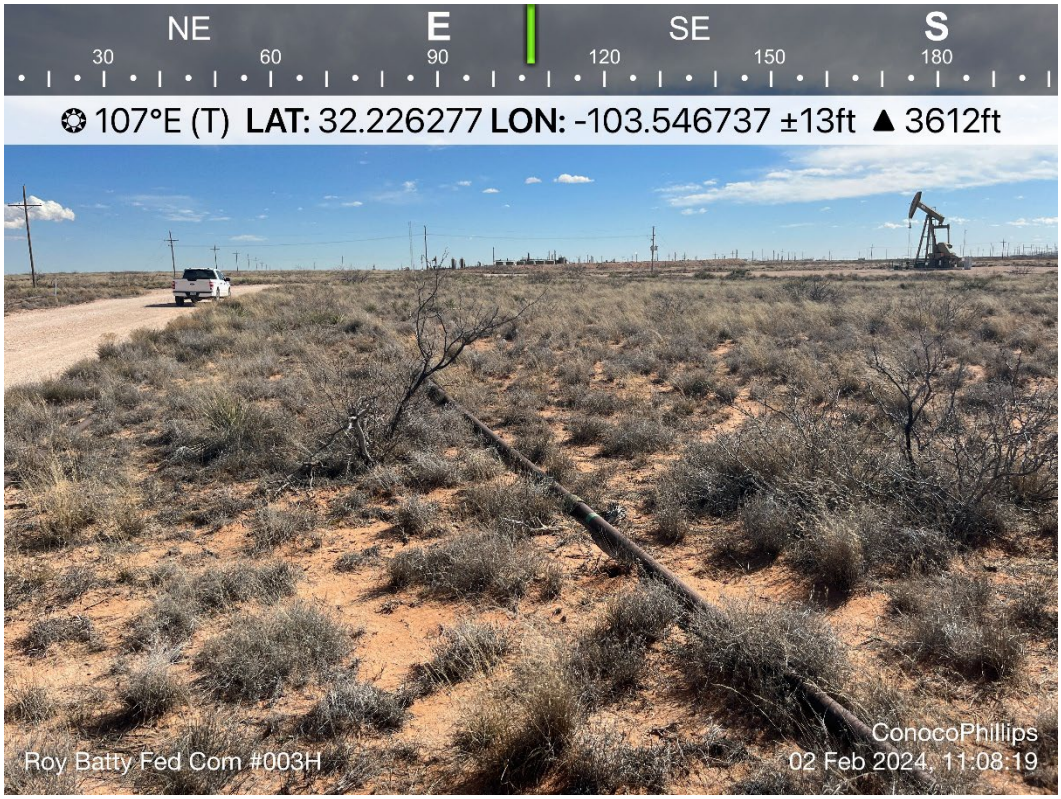
TETRA TECH, INC. PROJECT NO. 212C-MD-03244	DESCRIPTION	View south-southwest of approximate release area and steel polyline.	2
	SITE NAME	Roy Batty Federal Com #003H Release	2/2/2024
