2024 Soil Remediation Summary and Closure Request Report

Burch Keely Unit #142

Eddy County, New Mexico

Incident #NHMP1415747700

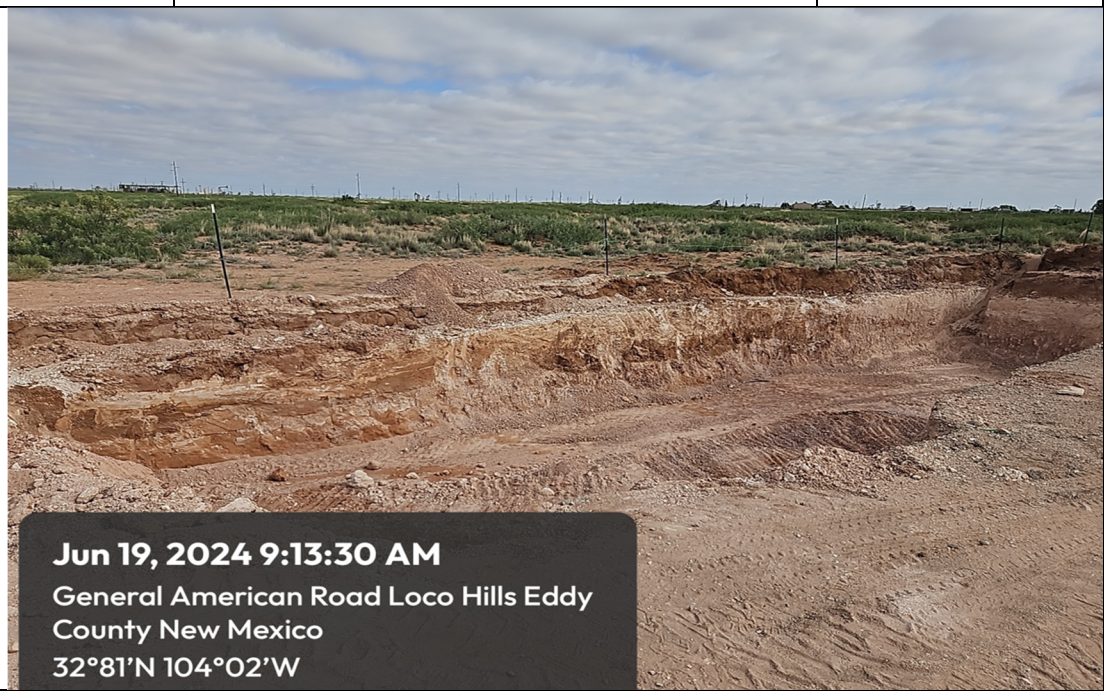
Sample location S-2

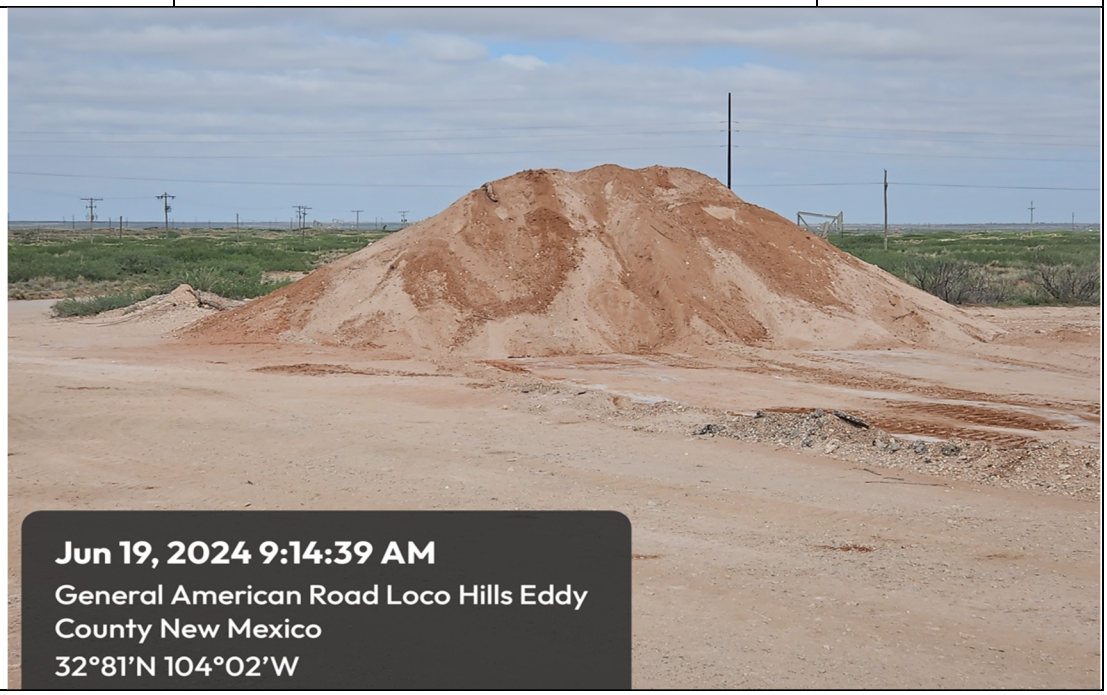
Reclamation backfill

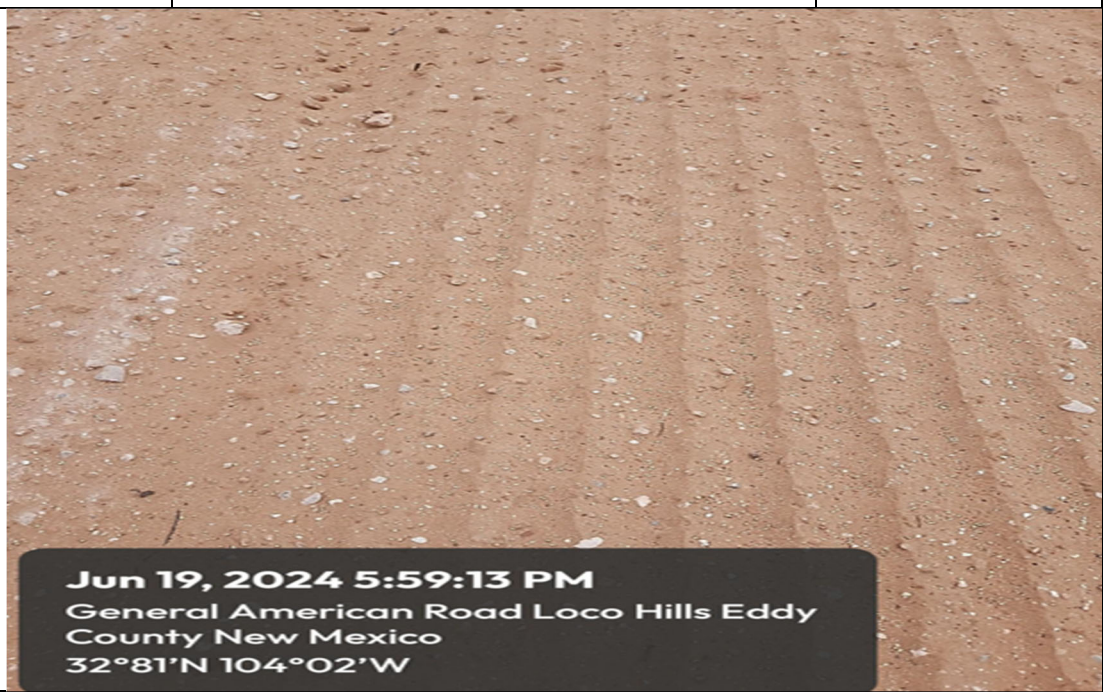
Sample location S-2

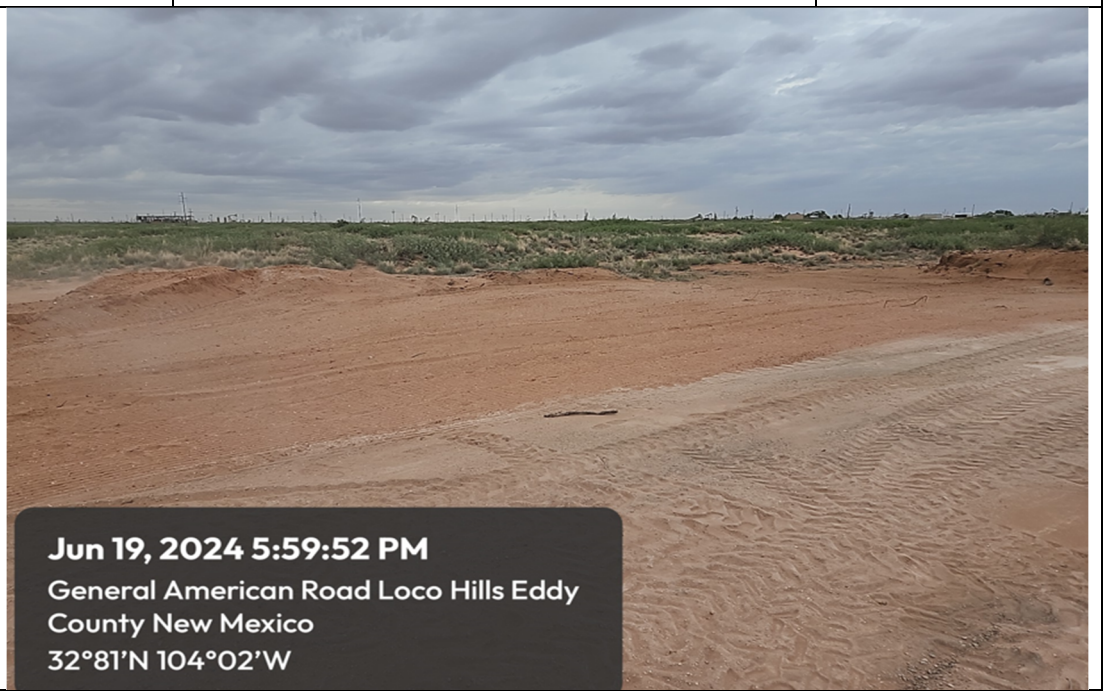
Remediated area reseeded and backfilled
