nRM2031146817
2023 Second (2nd) Quarter Groundwater Monitoring Report
Northeast Drinkard Unit (NEDU) #829, #830, #922, #928, and #929
Lea County, New Mexico

Larson & Associates, Inc.
Environmental Consultants

LAI Project No: 19-0112-22

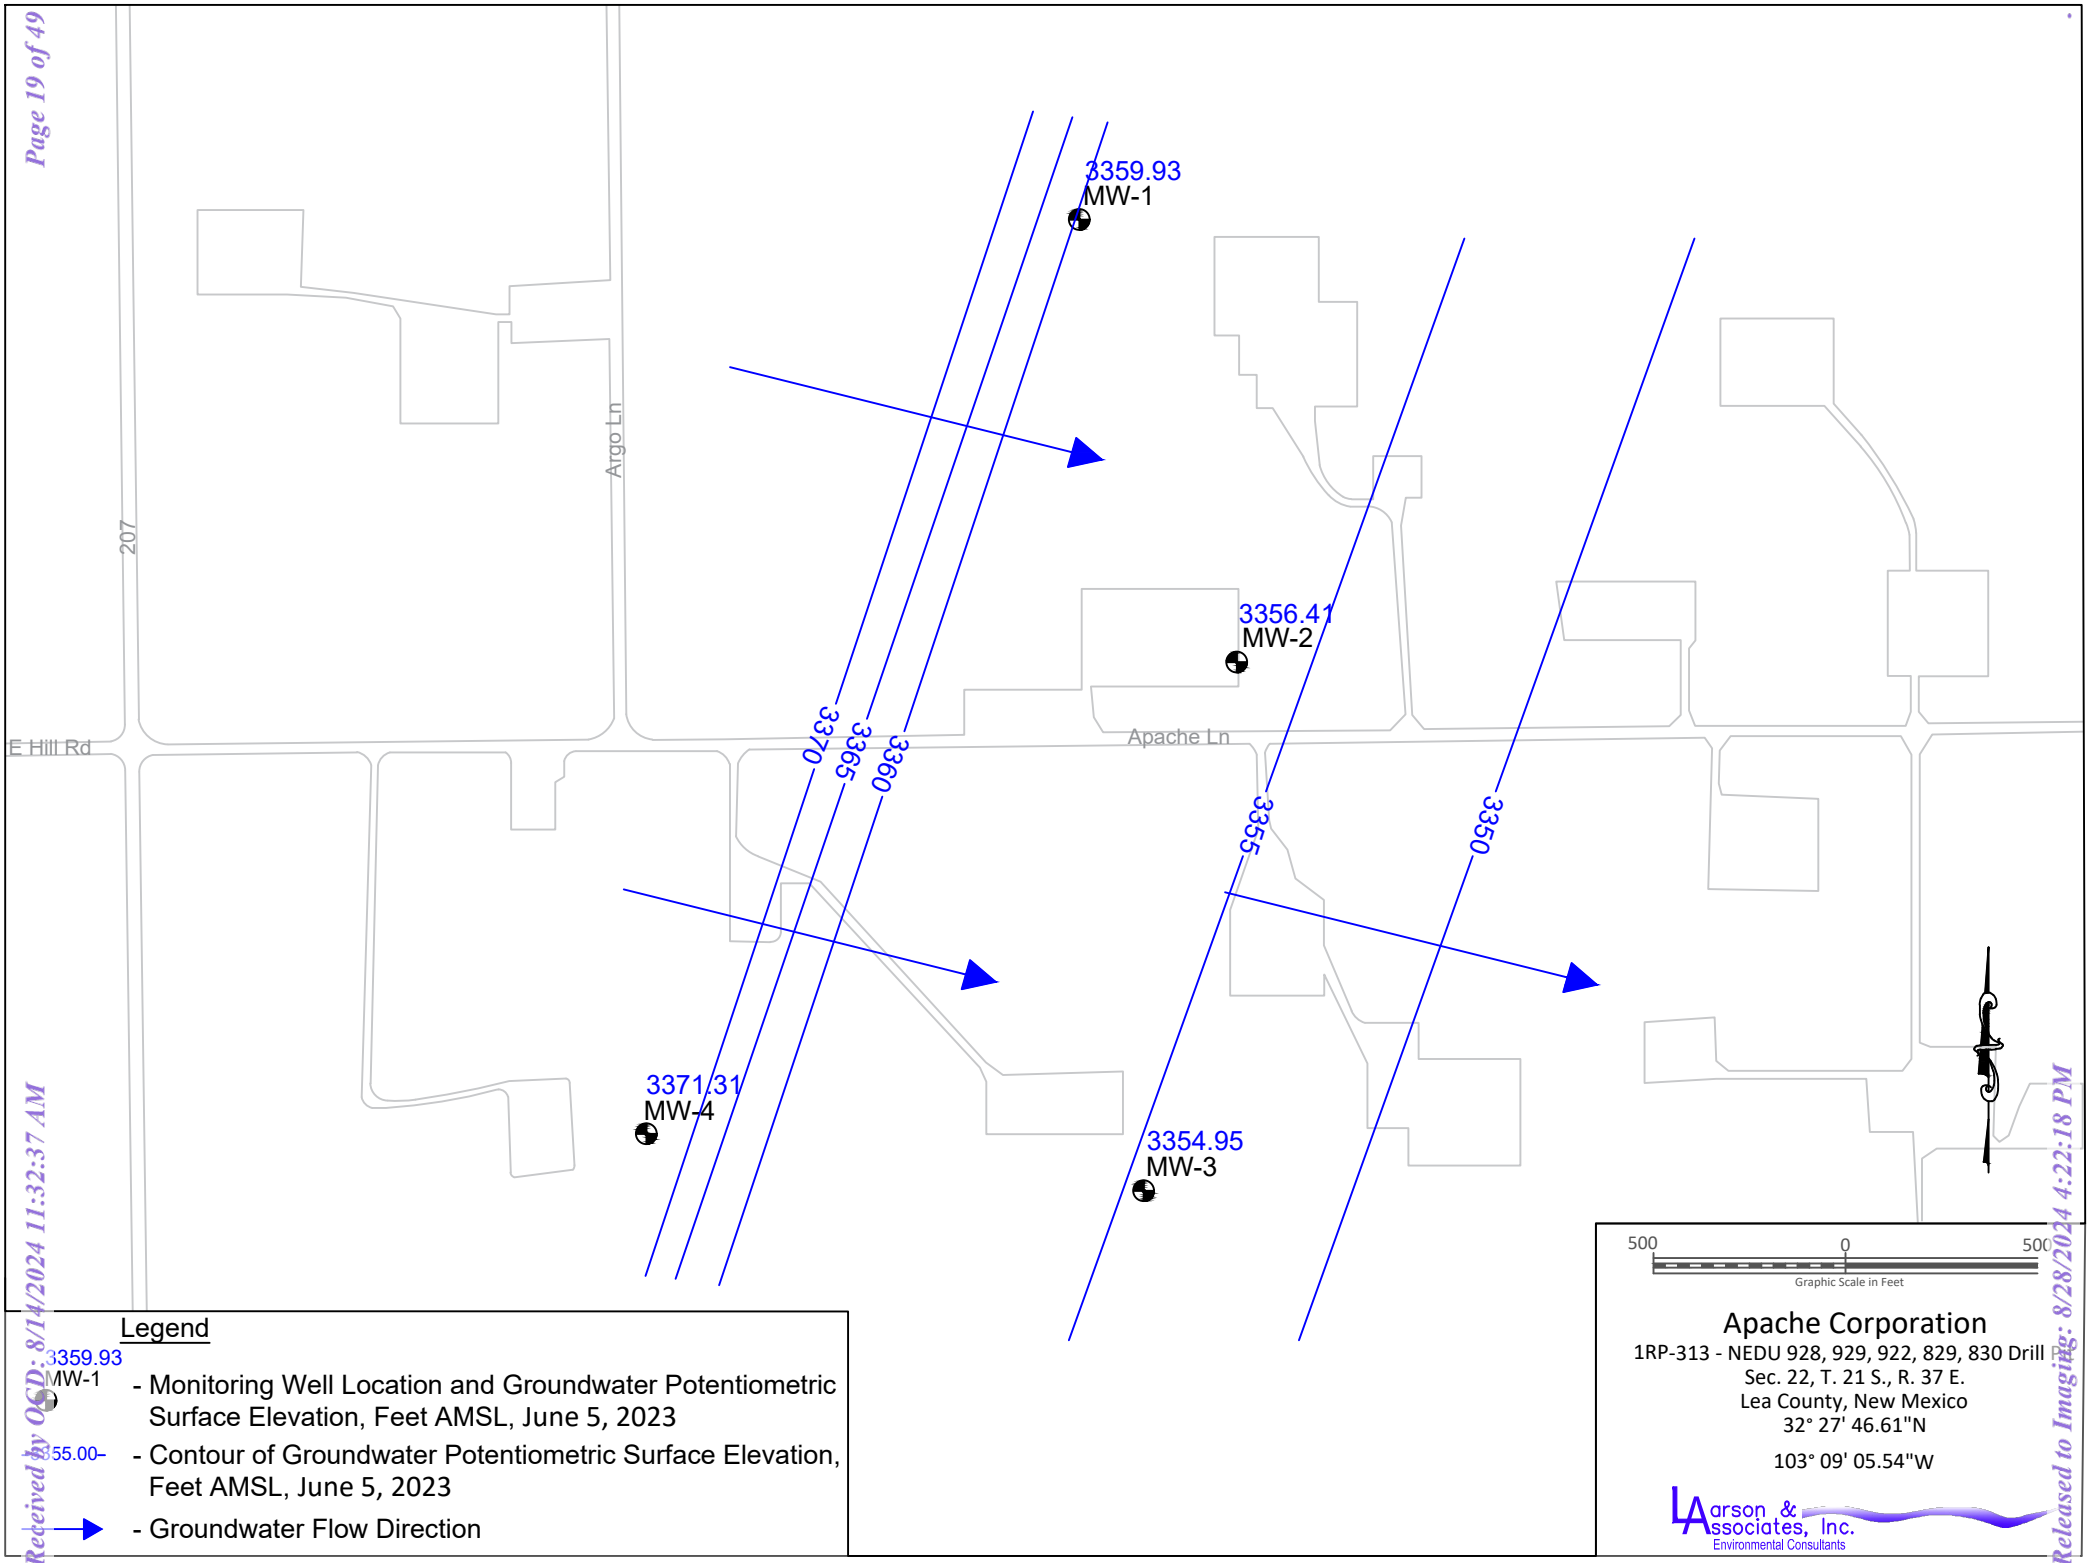
Figure 4b - Groundwater Potentiometric Map, June 5, 2023

On June 05, 2023, LAI personnel gauged monitoring wells MW-1 through MW-4 for depth to groundwater. Groundwater was gauged in monitoring well MW-1 (54.41 feet bgs), MW-2 (52.18 feet bgs), MW-3 (51.77 feet bgs), and MW-4 (40.63 feet bgs). The groundwater potentiometric surface elevation was recorded 3,371.31 feet above mean sea level (MSL) in well MW-4 (upgradient) and at 3,354.95 feet above MSL at well MW-3 (downgradient). The groundwater flow direction was from northwest to southeast at a gradient of about 0.013 ft/ft. Figure 4 presents the groundwater potentiometric surface map for June 05, 2023.

- Groundwater elevation ranged between 3,371.31 feet above MSL at well MW-4 (upgradient) and 3,354.95 (MSL) at well MW-3 (downgradient).
- The groundwater flow direction was from northwest to southeast at a gradient of about 0.013 feet per foot (ft/ft).

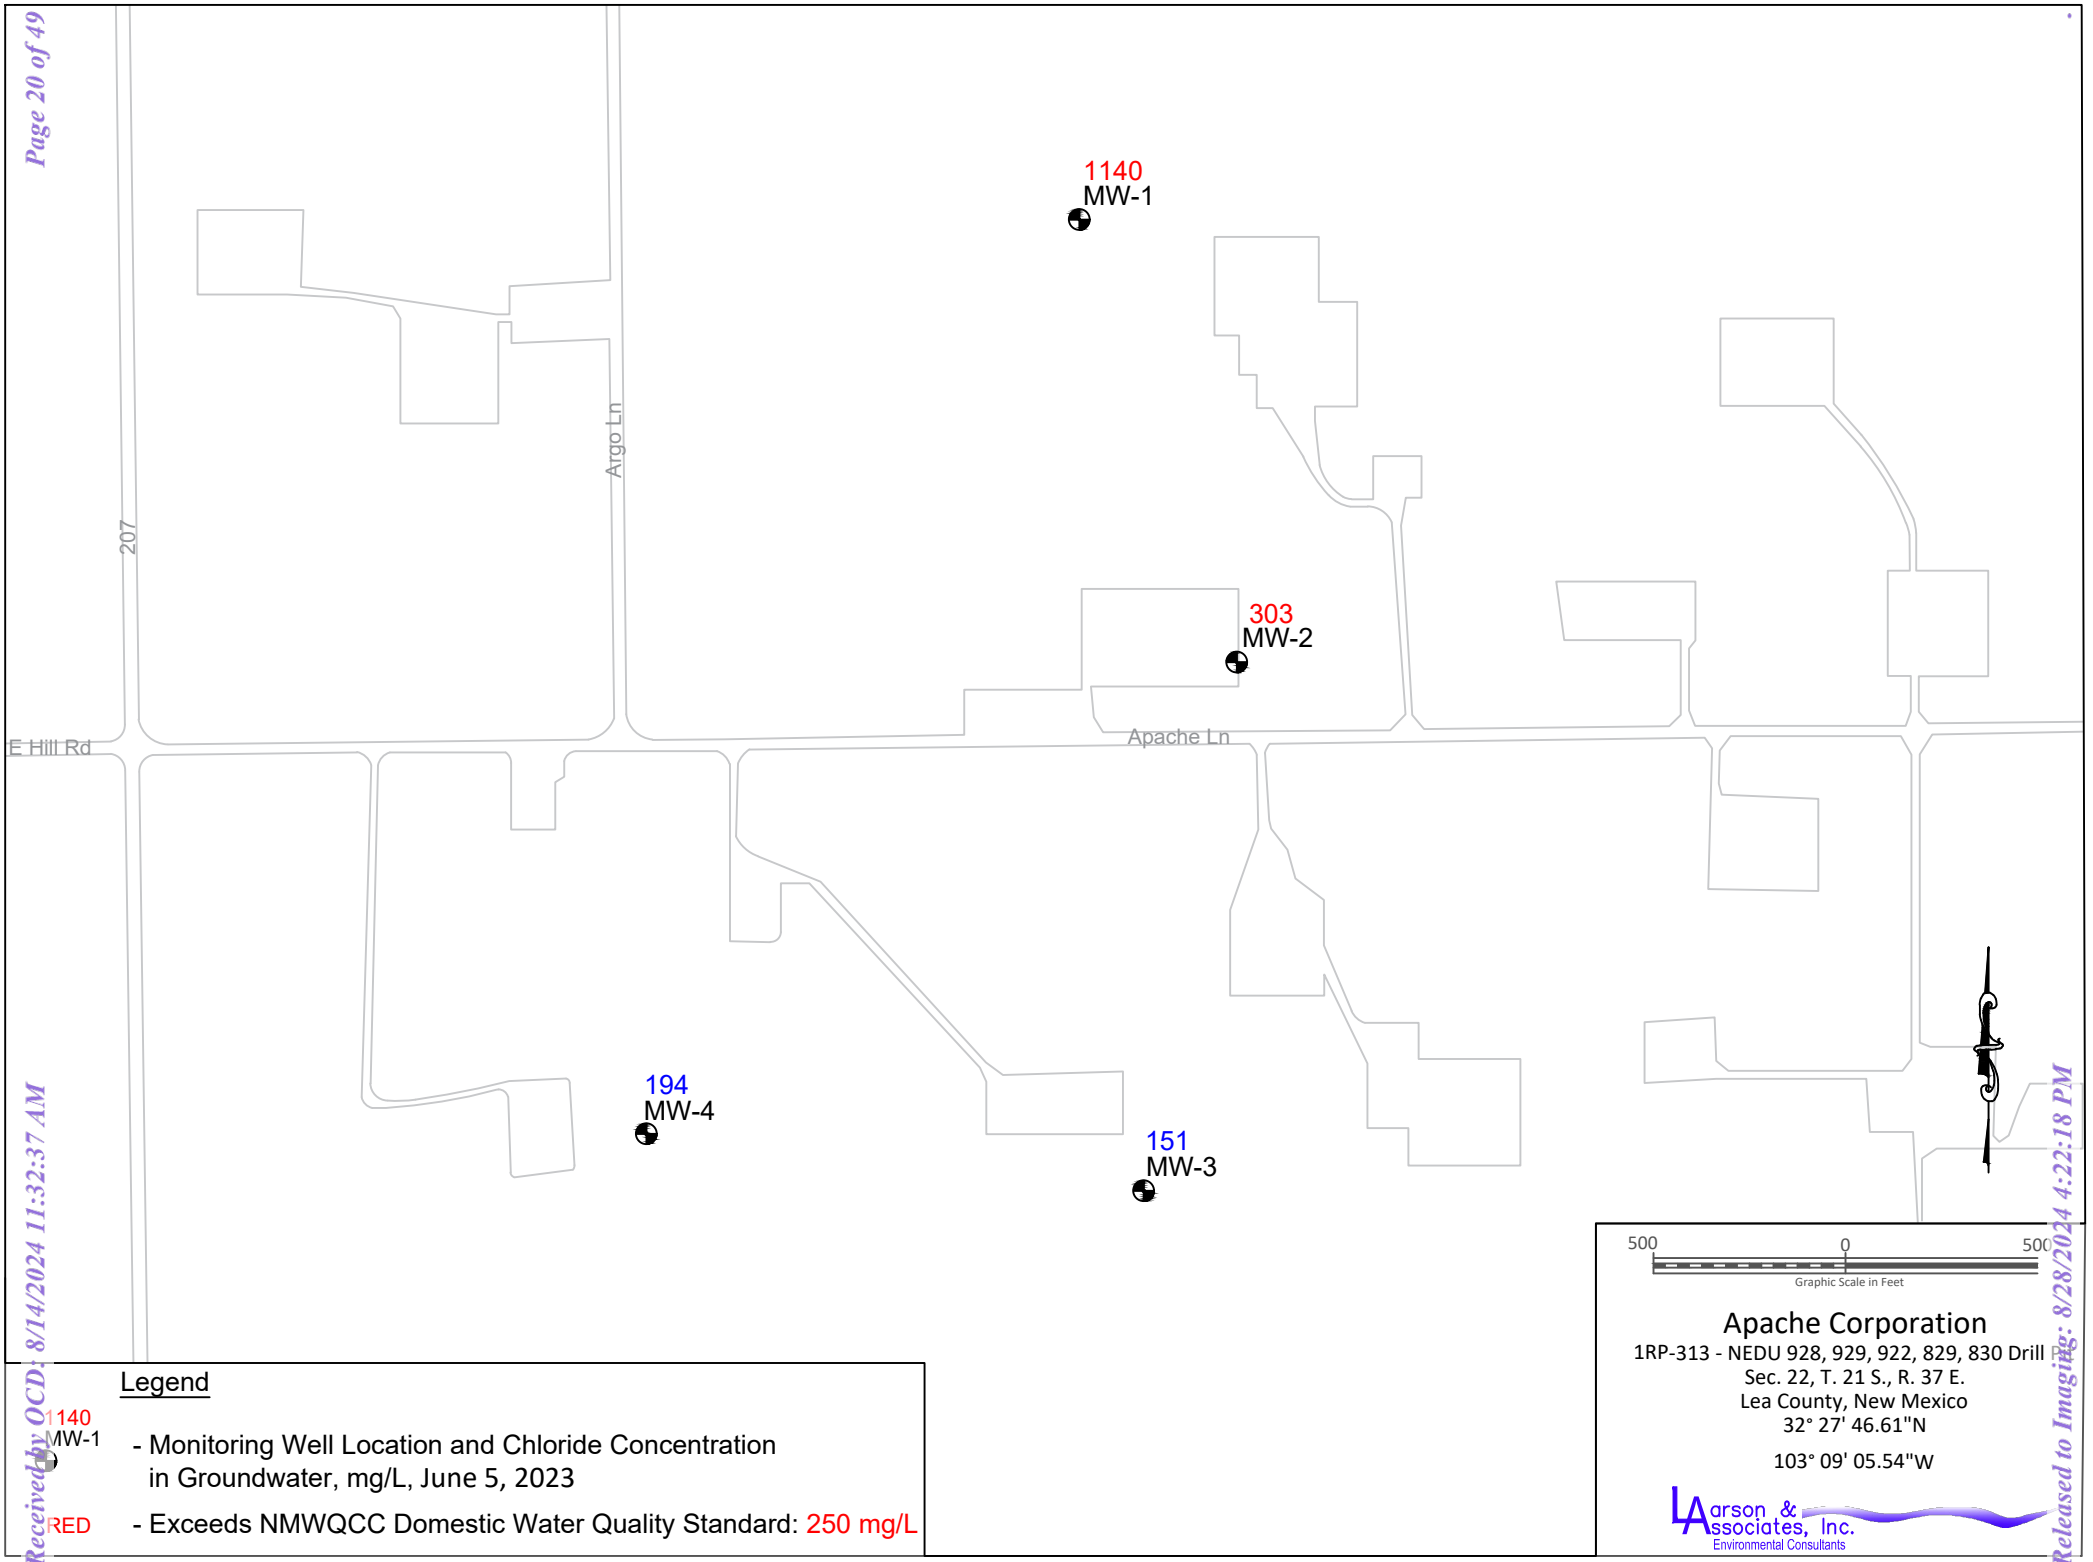
Figure 5b - Chloride Concentration in Groundwater, June 5, 2023

Chloride concentrations were reported below the NMWQCC domestic water quality standard of 250 mg/L in monitoring wells, MW-3 (151 mg/L), and MW-4 (194 mg/L). The chloride concentrations in the groundwater sample collected from monitoring well MW-1 (1,140 mg/L) and MW-2 (303 mg/L) were above the NMWQCC domestic water quality standard. The chloride concentration in the QA/QC sample (Dup-1) collected from monitoring well MW-2 was 242 mg/L and within 20.3 percent of the original chloride value for MW-2 (303 mg/L). No data exceptions were noted in the laboratory report case narratives. Figure 5 presents the chloride concentration map for June 05, 2023.

- Chloride concentrations were above the NMWQCC domestic water quality standard (250 mg/L) in samples from MW-1 (893 mg/L) and MW-2 (303 mg/L).
- Chloride concentrations were below the MNWQCC standard in samples from MW-3 (151 mg/L) and MW-4 (194 mg/L).

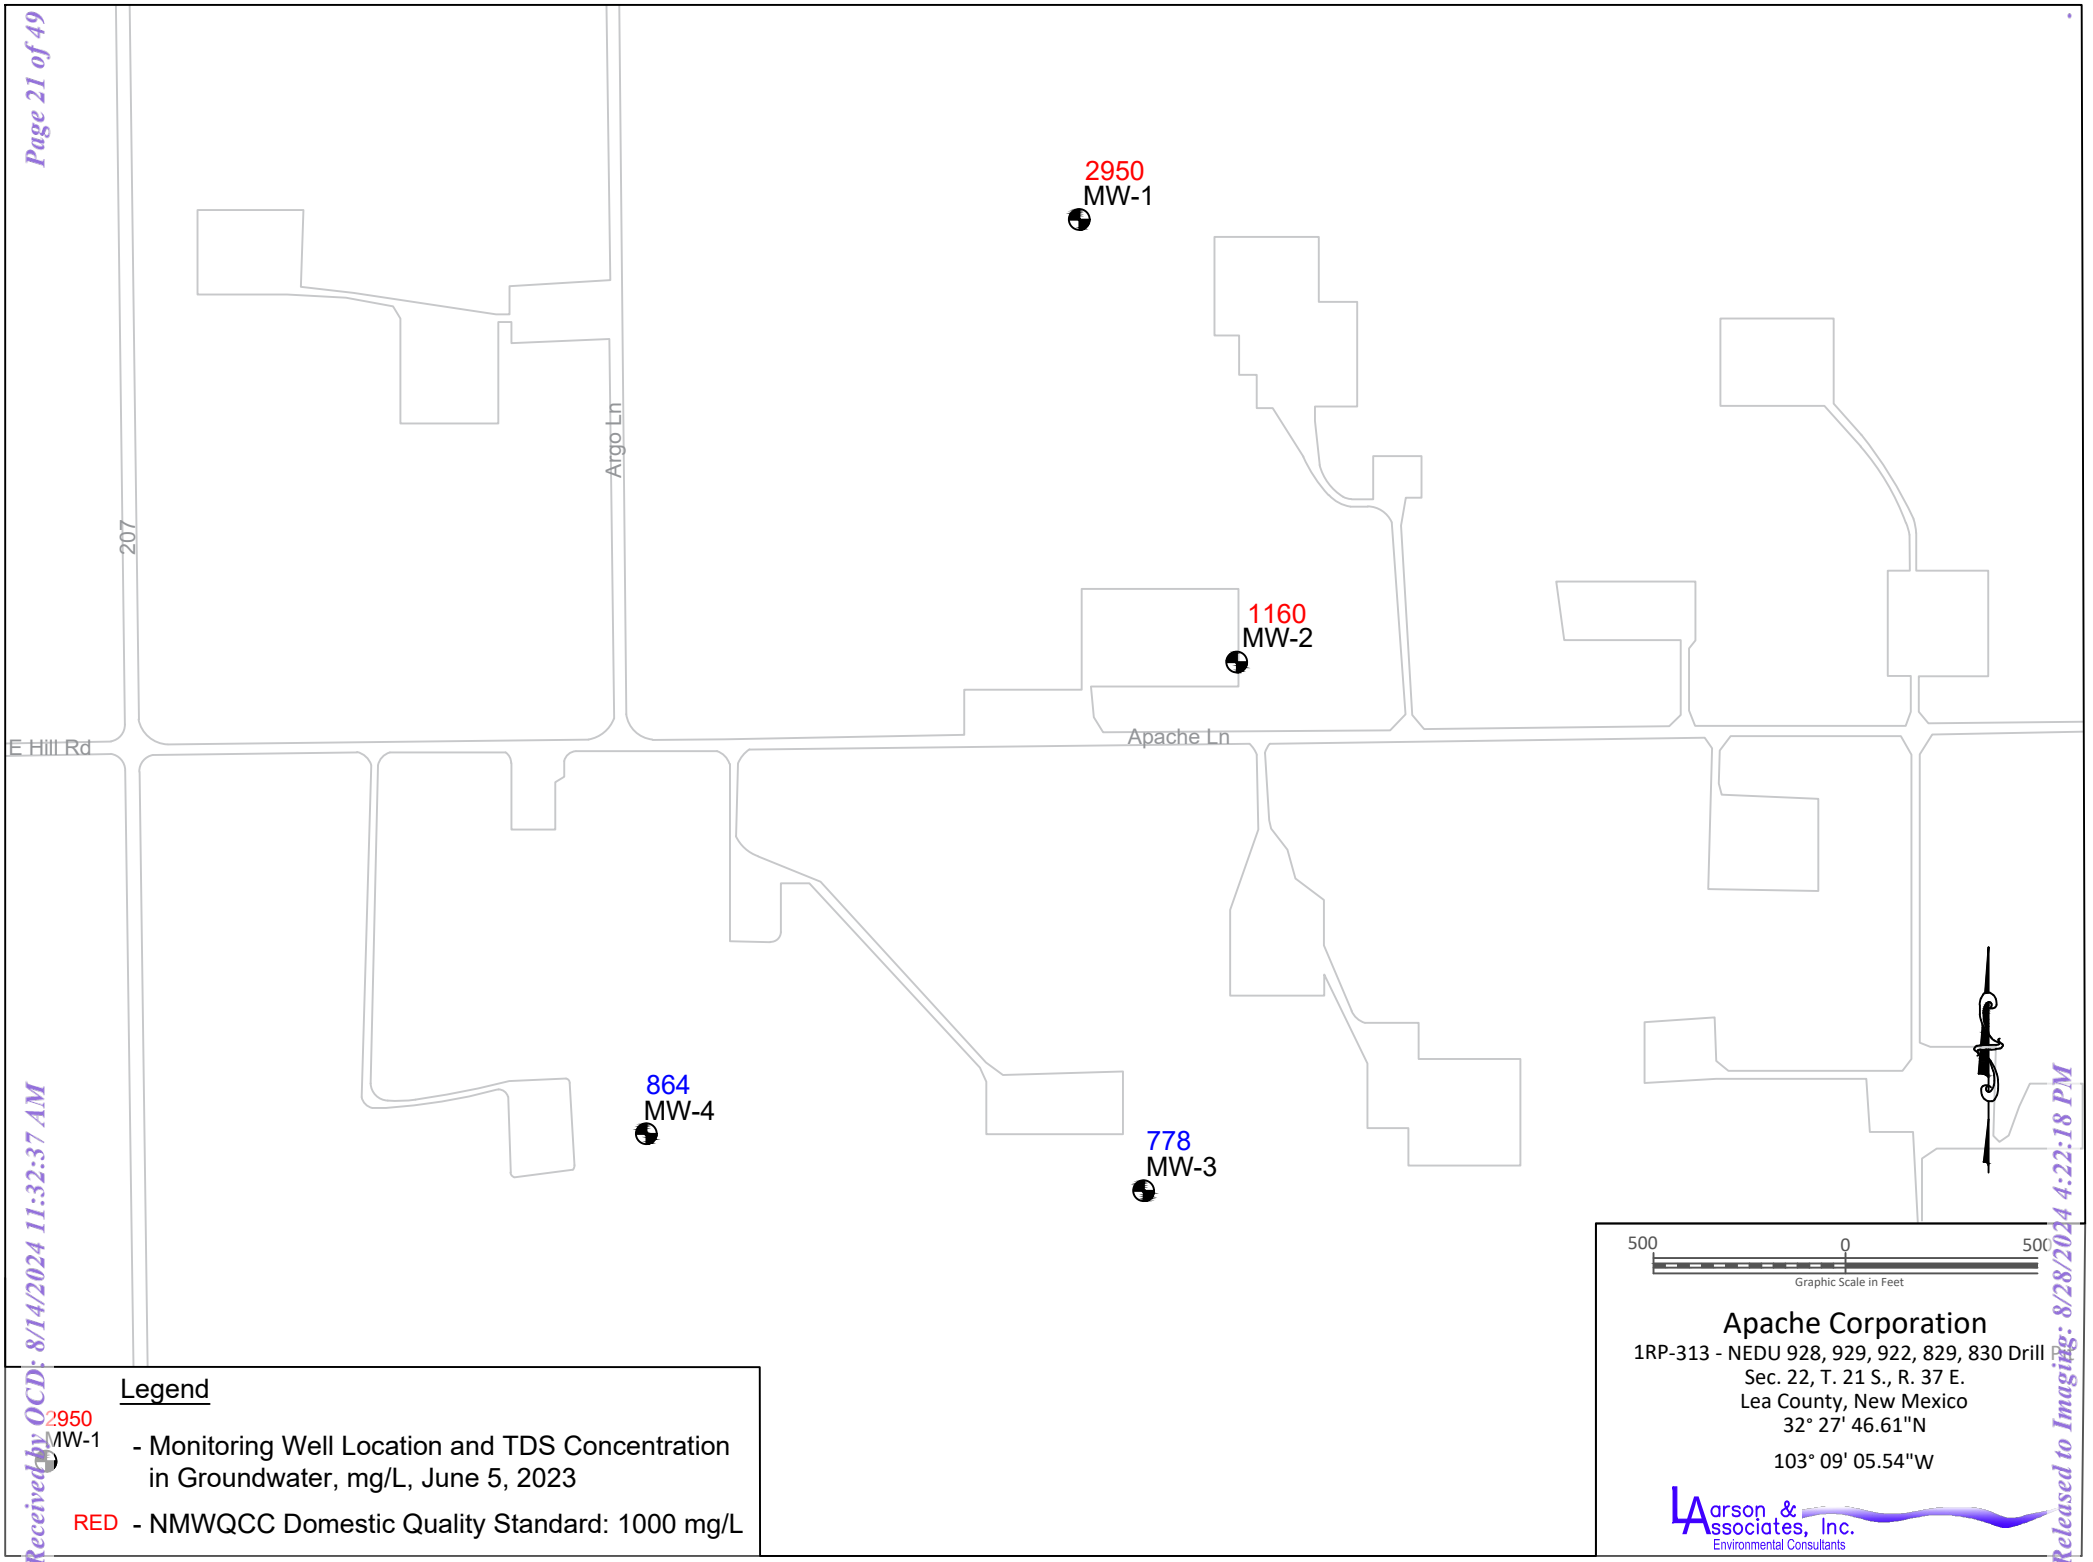
Figure 6b - TDS Concentration in Groundwater, June 5, 2023

TDS concentrations were reported above the NMWQCC domestic water quality standard of 1,000 mg/L in groundwater samples collected from monitoring wells MW-1 (2,950 mg/L) and MW-2 (1,160 mg/L). TDS concentrations were below the NMWQCC domestic water quality standard in groundwater samples from MW-3 (778 mg/L) and MW-4 (864 mg/L). The TDS concentration in the QA/QC sample (Dup-1) collected from monitoring well MW-2 was reported 1,270 mg/L and within 8.7 percent of the original chloride value for MW-2 (1,160 mg/L). No data exceptions were noted in the laboratory case narratives. Figure 6 presents the TDS concentration map for June 05, 2023.

- TDS concentrations were above the NMWQCC domestic water quality standard (1,000 mg/L) in the groundwater samples MW-1 (2950 mg/L) and MW-2 (1160 mg/L) and below the MNWQCC standard in samples from MW-3 (778 mg/L) and MW-4 (864 mg/L).
