nRM2031146817
2022 Third (3rd) Quarter Groundwater Monitoring Report
Northeast Drinkard Unit (NEDU) #829, #830, #922, #928, and #929
Lea County, New Mexico

Larson & Associates, Inc.
Environmental Consultants

LAI Project No: 19-0112-38

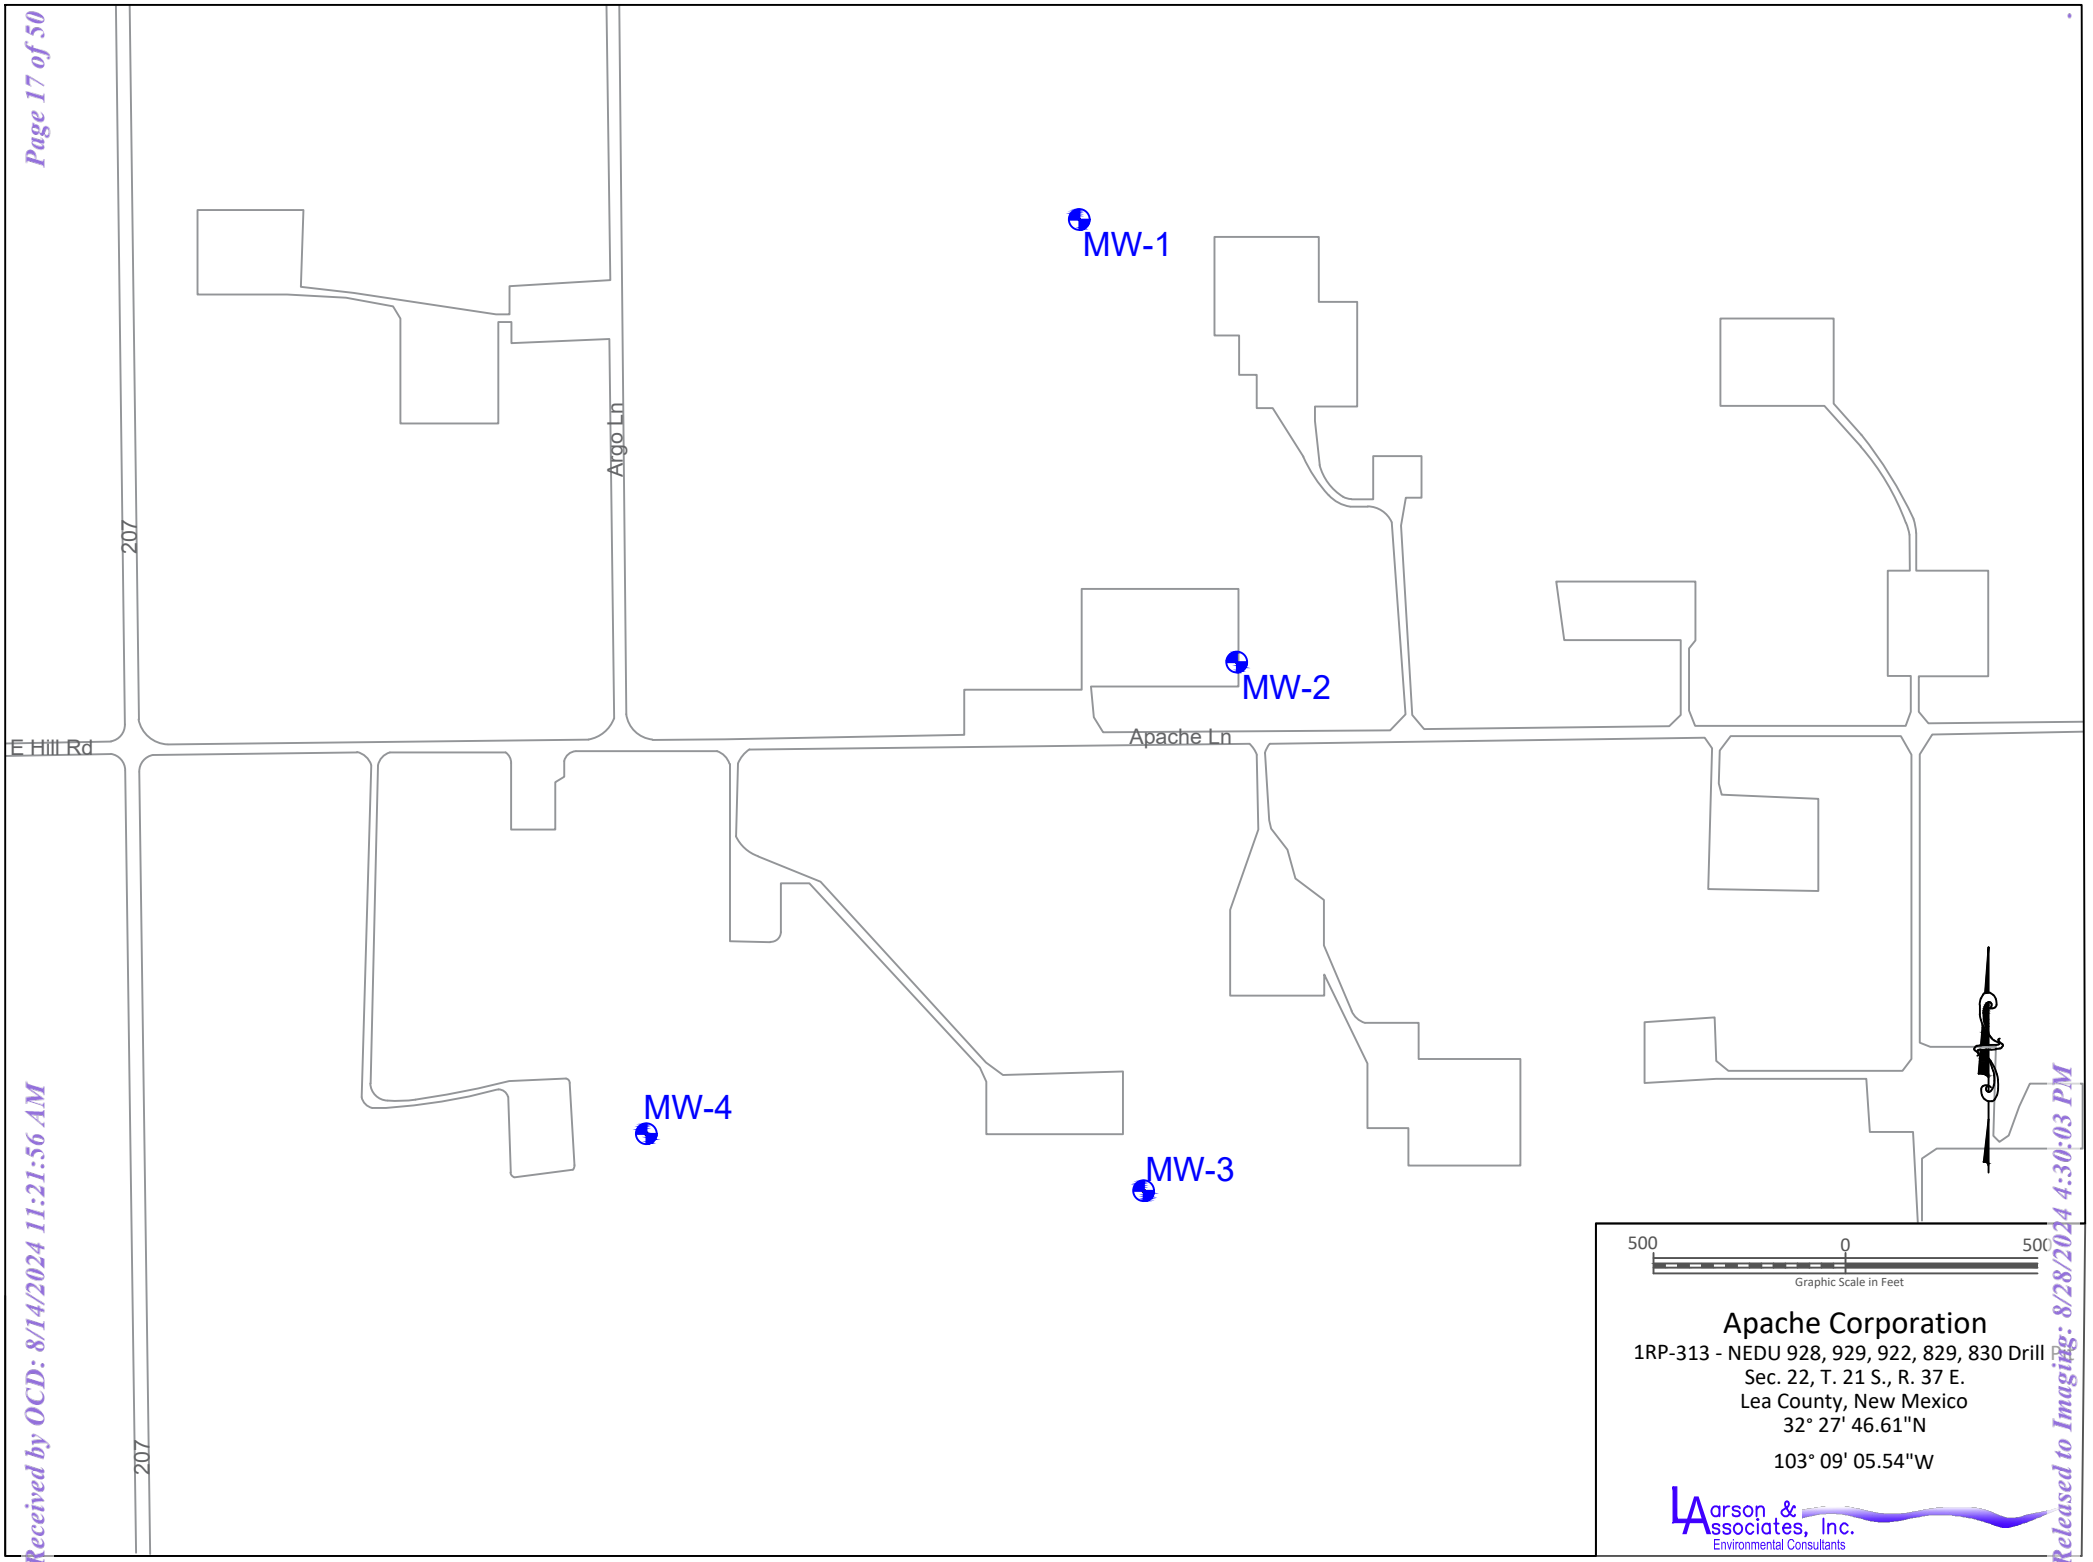
Figure 3 - Site Map

West Company, a State of New Mexico licensed Professional Land Surveyor (License Number 23263) surveyed the monitoring wells for location and elevation including top of casing and natural ground surface. Figure 3 presents Site drawing showing the monitoring well locations. Table 1 presents the monitoring well completion and gauging summary. Appendix B presents the monitoring well boring logs and well completion records.

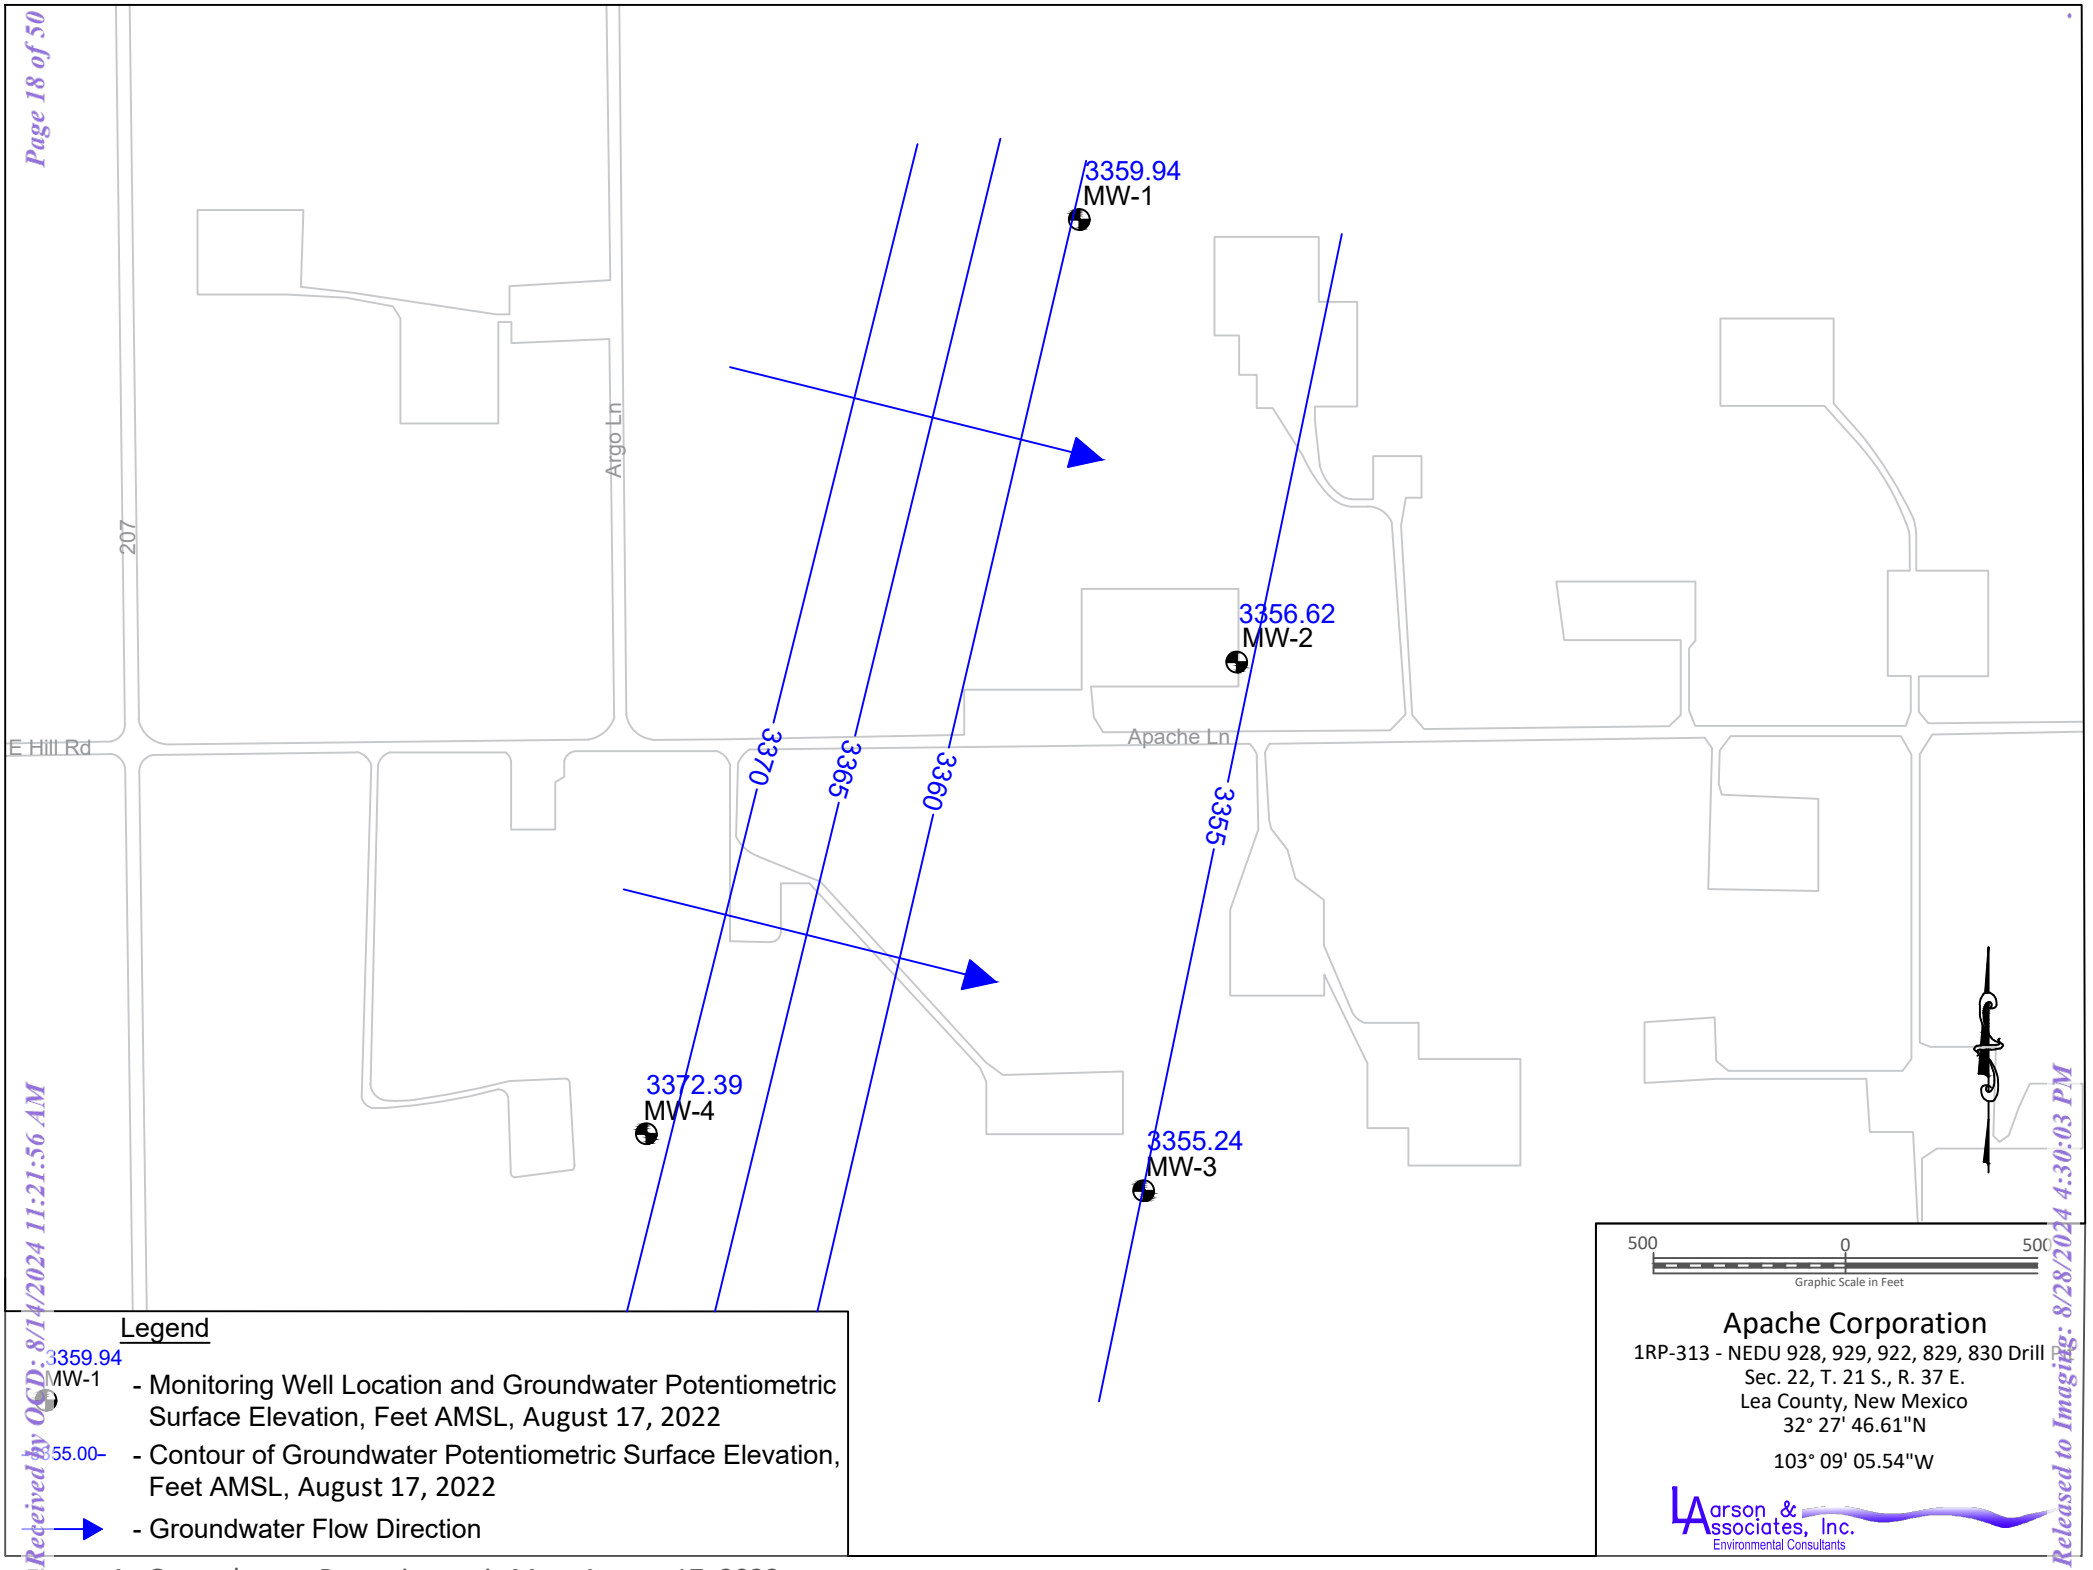
Figure 4 - Groundwater Potentiometric Map, August 17, 2022

- Groundwater flow is northwest to southeast at a gradient of about 0.013 feet per foot (ft/ft).
- BTEX compounds were below the analytical method reporting limit (RL) and New Mexico Water Quality Control Commission (NMWQCC) human health standards in groundwater samples from monitoring wells MW-1 through MW-4.

On August 17, 2022, LAI personnel gauged monitoring wells MW-1 through MW-4 for depth to groundwater. Groundwater was gauged in monitoring wells MW-1, MW-2, MW-3, and MW-4 at 54.40, 52.04, 51.48, and 39.55 feet bgs, respectively. Groundwater potentiometric surface elevation was recorded at 3,372.39 above MSL at MW-4 (upgradient) to 3,355.24 feet above MSL at MW-3 (downgradient). The groundwater flow direction is from northwest to southeast at a gradient of about 0.013 ft/ft. Figure 4 presents the groundwater potentiometric surface map for August 18, 2022.

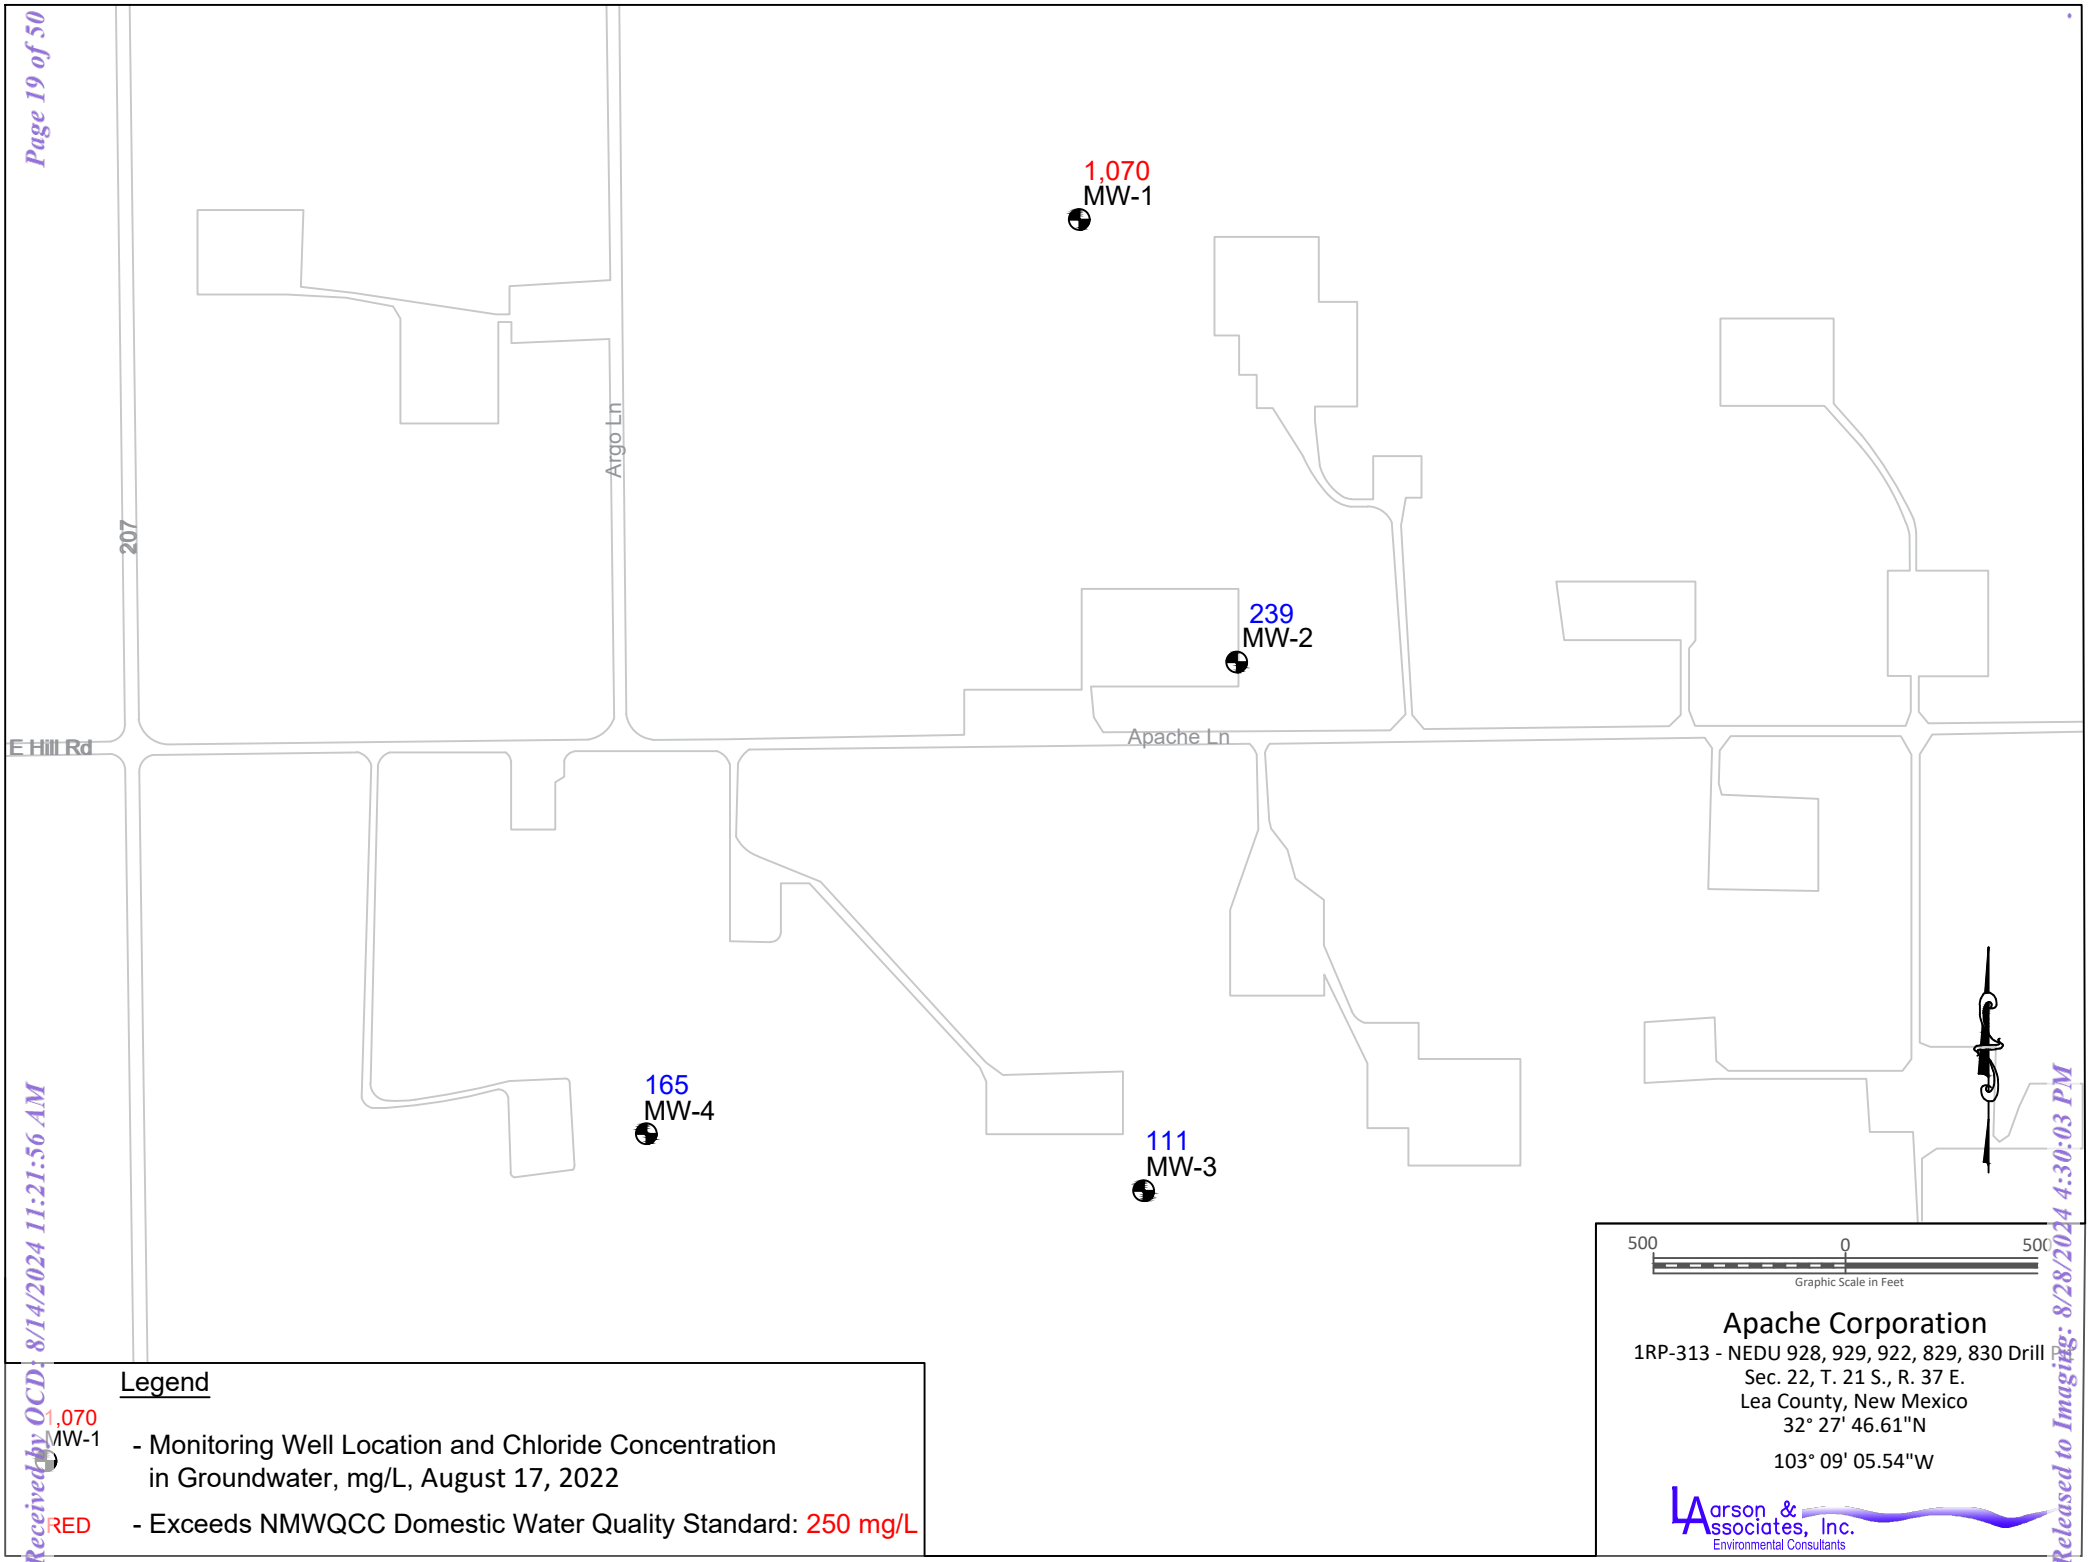
Figure 5 - Chloride Concentration in Groundwater, August 17, 2022

Chloride concentrations were reported below the NMWQCC domestic water quality standard of 250 mg/L in monitoring wells MW-2 (239 mg/L), MW-3 (111 mg/L), and MW-4 (165 mg/L). The chloride concentration in the groundwater sample collected from monitoring well MW-1 (1,070 mg/L) was above the NMWQCC domestic water quality standard. The chloride concentration in the QA/QC sample (Dup-1) collected from monitoring well MW-2 was 246 mg/L and within 2.9 percent of the original chloride value for MW-2 (239 mg/L). No data exceptions were noted in the laboratory report case narratives. Figure 5 presents the chloride concentration map for August 17, 2022.

- The chloride concentration in the groundwater sample collected from monitoring well MW-1 (1,070 mg/L) was above the NMWQCC domestic water quality standard of 250 mg/L.

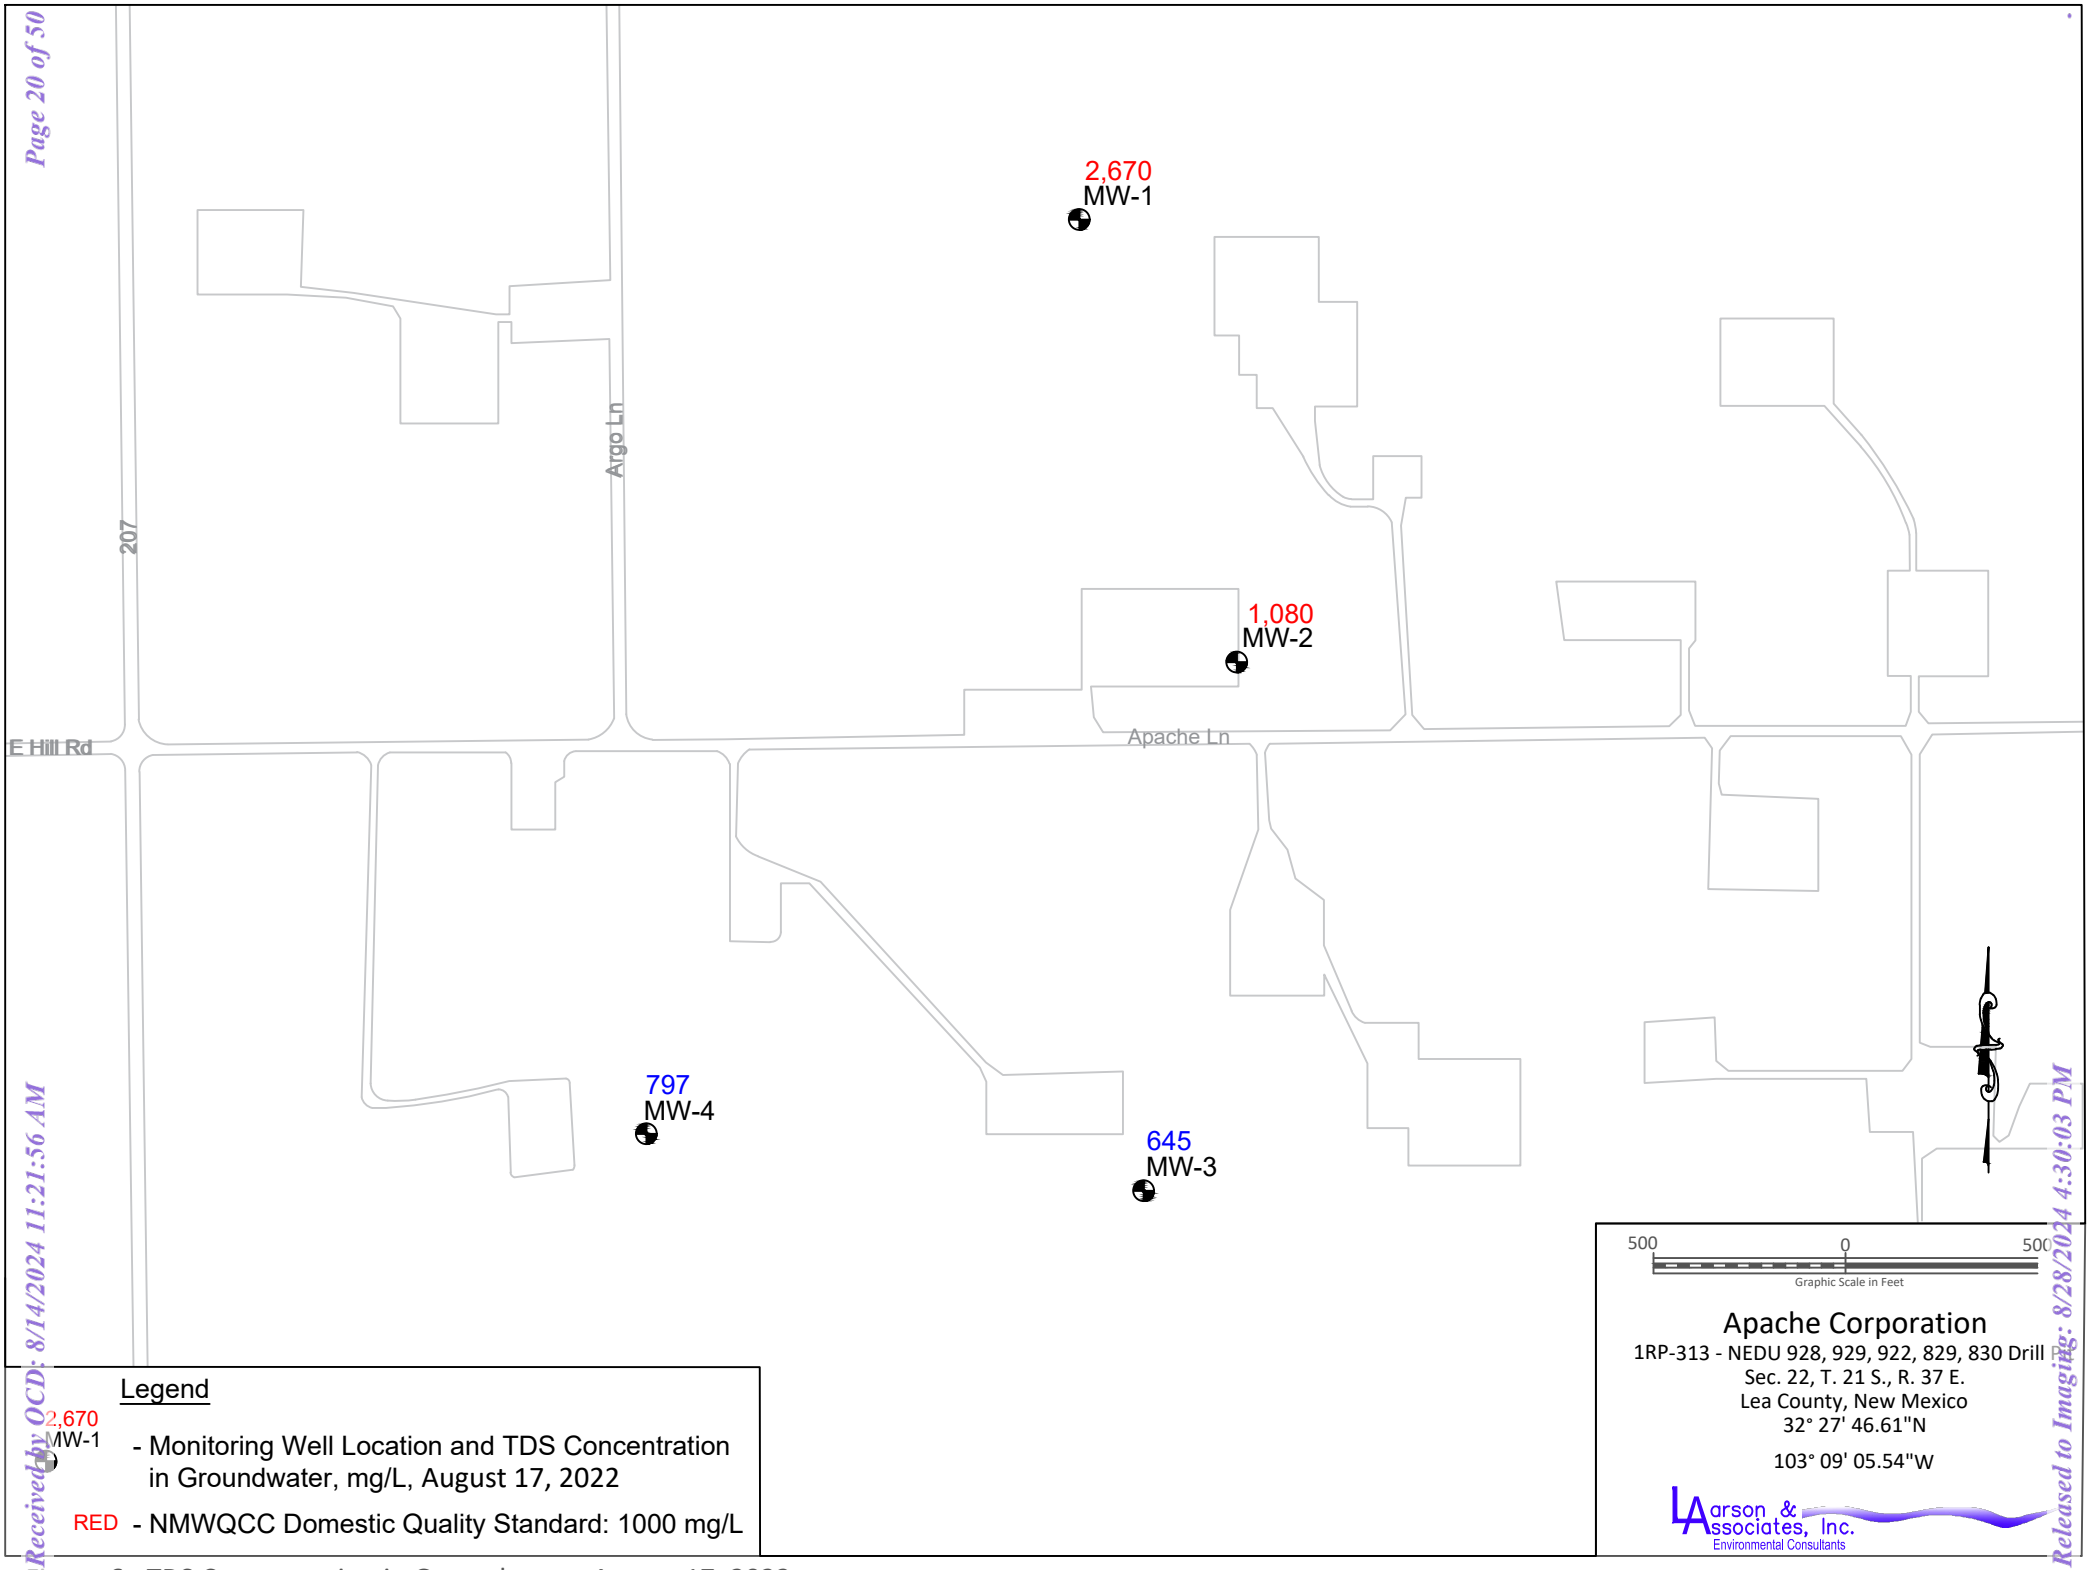
Figure 6 - TDS Concentration in Groundwater, August 17, 2022

TDS concentrations in groundwater samples collected from monitoring wells MW-1 (2,670 mg/L) and MW-2 (1,080 mg/L) were above the NMWQCC domestic water quality standard of 1,000 mg/L. TDS concentrations were below the NMWQCC domestic water quality standard in groundwater samples collected from MW-3 (645 mg/L) and MW-4 (797 mg/L). The TDS concentration in the QA/QC sample (Dup-1) was 1,090 mg/L and within 0.93 percent of the original TDS value for MW-2 (1,080 mg/L). No data exceptions were noted in the laboratory case narratives. Figure 6 presents the TDS concentration map for August 17, 2022.

- TDS concentrations in the groundwater samples collected from wells MW-1 (2,670 mg/L) and MW-2 (1,080 mg/L) were above the NMWQCC domestic water quality standard of 1,000 mg/L.
