Closure Report
DL 10 15 Ogopogo Federal Com #422H (10.16.2022 & 10.20.2022)
Lea County, New Mexico
Unit I Sec 10 T22S R33E
32.404479°, -103.555760°

Incident Number: NAPP2229333460
Produced Water Release
Point of Release: 8-inch hose failed
Release Dates: 10.16.2022
Volumes Released: 30 Barrels of Produced Water
Volumes Recovered: 27 Barrels of Produced Water

Incident Number: NAPP2230526211
Produced Water Release
Point of Release: Frac operations main water supply line failed
Release Dates: 10.20.2022
Volumes Released: 1,091 Barrels of Produced Water
Volumes Recovered: 1,000 Barrels of Produced Water

Re: Closure Report
DL 10 15 Ogopogo Federal Com #422H (10.16.2022 & 10.20.2022)
Incident IDs: NAPP2229333460 & NAPP2230526211
Chevron U.S.A., Inc.
Site Location: Unit I, S10, T22S, R33E
(Lat 32.404479º, Long -103.555760º)
Lea County, New Mexico

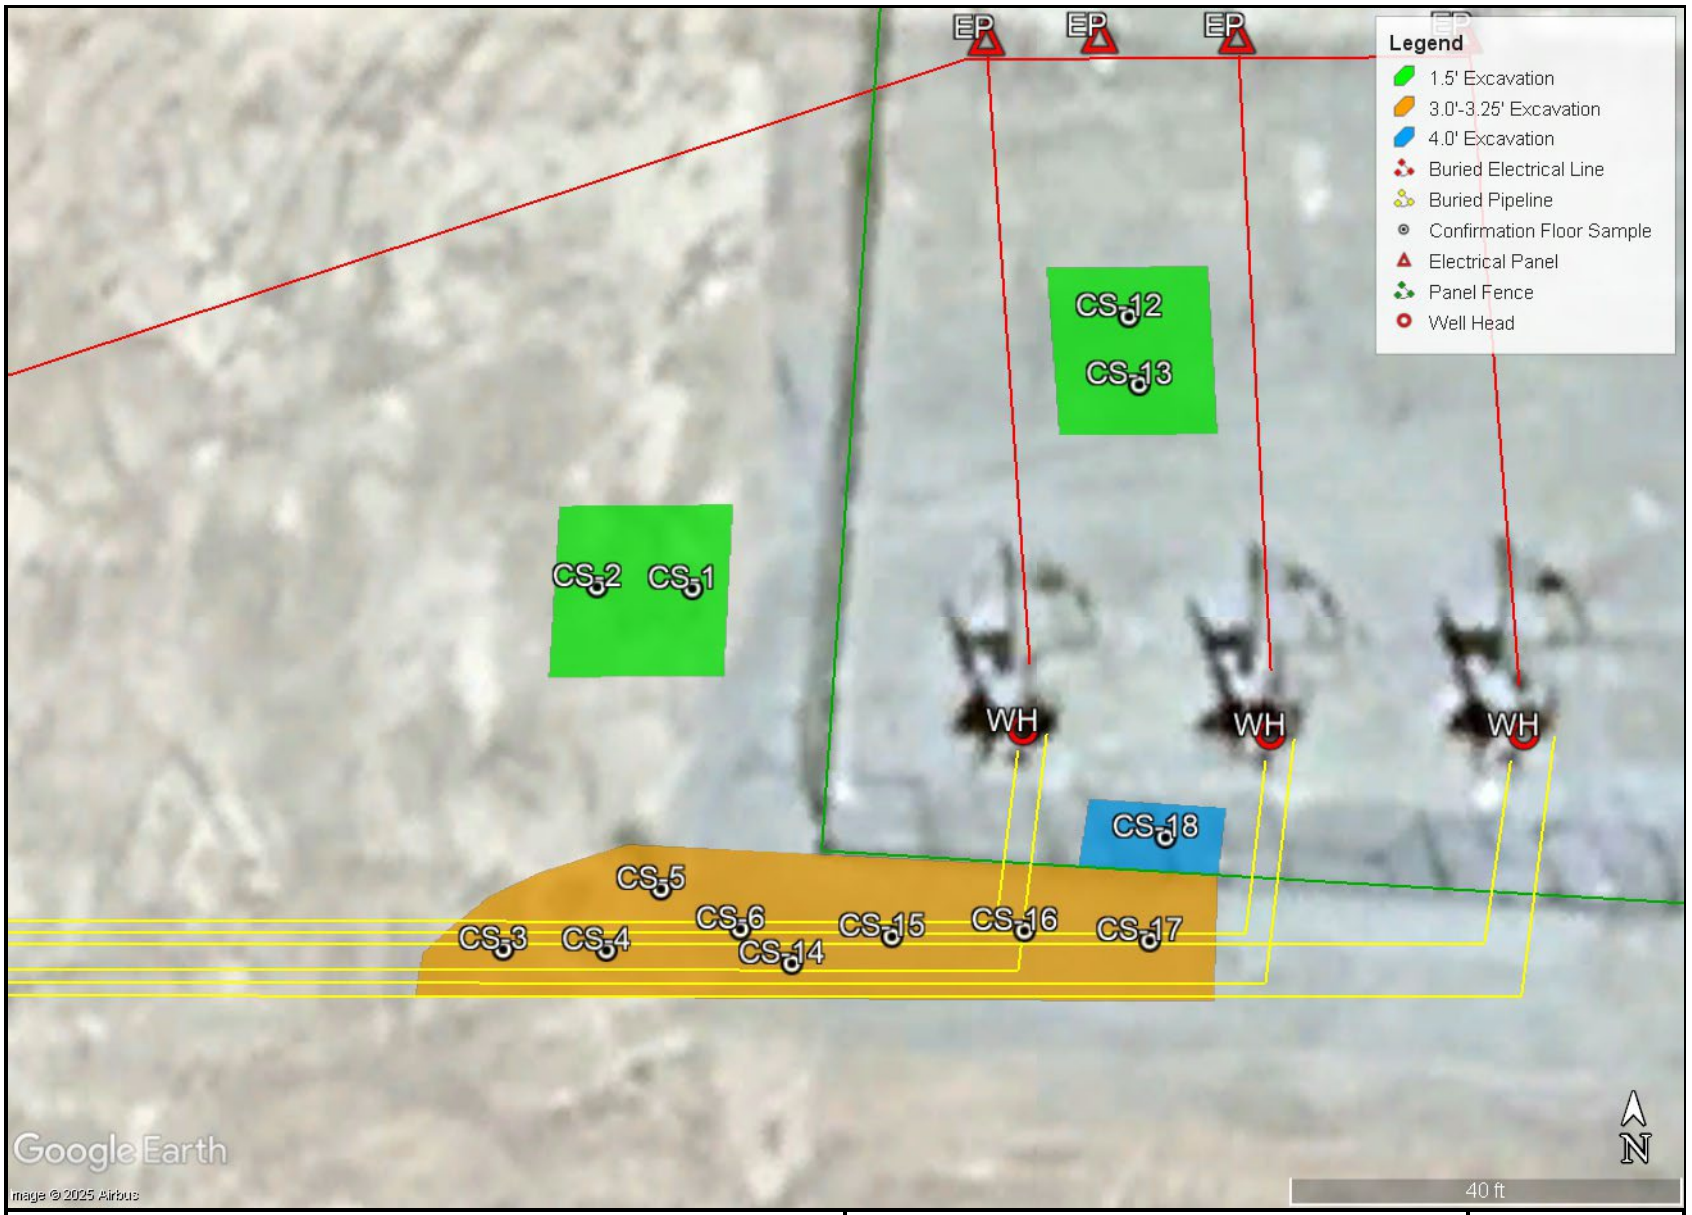
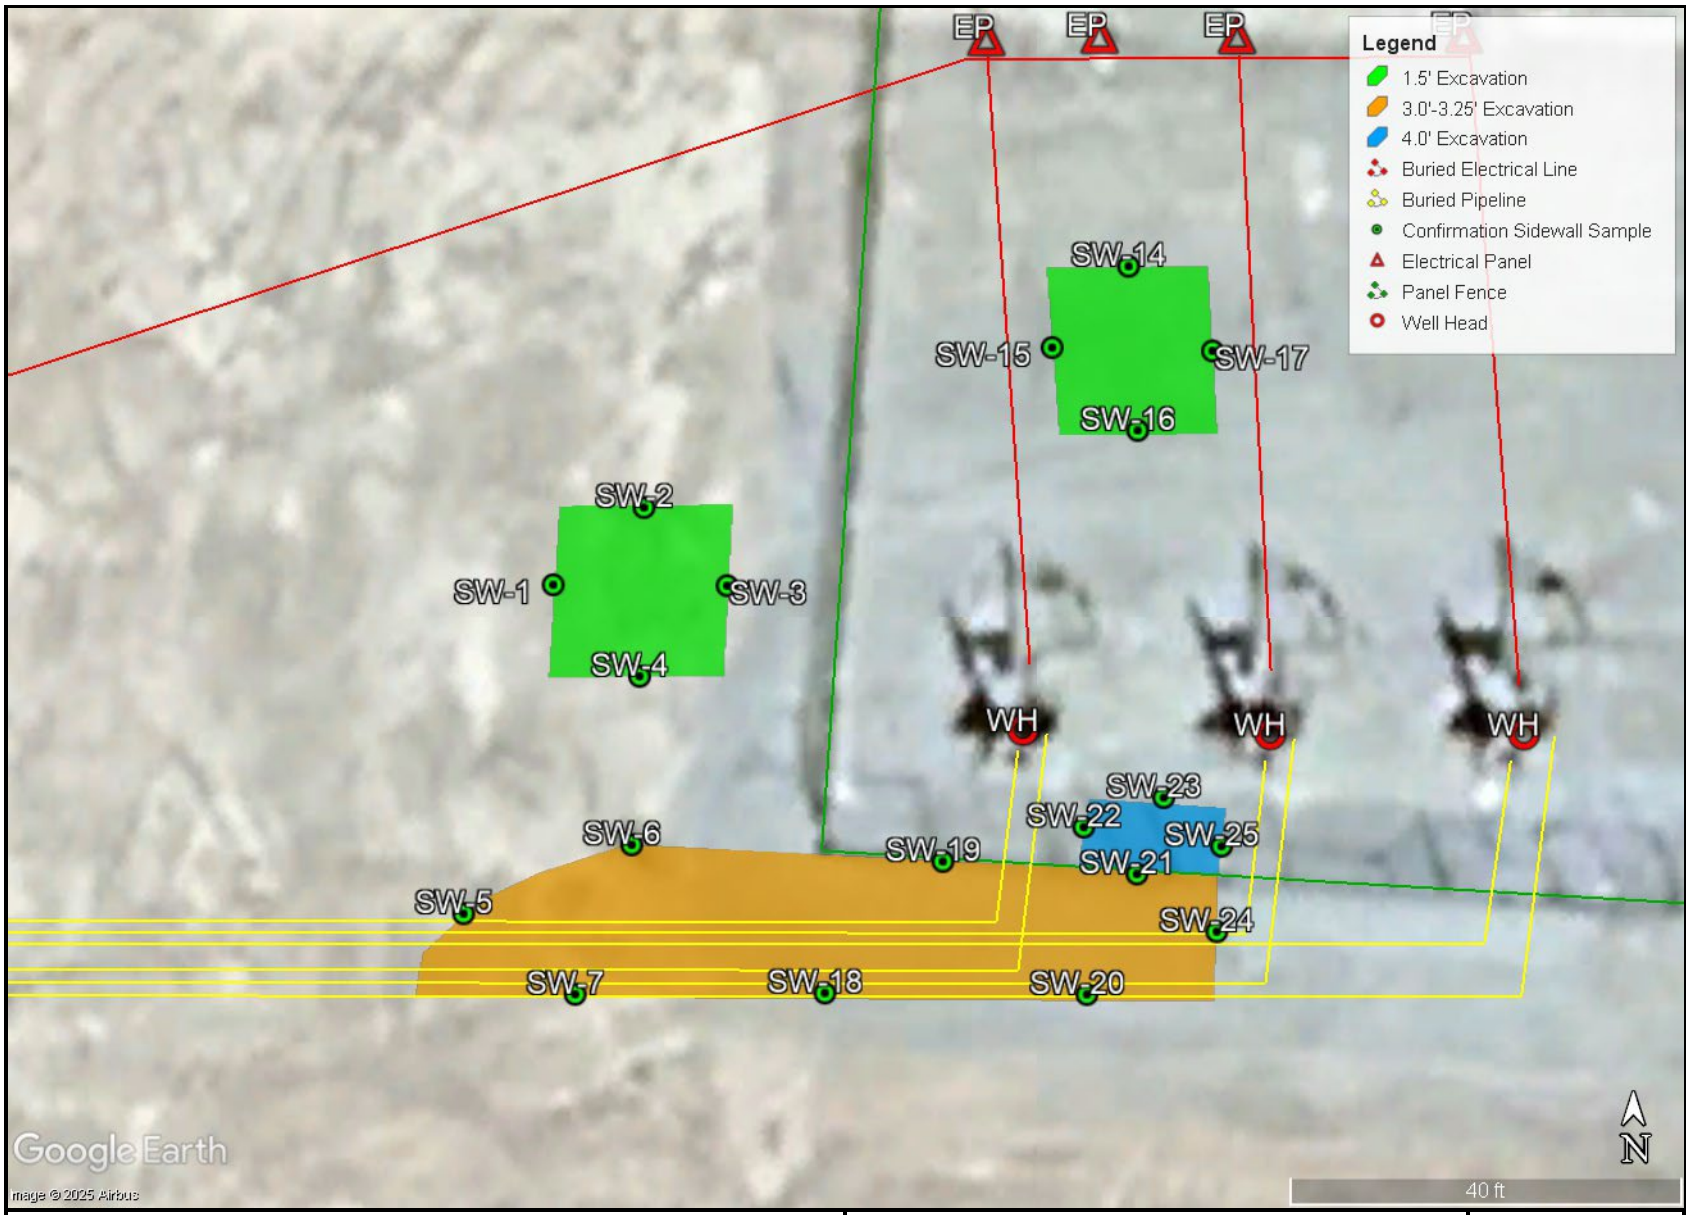
EXCAVATION DEPTH MAP CHEVRON U.S.A., INC. DL 10 15 OGOPOGO FEDERAL COM #422H LEA COUNTY, NEW MEXICO 32.404479°, -103.555760°	CARMONA RESOURCES	FIGURE 5A

collected (CS-1 through CS-18), and twenty-five (25) sidewall samples (SW-1 through SW-25) were collected every 400 square feet (per previously approved work plan sampling variance) to ensure the proper removal of the contaminated soils. The area "EX1 CS Southwall" is represented by "T-4" from the secondary site assessment and by "CS-12 & CS-13" during confirmation sampling. The area of "EX2 NW CS2" is represented by "T-3" from the secondary site assessment and by "CS-1 & CS-2" during confirmation sampling. The area of "EX2 NW CS4" is represented by "CS-3 through CS-6 & CS-14 through CS-18" during confirmation sampling. The area of "EX2 CS54" is represented by "CS-7 through CS-11" during confirmation sampling. For chemical analysis, the soil samples were collected and placed directly into laboratory-provided sample containers, stored on ice, and transported under the proper chain-of-custody protocol to Eurofins Laboratories in Midland, Texas. All collected samples were analyzed for TPH analysis by EPA method 8015 modified, BTEX by EPA Method 8021B, and Chloride by EPA method 300.0. Copies of laboratory analysis and chain-of-custody documentation are included in Appendix E. The excavation depths and confirmation sample locations are shown in Figures 5A-5D.

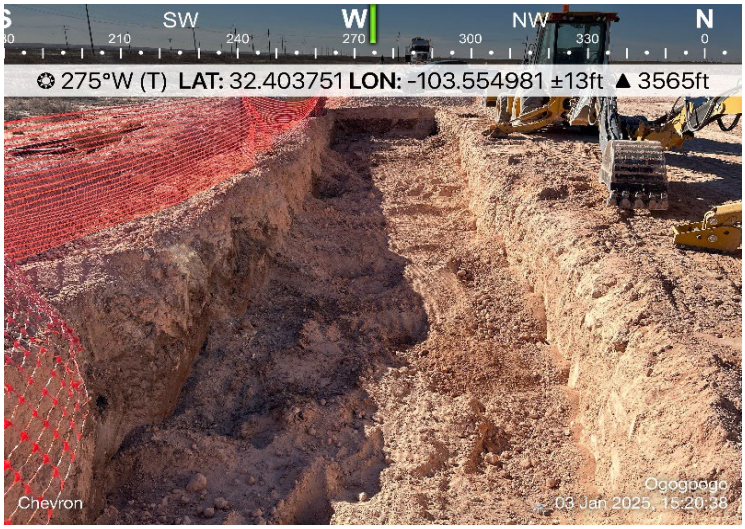
Description:
View West, Area of CS-3 through CS-6, CS-14 through CS-17.

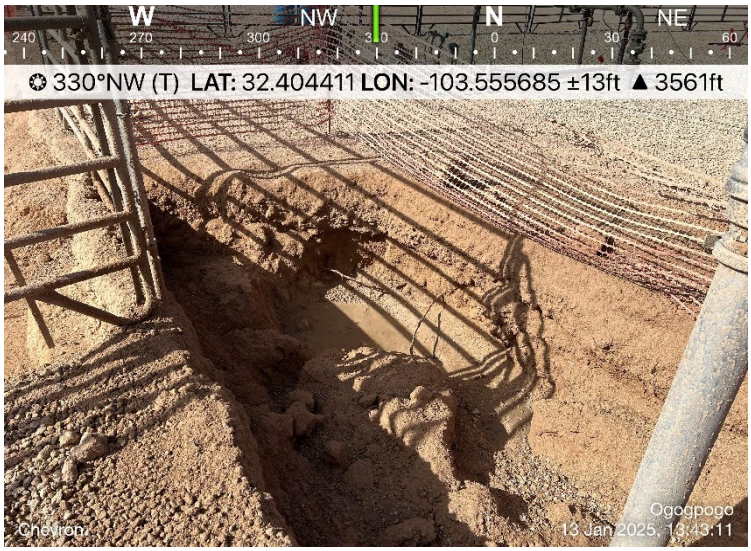
Description:
View North, Area of CS-3 through CS-6, CS-14 through CS-17.

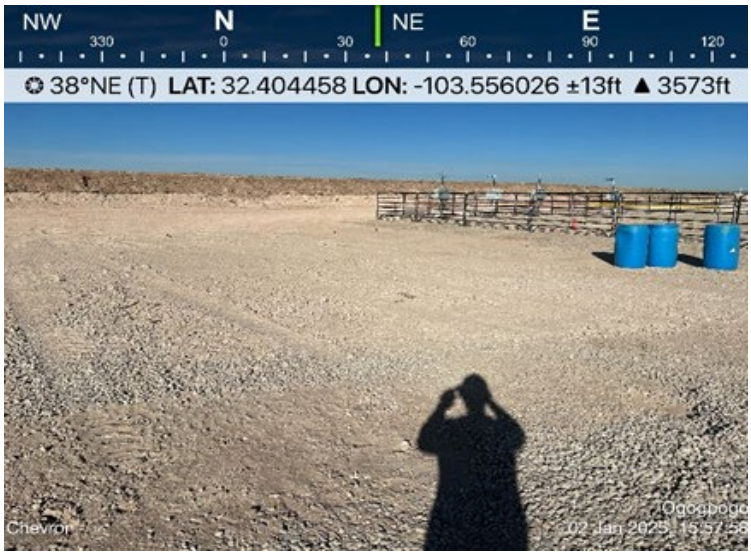
Description:
View East, Area of CS-1 & CS-2 backfilled.

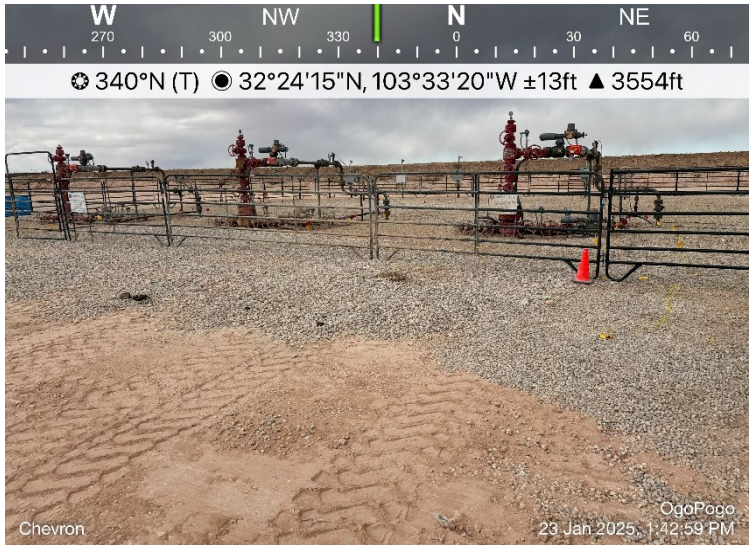
Description:
View East, Area of CS-12 & CS-13 backfilled.

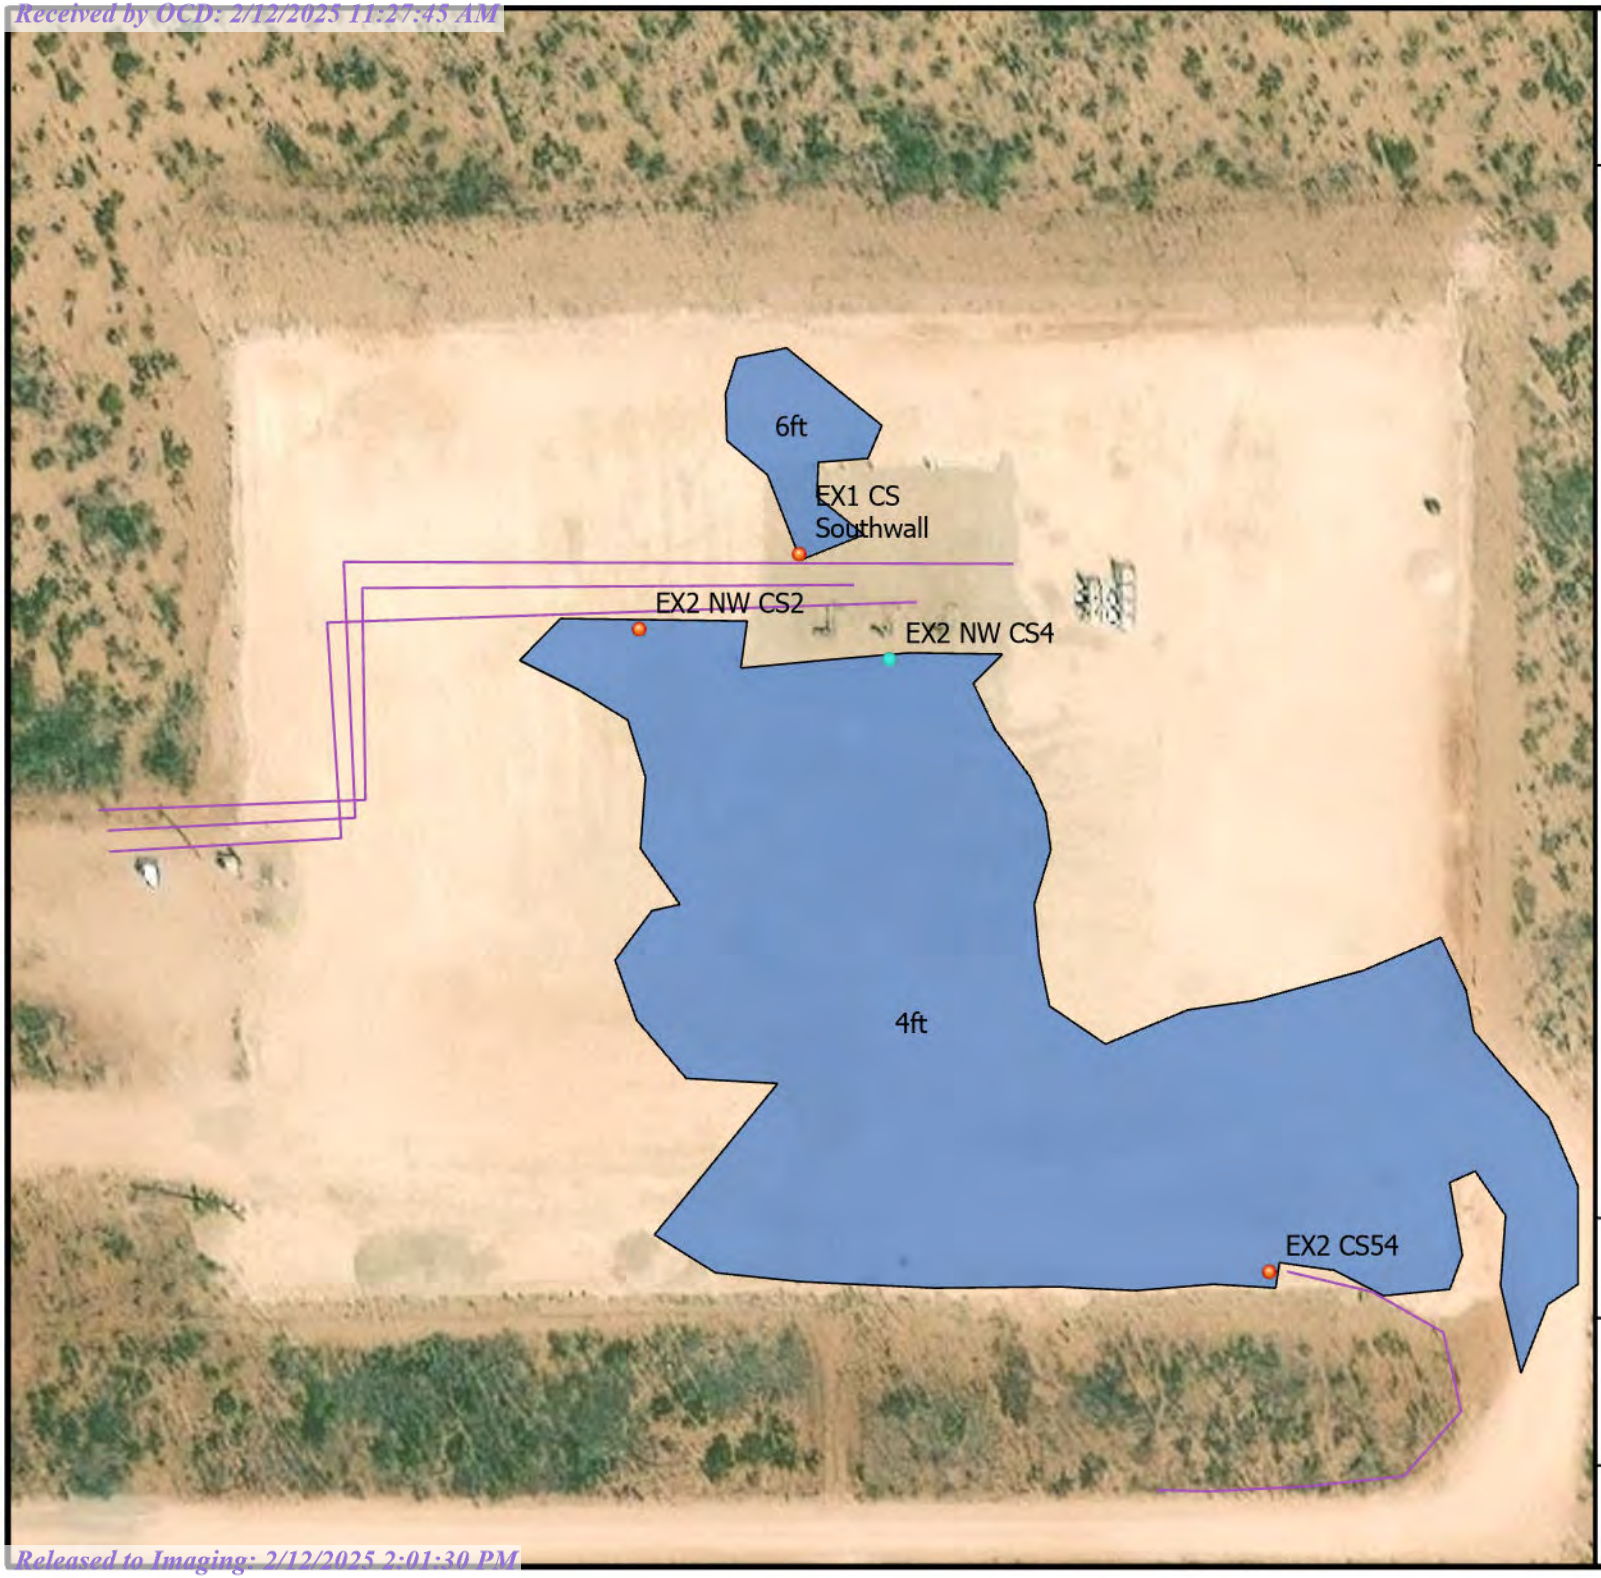
FIGURE 4
Ogopogo API 49907
Excavation & Deferral

In Figure 4 of the denied deferral, the buried flowlines are misrepresented and depict that they travel from the north side of the well heads and then travel to the west off site. (see 1st page of attachment)
Once the remediation began on 12.11.2024, field staff confirmed that the flowlines actually traveled from the south side of the well heads and then traveled to the west off site. (see 2nd page of attachment, actual flowline marked in yellow on the map)
Produced Water (chloride) staining was found over top of the buried flowlines, directly south and southwest of the well heads.
This area is represented by EX2 NW CS4, but also travels to the west over top of the flowlines.
This area will all be hydro-excavated and will have composite confirmation sidewall and floor samples. (see 2nd page of attachment, area shaded in pink on the map)

Areas of EX2 NW CS2 & EX1 CS Southwall (from the denied deferral report):
The areas on figure 4 between EX2 NW CS2 & EX1 CS Southwall (originally deferred) have now been confirmed to contain no buried flowlines. (see 2nd page of attachment, area shaded in dark blue on the map)
Our meeting this morning discussed the addition of four (4) test trenches (T-1 through T-4), in order to confirm that remediation work previously performed removed all impact and that the figures were mislabeled. (see 2nd page of attachment)
Any contamination found in the areas of T-1 through T-4 above the most stringent closure criteria must be delineated and remediated pursuant to 19.15.29 NMAC.

Following our meeting this morning in regard to the inconsistencies found from the denied deferral report and what was found onsite while hydro-excavating impact left in place over top of the buried flowlines, a 90-day extension is requested to complete the project.

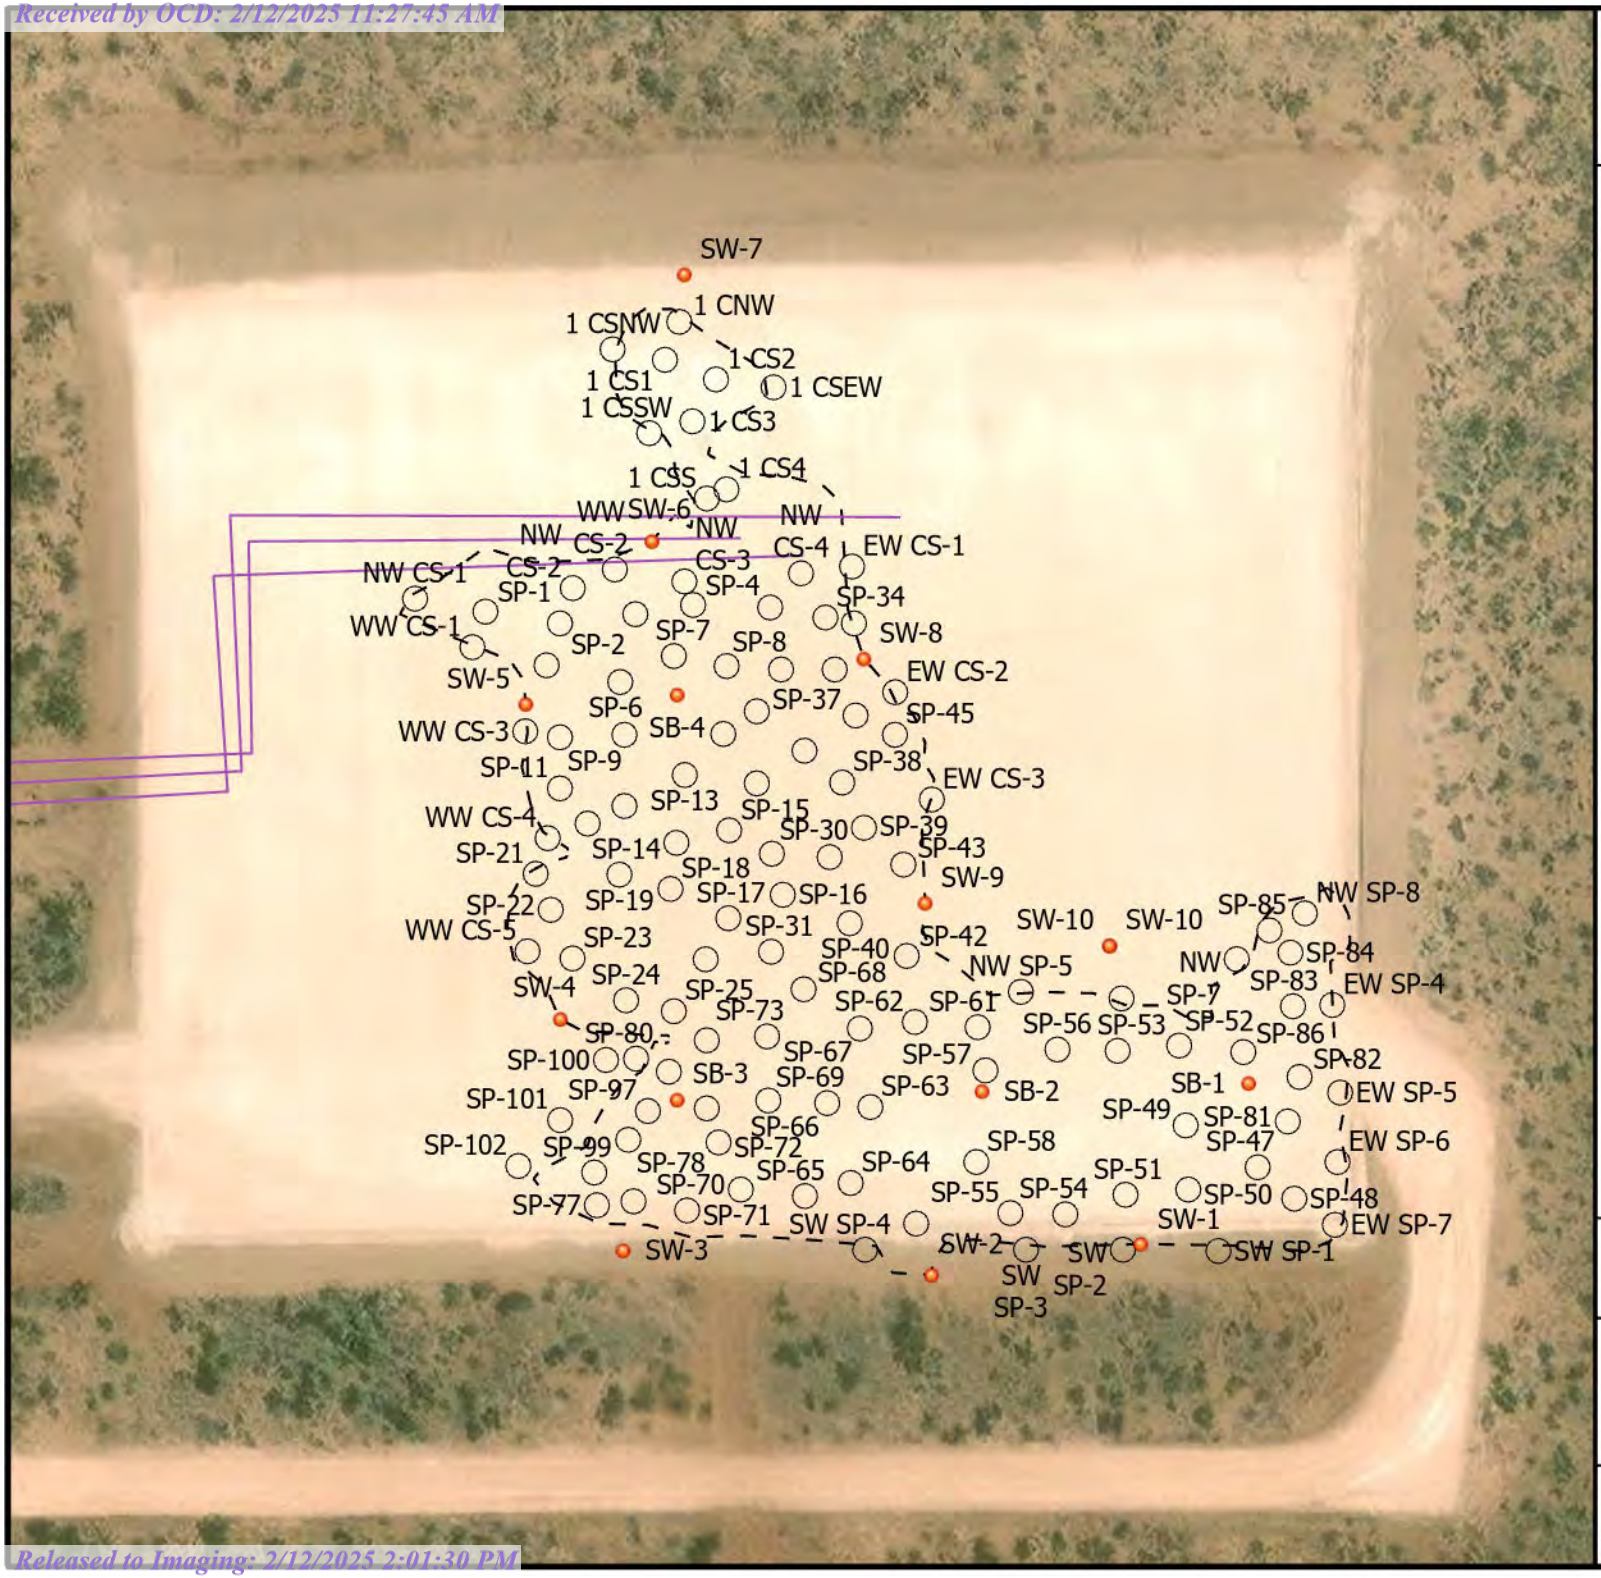
FIGURE 3
Ogopogo API 49907
Excavation & Sample Map

Sample ID names should be the same in your Table as in your Figures so the reviewer doesn't have to guess which sample is which. The shape of your excavation is different in Figure 3 from Figure 4 which makes it difficult to understand what occurred.

Figure 3 shows the extent of the excavation and existing sample locations. All laboratory results are summarized in Table 3. Laboratory reports are included in Appendix D.

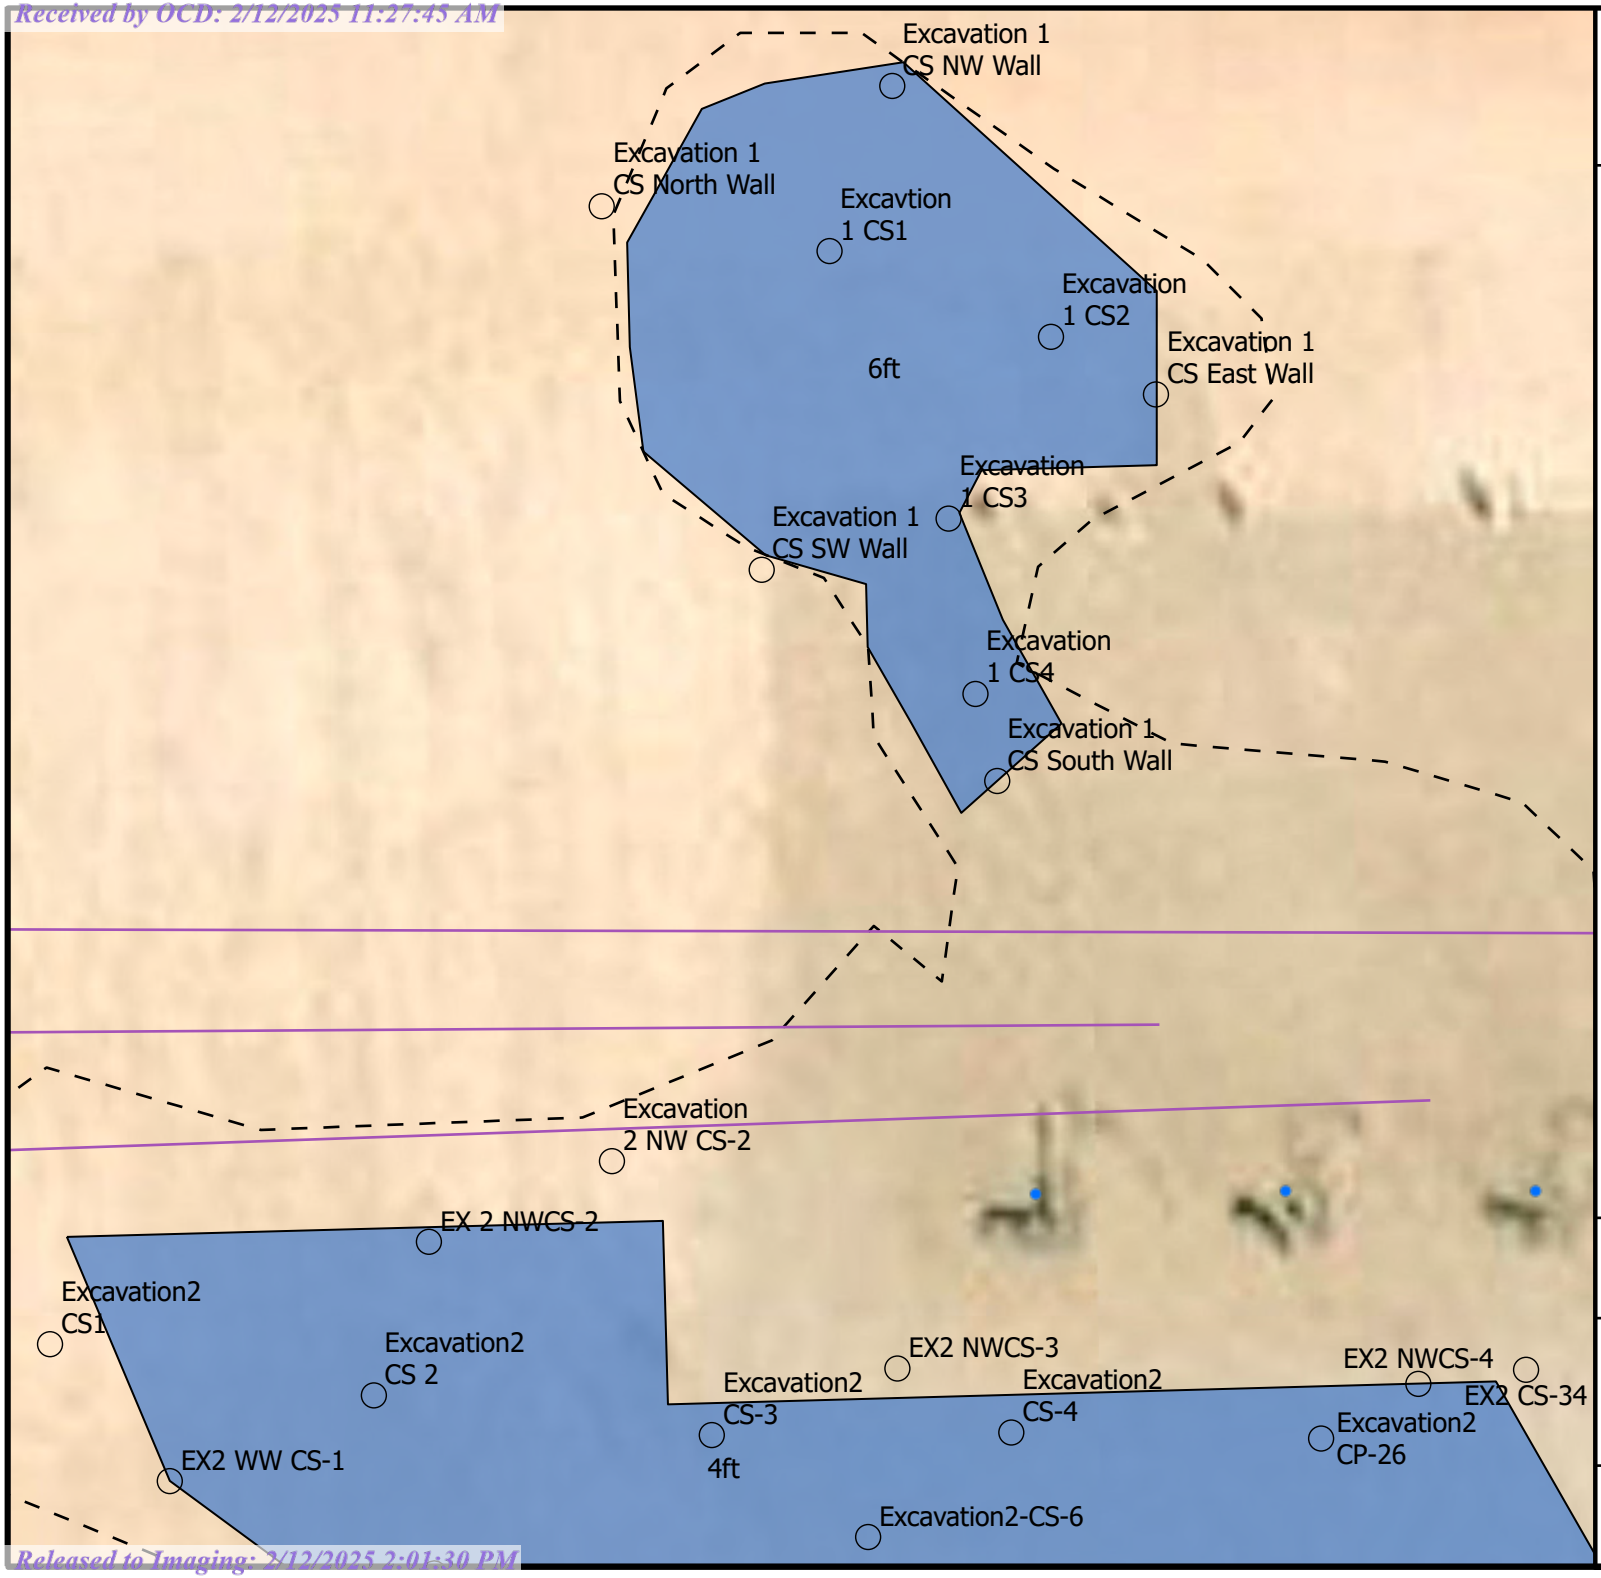
FIGURE 5
Ogopogo API 49907
Excavation & Deferral

The deferred areas have been fully delineated, see close-up figures 5 and 6.
