Welch A 28 CTB

Incident ID NAPP2511139082

Liner Inspection and Closure Report

May 12, 2025

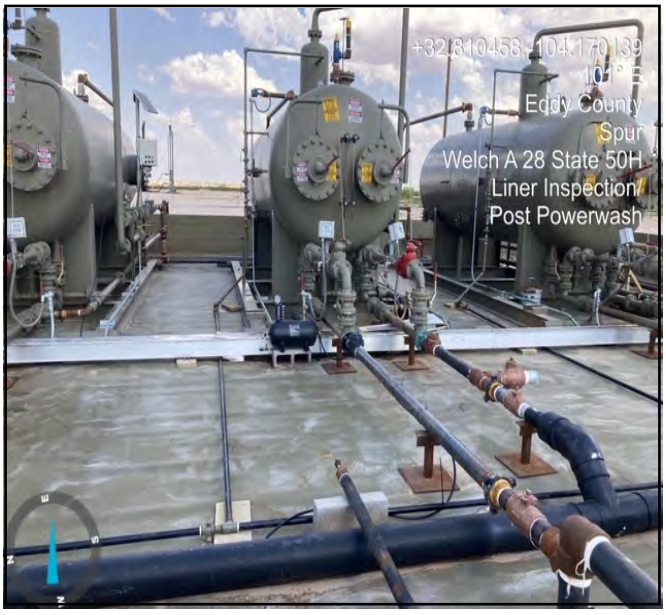
Site Information Sign.

Photo taken pursuant to power washing facing southeast.

Photo taken pursuant to power washing facing north.

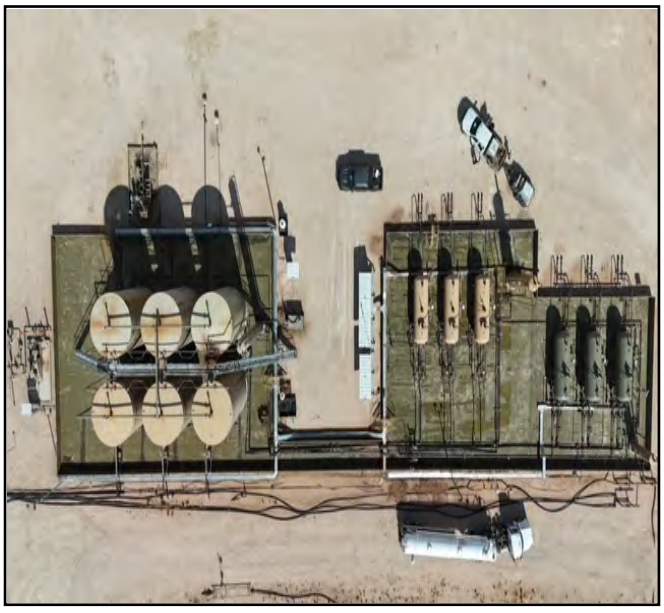
Photo taken pursuant to power washing facing east.

Photo taken pursuant to power washing facing southeast.

Photo taken pursuant to power washing facing west.
