Our ref.: 12686213-NMOCD-1

February 3, 2026

Closure Report
COG Operating, LLC
Way South State 31B CTB-RT Battery
Unit Letter E, Section 31, T26S, R28E
GPS: 32.00215, -104.13243
Eddy County, New Mexico

COG Operating, LLC
Way South 31 B CTB-RT Battery
Incident No. naPP2530734787
Eddy County, New Mexico

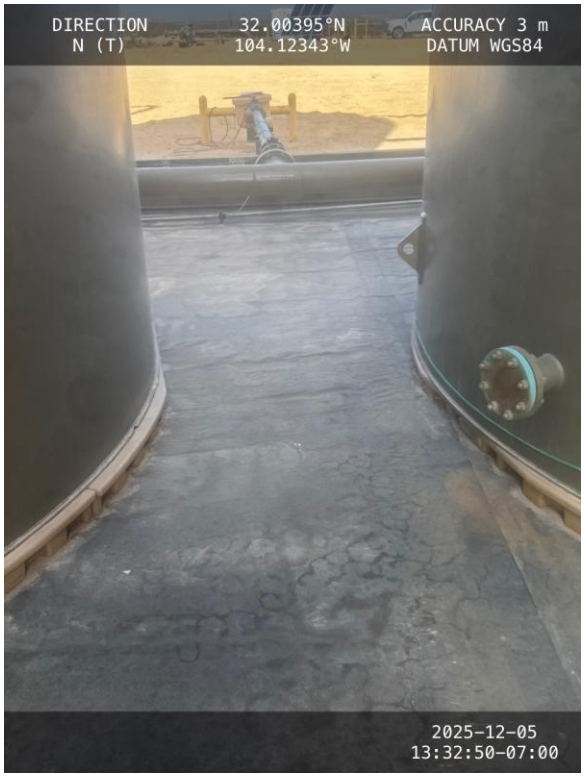
Photo 2 *View of containment towards east.*

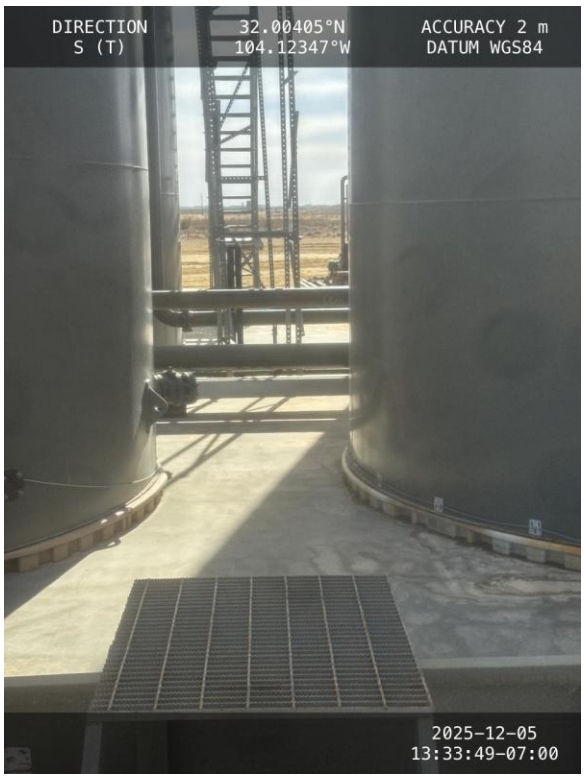
Photo 4 *View of southeast corner of containment.*

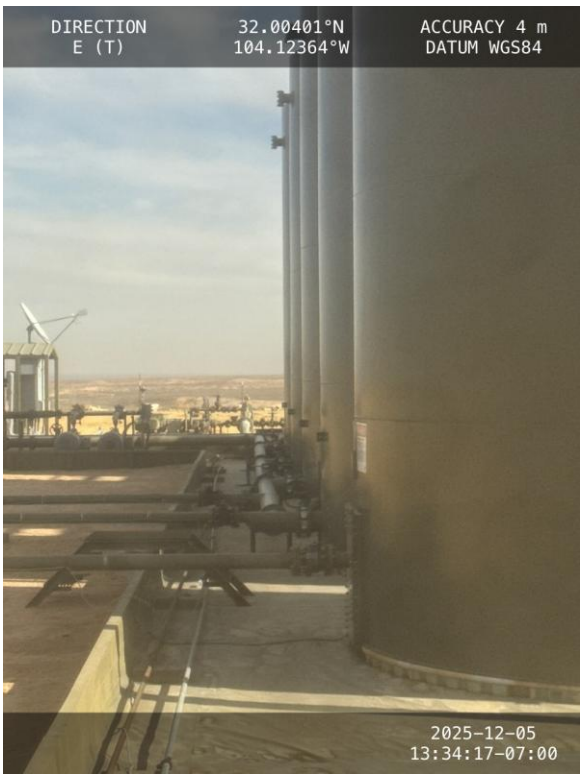
Photo 5 *View of containment towards south.*
