Q1 2012 GWMR

06 / 15 / 2012

Re: Periodic Progress Report for 1st Quarter 2012 for the Benson-Montin-Greer Highway 537 Llaves Pipeline 2008 Oil Release, Rio Arriba County, New Mexico

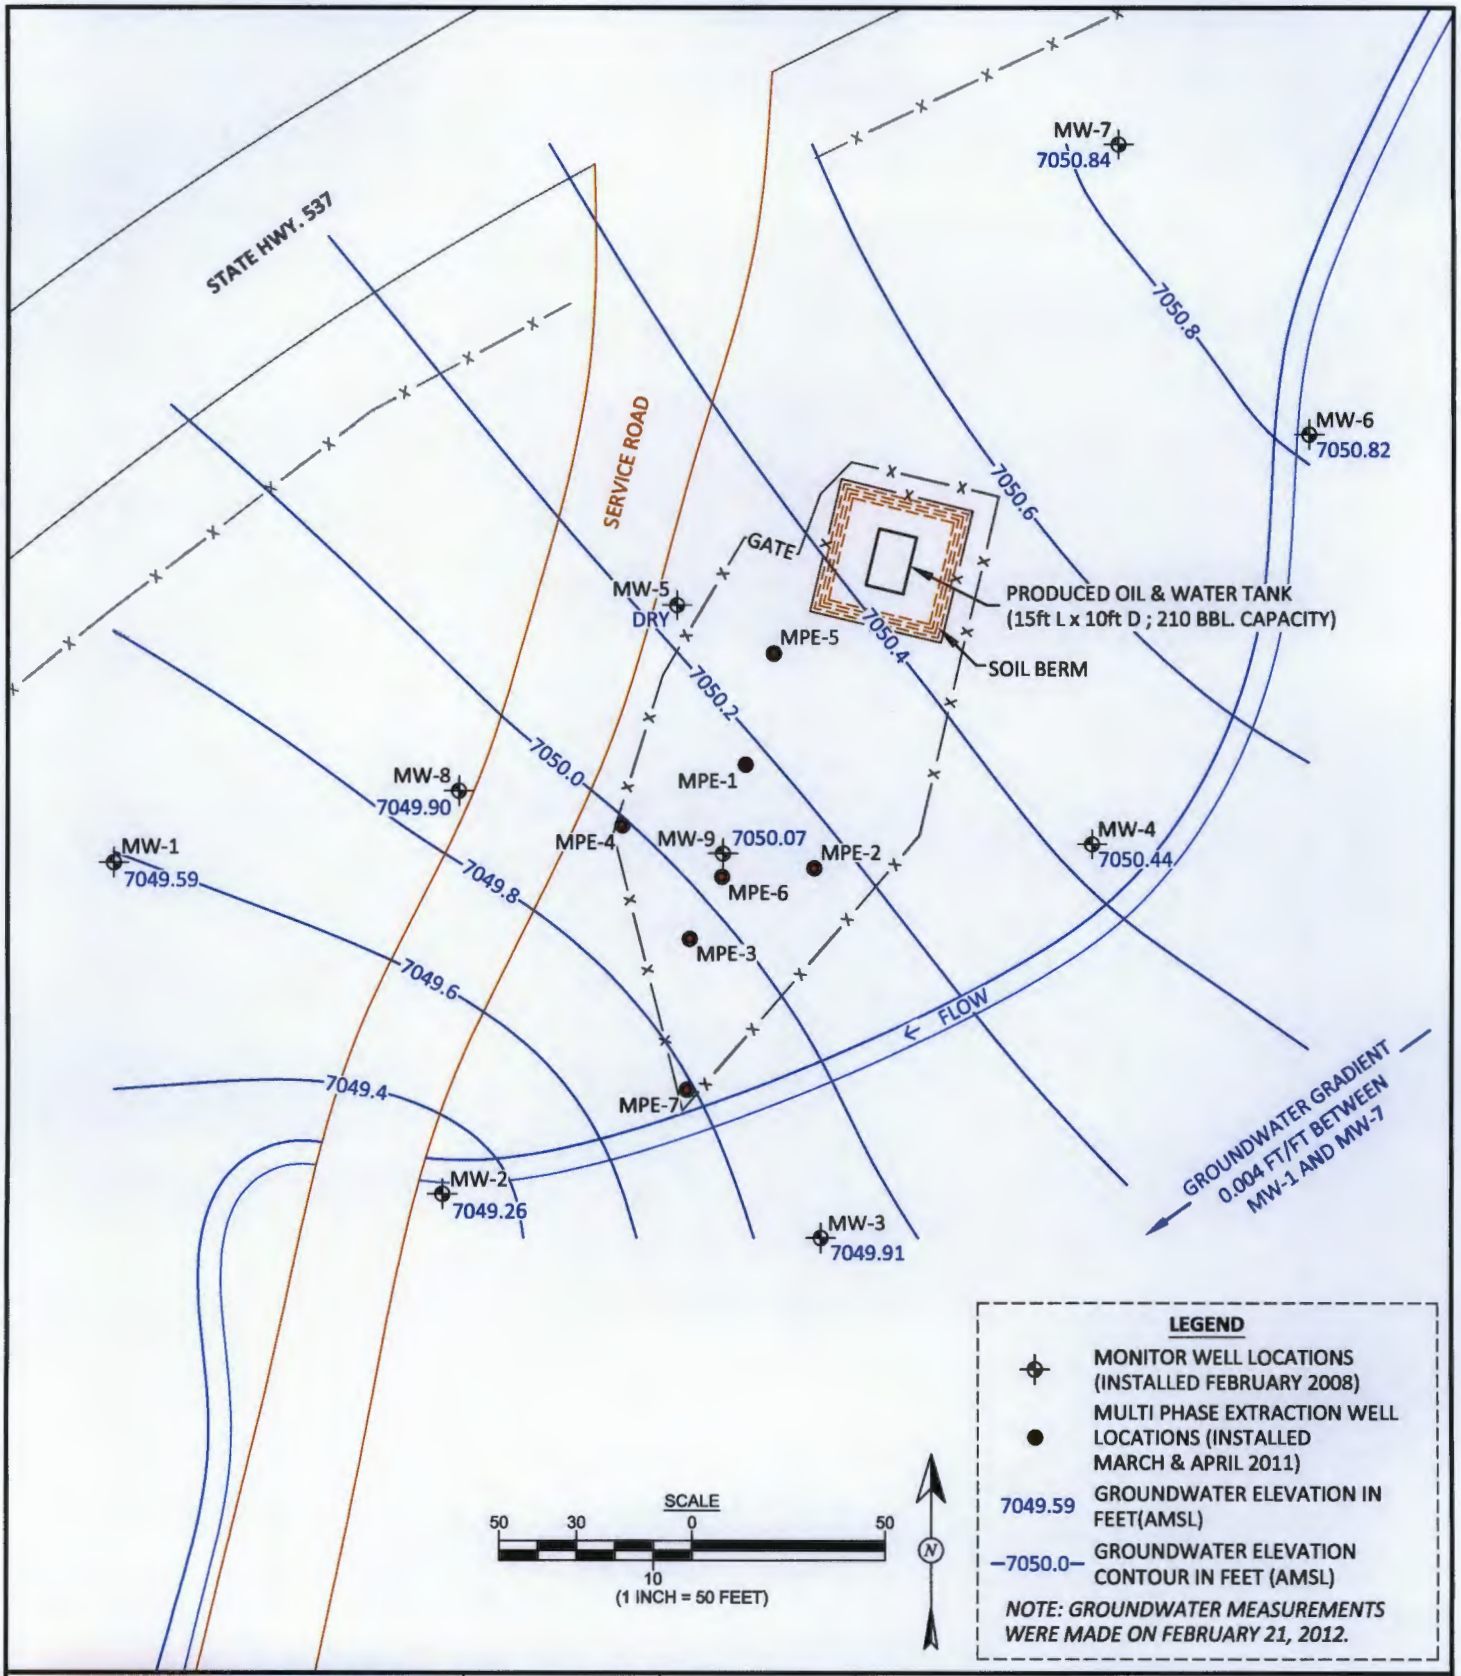
FIGURE 3

During the February 2012 sampling event, groundwater measurements were recorded for MW-1 through MW-4 and MW-6 through MW-8. A groundwater measurement was not recorded for MW-5 because the well was dry, and water quality measurements were not collected from MW-9 because the well contained non-aqueous phase liquid (NAPL or "free product"). Groundwater elevations were measured with a Keck water level (with accuracy to 0.01 foot) and ranged from 7,049.26 feet above mean sea level (AMSL) in MW-2 to 7,050.84 feet AMSL in MW-7. Groundwater gradient was calculated to be 0.004 ft/ft in a southwest direction, which is consistent with historical site data.

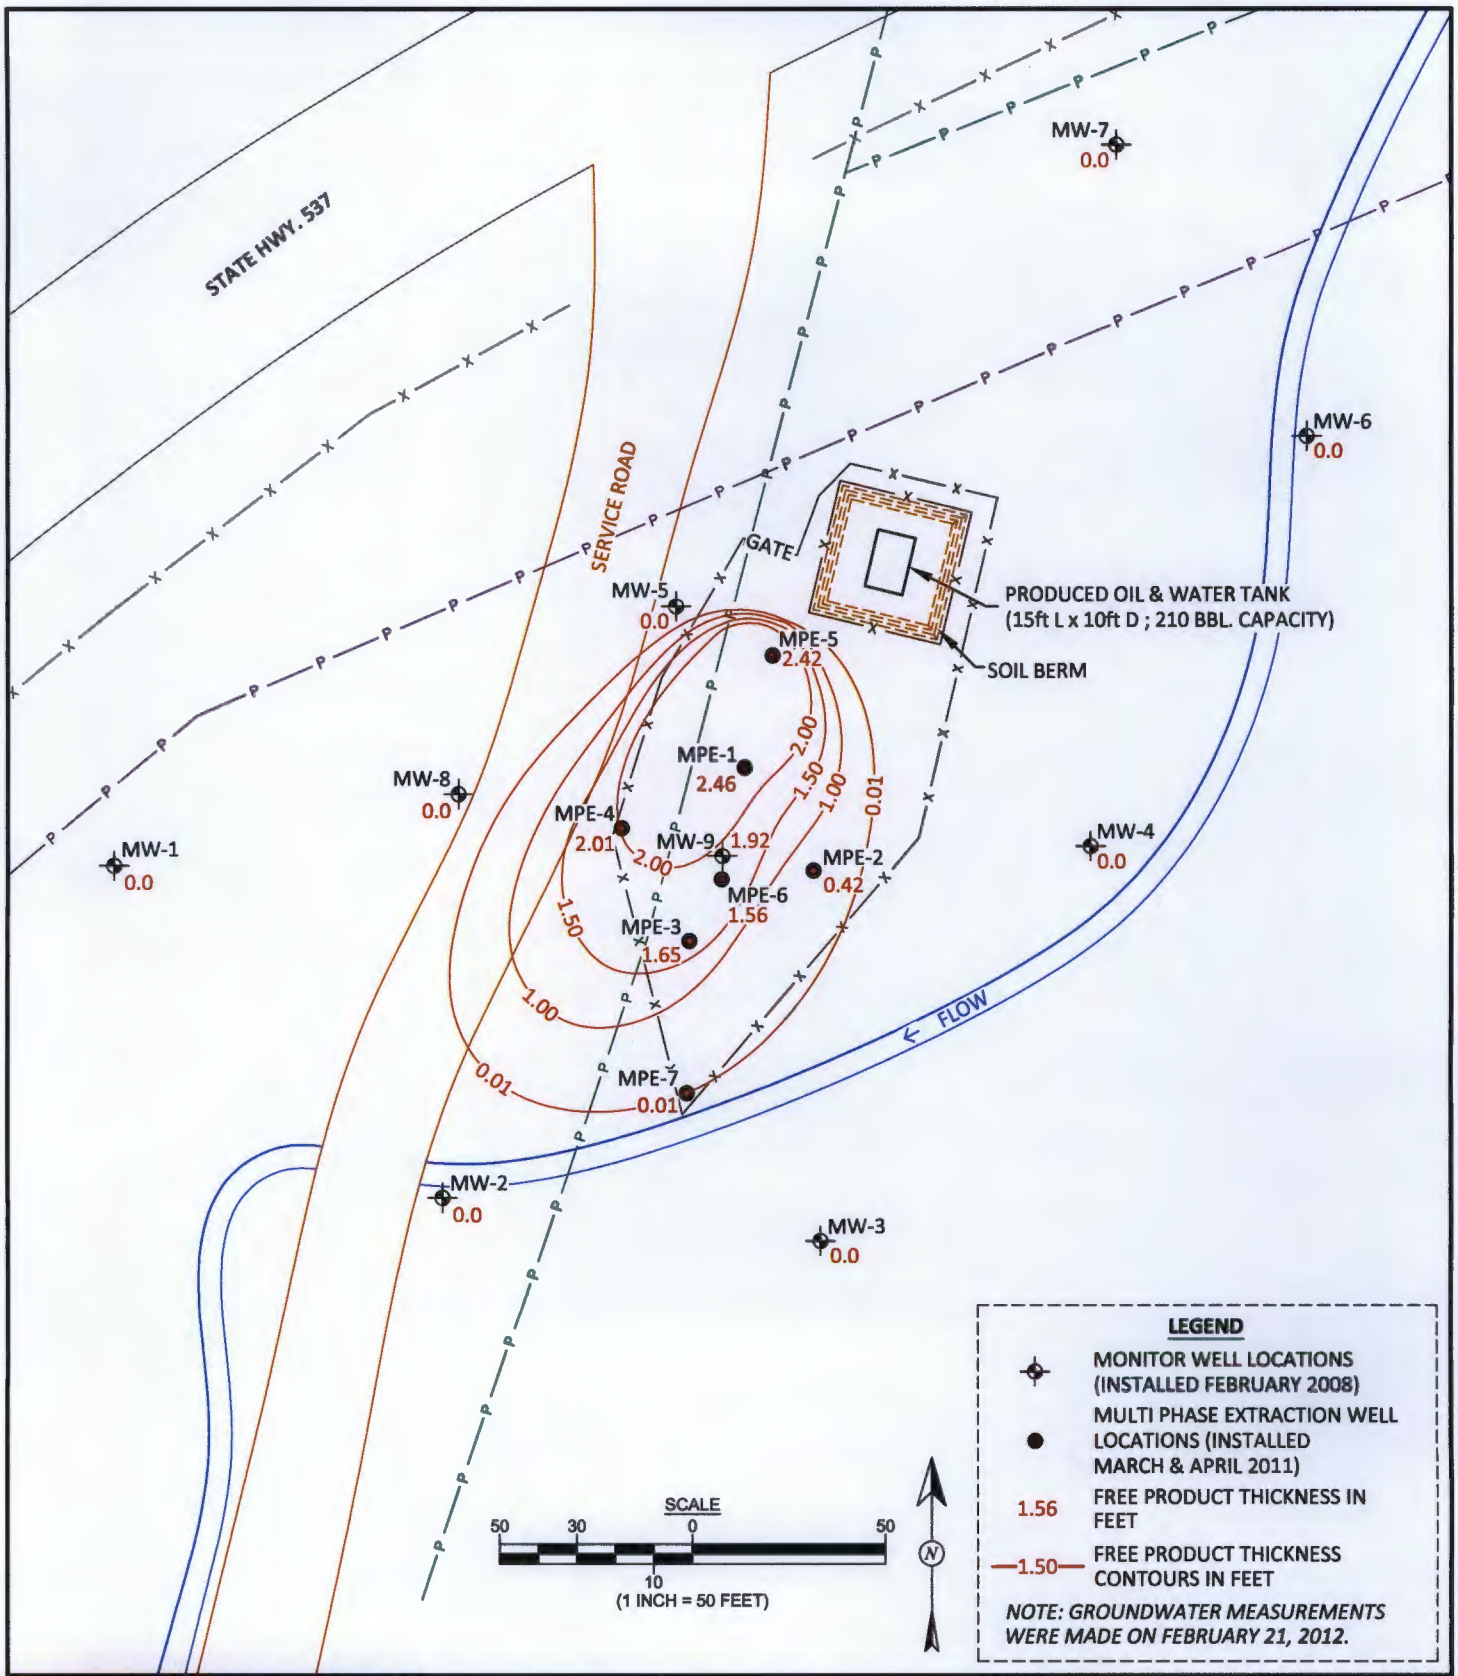
FIGURE 4

AES personnel measured depth to groundwater and measured free product thickness in the recently installed multi-phase extraction (MPE) wells on February 21, 2012. Free project thicknesses ranged from 0.01 feet in MPE-7 up to 2.46 feet in MPE-1. MPE well data are included in Table 1, and free product thickness contours from February 2012 are presented on Figure 4.

Free product was observed in MW-9 in February 2012 (1.92 feet). The MPE system operated between May and October 2011 and is scheduled to be re-activated in June 2012 for continued operations.

Based on recent laboratory analytical results, AES recommends continued quarterly monitoring and sampling of MW-8 and MW-9, and the 2nd Quarter 2012 sampling event was conducted on May 25, 2012. The 2nd Quarterly progress report is currently in progress and will include details on re-activation of the MPE system.
