Report Type: Closure Report

General Site Information:						
Site:	Yucca State Tank Battery					
Company:	COG Operating LLC					
Section, Township and Range	Unit J	Sec. 16	T-17-S	R-31-E		
Lease Number:	API-30-015-3312					
County:	Eddy County					
GPS:	32.82806° N			103.87367° W		
Surface Owner:	State					
Mineral Owner:						
Directions:	From NM-82 and 529, travel east on 82 0.3 miles, left on CR-223 1.0 mile, right 200' to location.

Re: Closure Report for the COG Operating LLC., Yucca State Tank Battery, Unit J, Section 16, Township 17 South, Range 31 East, Eddy County, New Mexico.

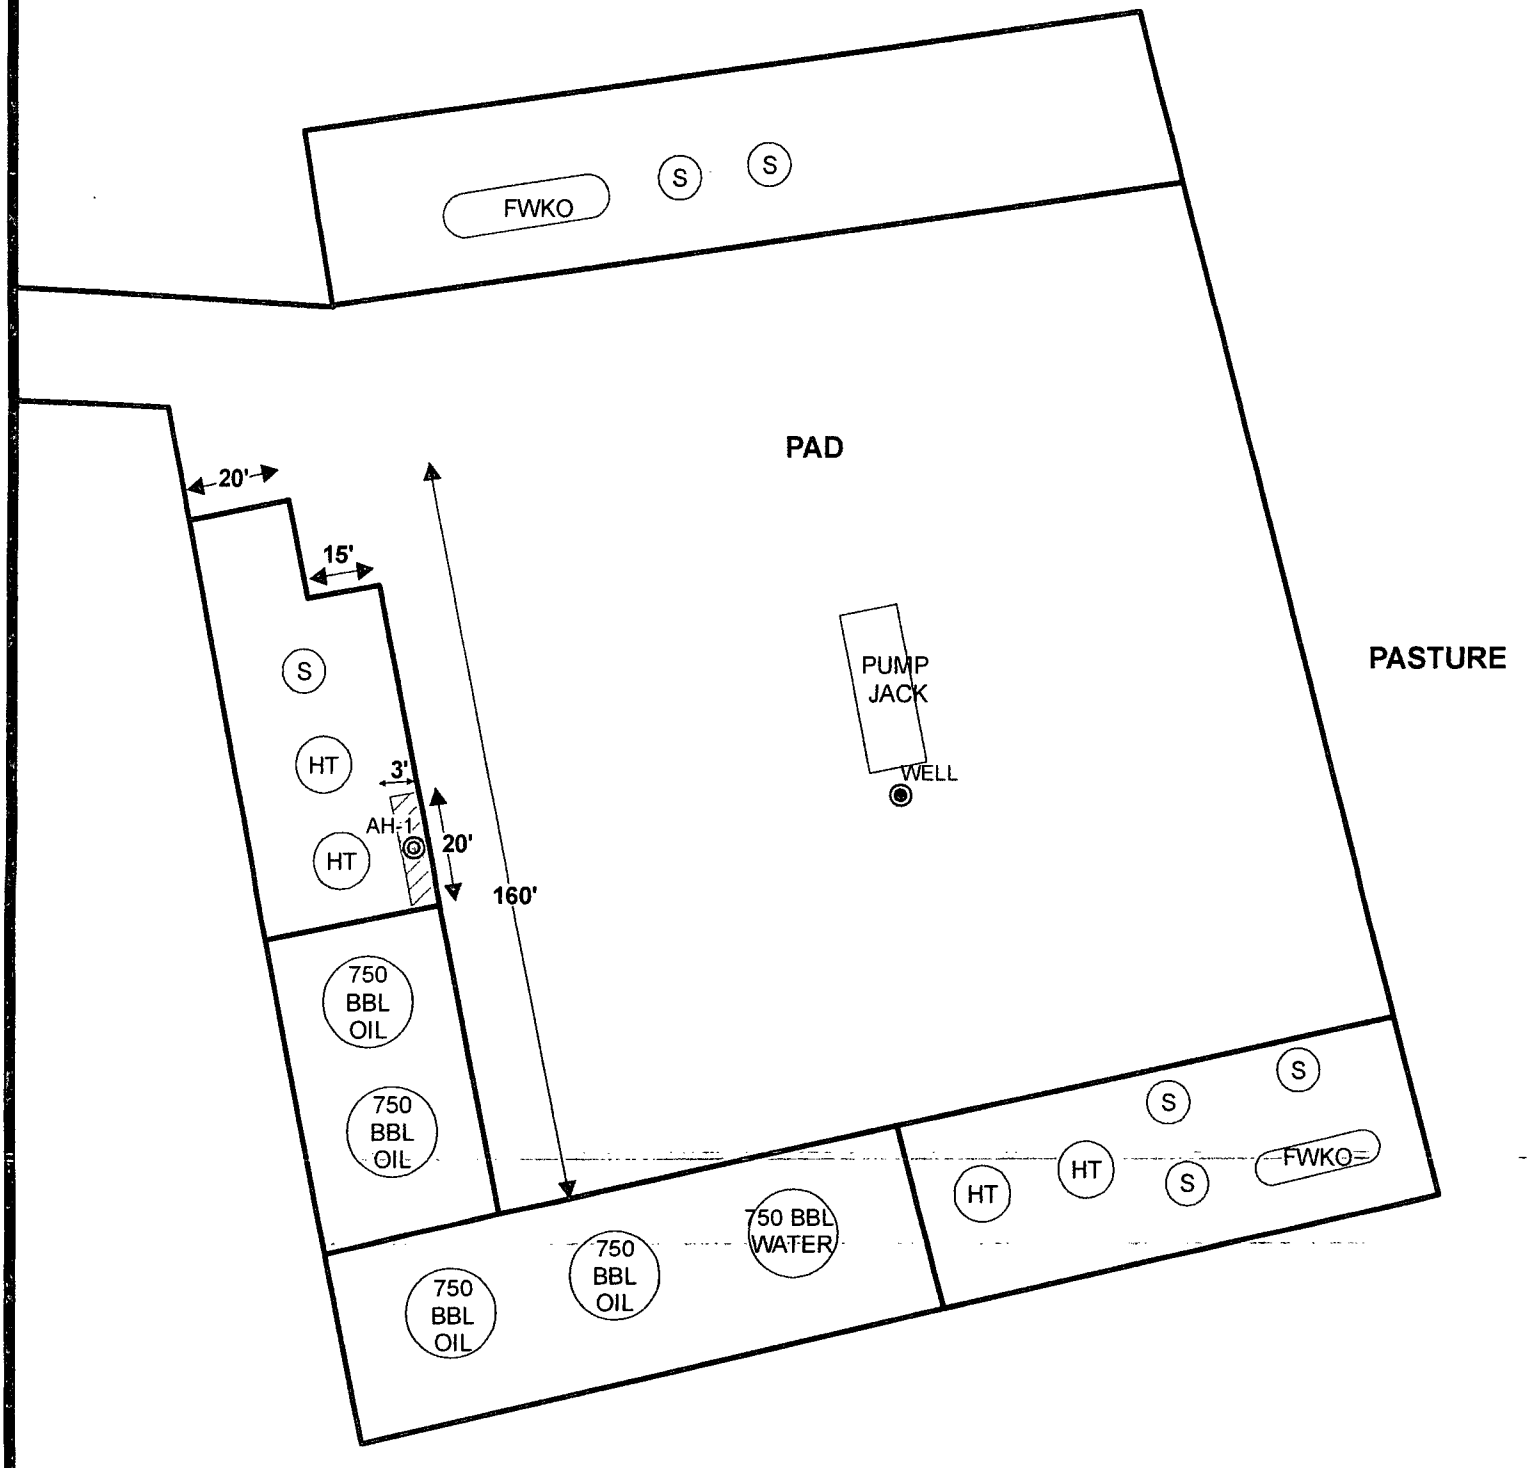
Figure 3

On February 7, 2012, Tetra Tech personnel inspected and sampled the spill area. One (1) auger hole (AH-1) was installed using a stainless steel hand auger to assess the impacted soils. Selected samples were analyzed for TPH analysis by EPA method 8015 modified, BTEX by EPA Method 8021B and chloride by EPA method 300.0. Copies of laboratory analysis and chain-of-custody documentation are included in Appendix C. The sampling results are summarized in Table 1. The auger hole location is shown on Figure 3.

Referring to Table 1, all of the submitted samples were below the RRAL for TPH and BTEX. A shallow chloride impact was detected in the soils, with a chloride concentration of 2,360 mg/kg at 0-1' below surface. The chloride concentration showed a significant declined to 295 mg/kg at 1-1.5' below surface. All remaining samples had chloride concentrations of <200 mg/kg.

Yucca State TB
Spill Assessment Map

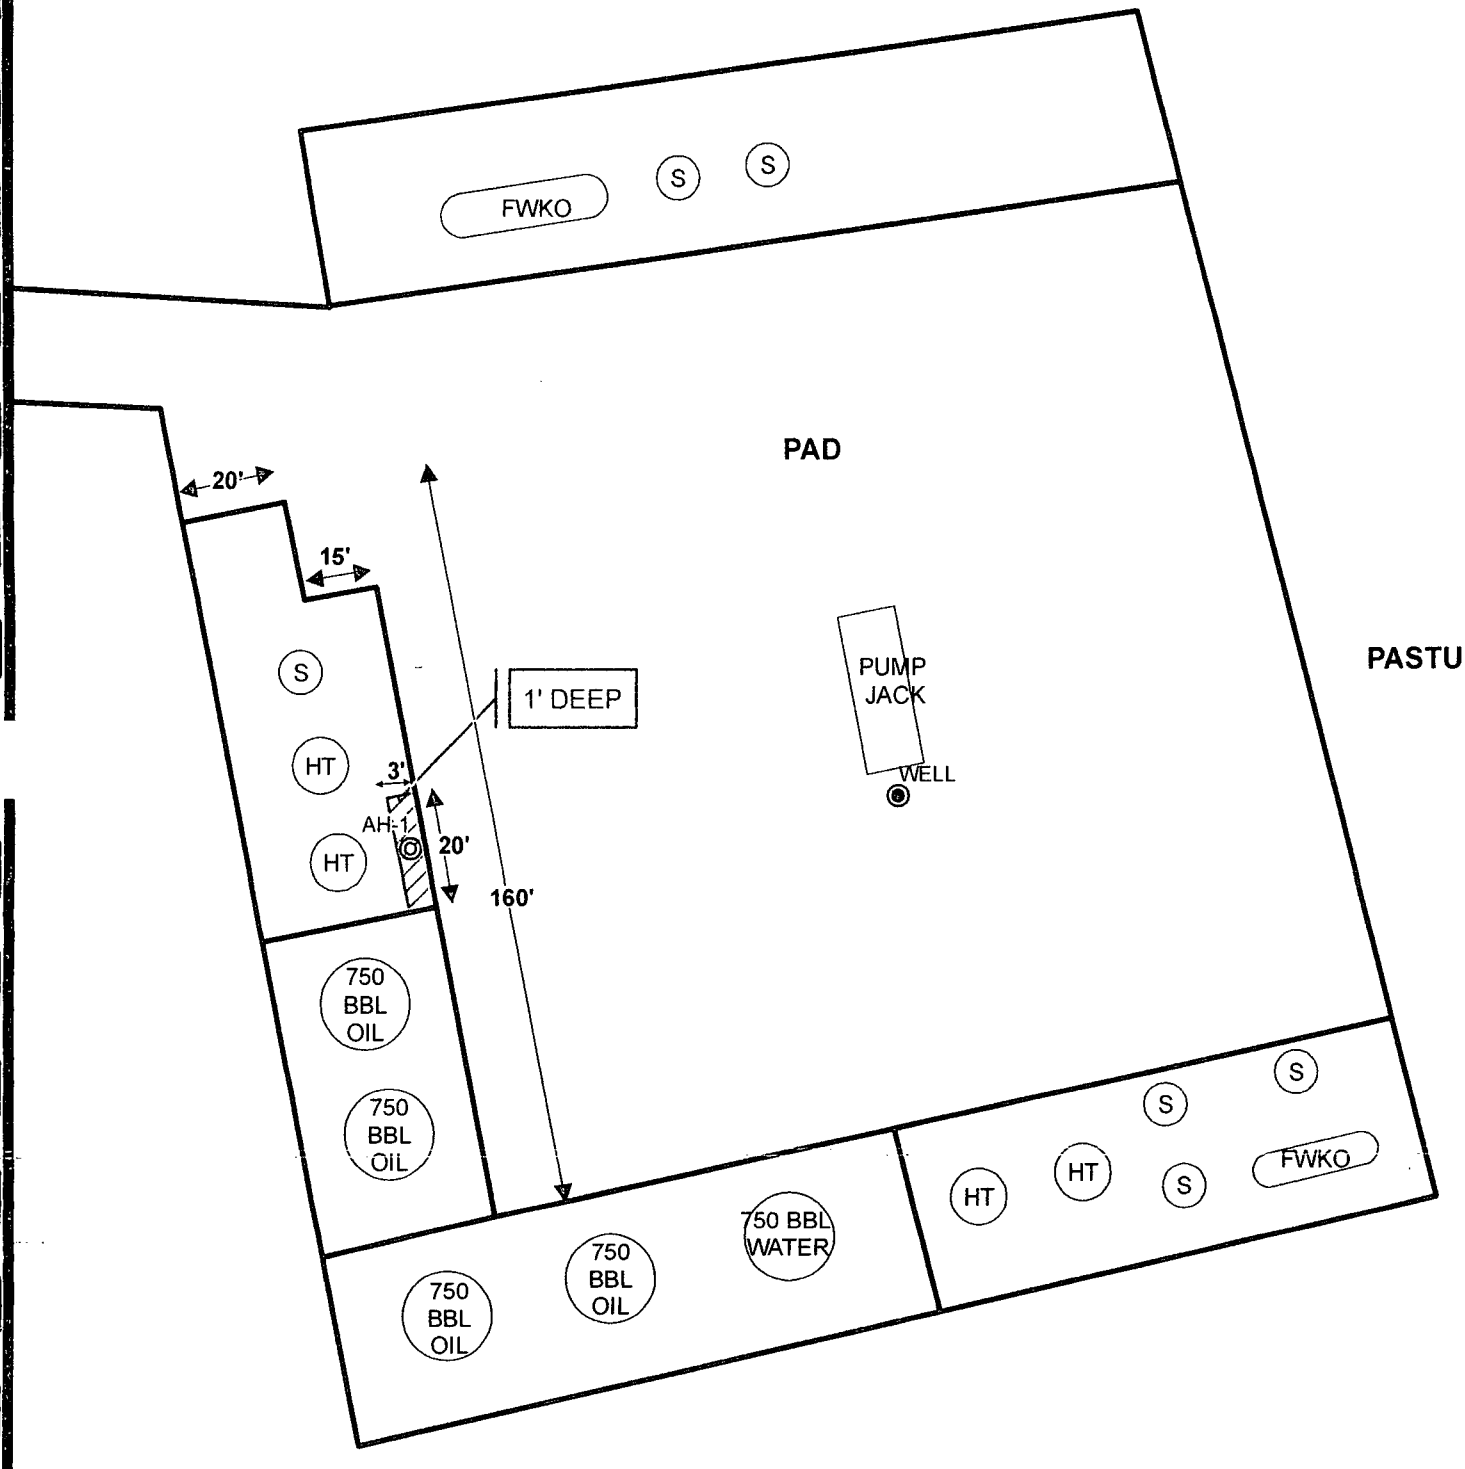
Figure 4

Excavation Area & Depth Map

On April 30, 2012 Tetra Tech personnel supervised the excavation of the spill area. The spill foot print and final excavation depth of the soil remediation were met as stated in the approved work plan. In order to remove the elevated chloride concentrations, the spill area was excavated to 1.0' below surface. Approximately 3 cubic yards of impacted soil were removed and disposed of at R360 facility. The excavated area was then backfilled with clean material to grade.

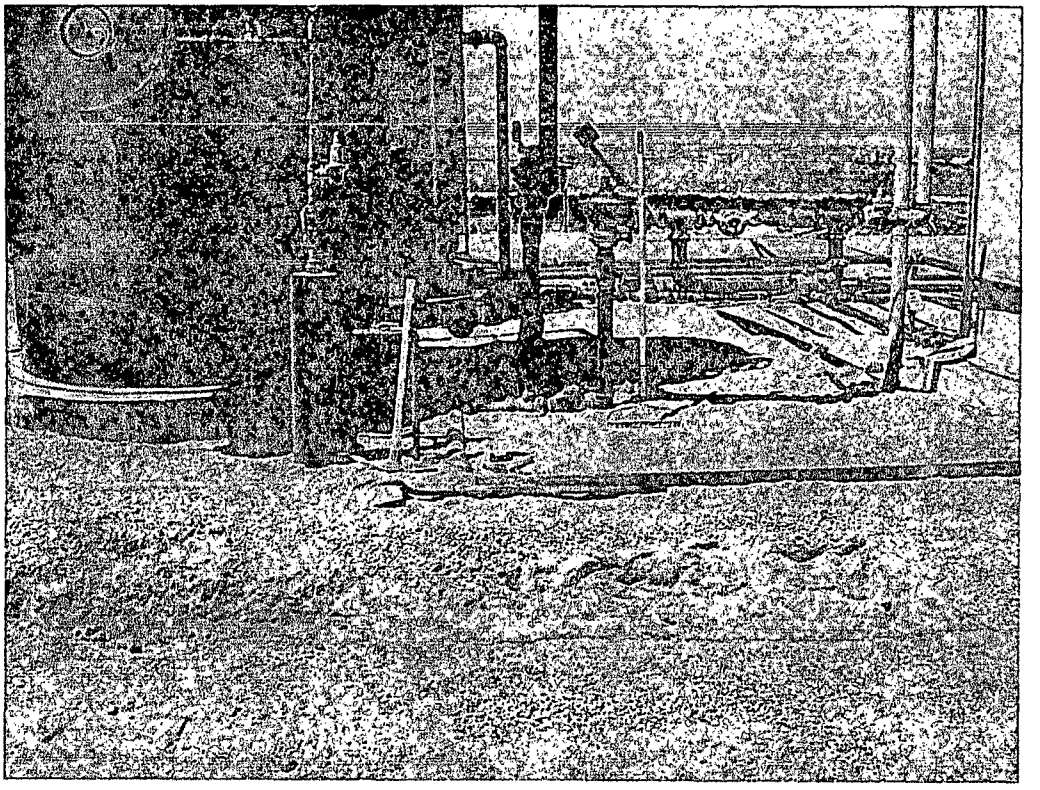
View West – Excavation of AH-1.

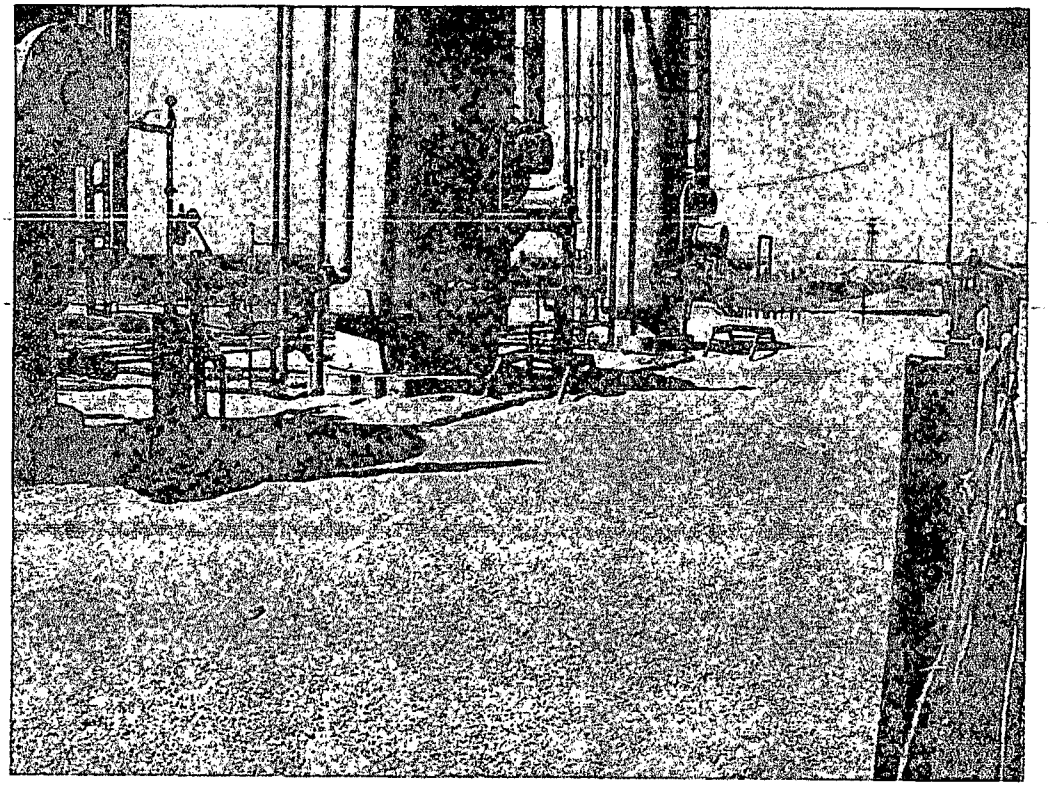
View Northwest – Backfill
