Corrective Action Work Plan

Re: Corrective Action Workplan
Gallegos Well Tie Line #90898, Gallegos #2 May 2012 Pipeline Release
SE ¼ NE ¼, Sec 29, T26N, R11W
San Juan County, New Mexico

Corrective Action Workplan

Gallegos Well Tie Line #90898,
Gallegos #2 May 2012 Pipeline Release
SE¼ NE¼ Section 29, T26N, R11W
San Juan County, New Mexico

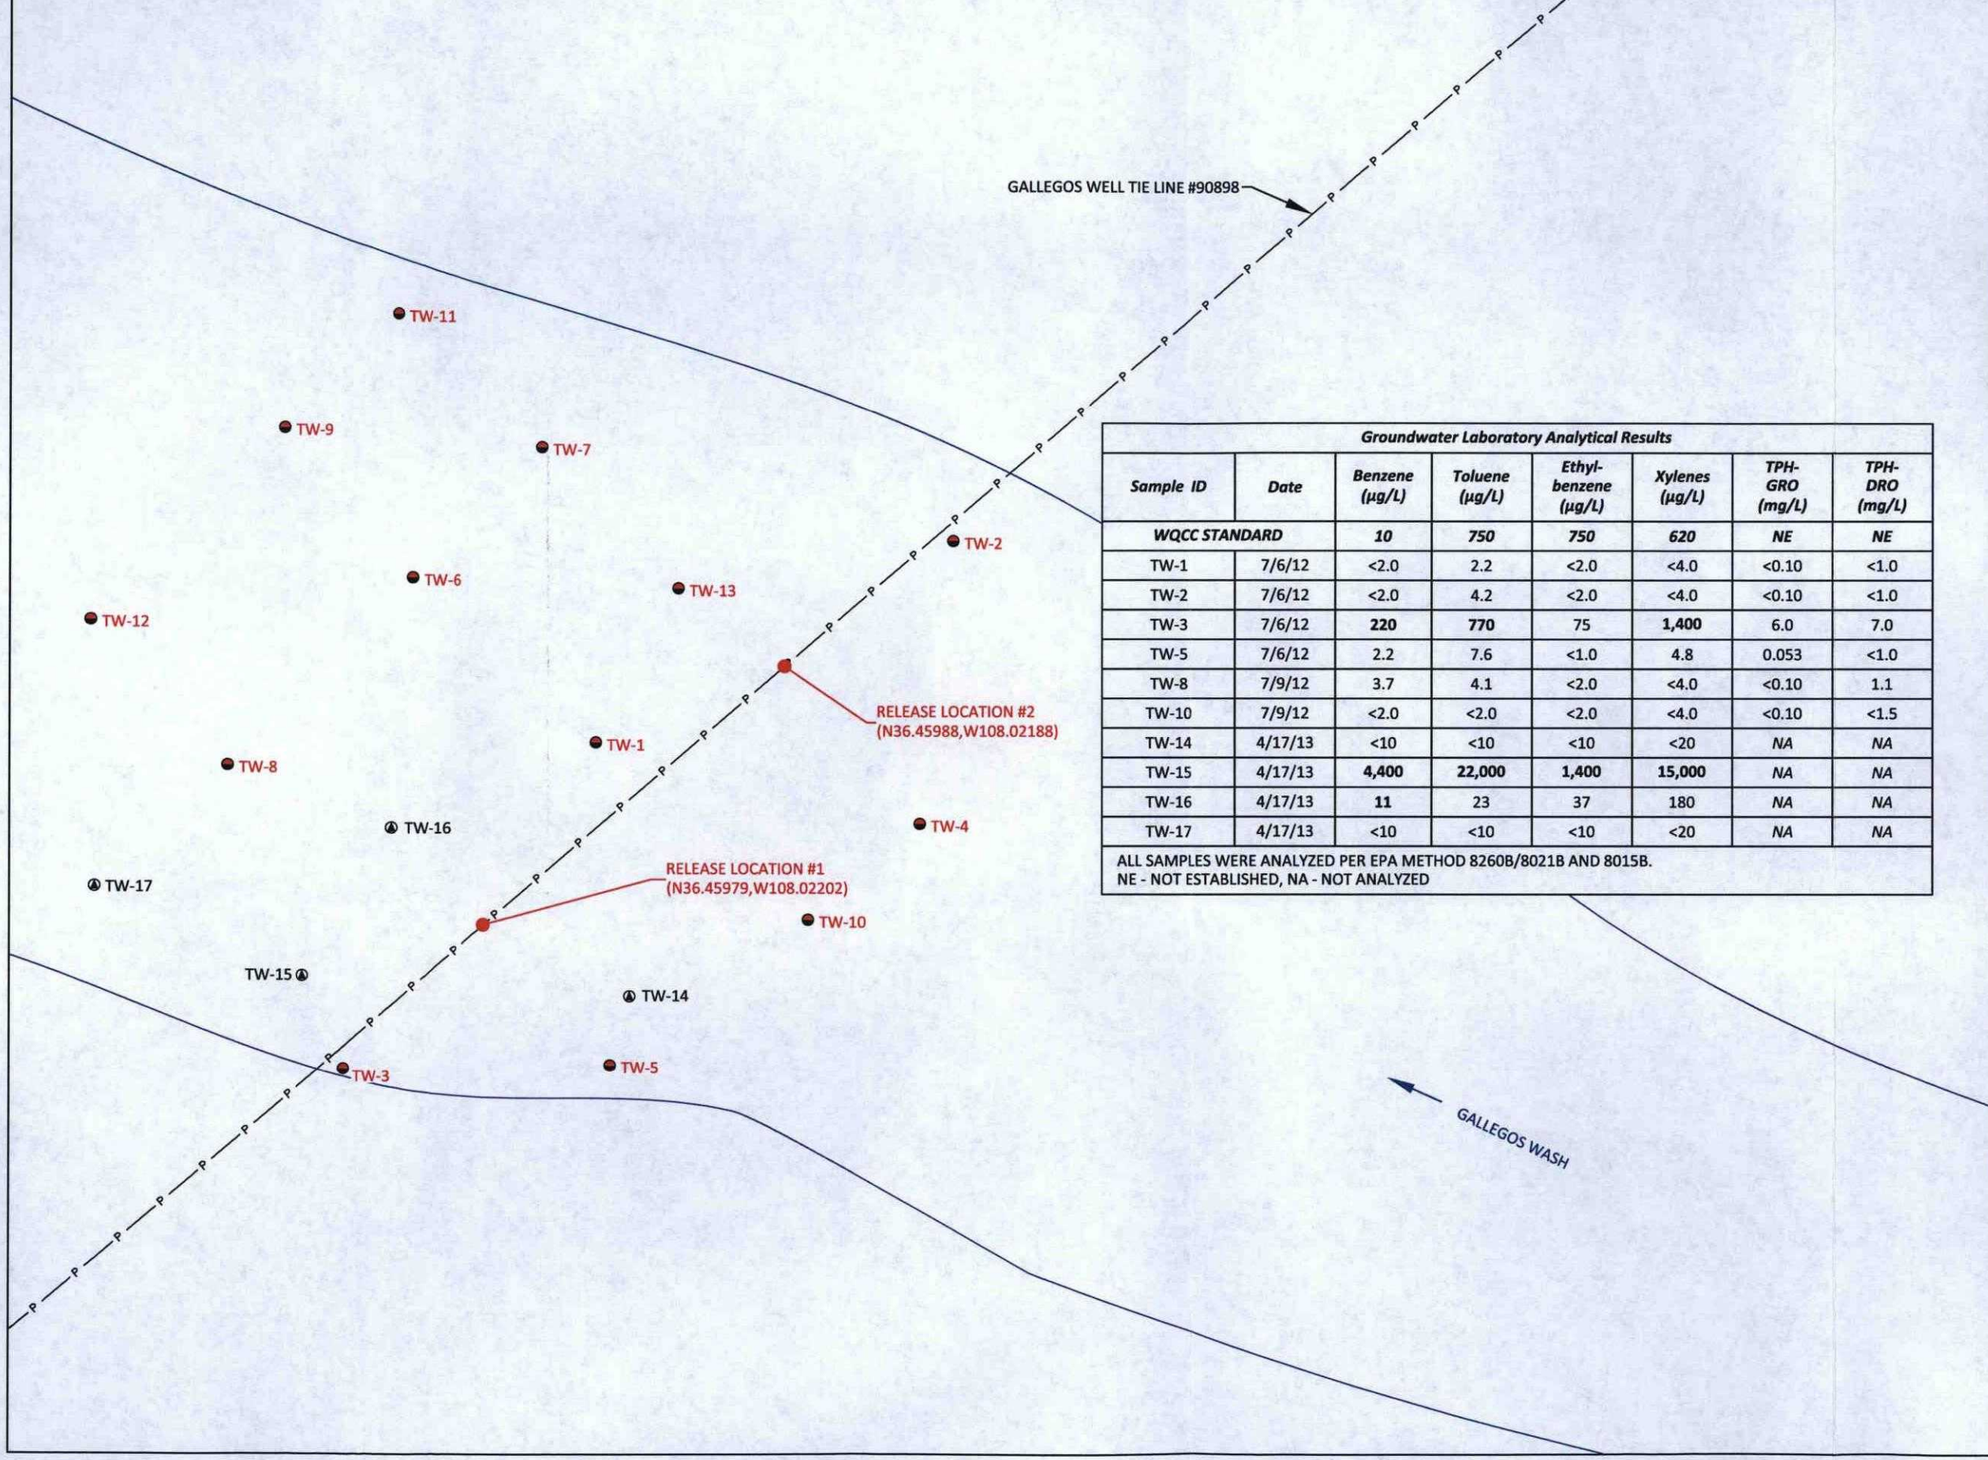
FIGURE 3

Laboratory analytical results for benzene, toluene, ethylbenzene, and xylenes were below laboratory detection limits in TW-10, TW-14, and TW-17. Dissolved phase benzene concentrations exceeded the WQCC standard of 10 µg/L in TW-15 (4,400 µg/L) and TW-16 (11 µg/L). Dissolved phase toluene, ethylbenzene, and xylene also exceeded WQCC standards in TW-15 with reported concentrations of 22,000 µg/L, 1,400 µg/L, and 15,000 µg/L, respectively. Laboratory analytical results are included in Table 2 and on Figure 3. Laboratory analytical reports are included in the Appendix.

Based on the analytical results described in the previous section, groundwater continues to be impacted above WQCC standards near the southern bank of the Gallegos Wash. AES recommends excavation and removal of residual petroleum hydrocarbon impacted soil and groundwater at the location. The proposed scope of work is described in the following sections, and a general project layout of the proposed excavation extents is presented in Figure 4.

HYDROPUNCH GROUNDWATER SAMPLING LOCATIONS AND RESULTS JULY 2012 AND APRIL 2013

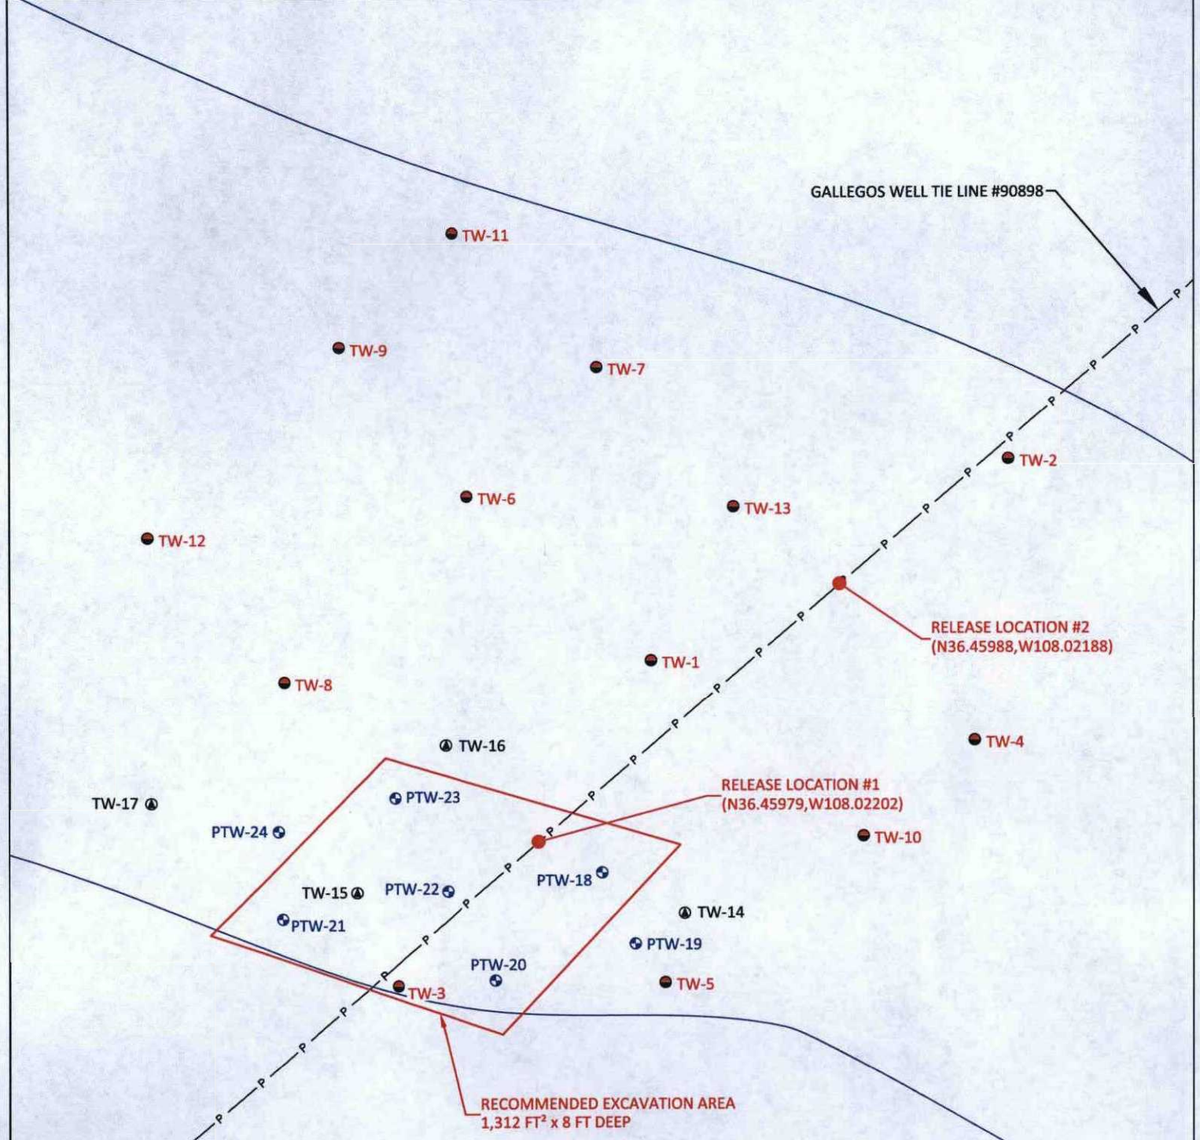
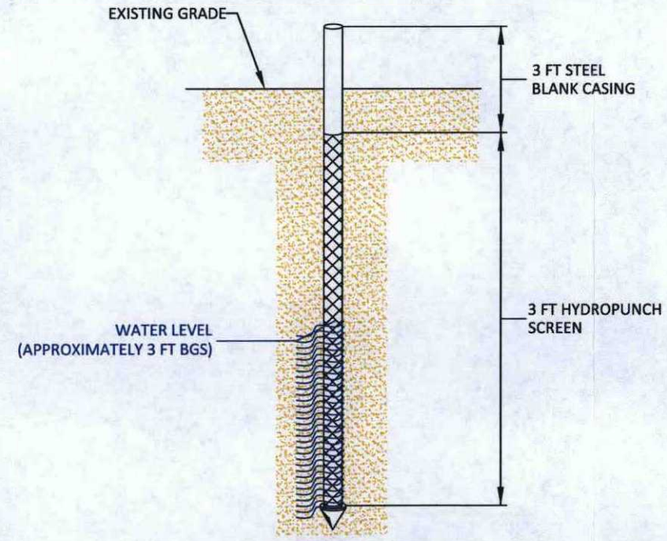
FIGURE 4

PROPOSED EXCAVATION RECOMMENDATIONS AND TEMPORARY MONITOR WELL LOCATIONS

AES proposes to excavate approximately 390 yd^3 of petroleum hydrocarbon impacted soil from the south bank of the Gallegos Wash within the pipeline corridor. Foutz and Bursm Construction Company, Inc. will be retained for the field work. Prior to excavation, a small hydrovac unit will be used to expose the pipeline for confirmation of the pipeline location. A John Deer 240 trackhoe will be used to excavate the soil into 10 yd^3 end dump trucks for transport. The dump trucks will have liners to prevent dripping from the wet sands during transport. Sets of equipment mats referred to as "swamp mats," comprised of four long wooden timbers, will be used beneath the excavator tracks to prevent the equipment from sinking into the wash sand. During excavation, two 80 barrel hydrovac trucks will be utilized to remove impacted groundwater from the excavation. Impacted soil and groundwater will be transported to the Envirotech Landfarm for proper disposal. Clean fill will be transported to the site on the return trip from the landfarm. Estimated excavation extents are shown on Figure 4.

In order to assess the effectiveness of the remediation efforts, AES proposes to install five temporary groundwater sampling points (TW-18 through TW-22) approximately six months after the excavation activities. The temporary sampling points will be installed in the vicinity of excavation extents and will be removed following sample collection. The proposed locations of the temporary wells, along with a construction schematic of a temporary well, are shown on Figure 4.

Temporary wells TW-18 through TW-22 will be installed utilizing a hand-driven HydroPunch sampling tool, which allows for in-situ collection of groundwater samples (see Figure 4 for schematic). At least four HydroPunch temporary wells will be installed within the vicinity of the excavation. Following installation, three well volumes will be purged from each temporary well and then allowed to stabilize for a minimum of one hour prior to sample
