Release Notification

CLOSURE REPORT

Lateral C-14 Pipeline Release
NW 1/4, S25 T27N R9W
San Juan County, New Mexico

October 12, 2018
Apex Project No. 725040112507

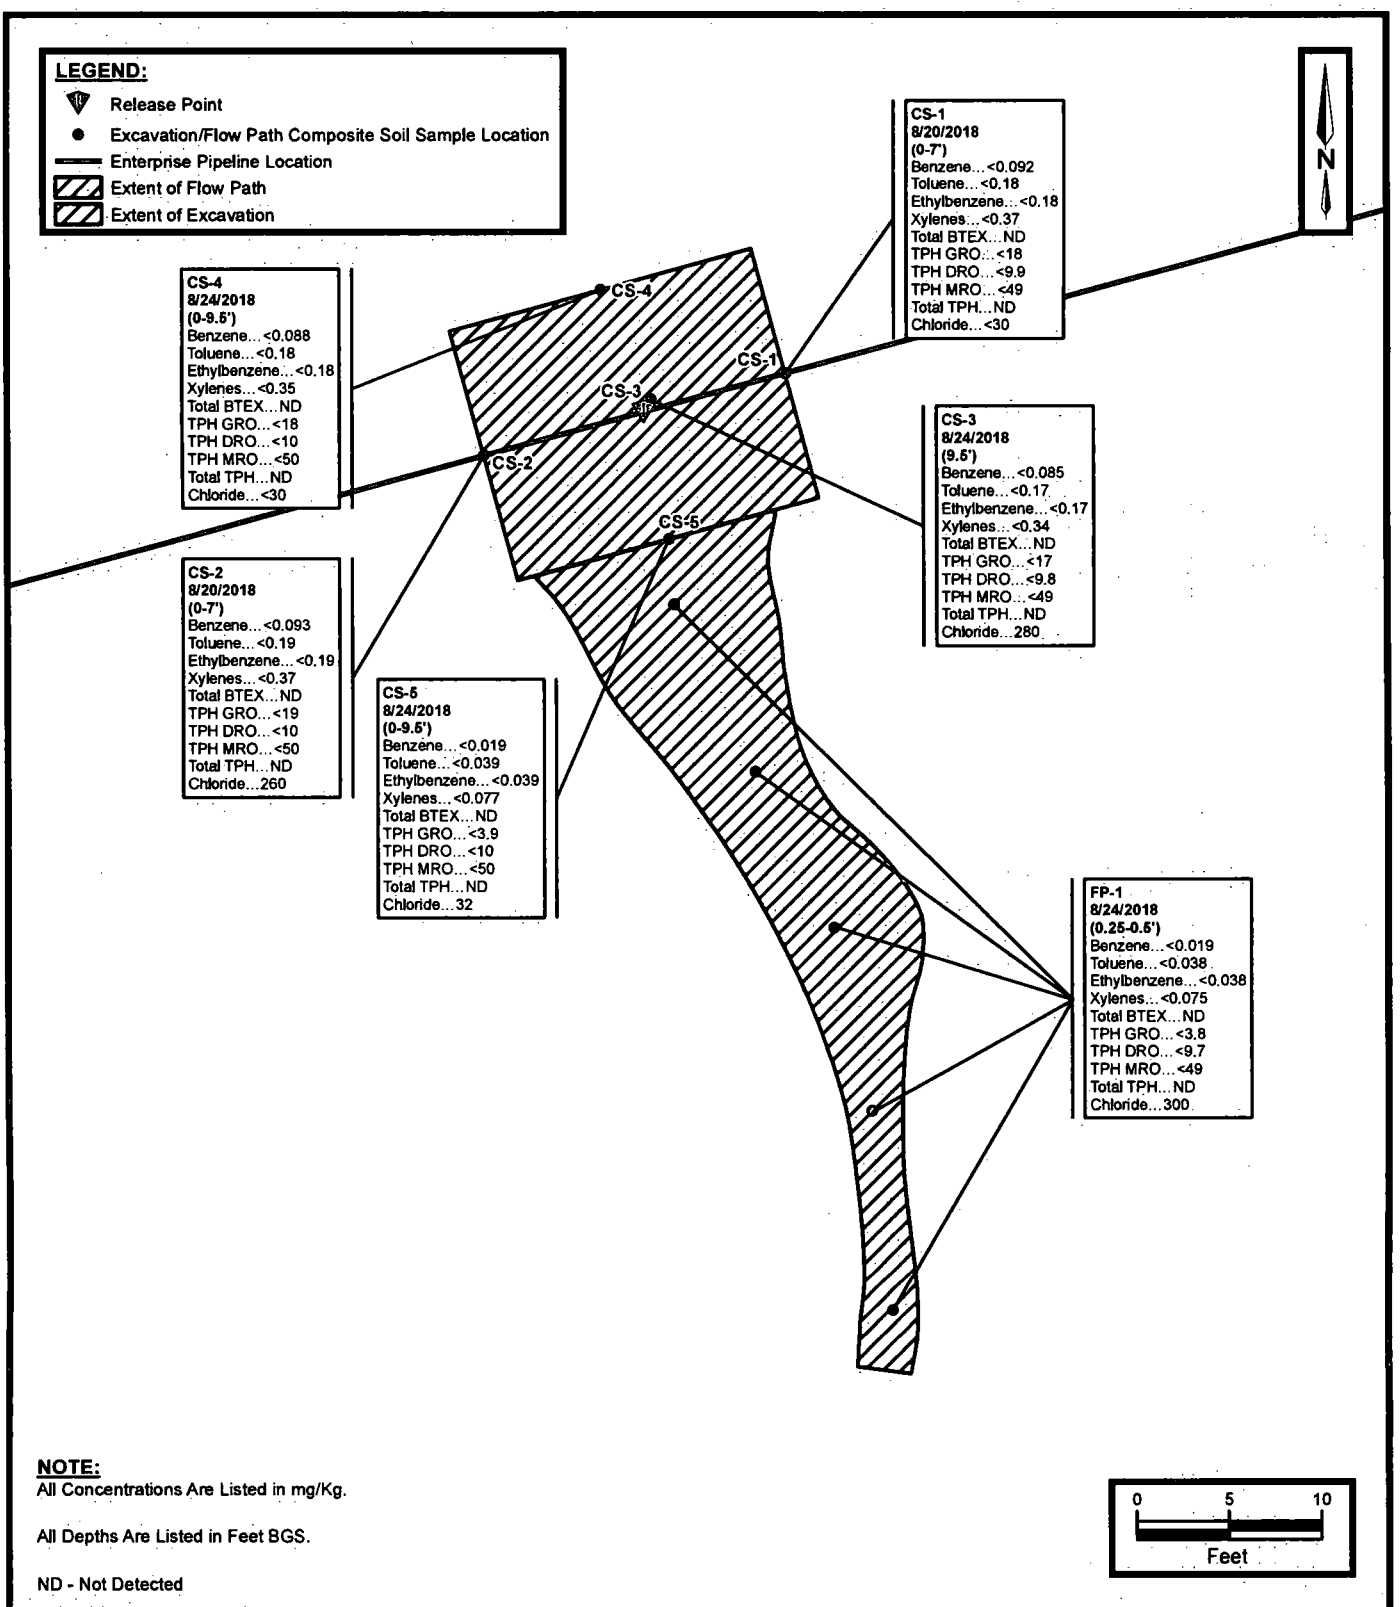
FIGURE 3

The final remediation excavation measured approximately 17 feet long by 14 feet wide. The maximum depth of the excavation measured approximately 9.5 feet bgs. The flow path measured approximately 50 feet in length.

Site Map with Soil Analytical Results

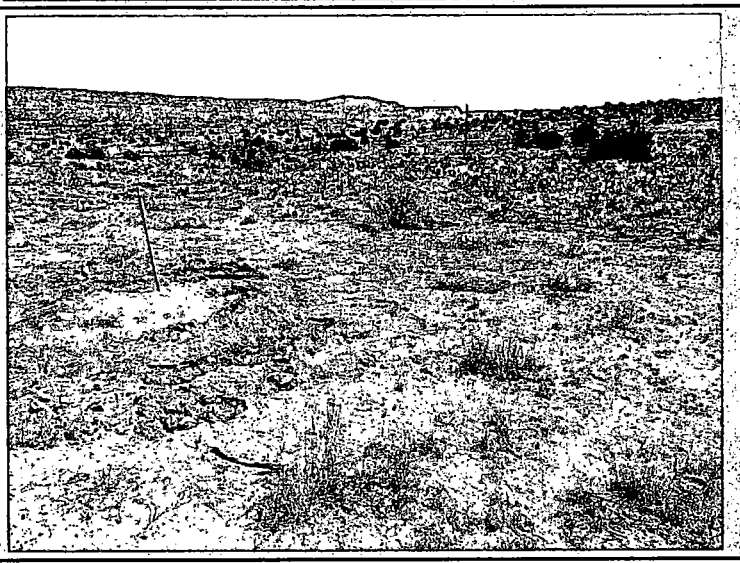
Photograph 2

View of the release area and flow path, facing east.

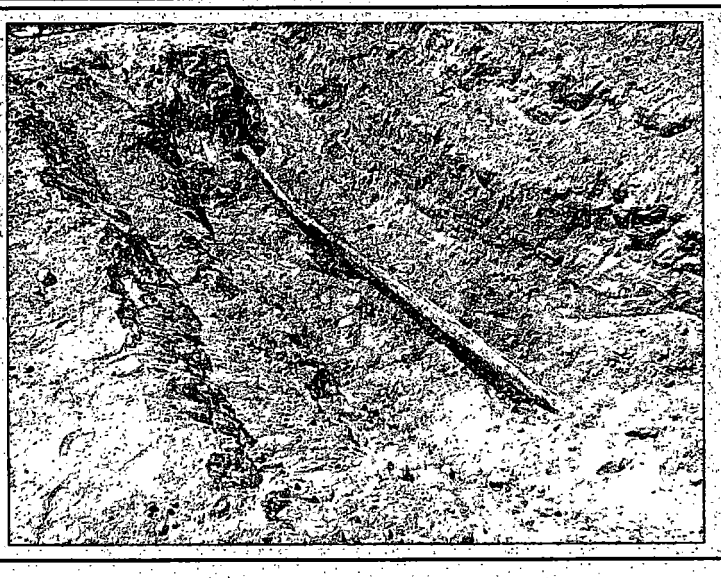
Photograph 3

View of the initial excavation, facing southwest.

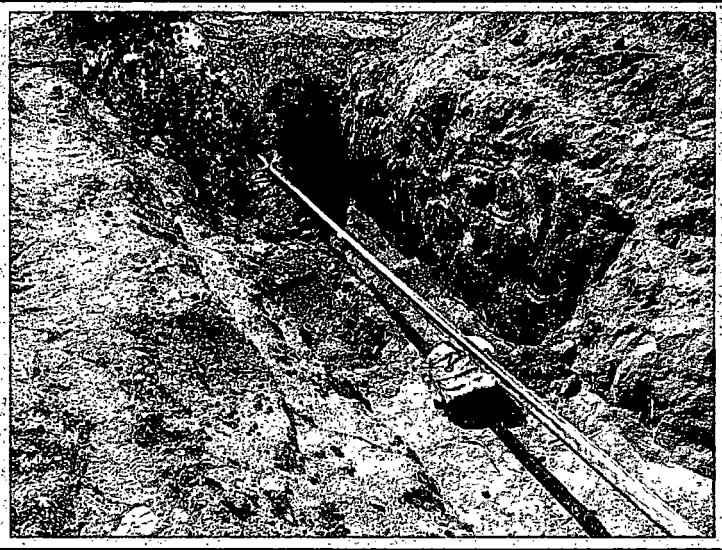
Photograph 4

View of in process excavation activties, facing southwest.

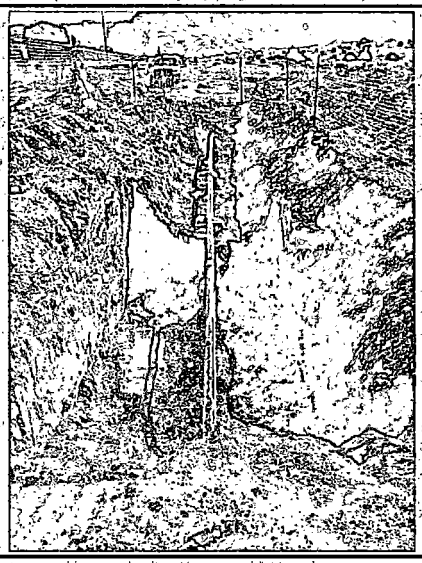
Photograph 5

View of the final excavation, facing northeast.
