STAGE 1 ABATEMENT PLAN

RE: **Stage I Abatement Plan**
C-16(2) Release
EME Salt Water Disposal System
UL-C, Sec 16 T20S R37E
NMOCD Case Number: 1R0477

Stage I Abatement Plan

EME Salt Water Disposal System
C-16(2) Release
UL-C, Sec 16 T20S R37E
OCD No. 1R0477

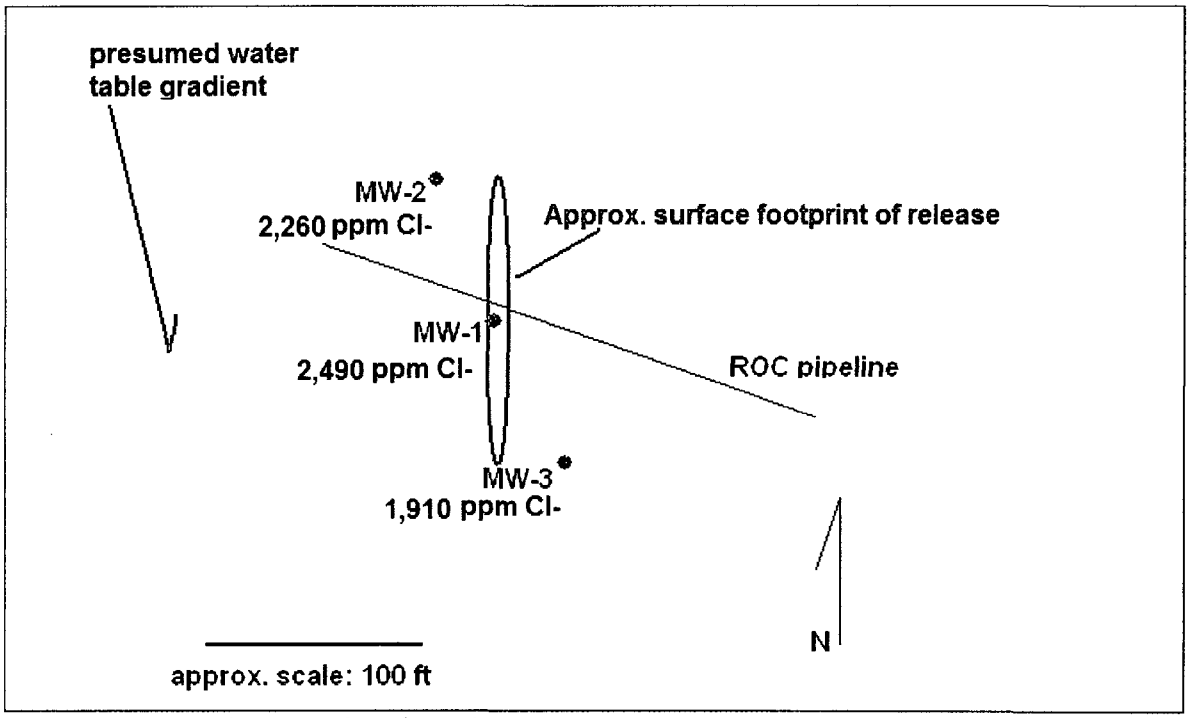
The surface area affected by this release was approximately 2,142 sq ft (less than 1/20th of an acre; Figure 2). Regional groundwater information indicates that the depth to groundwater is approximately 17 to 20 ft below ground surface at this location.

Figure 2 – Approximate surface footprint of release and groundwater chloride concentrations sampled on December 22nd, 2006.

Groundwater samples taken from these wells on December 22nd, 2006 did not immediately reveal a clear picture of the effects of the release, as all three wells had elevated (> 1,900 ppm) chloride levels (Figure 2). OCD was notified of groundwater impact on January 24th, 2007. OCD subsequently placed this project under "Rule 19" on March 26th, 2007, and requested a Stage I Abatement Plan.

In order to protect groundwater approximately 60 cu yds of chloride-contaminated soil material from the upper 6 inches was subsequently removed. This material was taken to the Sundance Disposal facility in Eunice, NM in March, 2006. The site was re-graded to original contours, using clean soil material as backfill.

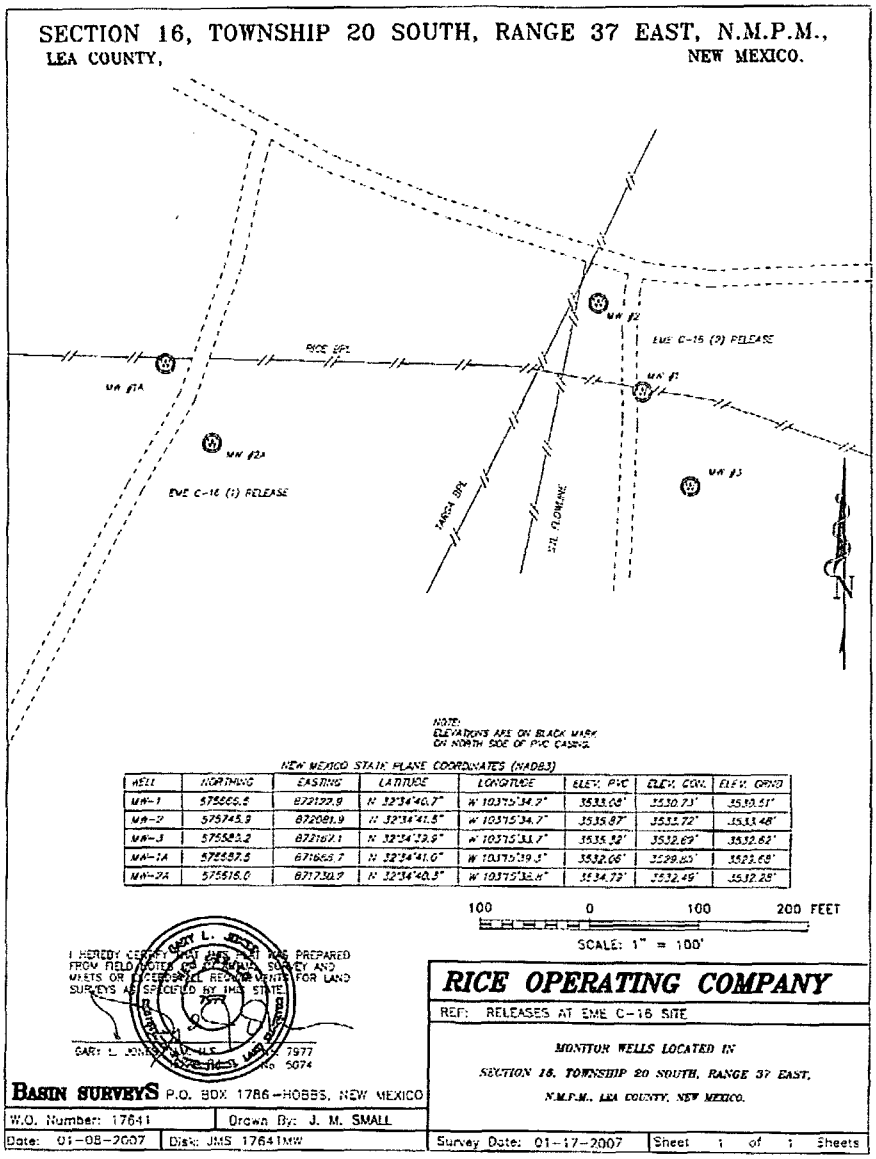
In accordance with the OCD approved Investigation and Characterization Plan of November 24th, 2006, three groundwater monitor wells (Figures 2 &) were drilled by Harrison and Cooper, Inc. on December 12th, 2006. Soil cuttings were logged by Peter Galusky of Texerra.

Figure 3 – Surveyed plat showing monitor well locations. (Monitor well locations for C16(2) are in the right of the figure).
