ANNUAL MONITORING REPORT

SAN JUAN RIVER PLANT
2002 ANNUAL REPORT

APRIL 2003

El Paso Natural Gas Company
614 Reilly Avenue
Farmington, New Mexico 87401

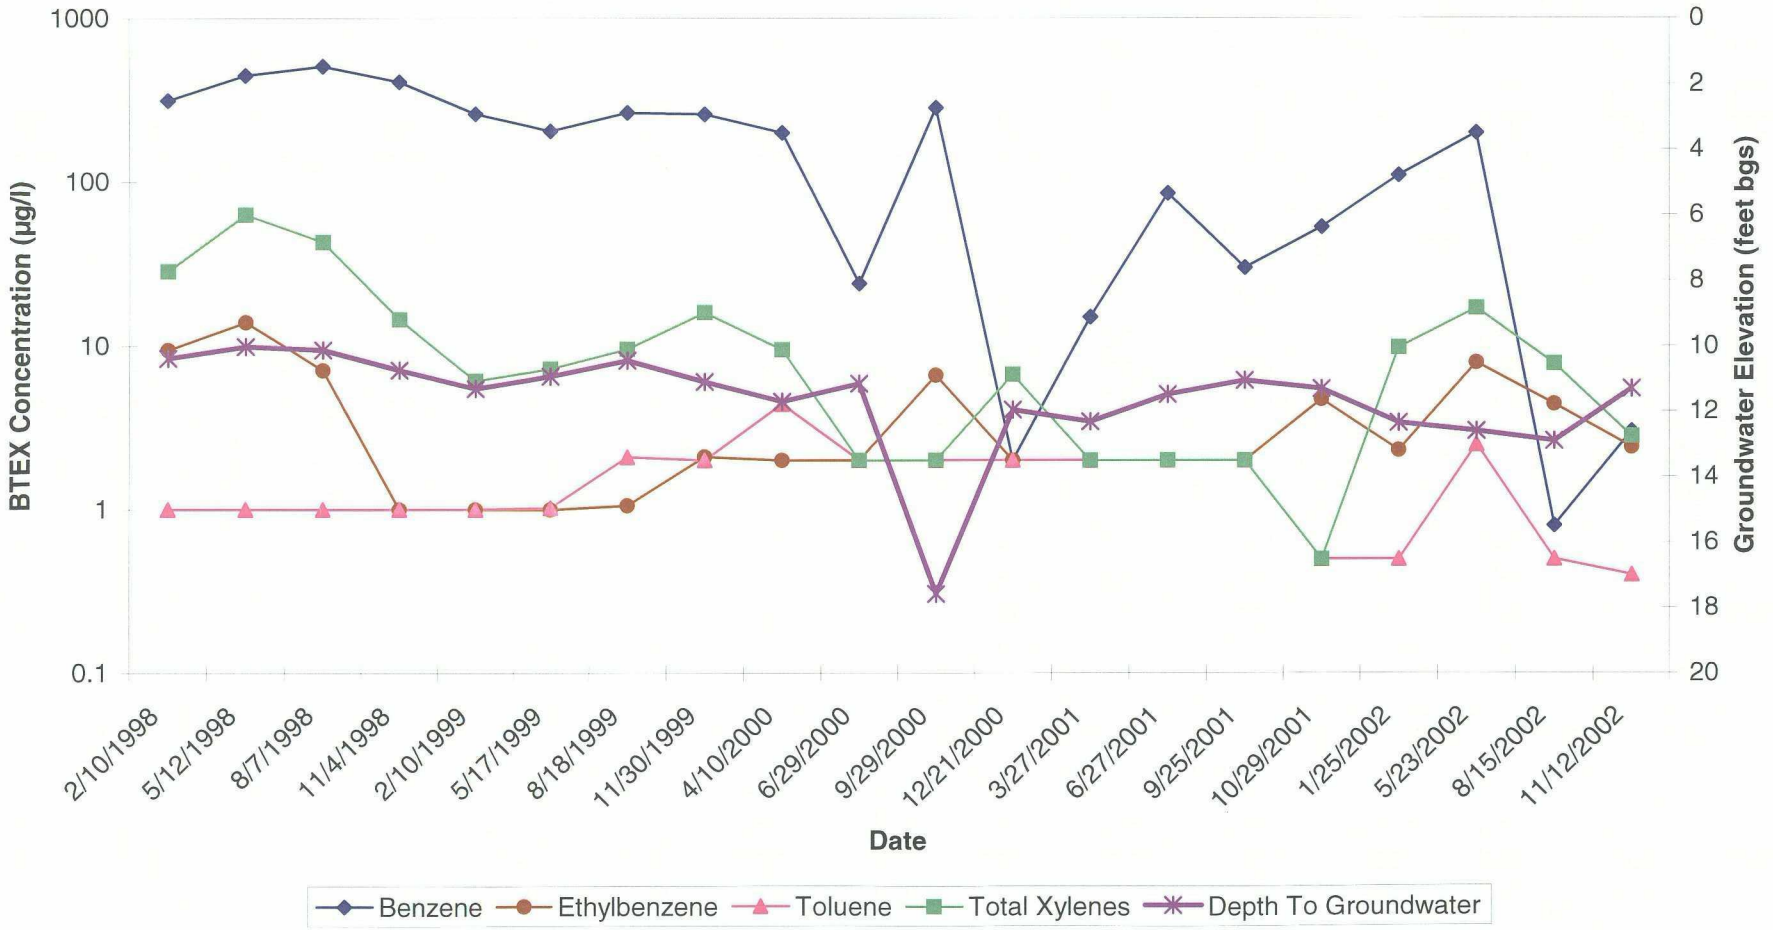
Figure 4
BTEX Concentration and Groundwater Elevation vs. Time
San Juan River Plant
MW-8

- Benzene concentrations in MW-8 continued to decline during 2002 from a high concentration of 200 µg/l during May to approximately 0.8 µg/l in August. Dissolved oxygen concentrations in this well ranged from 8.9 mg/l to approximately 7.3 mg/l indicating that there is adequate oxygen available to support natural attenuation processes.

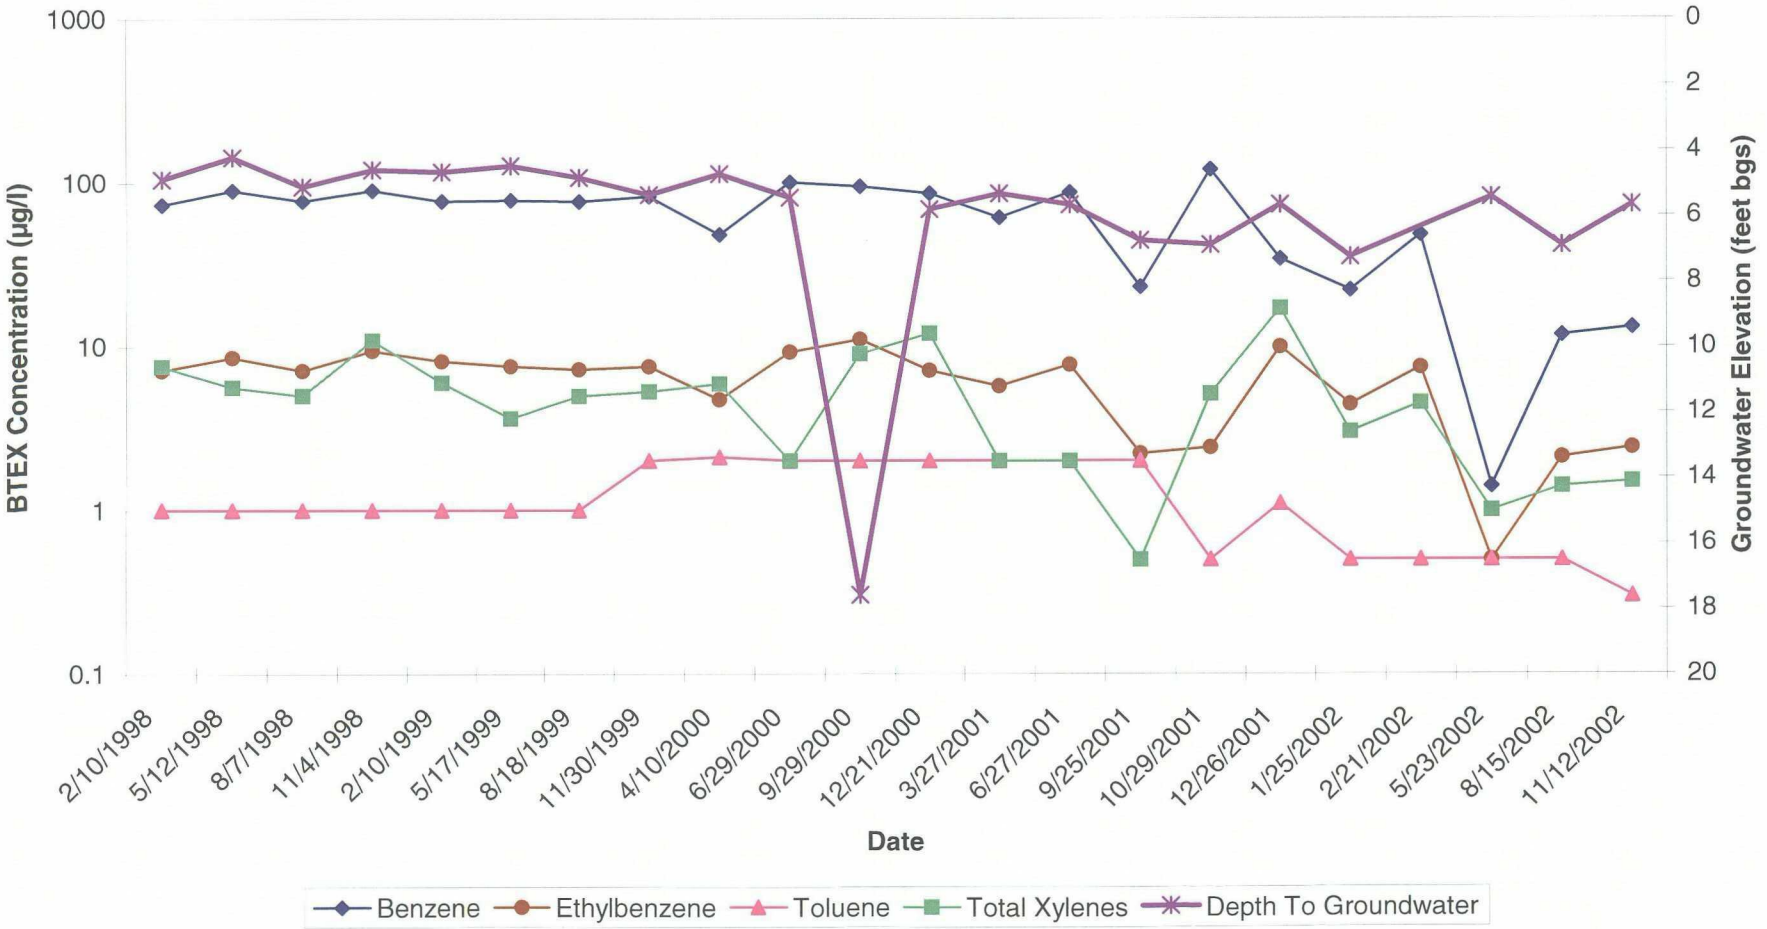
Figure 5
BTEX Concentration and Groundwater Elevation vs. Time
San Juan River Plant
MW-9

- Benzene concentrations in MW-9 also continued to decline as a result of air sparging efforts. Benzene results for this well ranged from 48 µg/l in February to 1.4 µg/l in May as compared with a benzene concentration range of 53 µg/l to 22 µg/l measured during 2001.

- It is recommended that air sparging continue at MW-9 until quarterly sampling results reflect compliance with NMWQCC standards, the sparge system will then be turned off for approximately 8 weeks and groundwater samples will be collected from MW-9 to assess the potential for a rebound in concentration. If laboratory analysis indicate no rebound in BTEX concentrations in MW-9, the sparge system will remain off and quarterly closure monitoring will be initiated.

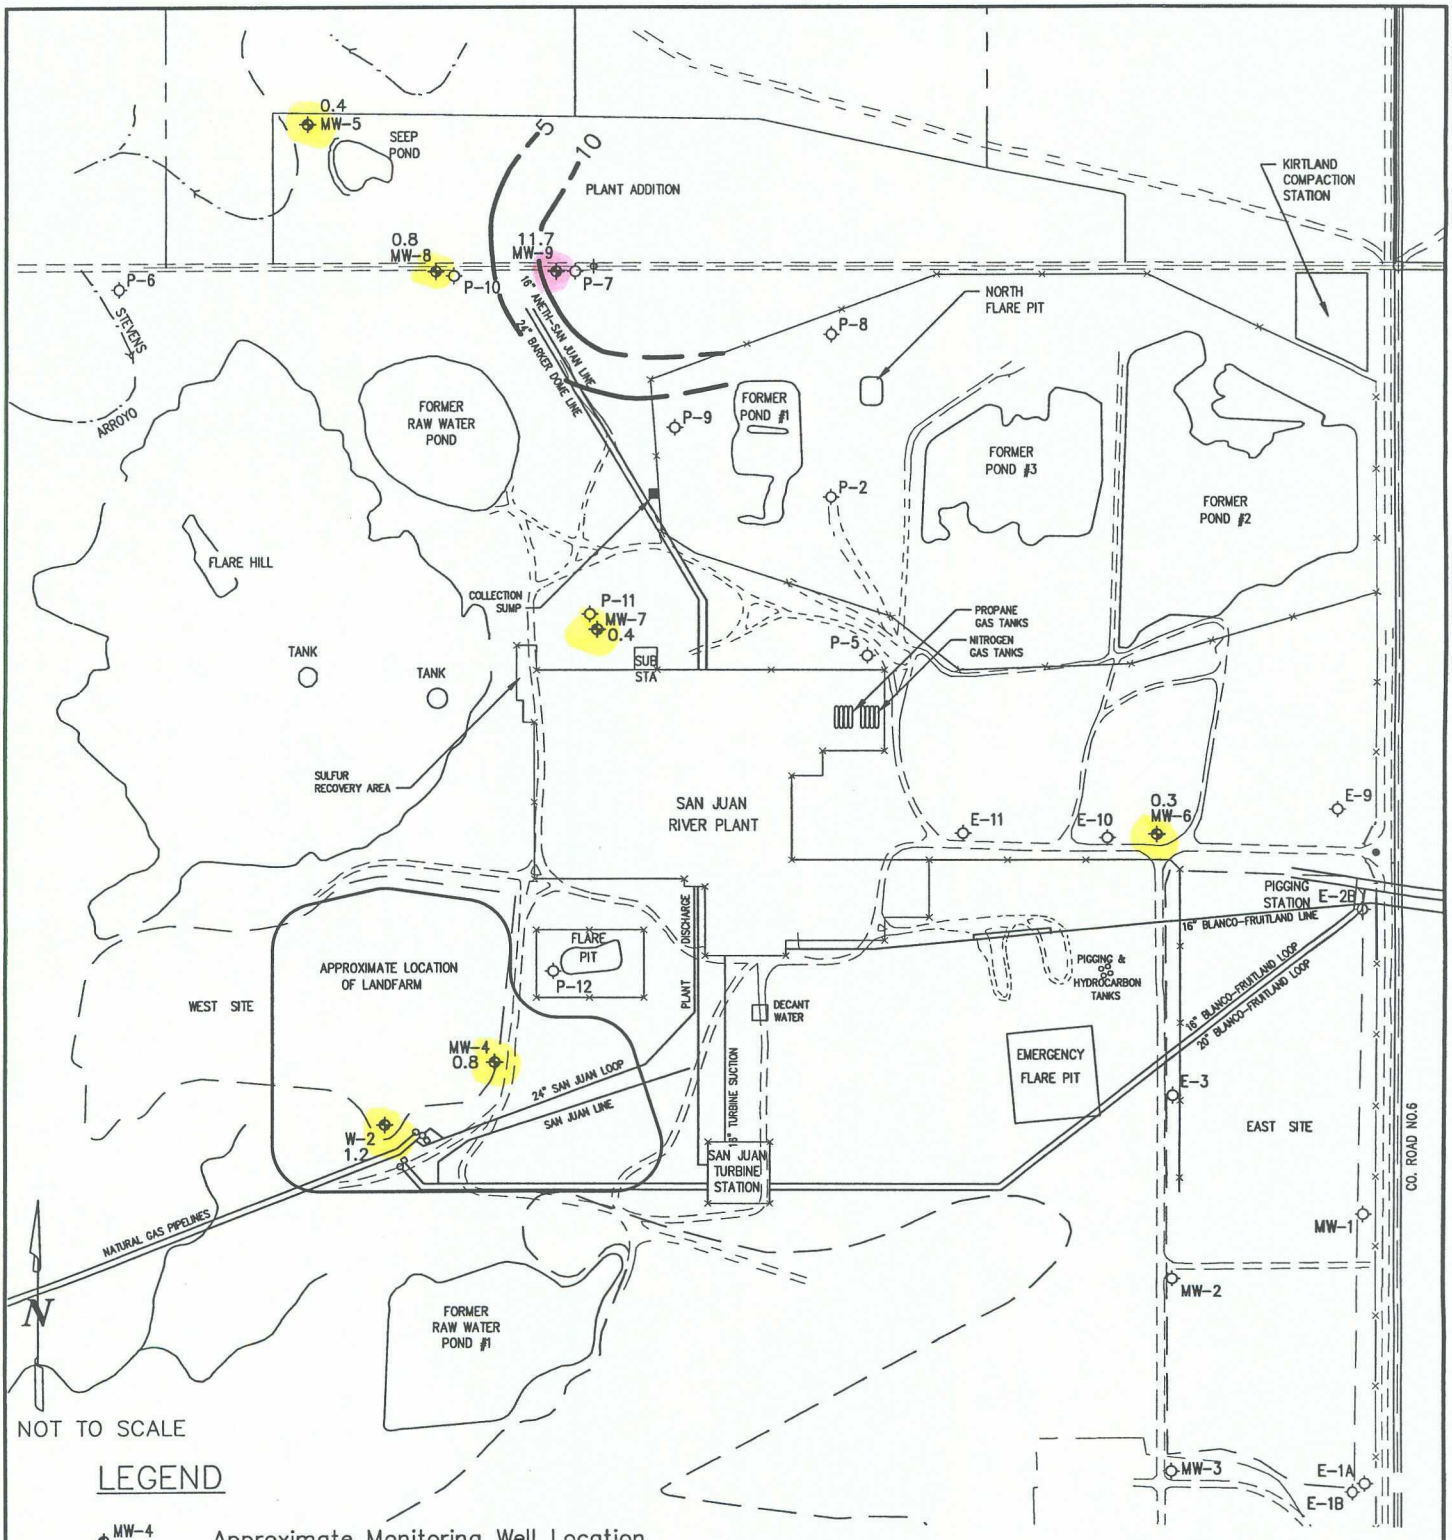
FIGURE 6

BENZENE ISOCONCENTRATION MAP
AUGUST 2002
SAN JUAN RIVER PLANT

- Benzene concentrations in the monitoring wells containing dissolved-phase hydrocarbon contamination (MW-8 and MW-9) continue to decline as a result of active remediation efforts. Both monitoring wells had at least one sampling event during 2002 that indicated concentrations were below NMWQCC standards.

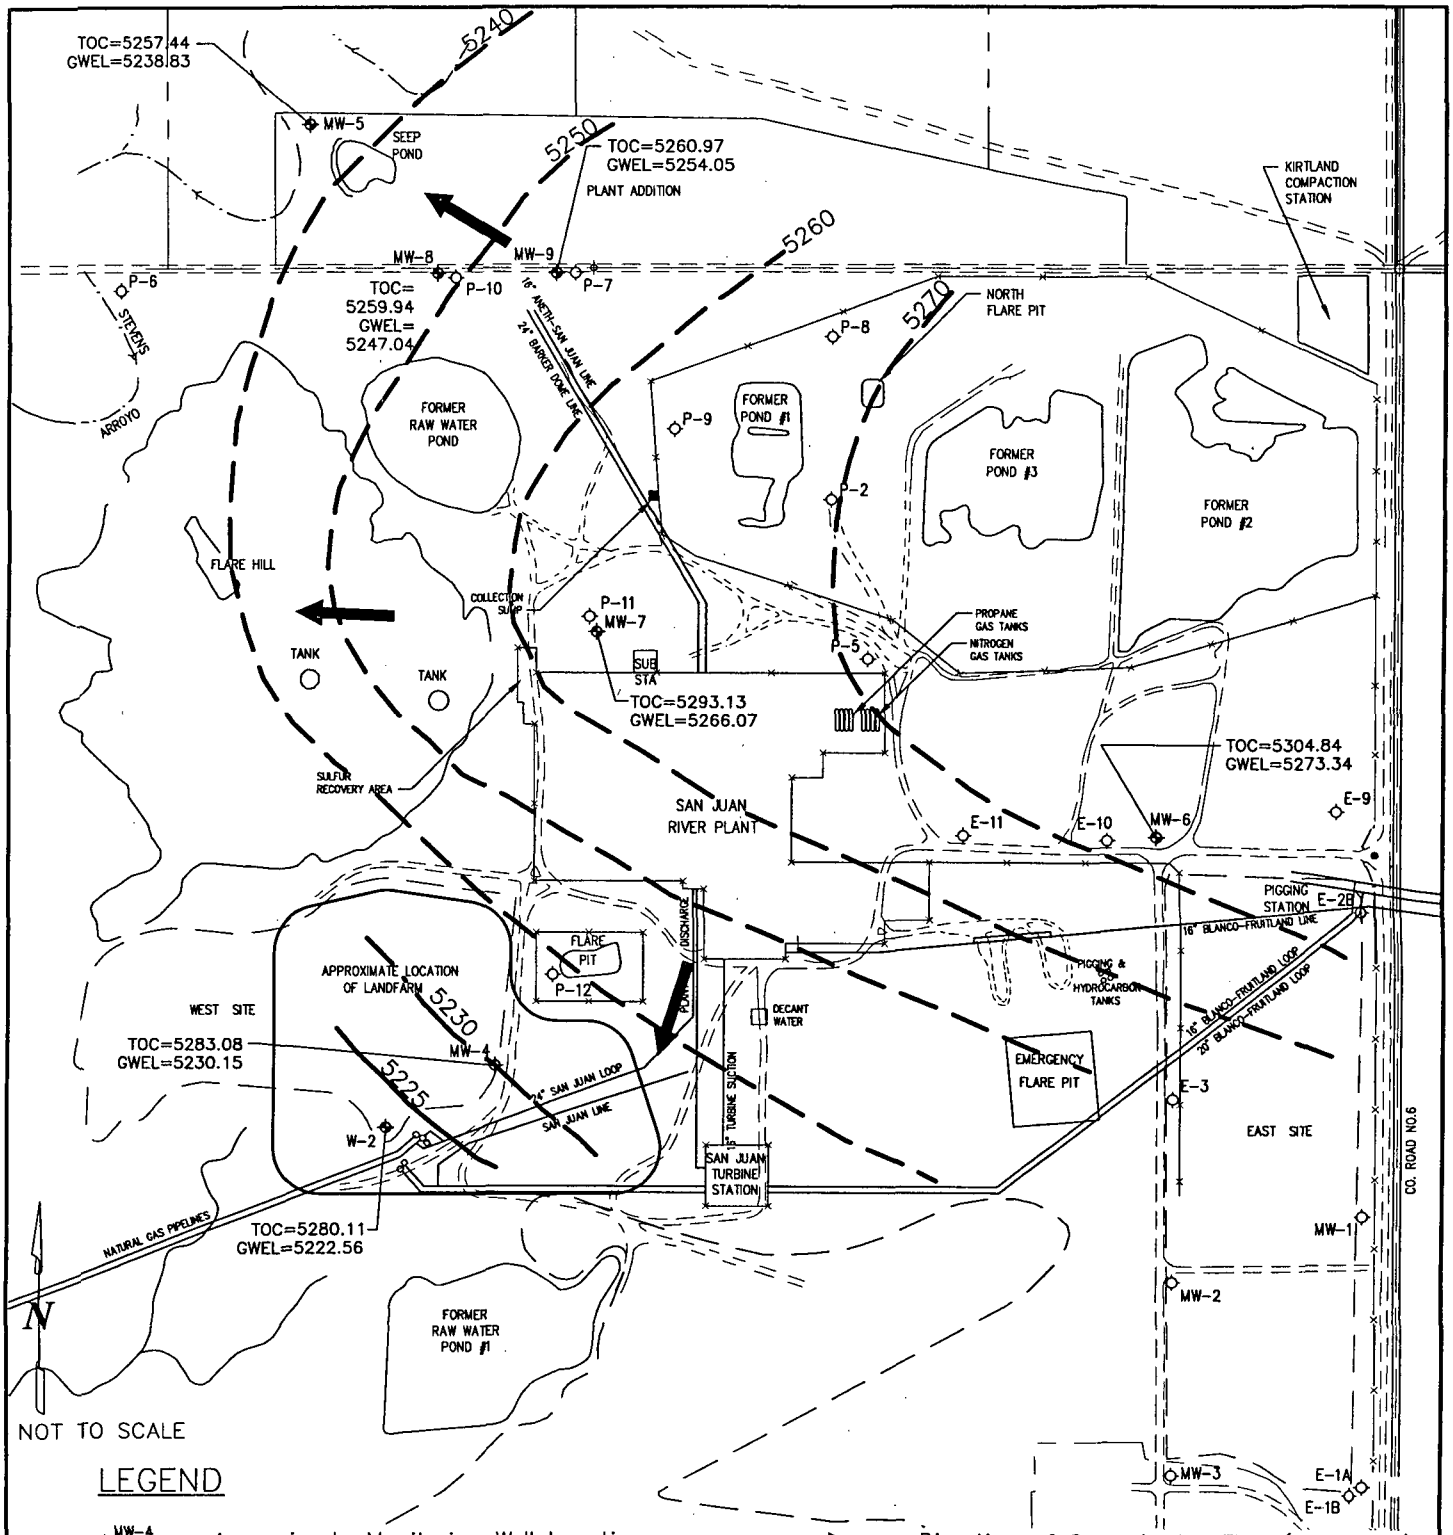
FIGURE 7

GROUNDWATER ELEVATION MAP
AUGUST 2002
SAN JUAN RIVER PLANT

- Groundwater flows radially away from the rise on which SJRP is located. In the north plant area, groundwater flow is towards the north and northwest; in the south plant area groundwater flow is primarily towards the south and southwest.

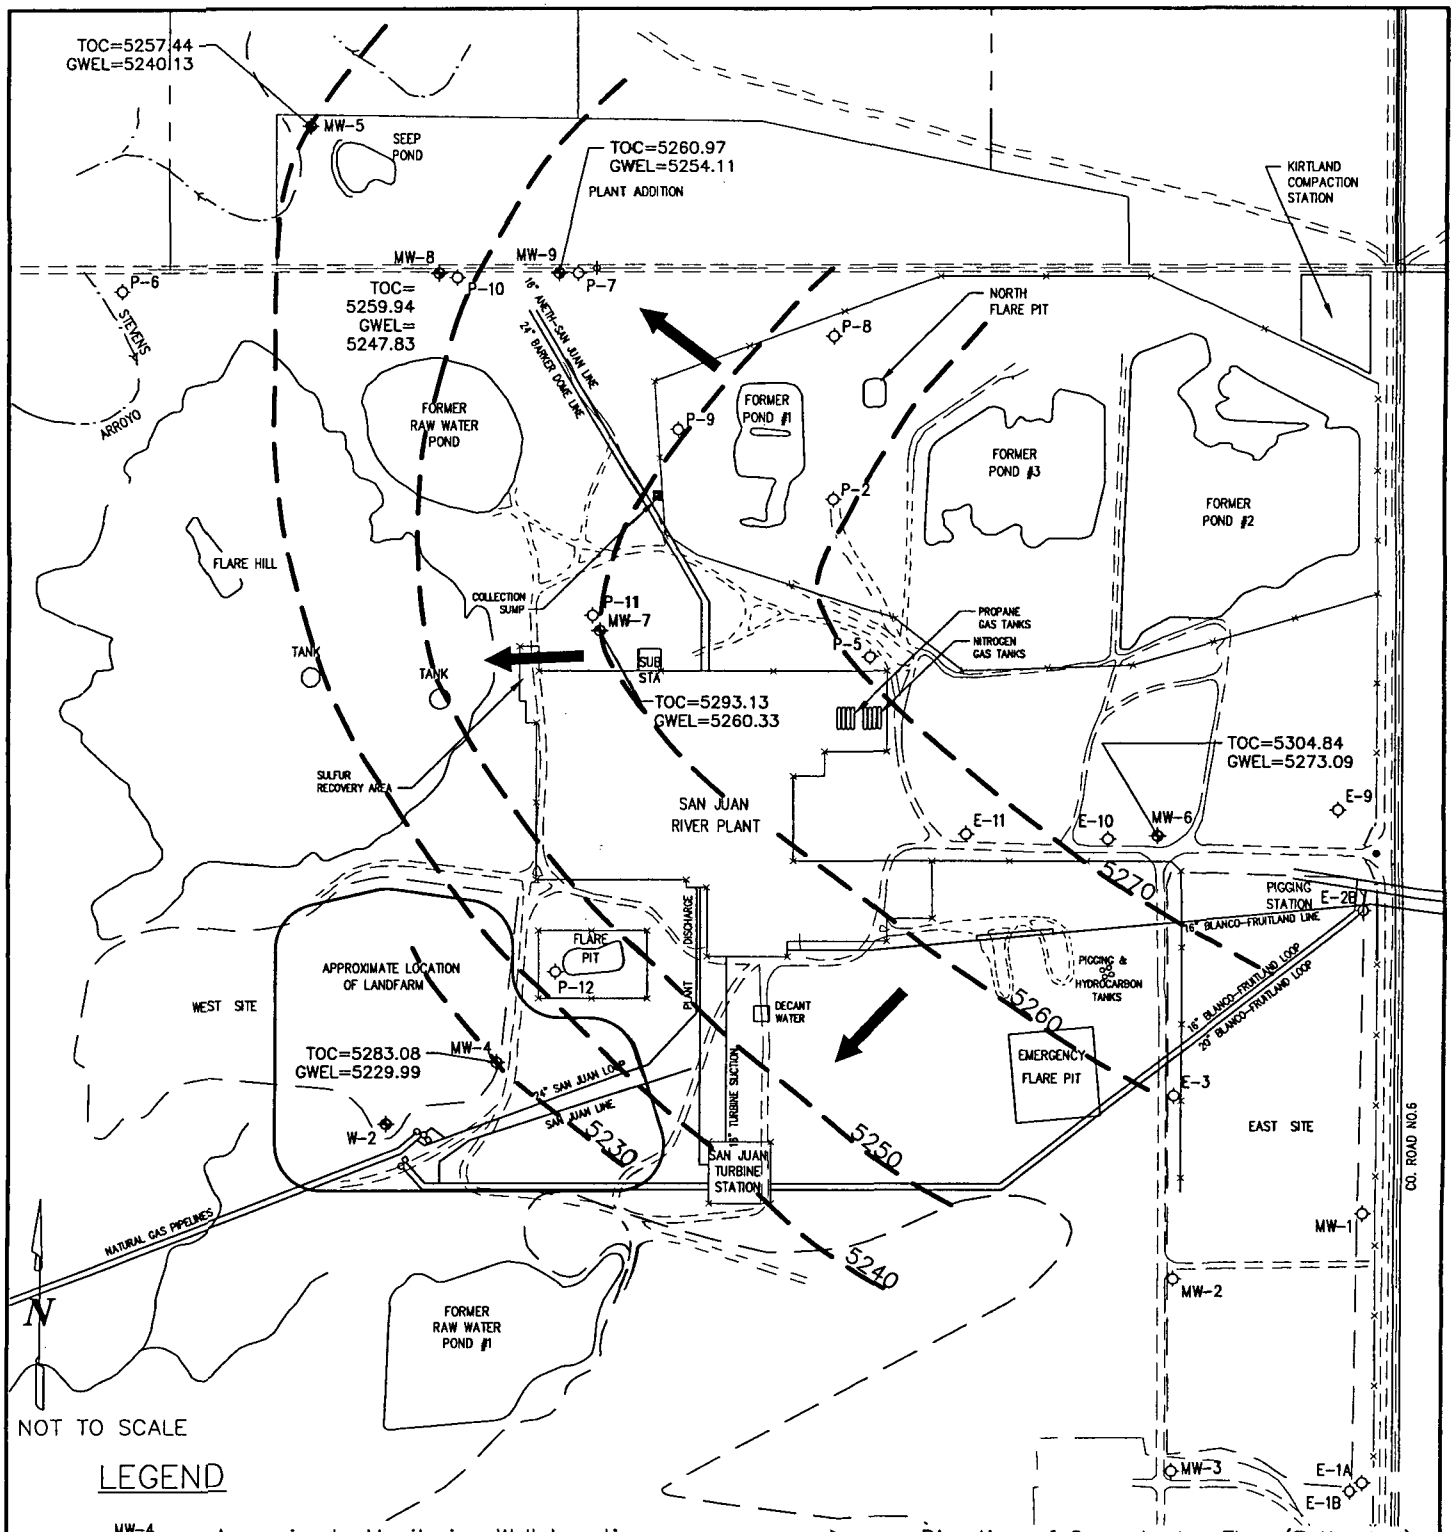
FIGURE 8

GROUNDWATER ELEVATION MAP
NOVEMBER 2002
SAN JUAN RIVER PLANT

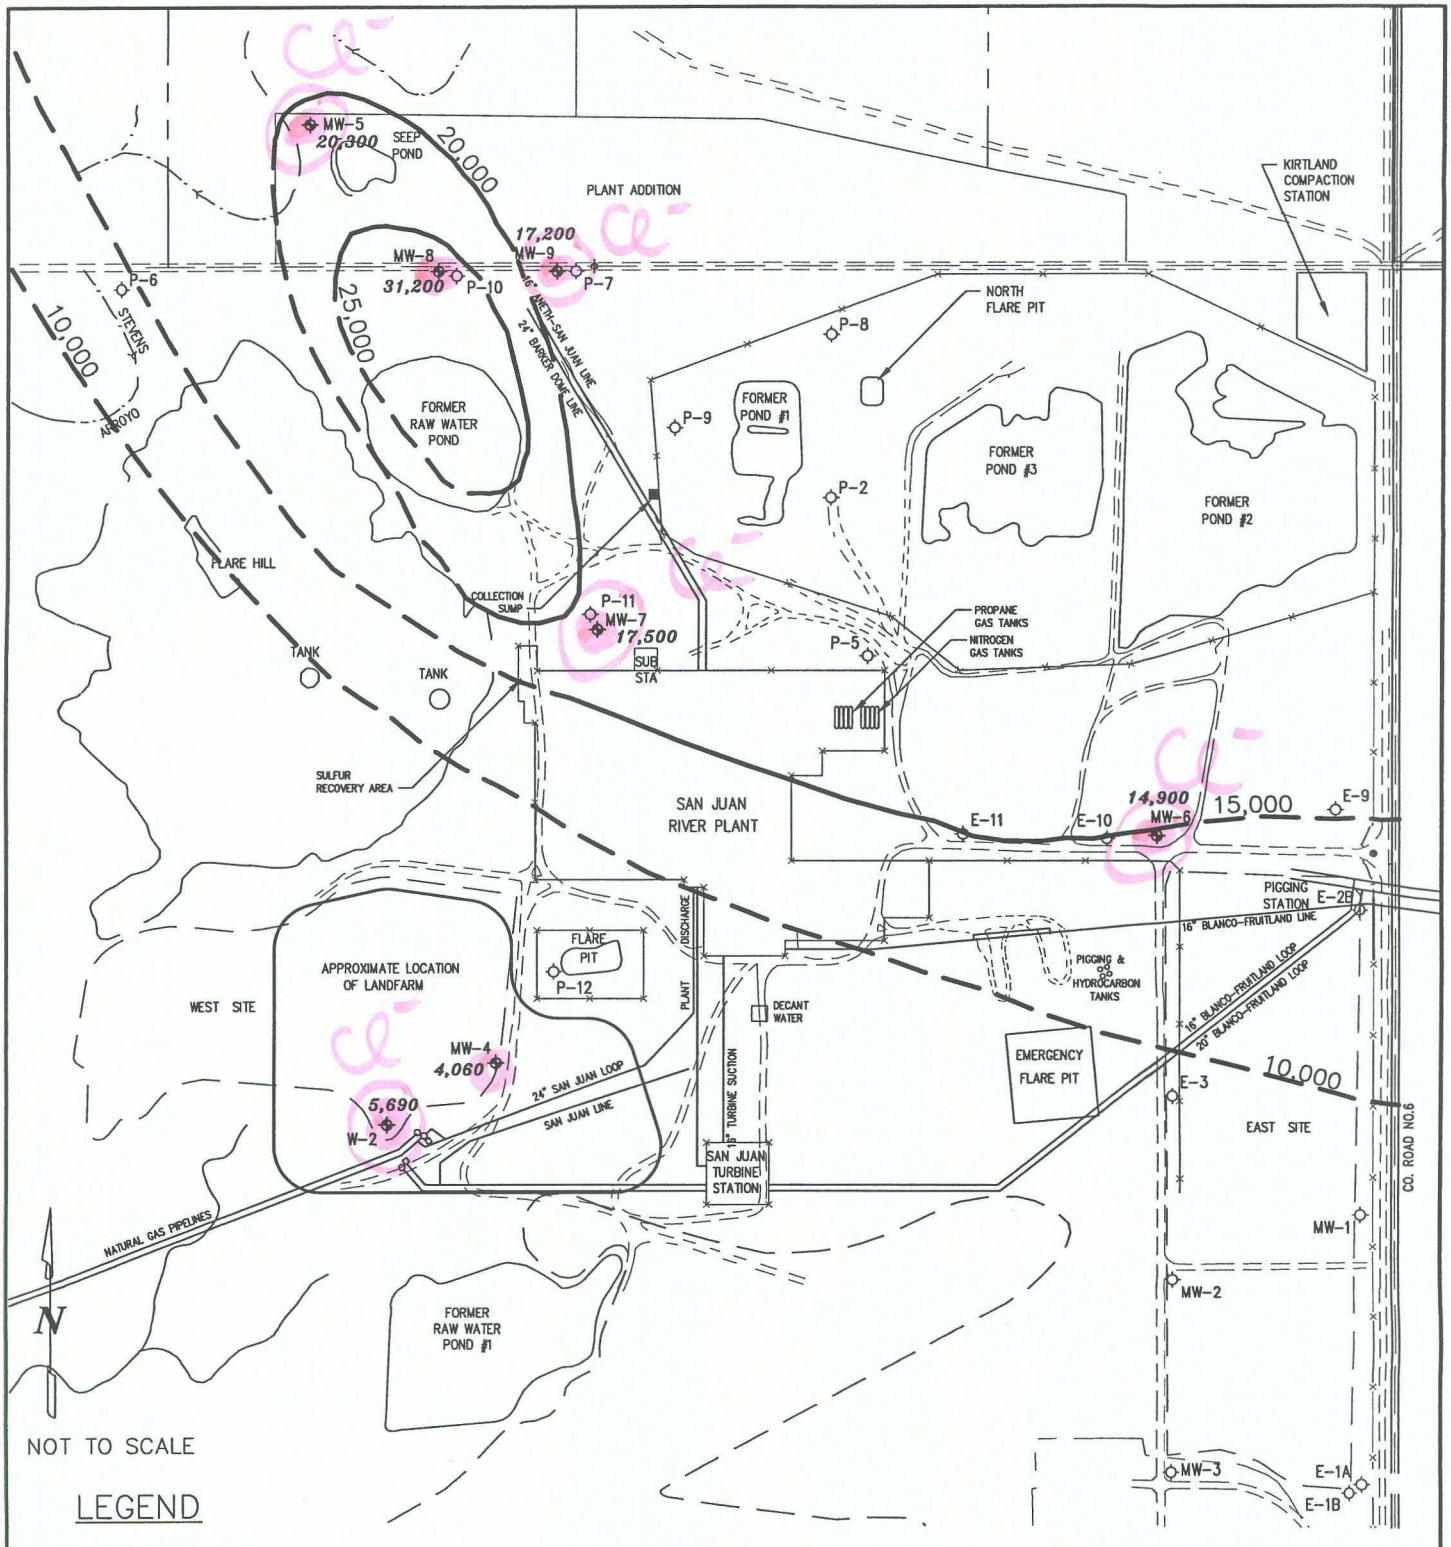
FIGURE 9

TDS ISOCONCENTRATION MAP
AUGUST 2002
SAN JUAN RIVER PLANT

- Inorganic constituents were measured above NMWQCC standards during the August 2002 sampling event. While, in some cases, the elevated concentrations of TDS and sulfate may reflect past practices, it is likely that some elevated concentrations are naturally occurring.

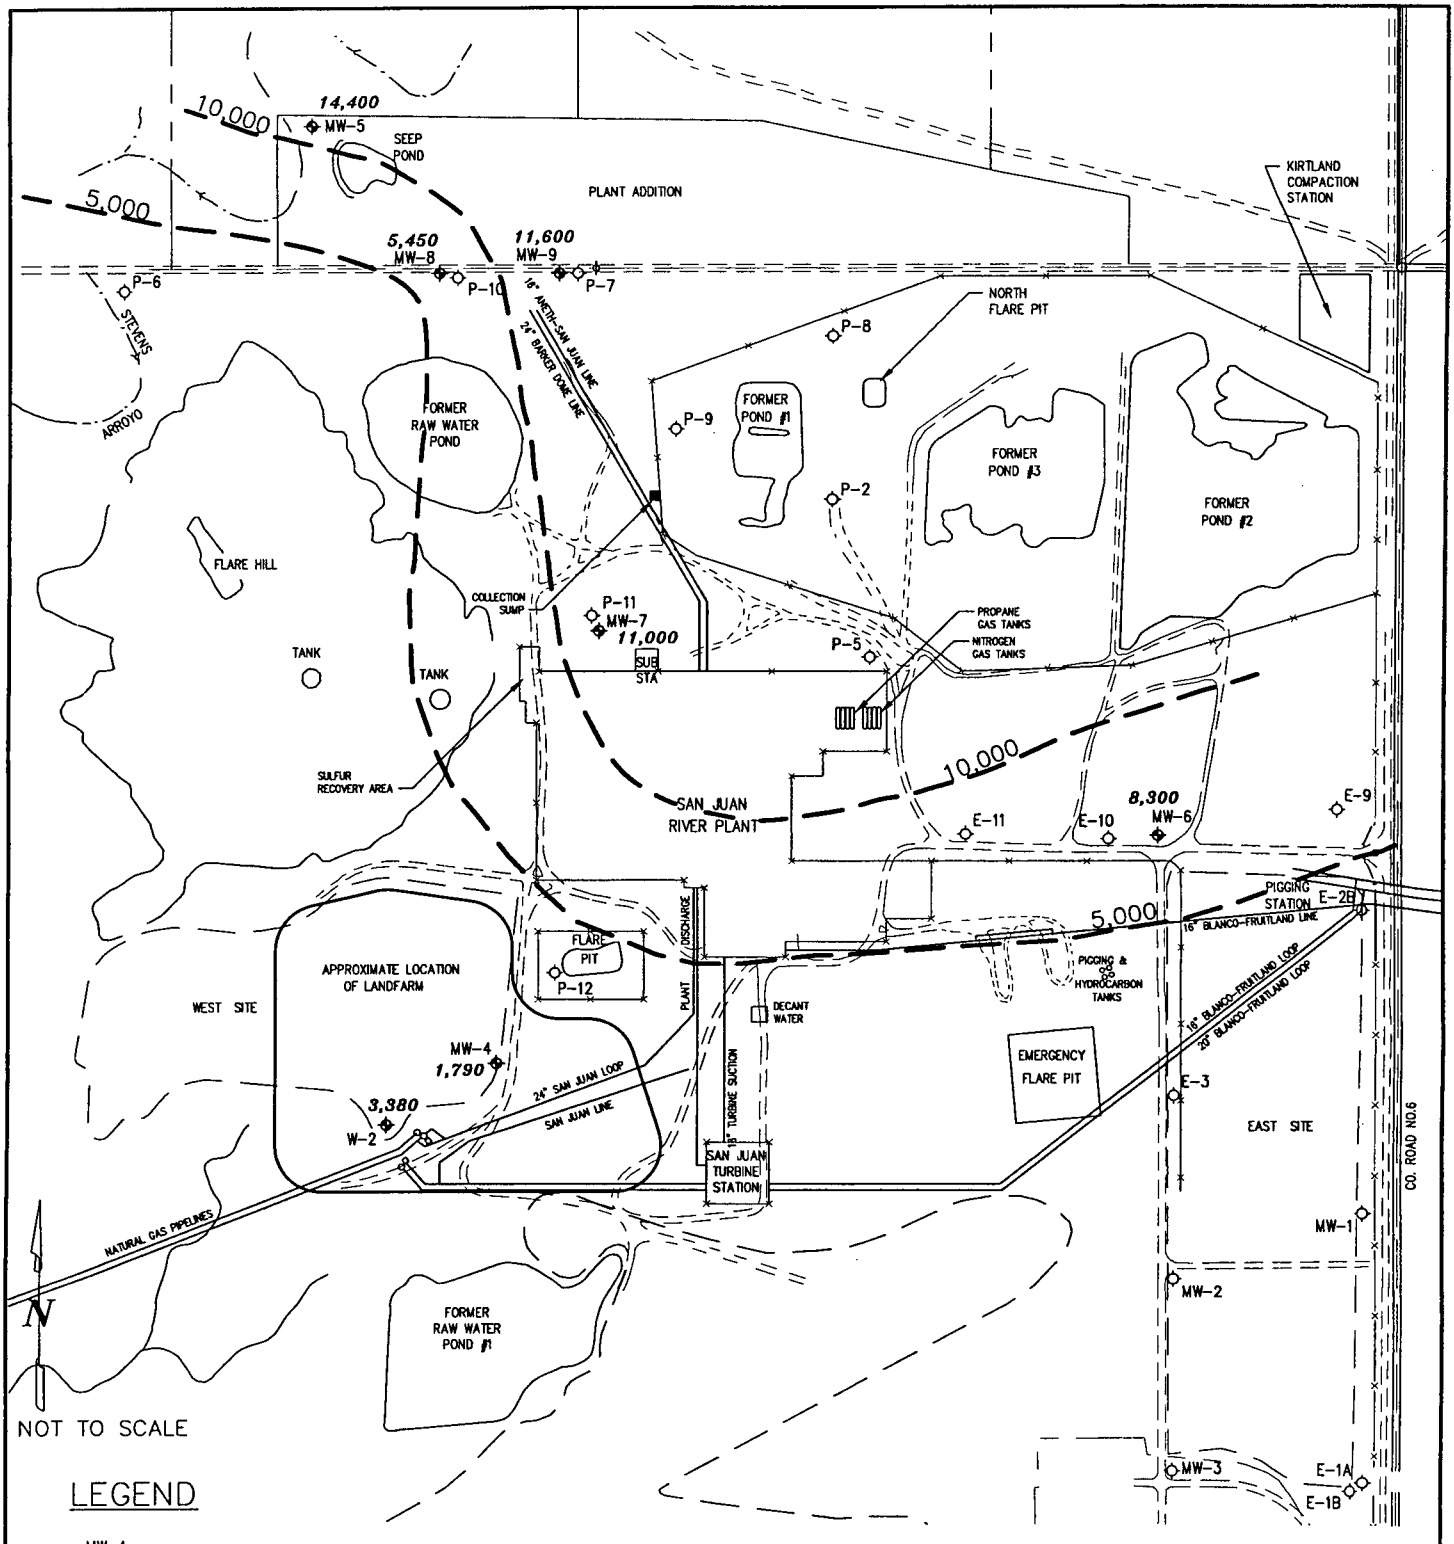
FIGURE 10

SULFATE ISOCONCENTRATION MAP
AUGUST 2002
SAN JUAN RIVER PLANT
