Reference: North Benson Queen Unit 016 30 015 10087
J-28-18S-30E Eddy County, New Mexico
2RP-226, 2RP-219, 2RP-249

Corrective Action Plan
North Benson Queen Unit
Tank Battery & Well No. 16
Produced Water Spills

Prepared For: Arena Resources, Inc.
2130 West Bender Blvd.
Hobbs, NM 88240

Prepared By: Etech Environmental & Safety Solutions, Inc.
Date Prepared: September 22, 2008
Project Number: 094-1748 & 1749-000

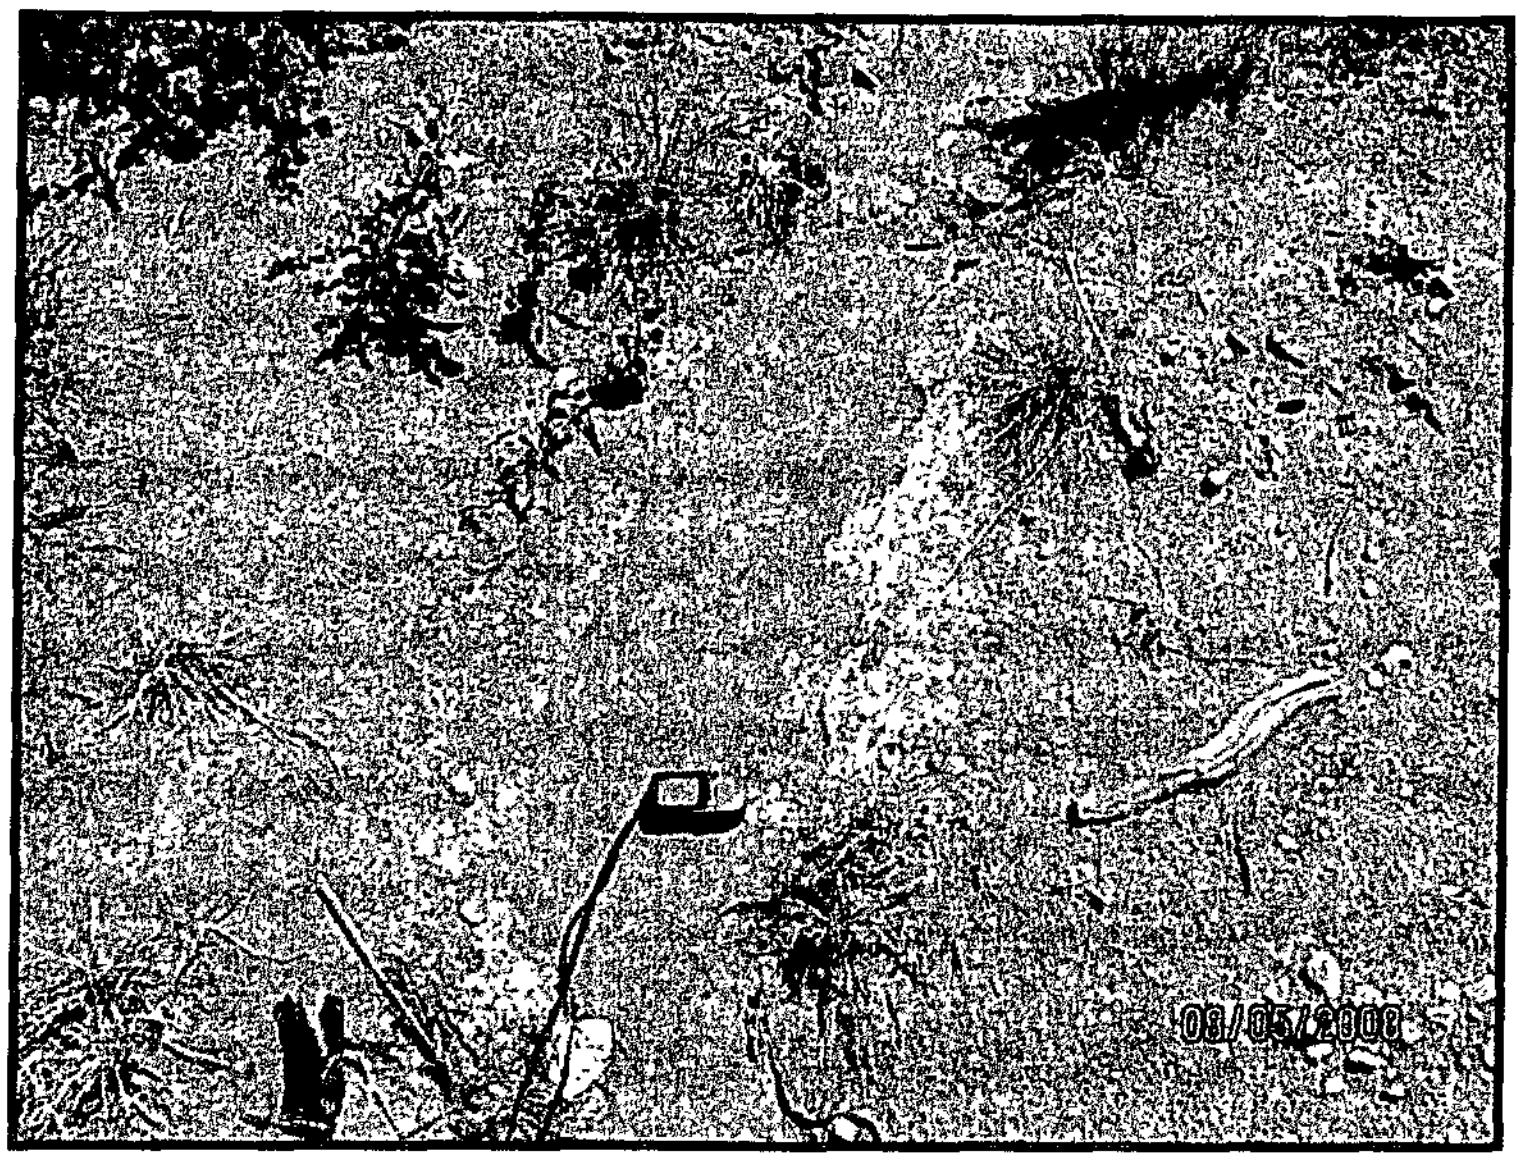
The storm water pathways on the west segment are very narrow averaging of 12 inches in width. The pathways on the north segment range from 1-3 feet in width. No vegetation was observed in the majority of the bottoms of the pathways. Representations of the pathways are provided in Photographs 3 & 4 presented on the following page.

Photograph 3: Bottom of the storm water pathway on the west segment of the spill.

The spill pathways, particularly to the west are quite narrow and have a relatively small surface area. These areas will be treated with granular calcium nitrate at a rate of 200 lbs per acre-foot and tilled into the soil at a depth of 6-8 inches. This reagent was selected as it has been very successful in treating spills of this type and dissolves very quickly into the soil providing a high level of calcium for ion exchange. This remediation approach to this area was selected because; 1.The areas are mostly void of vegetation due to storm water runoff and will likely never vegetate and, 2.This approach will provide the minimal amount of disturbance to the surrounding soil.

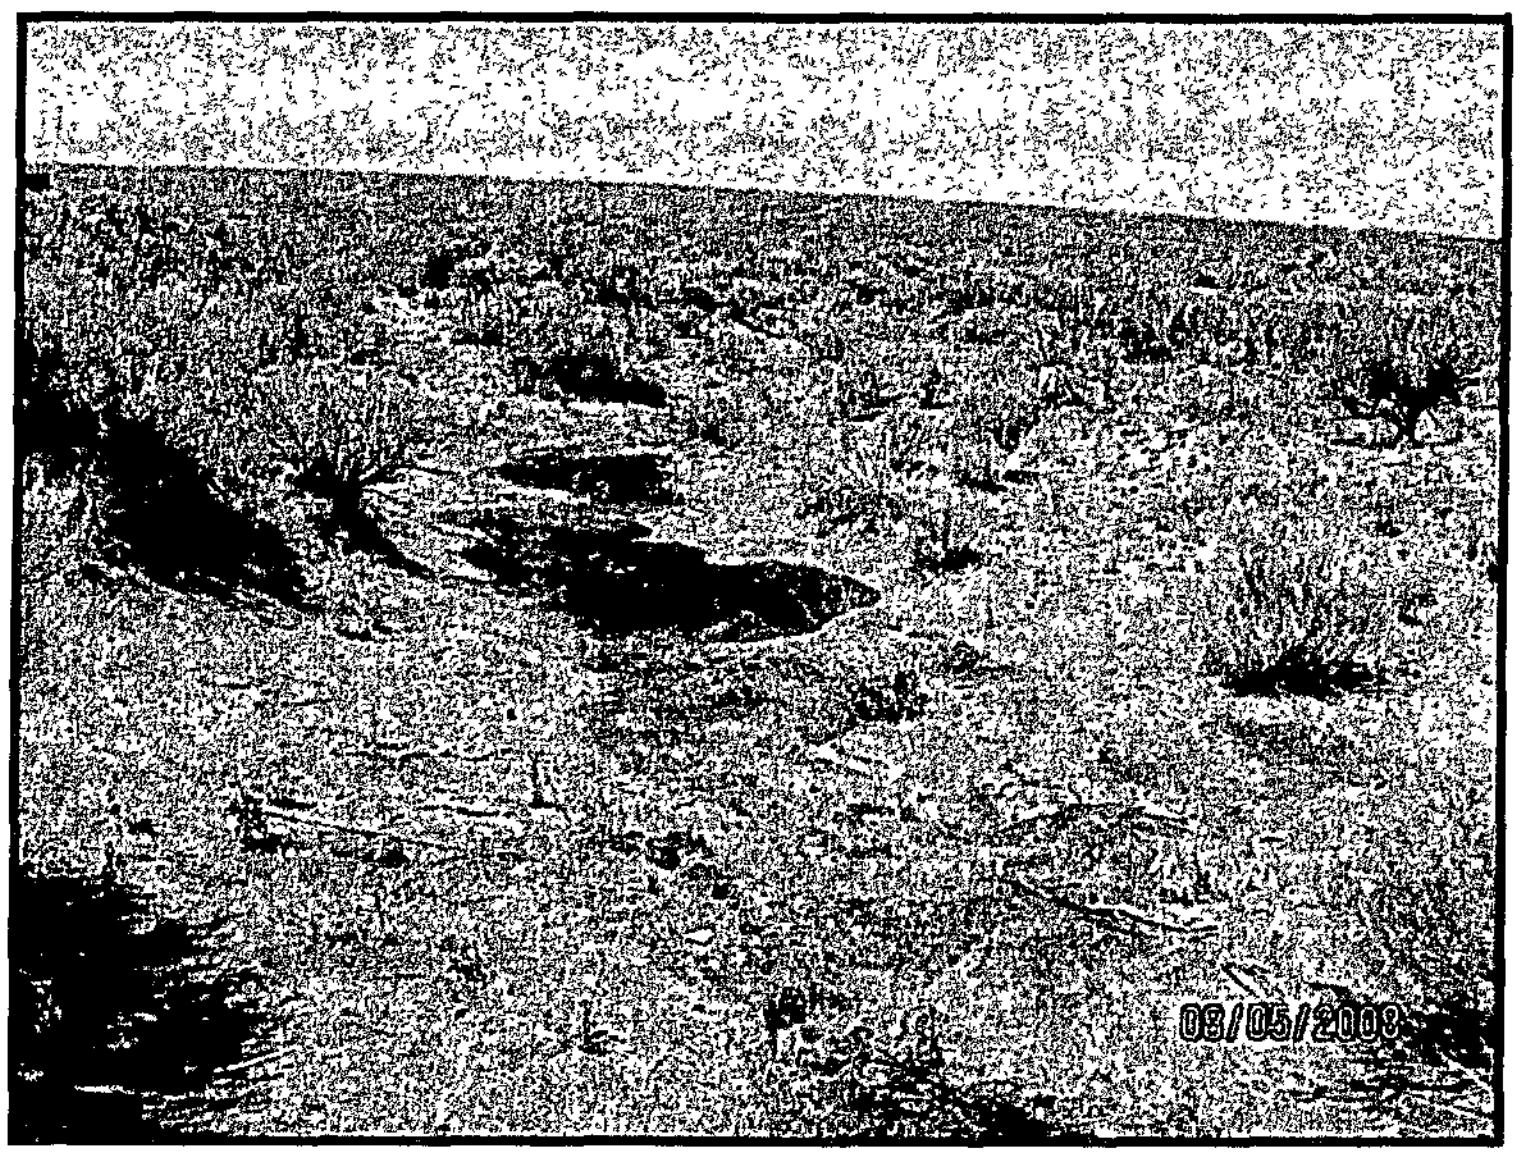
Photograph 4: Bottom of the storm water pathway on the north segment of the spill.

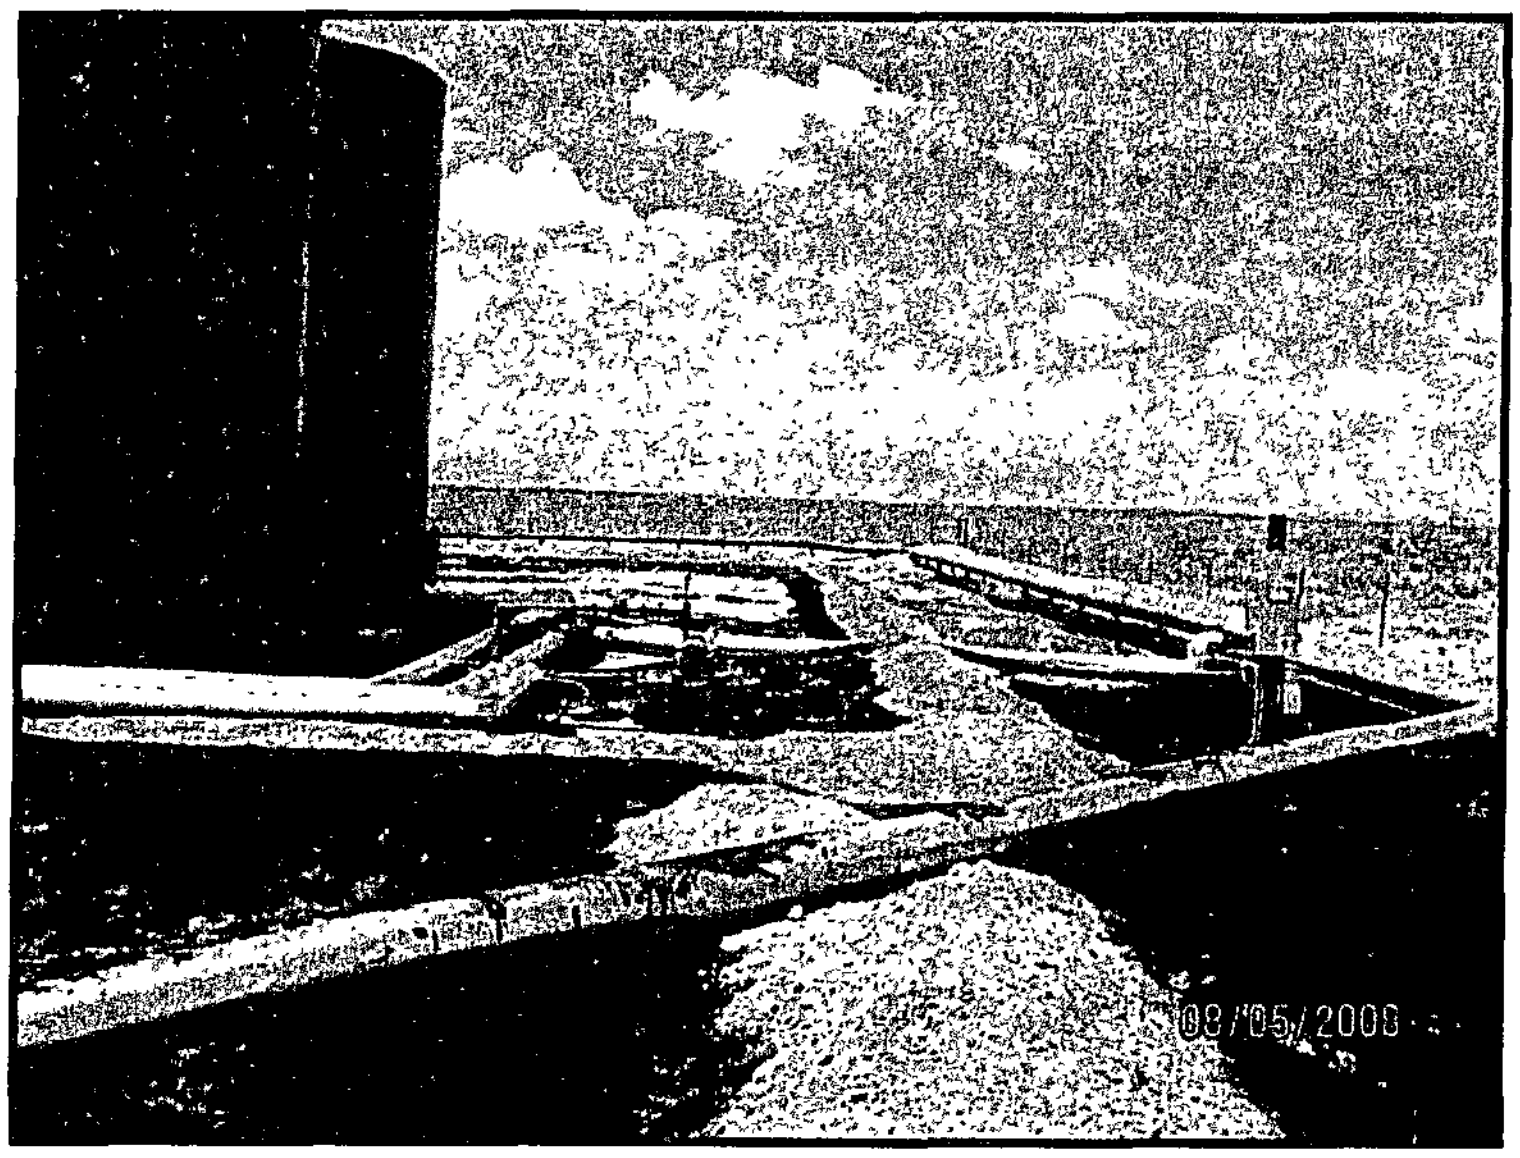
Arena reported that the north containment has a liner in place. The south containment does not. Also, the south containment is noted to be one of the original containments on the site which was built prior to the acquisition of the site by Arena. Hydrocarbon staining was prevalent across most of the bottom of both containments and in the surface soils. The staining in the soils outside of the containment appeared to be confined to the first ½ inch of surface soils. Representations of the pathways are provided in Photographs 5 & 6 presented below.

Photograph 5: View of the staining in the northern containment and adjoining area on the east side. A portion of the southern containment is in the foreground, lower right.

The remediation of the site will occur in three phases. In Phase I, all impacted soils in the north containment will be removed until the levels of total petroleum hydrocarbons (TPH) and chlorides reach 5,000/500 mg/kg or less (respectively). The impacted soils will be treated on-site via soil washing in a cell constructed on this site.

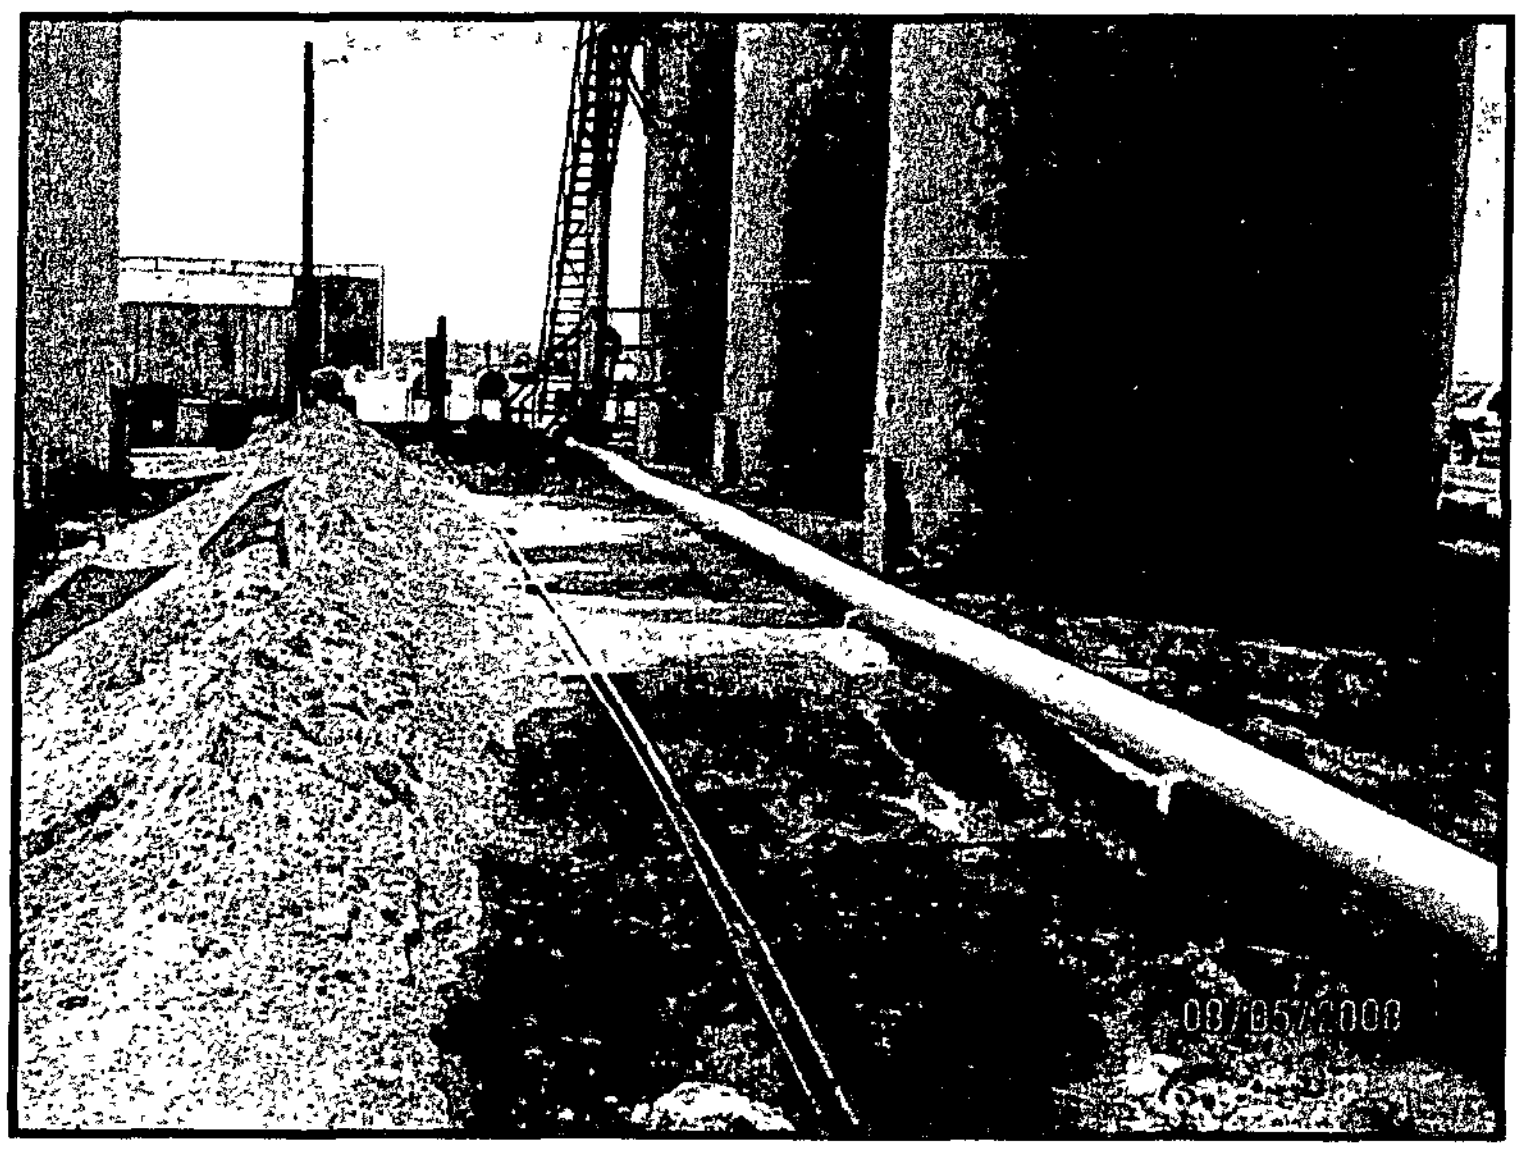
Photograph 6: View of the south side of the interior of the southern containment.

In Phase II, the tanks and associated equipment in the southern containment will be removed and the permanently staged to the northern containment. Once this is done, the impacted soils will be treated on-site via soil washing and the area backfilled with clean soil to-grade. In Phase II any impacted soils from the spill outside of the containment will be will be treated on-site via soil washing as well.

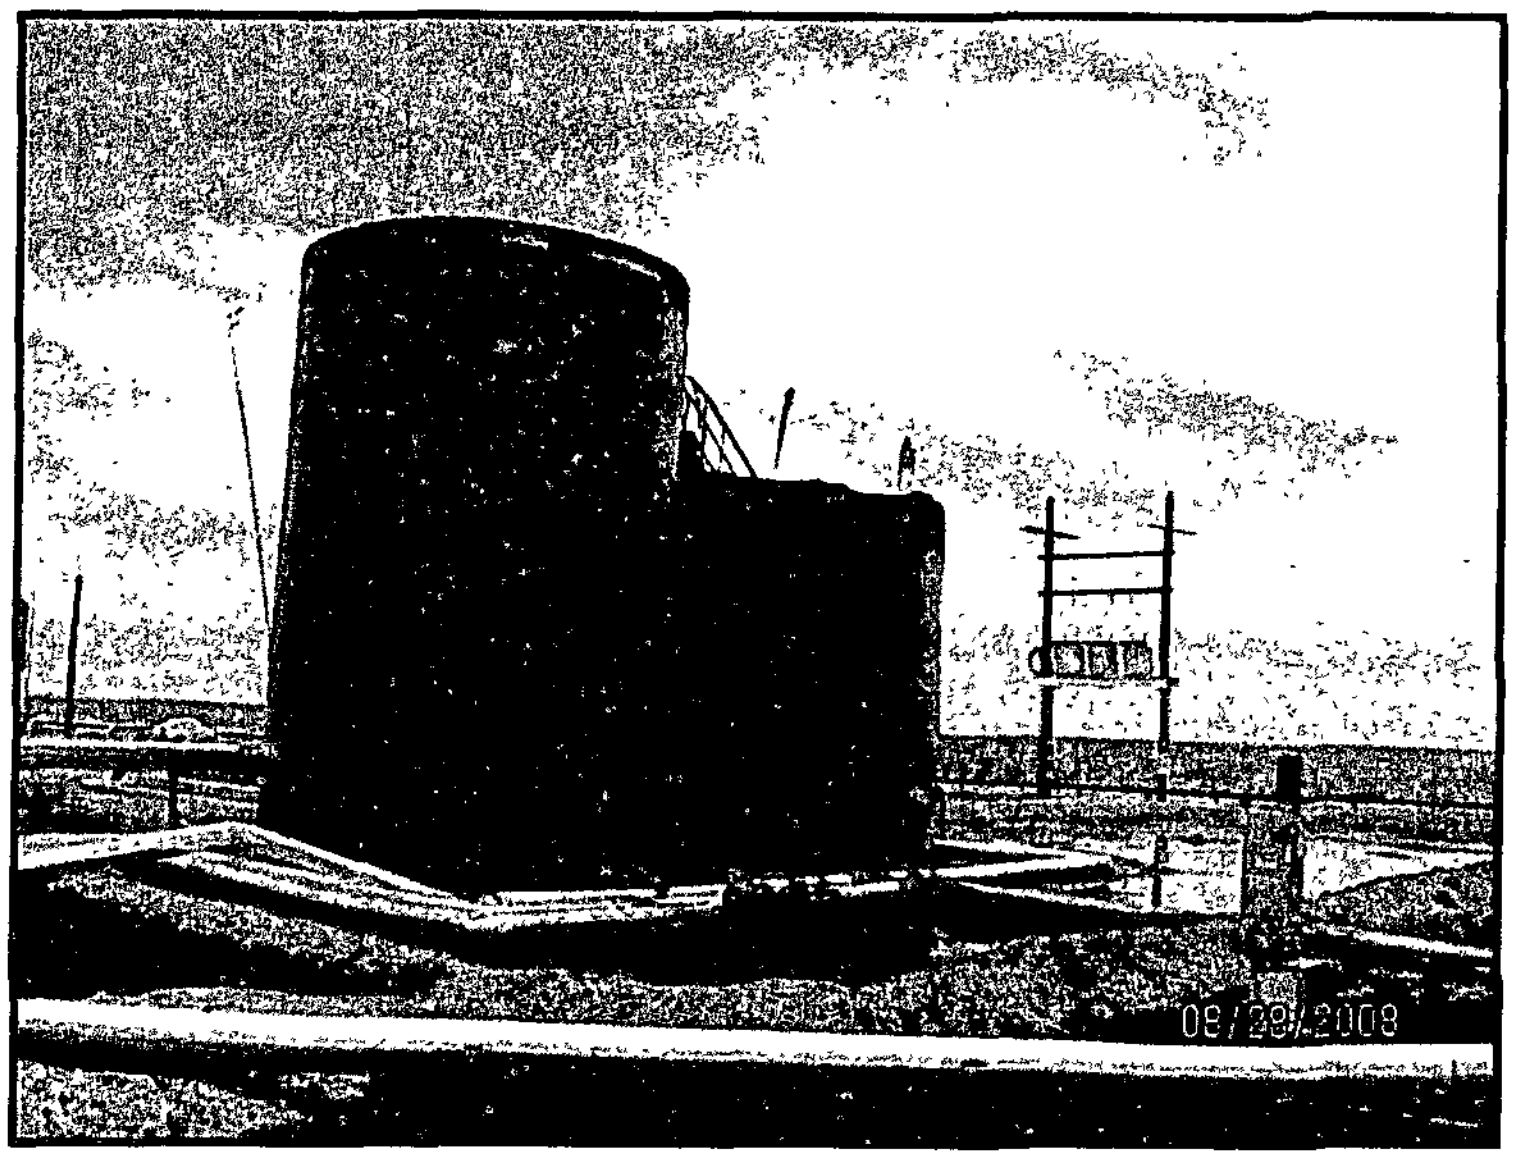
The second spill of produced water filled the containment located on the east side of the site. A breach of the east firewall occurred allowing some produced water to release along the east side of the containment and migrate northward. All fluids from the releases stayed within the confines of the tank battery pad. Photographs of this release event are provided in Photographs 7 & 8 presented on the following page:

Photograph 7: View from the southeast corner of the containment looking west northwest of the two tanks involved in the release.

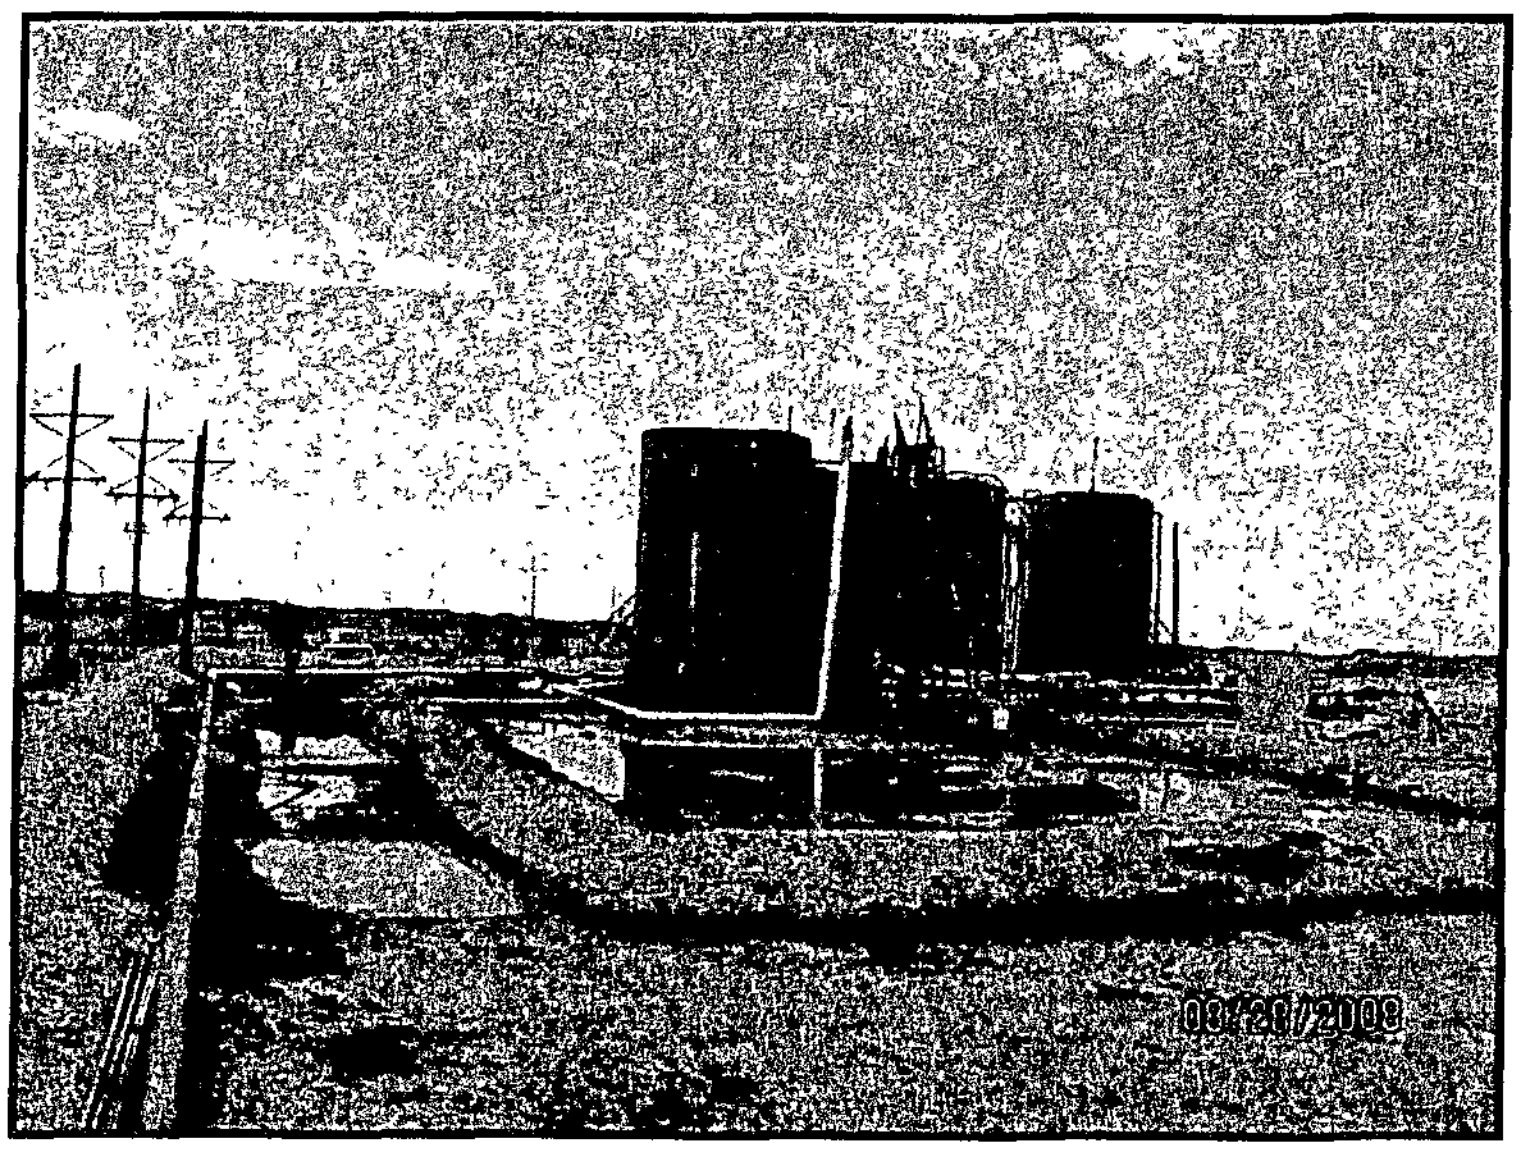
Photograph 8: View from the northeast corner looking south of the facility following the release.

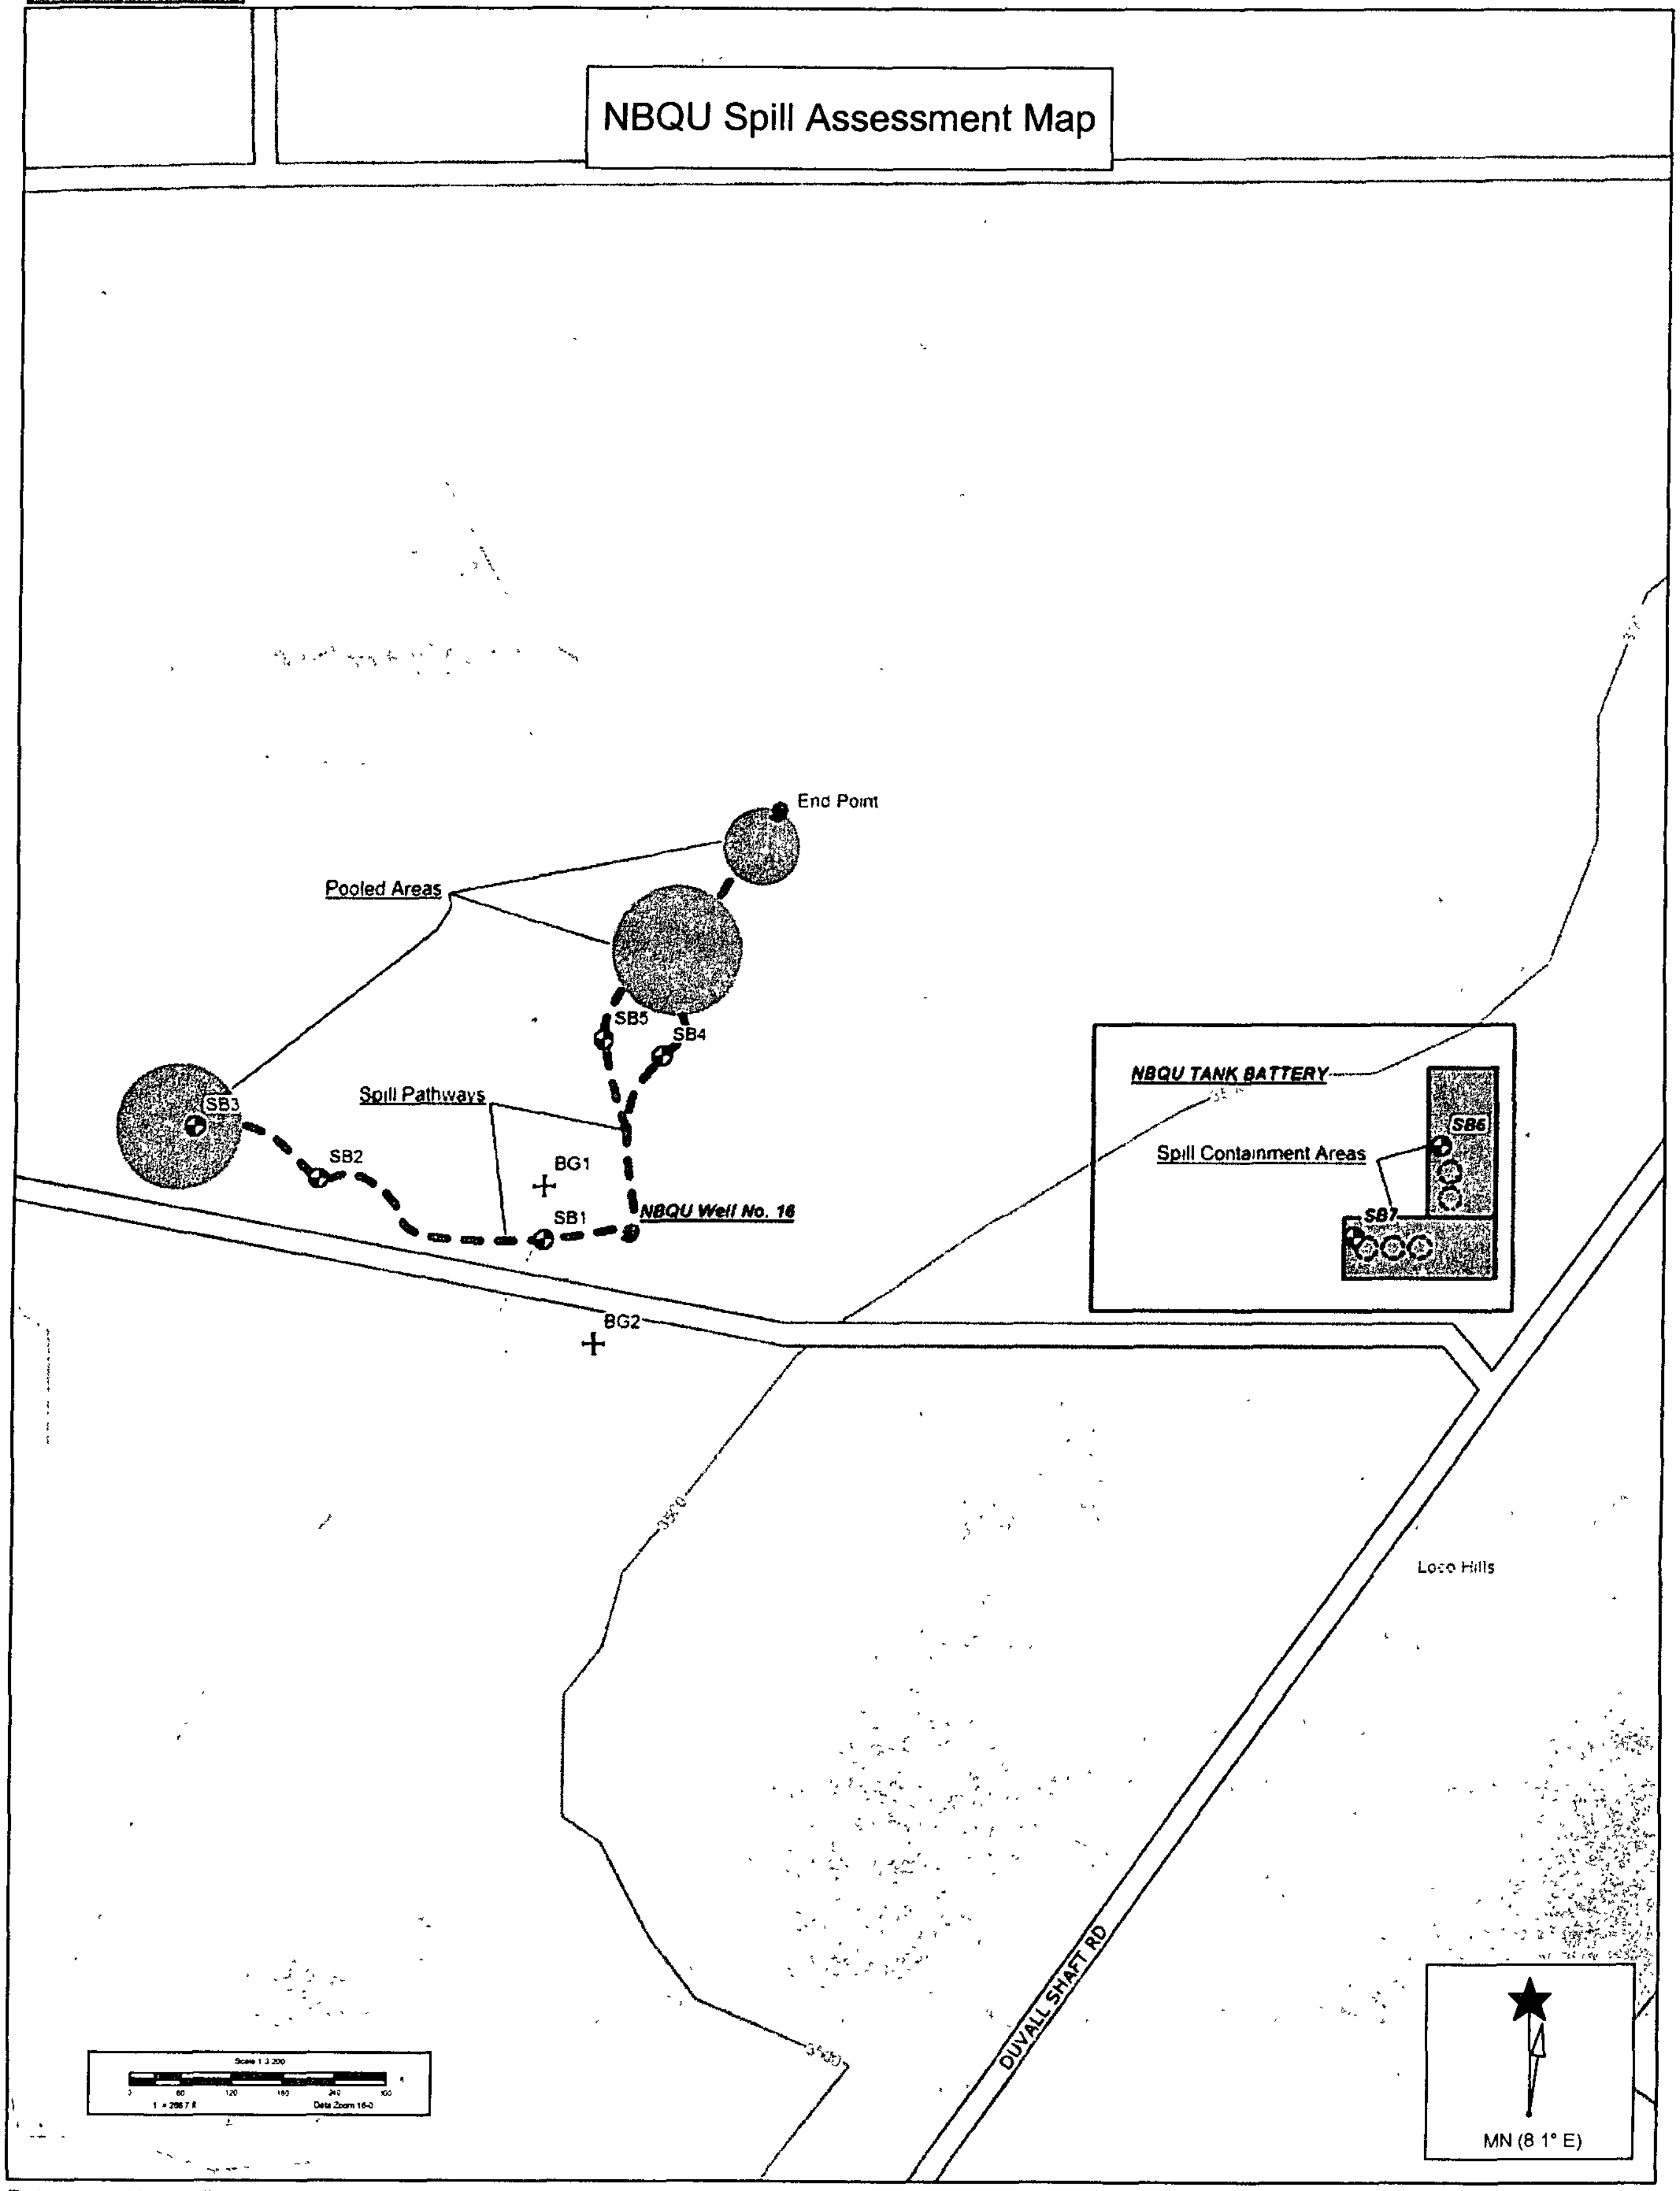
NBQU Spill Assessment Map
End Point
Pooled Areas
SB5
SB4
SB3
Spill Pathways
SB2
BG1
SB1
NBQU Well No. 16
NBQU TANK BATTERY
SB6
Spill Containment Areas
SB7
BG2
Loco Hills
DUVALL SHAFT RD
MN (8 1° E)
