XTO ENERGY INC.

ANNUAL GROUNDWATER REPORT

JACK FROST B #2
3RP-416
(D) SECTION 27 – T27N – R10W, NMPM
SAN JUAN COUNTY, NEW MEXICO

PREPARED FOR:
MR. GLENN VON GONTEN
NEW MEXICO OIL CONSERVATION DIVISION

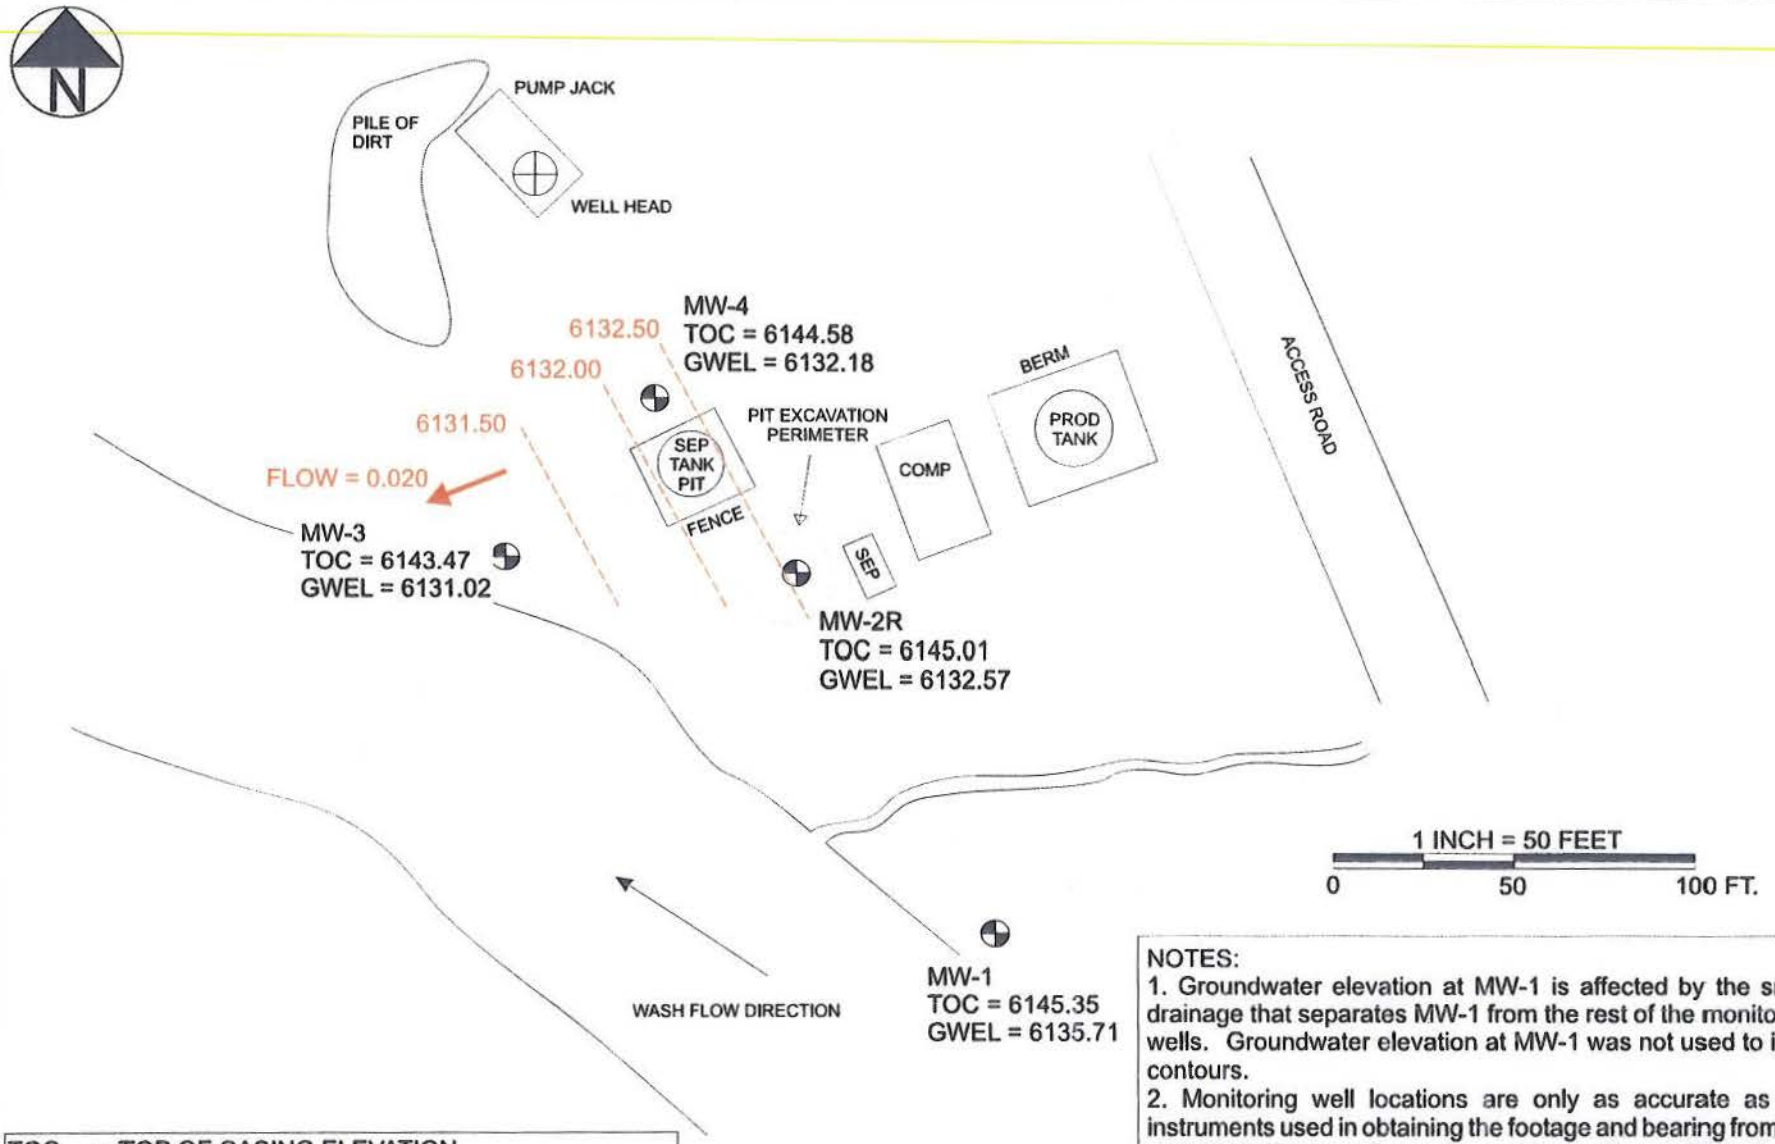
Lodestar Services, Inc PO Box 3861 Farmington, NM 87499	JACK FROST B #2 NW/4 NW/4 SEC. 27, T27N, R10W SAN JUAN COUNTY, NEW MEXICO	PROJECT: XTO GROUND WATER DRAWN BY: ALA REVISED: 06/30/08	GROUNDWATER GRADIENT MAP 06/03/2008

NOTES:
1. Groundwater elevation at MW-1 is affected by the small drainage that separates MW-1 from the rest of the monitoring wells. Groundwater elevation at MW-1 was not used to infer contours.
2. Monitoring well locations are only as accurate as the instruments used in obtaining the footage and bearing from the well head (Brunton Compass and Laser Range Finder). All other structures displayed on the site map are solely for reference and may not be to scale.

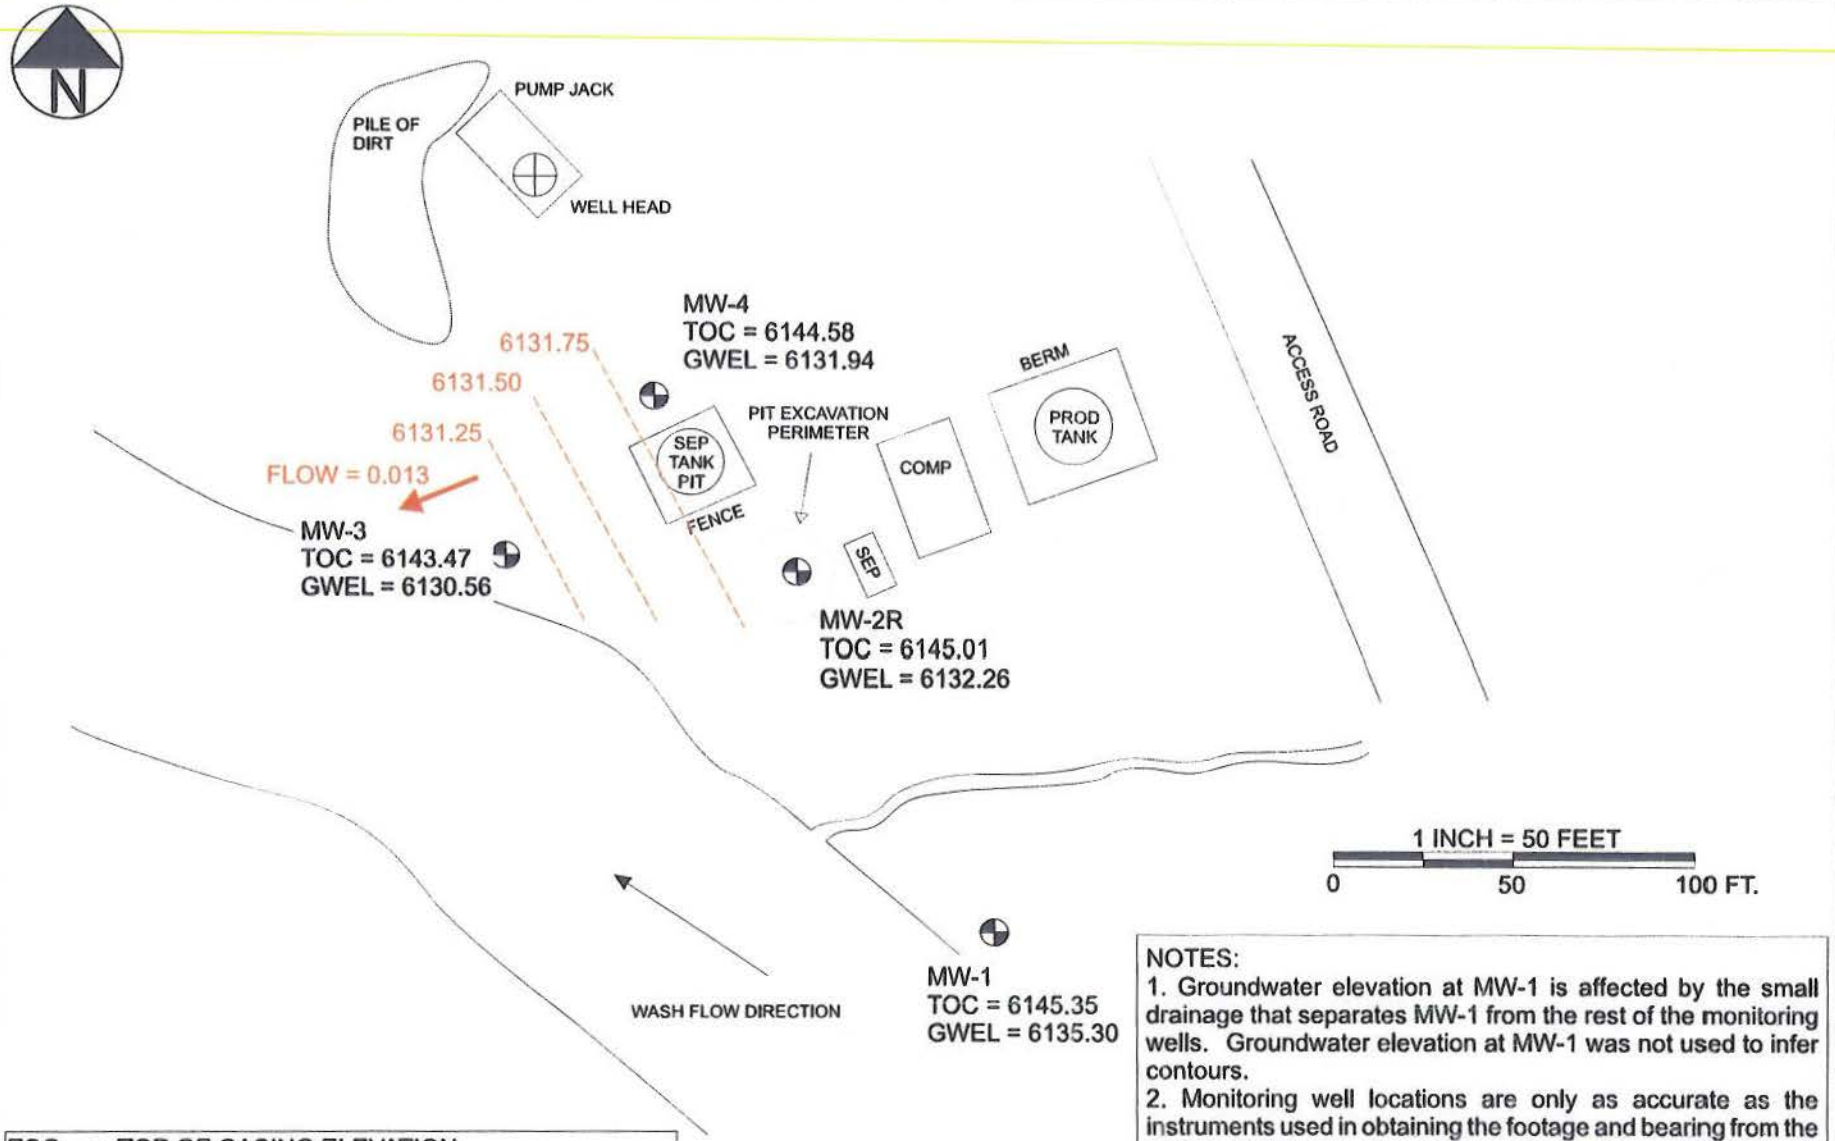
Lodestar Services, Inc PO Box 3861 Farmington, NM 87499	JACK FROST B #2 NW/4 NW/4 SEC. 27, T27N, R10W SAN JUAN COUNTY, NEW MEXICO	PROJECT: XTO GROUND WATER DRAWN BY: ADH REVISED: 09/30/08	GROUNDWATER GRADIENT MAP 09/22/2008

NOTES:
1. Groundwater elevation at MW-1 is affected by the small drainage that separates MW-1 from the rest of the monitoring wells. Groundwater elevation at MW-1 was not used to infer contours.
2. Monitoring well locations are only as accurate as the instruments used in obtaining the footage and bearing from the well head (Brunton Compass and Laser Range Finder). All other structures displayed on the site map are solely for reference and may not be to scale.

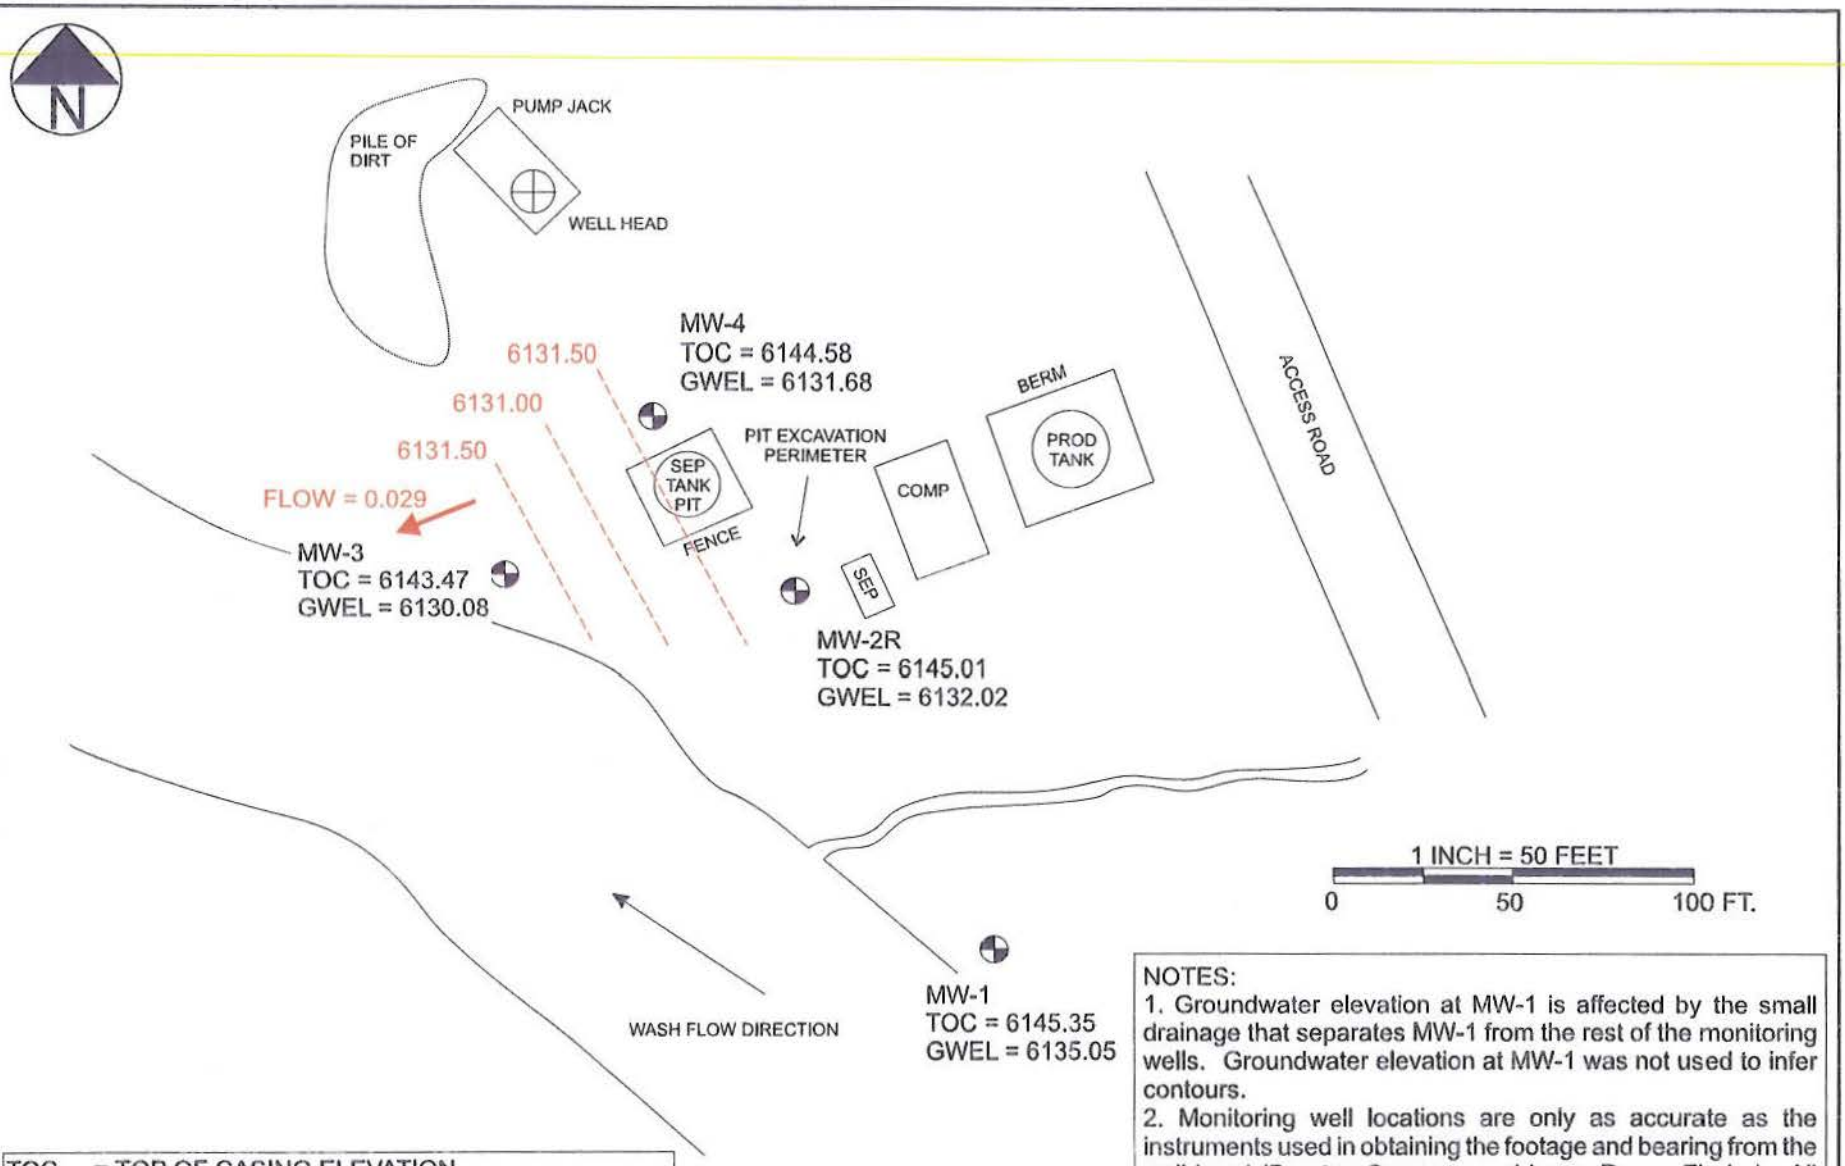
Lodestar Services, Inc PO Box 3861 Farmington, NM 87499	JACK FROST B #2 NW/4 NW/4 SEC. 27, T27N, R10W SAN JUAN COUNTY, NEW MEXICO	PROJECT: XTO GROUND WATER DRAWN BY: ADH REVISED: 12/22/2008	GROUNDWATER GRADIENT MAP 12/04/2008

NOTES:
1. Groundwater elevation at MW-1 is affected by the small drainage that separates MW-1 from the rest of the monitoring wells. Groundwater elevation at MW-1 was not used to infer contours.
2. Monitoring well locations are only as accurate as the instruments used in obtaining the footage and bearing from the well head (Brunton Compass and Laser Range Finder). All other structures displayed on the site map are solely for reference and may not be to scale.

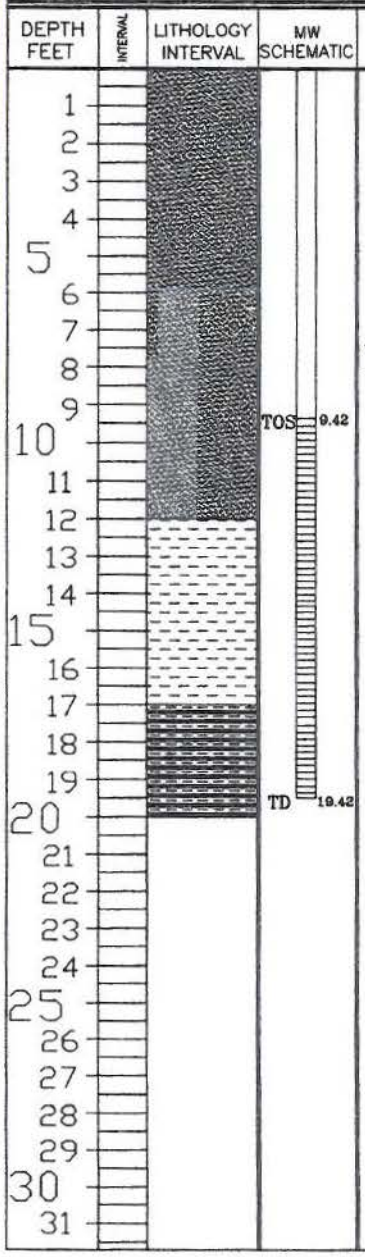
BORING # BH - 1
MW # 1
PAGE # 1
DATE STARTED 9/21/99
DATE FINISHED 9/21/99
OPERATOR REP
PREPARED BY NJV

MODERATE YELLOWISH SAND TO SILTY SAND, NON COHESIVE, SLIGHTLY MOIST, FIRM, NO APPARENT DISCOLORATION OBSERVED OR HYDROCARBON ODOR DETECTED PHYSICALLY (0.0 – 12.0 FT. INTERVAL).

▼ GW DEPTH ON 9/27/99 = 8.15 FT. (APPROX.) FROM GROUND SURFACE.

DARK YELLOWISH SILTY CLAY, COHESIVE, SLIGHTLY MOIST, FIRM TO STIFF, NO APPARENT DISCOLORATION OBSERVED OR HYDROCARBON ODOR DETECTED PHYSICALLY (12.0 – 17.0 FT. INTERVAL).

OLIVE GRAY CLAY, PLASTIC TO HIGHLY PLASTIC, SLIGHTLY MOIST TO SLIGHTLY SATURATED, STIFF TO VERY STIFF, NO APPARENT DISCOLORATION OBSERVED OR HYDROCARBON ODOR DETECTED PHYSICALLY (17.0 – 20.0 FT. INTERVAL).

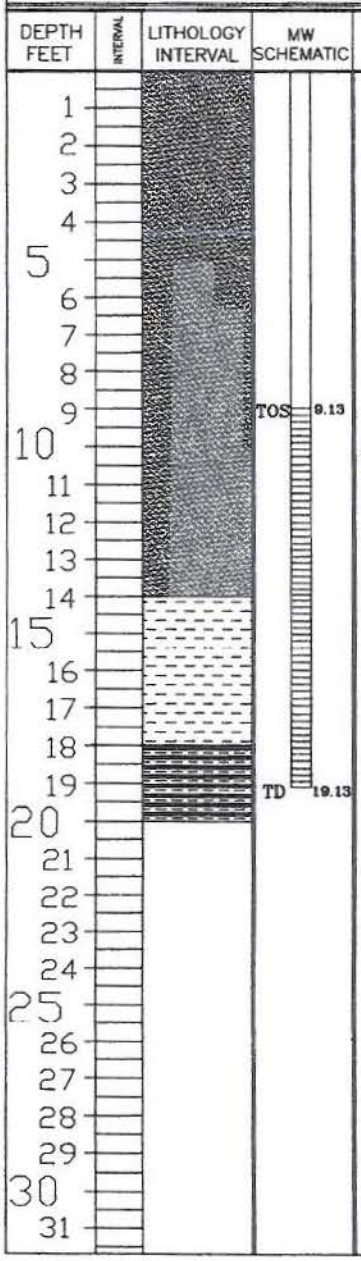
BORING # ..... BH - 2
MW # 2
PAGE # 2
DATE STARTED 9/21/99
DATE FINISHED 9/21/99
OPERATOR ..... REP
PREPARED BY NJV

MODERATE YELLOWISH SAND, NON COHESIVE, SLIGHTLY MOIST, FIRM, NO APPARENT DISCOLORATION OBSERVED OR HYDROCARBON ODOR DETECTED PHYSICALLY (0.0 – 14.0 FT. INTERVAL).

▼ GW DEPTH ON 9/27/99 = 10.84 FT. (APPROX.) FROM GROUND SURFACE.

MEDIUM TO DARK GRAY SILTY SAND, NON COHESIVE, SLIGHTLY MOIST, FIRM TO LOOSE, NO APPARENT DISCOLORATION OBSERVED OR HYDROCARBON ODOR DETECTED PHYSICALLY (14.0 – 18.0 FT. INTERVAL).

LIGHT TO MEDIUM GRAY SILTY CLAY TO CLAY, PLASTIC TO HIGHLY PLASTIC, SLIGHTLY MOIST TO SLIGHTLY SATURATED, STIFF TO VERY STIFF, NO APPARENT DISCOLORATION OBSERVED OR HYDROCARBON ODOR DETECTED PHYSICALLY (18.0 – 20.0 FT. INTERVAL).

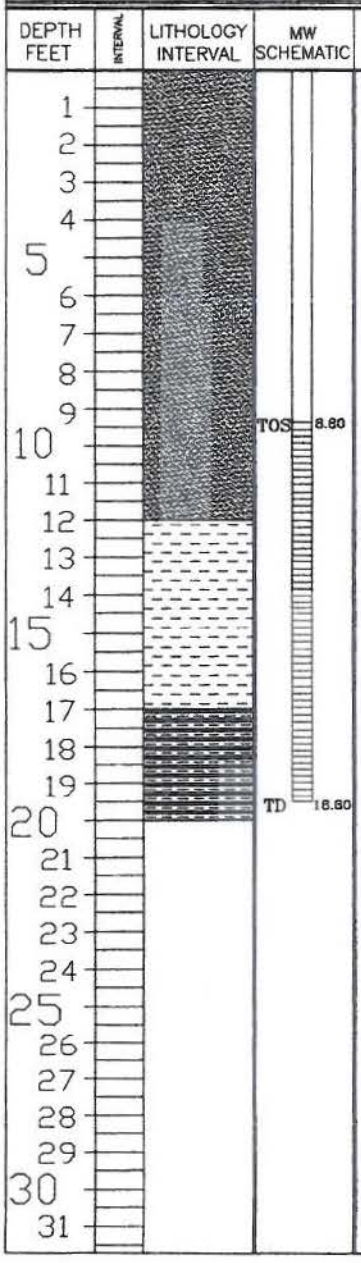
BORING # BH - 3
MW # 3
PAGE # 3
DATE STARTED 9/21/99
DATE FINISHED 9/21/99
OPERATOR REP
PREPARED BY NJV

MODERATE YELLOWISH SAND TO SILTY SAND, NON COHESIVE, SLIGHTLY MOIST, FIRM, NO APPARENT DISCOLORATION OBSERVED OR HYDROCARBON ODOR DETECTED PHYSICALLY (0.0 – 12.0 FT. INTERVAL).

▼ GW DEPTH ON 9/27/99 = 12.56 FT. (APPROX.) FROM GROUND SURFACE.

DARK YELLOWISH SILTY CLAY, COHESIVE, SLIGHTLY MOIST, FIRM TO STIFF, NO APPARENT DISCOLORATION OBSERVED OR HYDROCARBON ODOR DETECTED PHYSICALLY (12.0 – 17.0 FT. INTERVAL).

OLIVE GRAY CLAY, PLASTIC TO HIGHLY PLASTIC, SLIGHTLY MOIST TO SLIGHTLY SATURATED, STIFF TO VERY STIFF, NO APPARENT DISCOLORATION OBSERVED OR HYDROCARBON ODOR DETECTED PHYSICALLY (17.0 – 20.0 FT. INTERVAL).

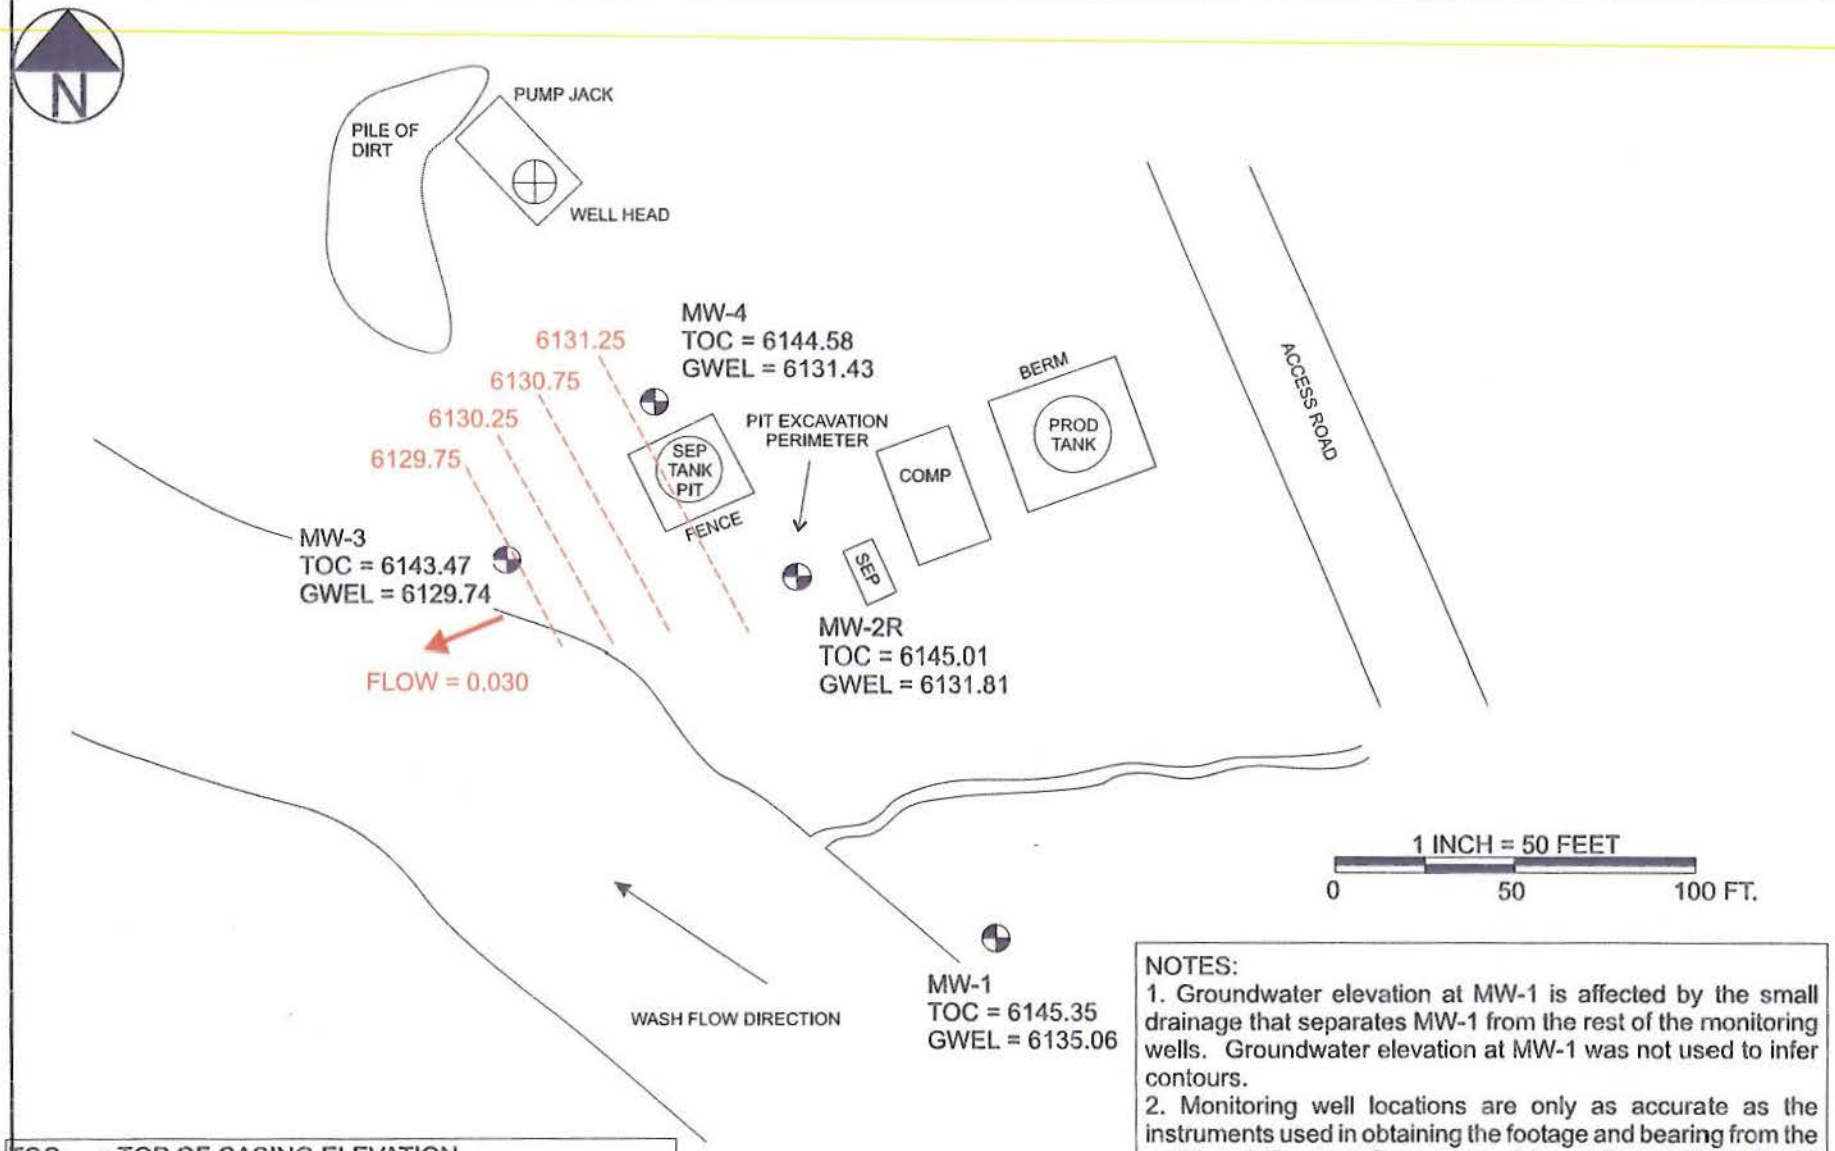
Lodestar Services, Inc PO Box 3861 Farmington, NM 87499	JACK FROST B #2 NW/4 NW/4 SEC. 27, T27N, R10W SAN JUAN COUNTY, NEW MEXICO	PROJECT: XTO GROUND WATER DRAWN BY: ADH REVISED: 04 Mar 09	GROUNDWATER GRADIENT MAP 02 Mar 09

Field data collected during site monitoring activities indicate a groundwater gradient that trends towards the west with a slight southwest component, following surface contours and the general flow of the arroyo. Figures 3-6 illustrate the estimated groundwater gradients for 2008 and 2009.

NOTES:
1. Groundwater elevation at MW-1 is affected by the small drainage that separates MW-1 from the rest of the monitoring wells. Groundwater elevation at MW-1 was not used to infer contours.
2. Monitoring well locations are only as accurate as the instruments used in obtaining the footage and bearing from the well head (Brunton Compass and Laser Range Finder). All other structures displayed on the site map are solely for reference and may not be to scale.
