Re: Site 3R-424 Quarterly Report for Heath Gas Com G1 Remediation Site

To:	Mr. Steven Moskal BP America Production, Farmington, NM
From:	Mr. John Pietz, P.E.
cc:	Mr. Jeff Blagg, Blagg Engineering, Inc.
Date:	November 9, 2017
Re:	Second Quarter Report, April – June 2016, Heath GC G#1 Well Site San Juan County, New Mexico

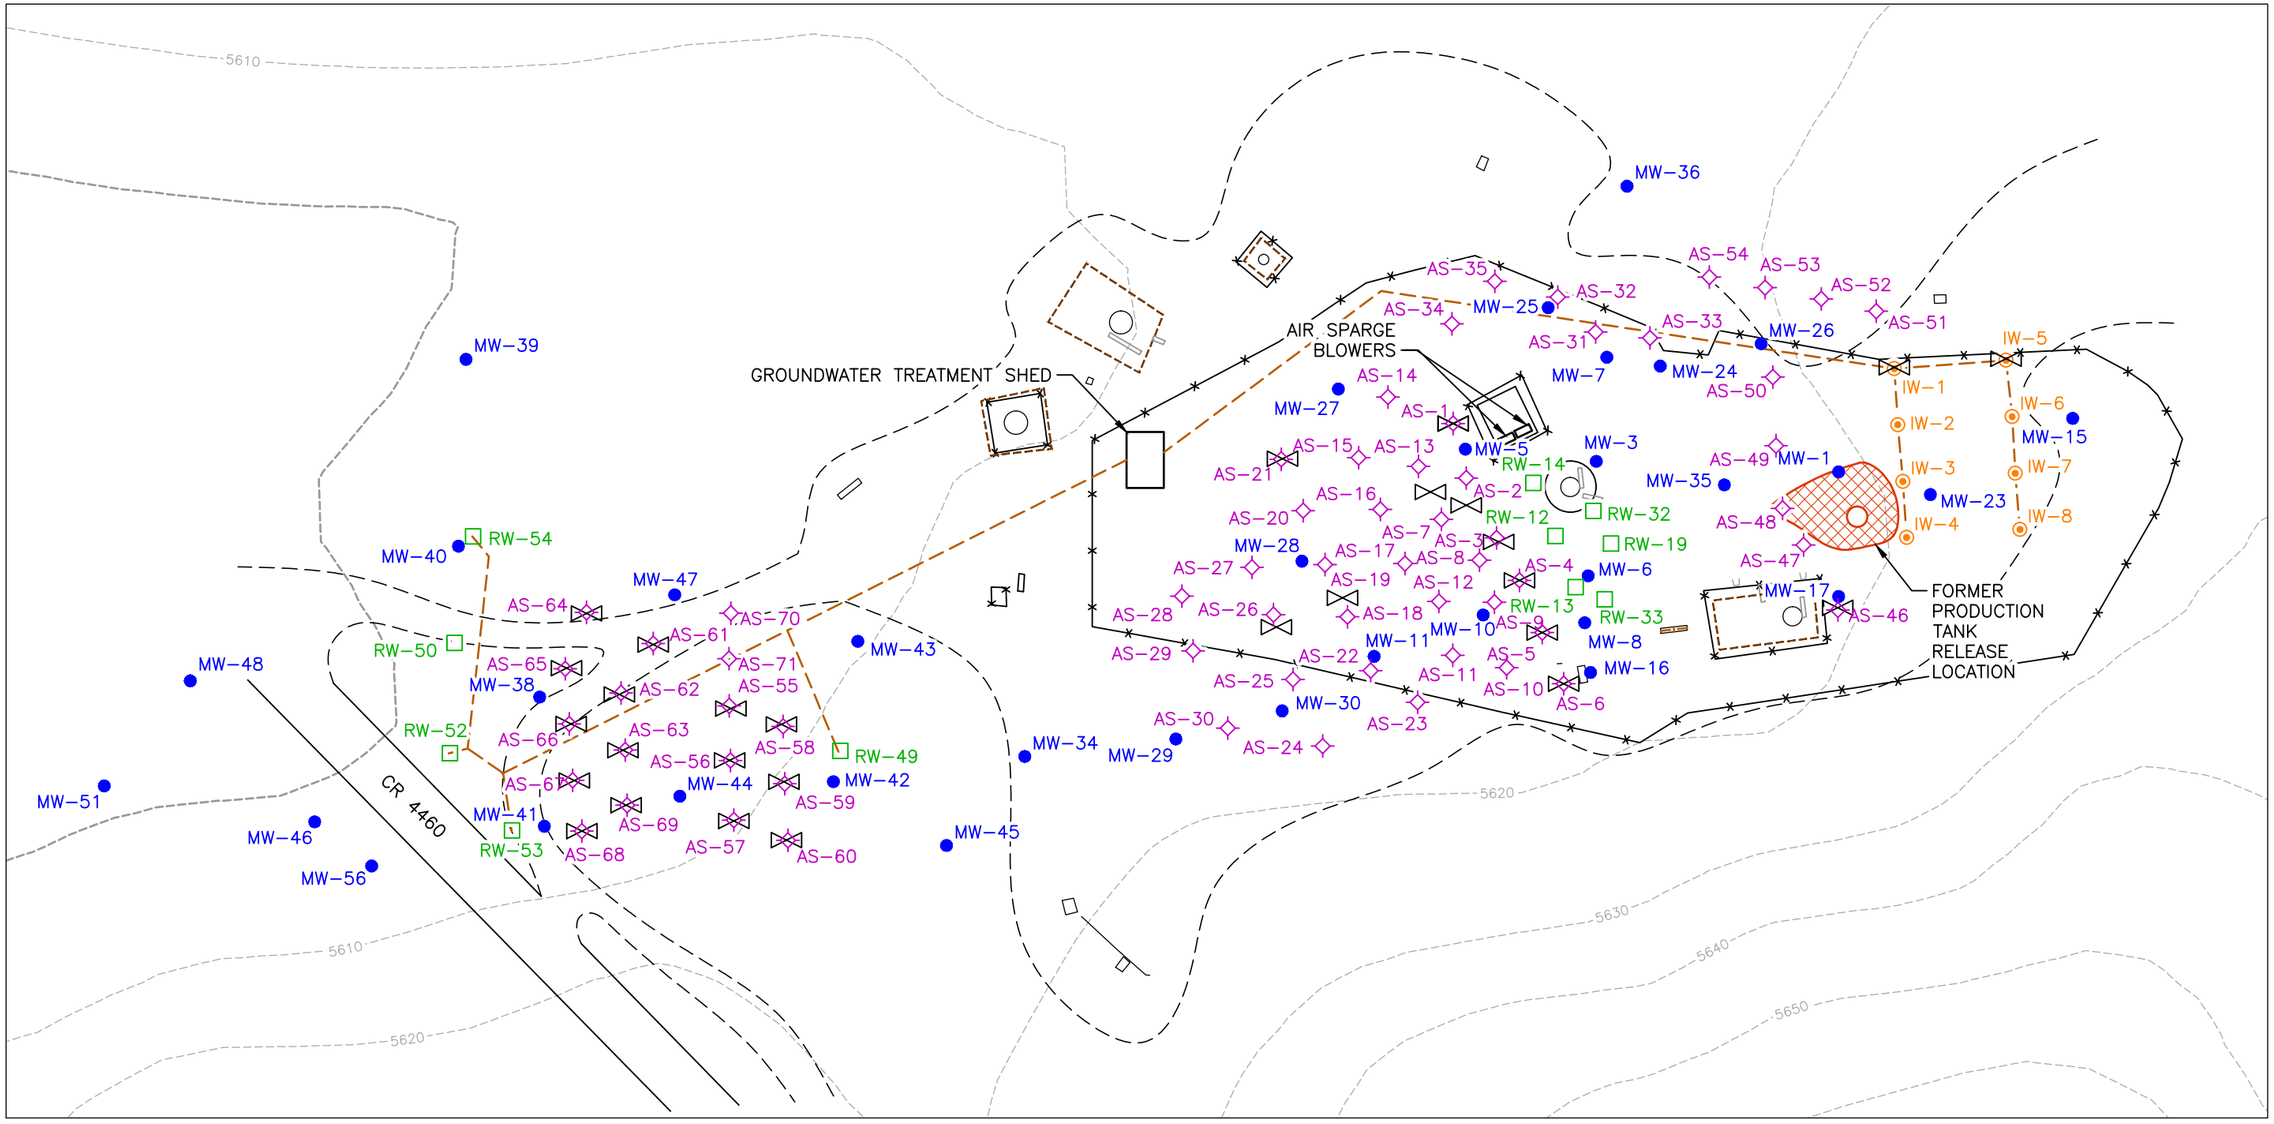
The air sparge system was installed in several phases, and started operation in March 2010. The current air sparge system is shown in Figure 2. The system consists of three areas with 69 wells: the central area consisting of 30 wells (AS-1 through AS-30), the west area consisting of 15 wells (AS-55 through AS-69), and the northeast area consisting of 24 wells (AS-31 through AS-54). The central and northeast area systems were installed in February - August 2010. The western area system was installed in June and July 2010 in response to elevated BTEX concentrations down-gradient of well MW-30, and detections of BTEX in down-gradient wells MW-41 through MW-44.

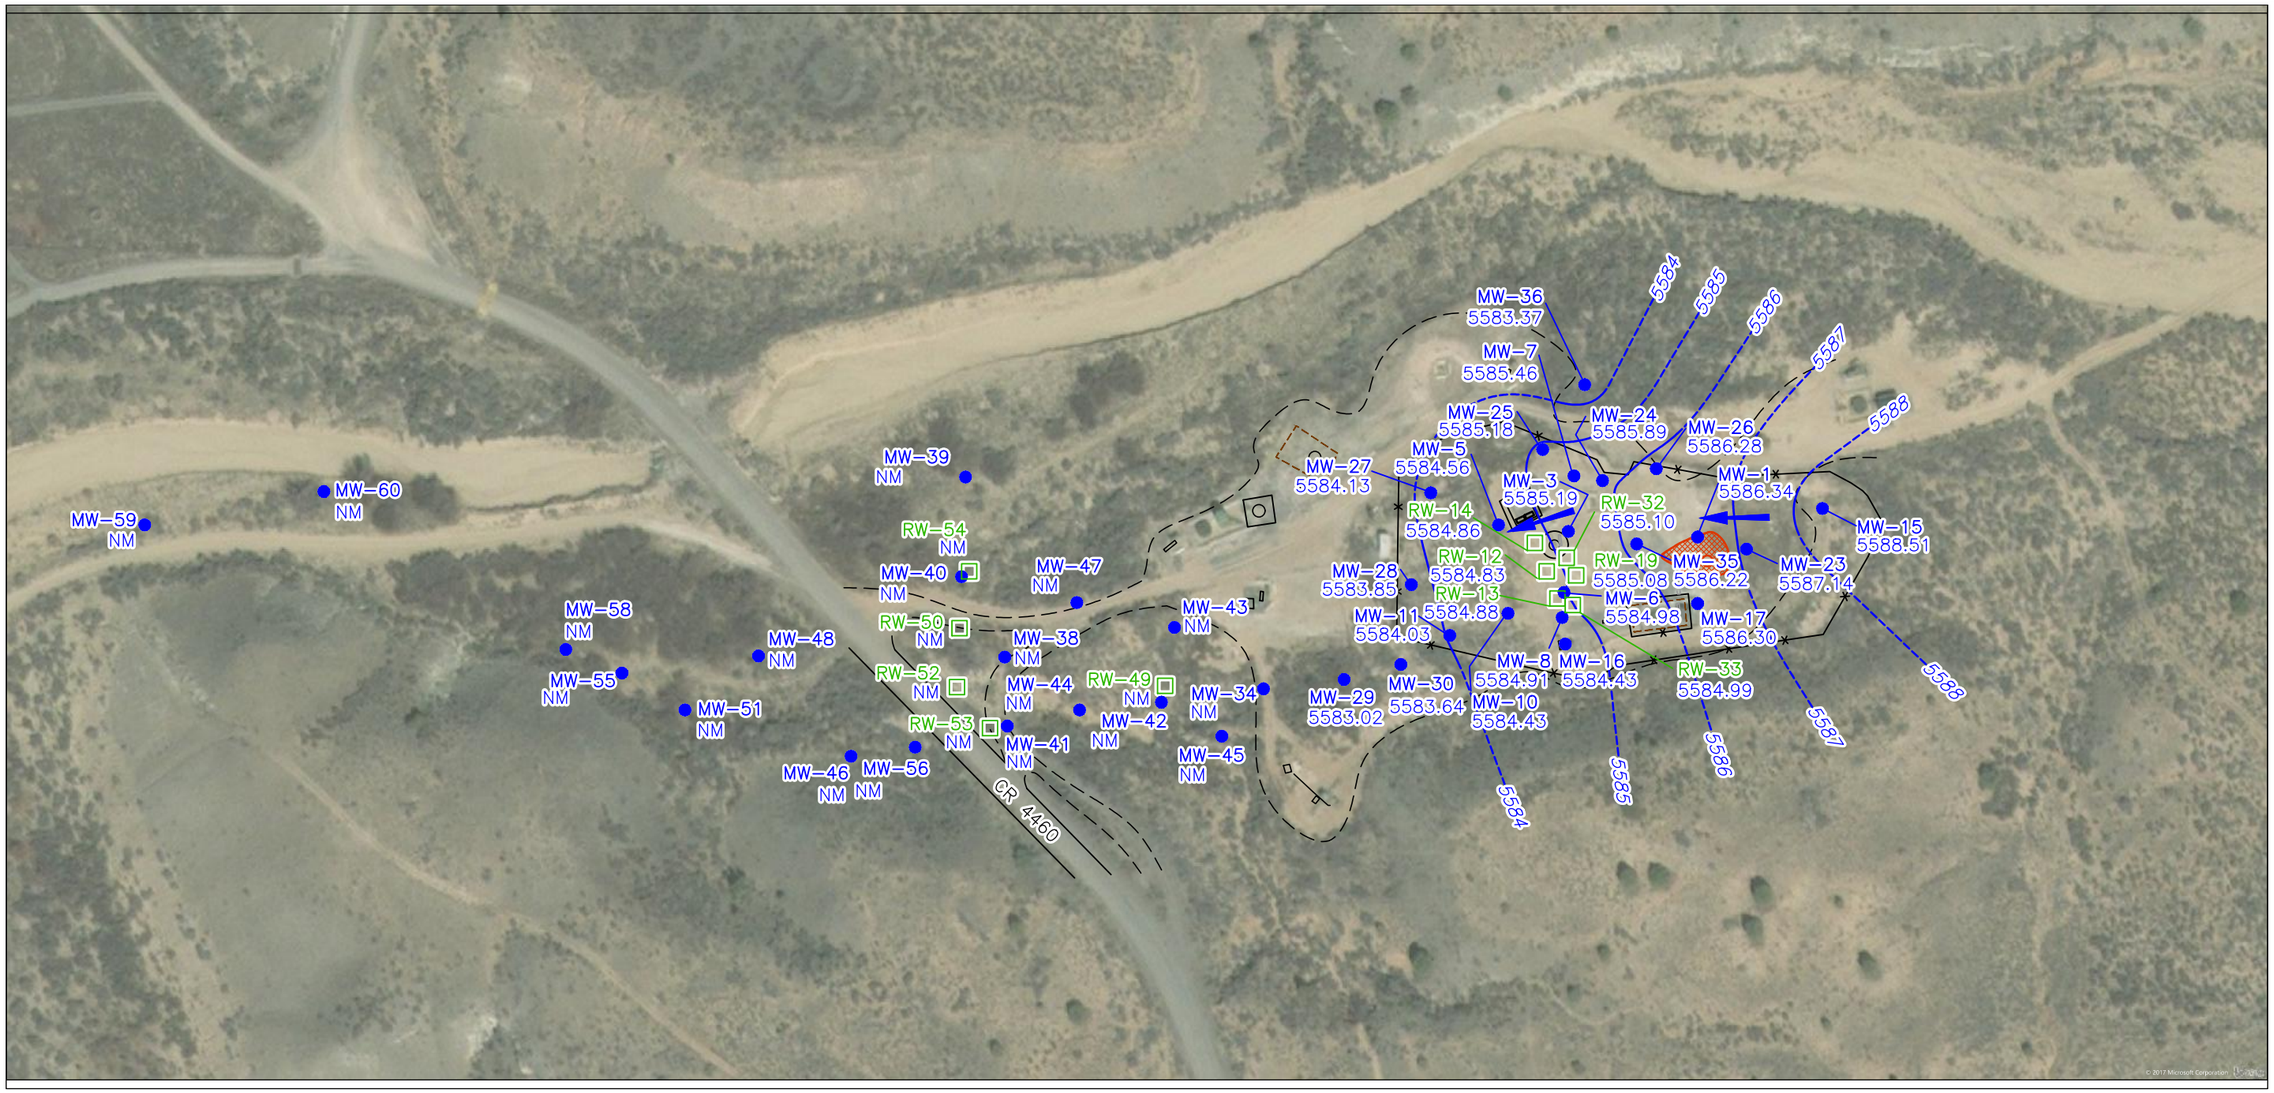
The potentiometric surface contours for the June 2, 2016 data are shown on Figure 3. Groundwater generally appears to flow east to west at an average gradient of approximately 0.009 ft/ft between the release area and the down-gradient edge of the site at County Road 4460 (CR 4460), which is consistent with previous results. Hydrographs for four site monitoring wells (MW-1, MW-7, MW-17, and MW-34), located on the east and central areas of the site, are shown on Figure 4.

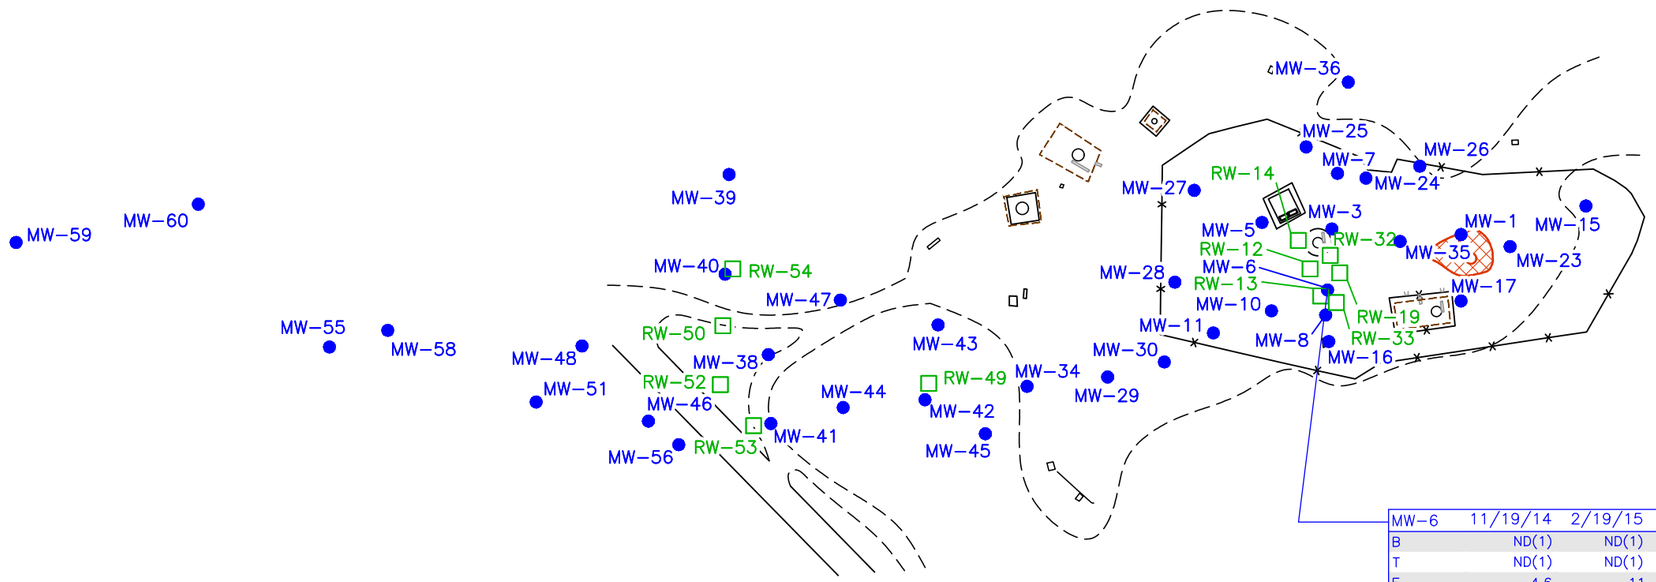
MW-6	11/19/14	2/19/15	5/13/15	8/28/15	11/30/15	6/2/16
B	ND(1)	ND(1)	ND(1)	ND(1)	ND(1)	ND(1)
T	ND(1)	ND(1)	ND(1)	ND(1)	ND(1)	ND(1)
E	4.6	11	1.8	ND(1)	ND(1)	ND(1)
X	ND(2)	7.9	ND(2)	ND(2)	ND(2)	ND(2)

The analytical results for BTEX for the current and past sampling events are presented in Table 3. Figure 5 provides a summary map of the June 2016 quarterly results for site monitoring wells. The tables

Several observations can be drawn from the June 2016 results for MW-6, as follows:

- Benzene was not detected above the NMWQCC standard of 10 micrograms per liter (ug/L).
- Toluene was not detected above the NMWQCC standard of 750 ug/L.
- Ethylbenzene was not detected above the NMWQCC standard of 750 ug/L.
- Xylene was not detected above the NMWQCC standard of 620 ug/L.
- This well has now completed 8 consecutive quarters of compliance with the above standards.

In consultation with BP, the following recommendations have been identified to optimize site remediation:

- Terminate operation of the air sparge system
- Prepare the final quarterly reports and prepare a site closure report, given that the required eight consecutive quarters of compliance with BTEX groundwater standards in all monitoring wells.

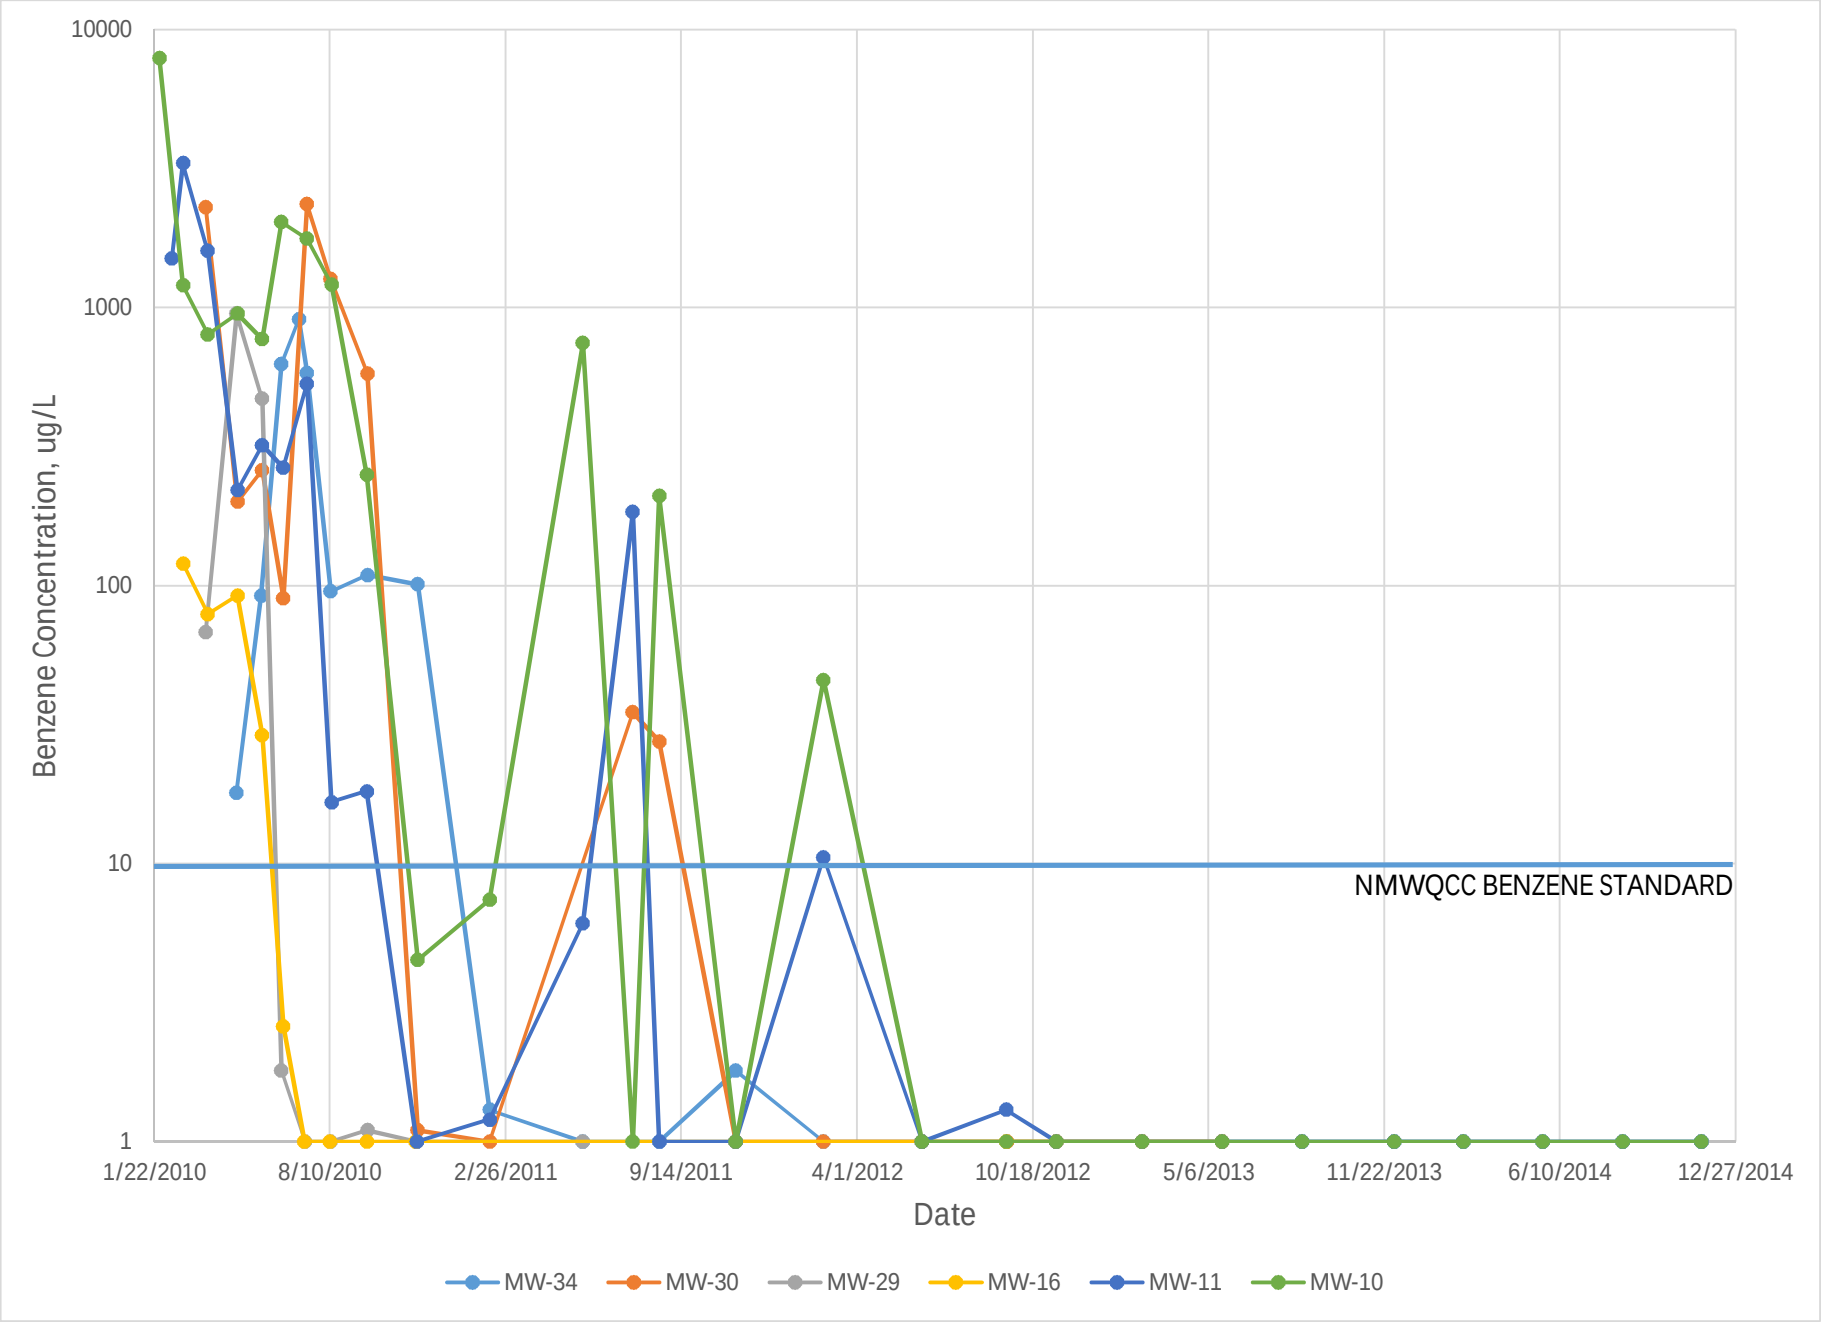
Figure 6 Benzene Concentration Trends Central Wells

Performance of the air sparge system is tracked and evaluated through the groundwater monitoring program described above. This system has been effective in reducing BTEX concentrations in numerous site monitoring wells (see Figures 6, 7 and 8). In addition to the volatilization of BTEX associated with sparging, contaminant mass loss may also be attributable to natural attenuation process such as aerobic biodegradation, advection, dispersion, and dilution.
