RCRA FACILITY INVESTIGATION
PHASE II REPORT
NORTH COLONY LANDFARM
NAVAJO REFINERY
ARTESIA, NEW MEXICO

February 1996

RCRA FACILITY INVESTIGATION
NORTH COLONY LANDFARM
NAVAJO REFINERY
ARTESIA, NEW MEXICO

Re: Submittal of North Colony Landfarm RFI Phase II Report

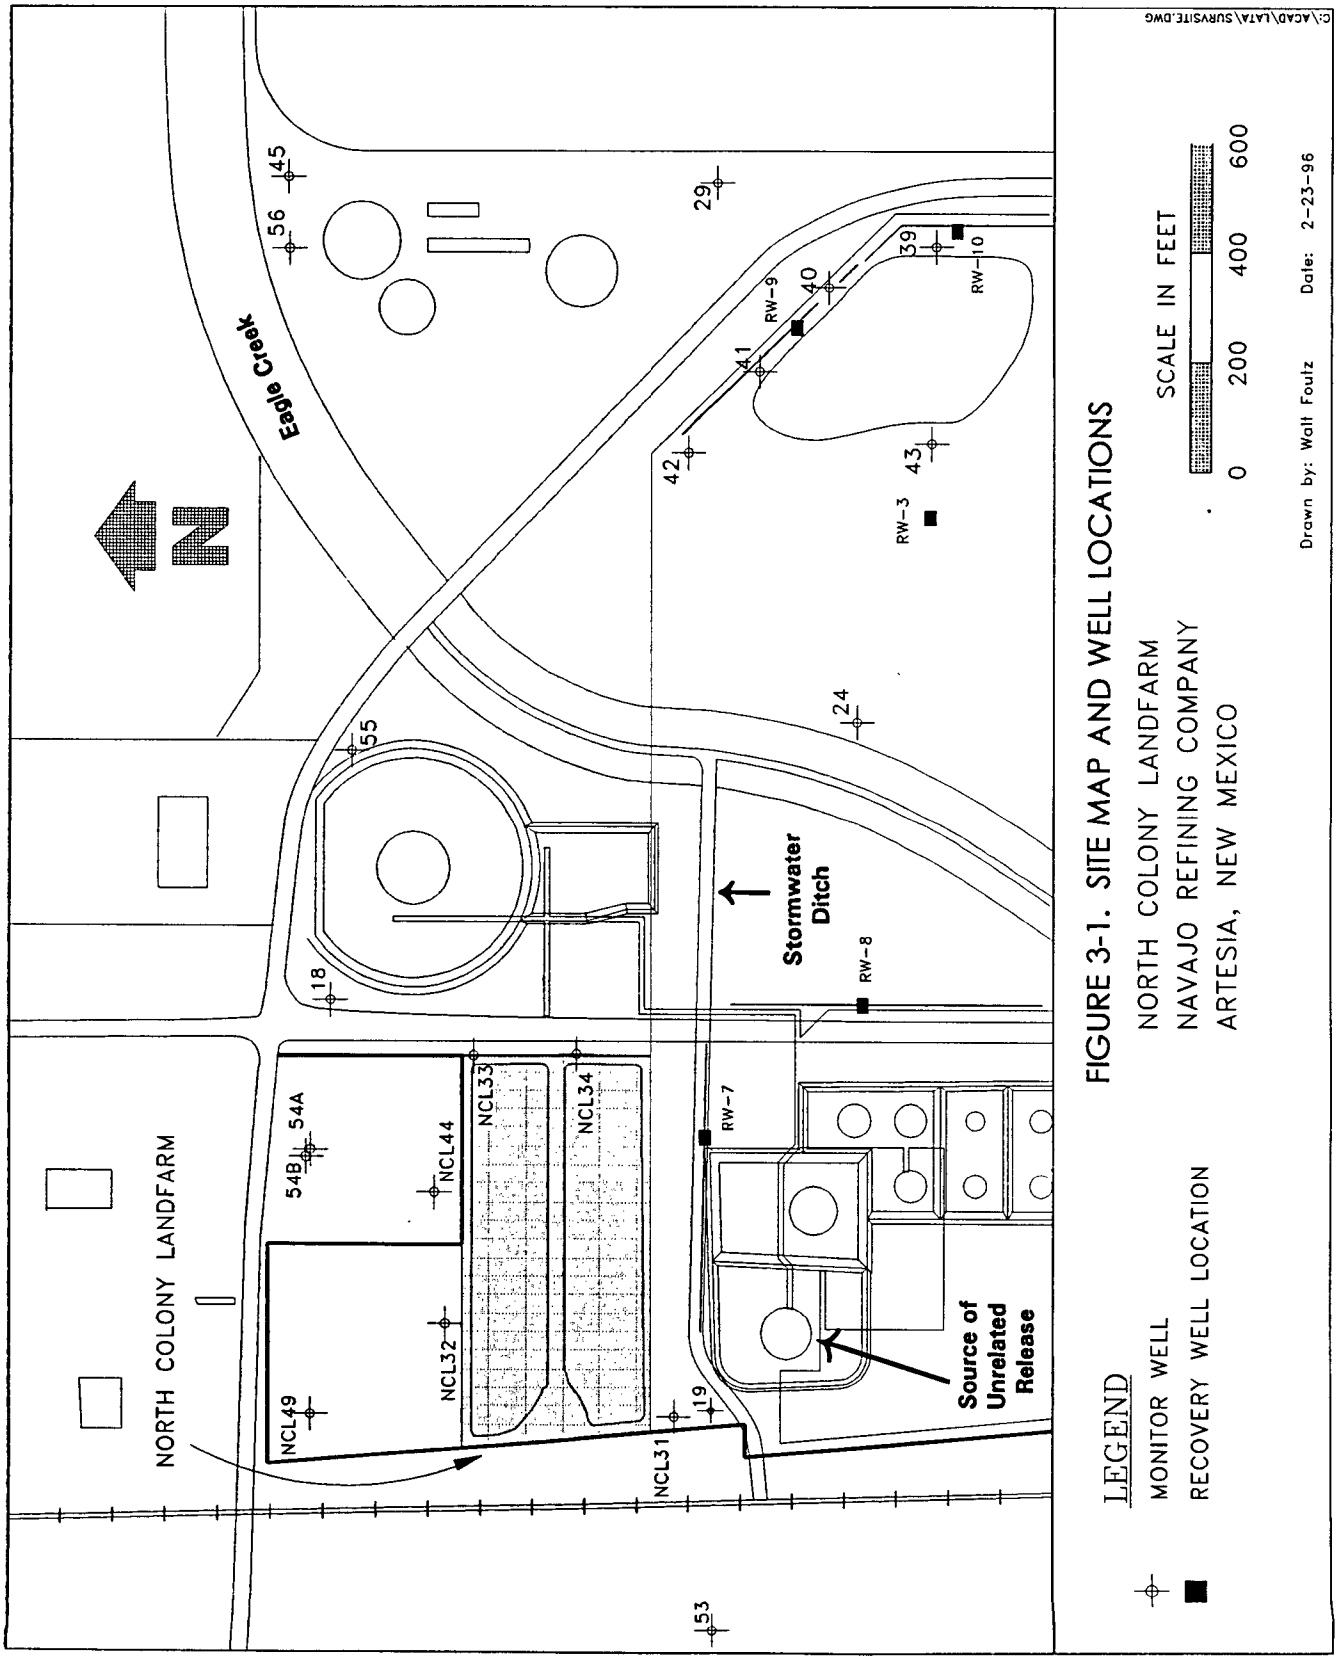
FIGURE 3-1. SITE MAP AND WELL LOCATIONS
NORTH COLONY LANDFARM
NAVAJO REFINING COMPANY
ARTESIA, NEW MEXICO

A minor stormwater conveyance which receives runoff from city streets west of the refinery passes immediately to the south of the NCL before it empties into Eagle Creek (Figure 3-1). Groundwater observations obtained during the performance of the RFI Phase I suggested that fluctuations in hydraulic potential and direction of flow in the NSSZ in the vicinity of the NCL may be significantly influenced by this surface drainage feature.

At the time of the NCL RFI Phase I study, a deep geotechnical boring was completed to a total depth of 100 feet at a location immediately north of the NCL (Figure 3-1). The deep boring profile revealed caliche gravel seams distributed from about 14 to 38 feet, with the first saturated gravel seam being encountered at 21 feet. The NSSZ in this area was primarily underlain by at least 60 feet of dry, hard clays (RFI Phase I report, Appendix D). The RFI Phase I deep boring profile was consistent with borehole logs for two geotechnical borings which were completed south of the NCL in preparation for unrelated facility construction activities (Figure 7-2, RFI Phase I report).

Five new groundwater monitoring wells (MW-53, 54A, 54B, 55, and 56) were installed during the RFI Phase II. MW-53 was installed as an upgradient well, and the remaining wells were located so as to be immediately downgradient of the hydrocarbon product plume. The new well locations are included on Figure 3-1, together with locations of several pre-existing groundwater monitoring wells associated with the refinery's groundwater monitoring network. The new monitoring wells were installed according to the methods and procedures delineated in the February 1995 RFI Phase II workplan. Details of monitoring installation and construction are shown in Appendix A.

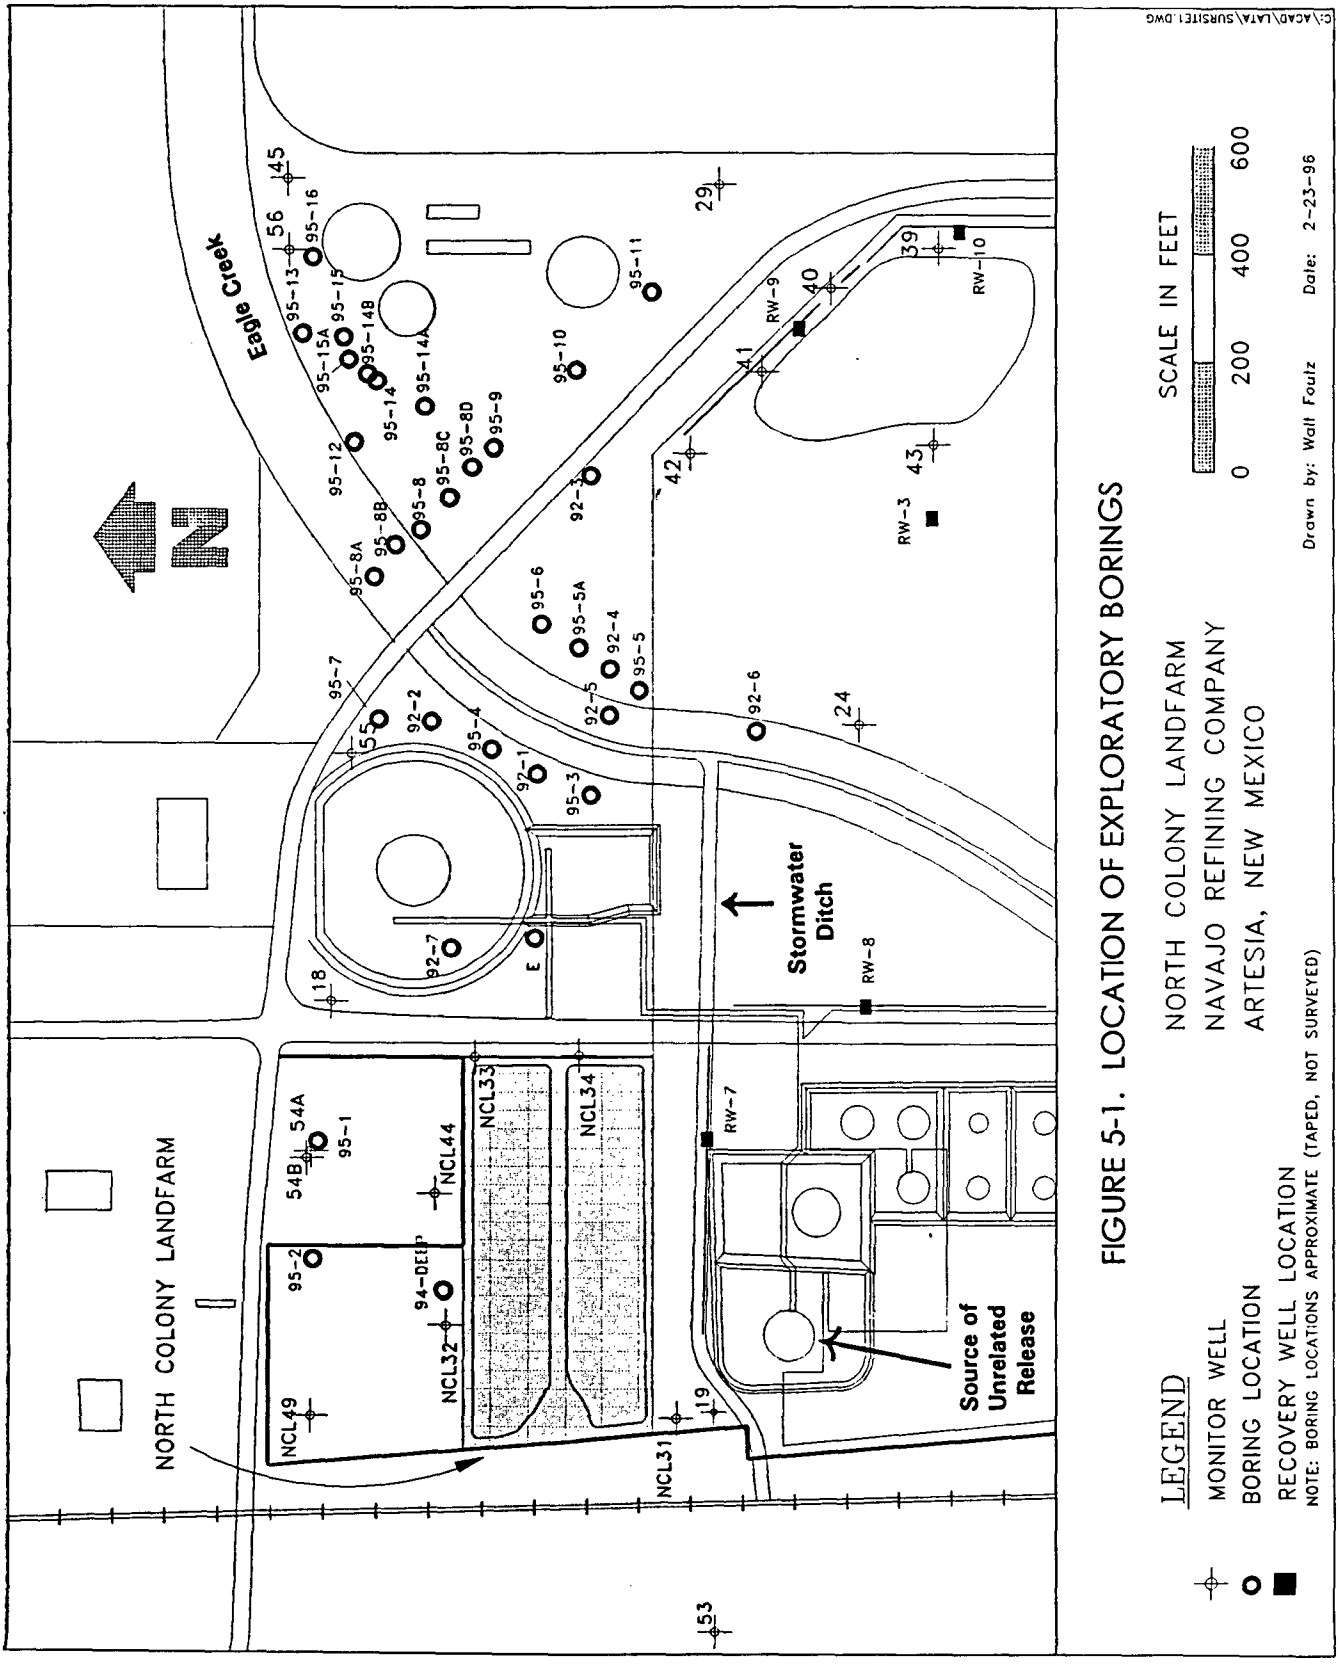
FIGURE 5-1. LOCATION OF EXPLORATORY BORINGS
NORTH COLONY LANDFARM
NAVAJO REFINING COMPANY
ARTESIA, NEW MEXICO

Descriptive logs for the RFI Phase II borings are presented in Appendix A. Also presented in the appendix are logs for additional boring locations shown in Figure 5-1 which were completed prior to the execution of the RFI Phase II study. These include seven borings completed by NRC in the study area in August 1992 and the log of the deep boring located adjacent to NCL-32 that was completed in 1994 as part of the NCL Phase I investigation. Logs of two deep geotechnical borings cored prior to construction of new refinery processing unit are included also.

The Phase II soil borings demonstrate that the NSSZ is a highly variable network of interconnected, but sporadically distributed saturated zones. This fact is perhaps most clearly demonstrated by observations made at Phase II boring locations NCL 95-14 and 14B (Appendix A, Figure 5-1, and Table 6-1), which were separated by a distance of about 4 feet. Despite their near proximity, the borings were strikingly dissimilar in terms of the occurrence of hydrocarbons. Specifically, NCL 95-14 yielded no evidence of free-phase hydrocarbon product whereas NCL 95-14B yielded free-phase product.

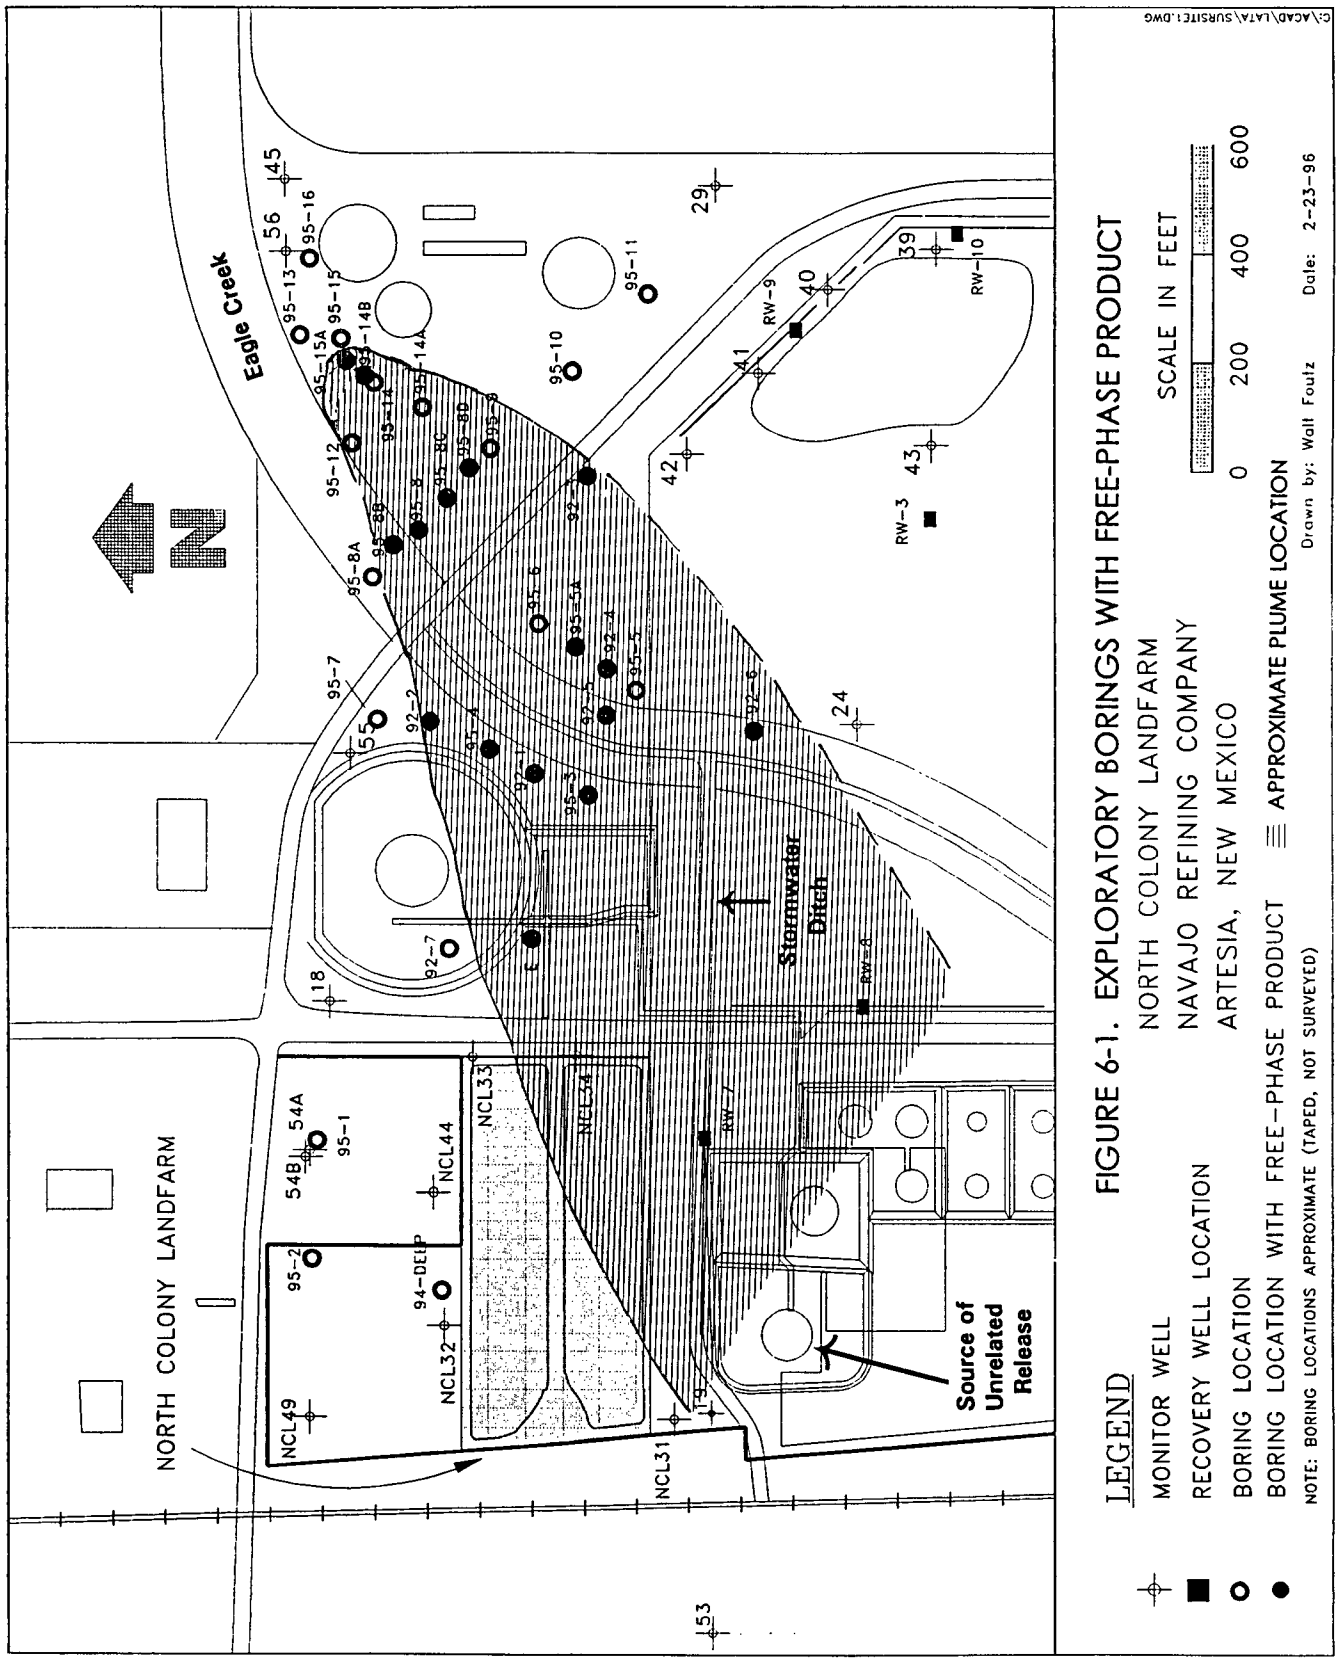
Moisture was generally encountered at depths from 12 to 18 feet, although exact depths were difficult to ascertain in the core samples unless a coarse-grained zone was encountered. Where coarser zones were not encountered, softness in an otherwise dry clay sample generally provided an indication of moisture. The moisture was likely released to the cored hole from thin, slightly silty zones in the clays that were not visually observed in the splitspoon cores. Commonly, zones located within a few inches above or below the moist zones were completely free of moisture and logged as dry and crumbly.

Coarse grained material of one type or another was encountered in 9 of the 20 coring boreholes which were logged. This material commonly consisted of a thin zone of small limestone pebbles or gravels in the clay matrix. The larger caliche gravels ranged up to about one inch in diameter and commonly were observed to exhibit varying degrees of cementation with each other. In a zone of saturation, these caliche gravels were a primary source of water to the borehole. The

zones were usually very thin, and in 6 of the 9 borings, the thickness of these zones ranged from 1 to 3 inches. Two of the borings, NCL 95-13 and NCL 95-16, had greater thicknesses of caliche gravel. These wells, located at the far northeast corner of the investigation area (Figure 6-1), had gravel thicknesses of 1 and 1.5 feet at depths of 18 and 19 feet, respectively. Both borings were free of hydrocarbons, and NCL 95-16 was completed as downgradient well MW-56. Since the coarser clayey gravel zones were encountered in relatively few borings at variable depths, they were not considered to be contiguous over the zone of investigation. However, the occurrence of the shallow thin gravel zones was observed to increase in the northeast area of the investigation in the vicinity of the trickling filter used in NRC's wastewater treatment system.

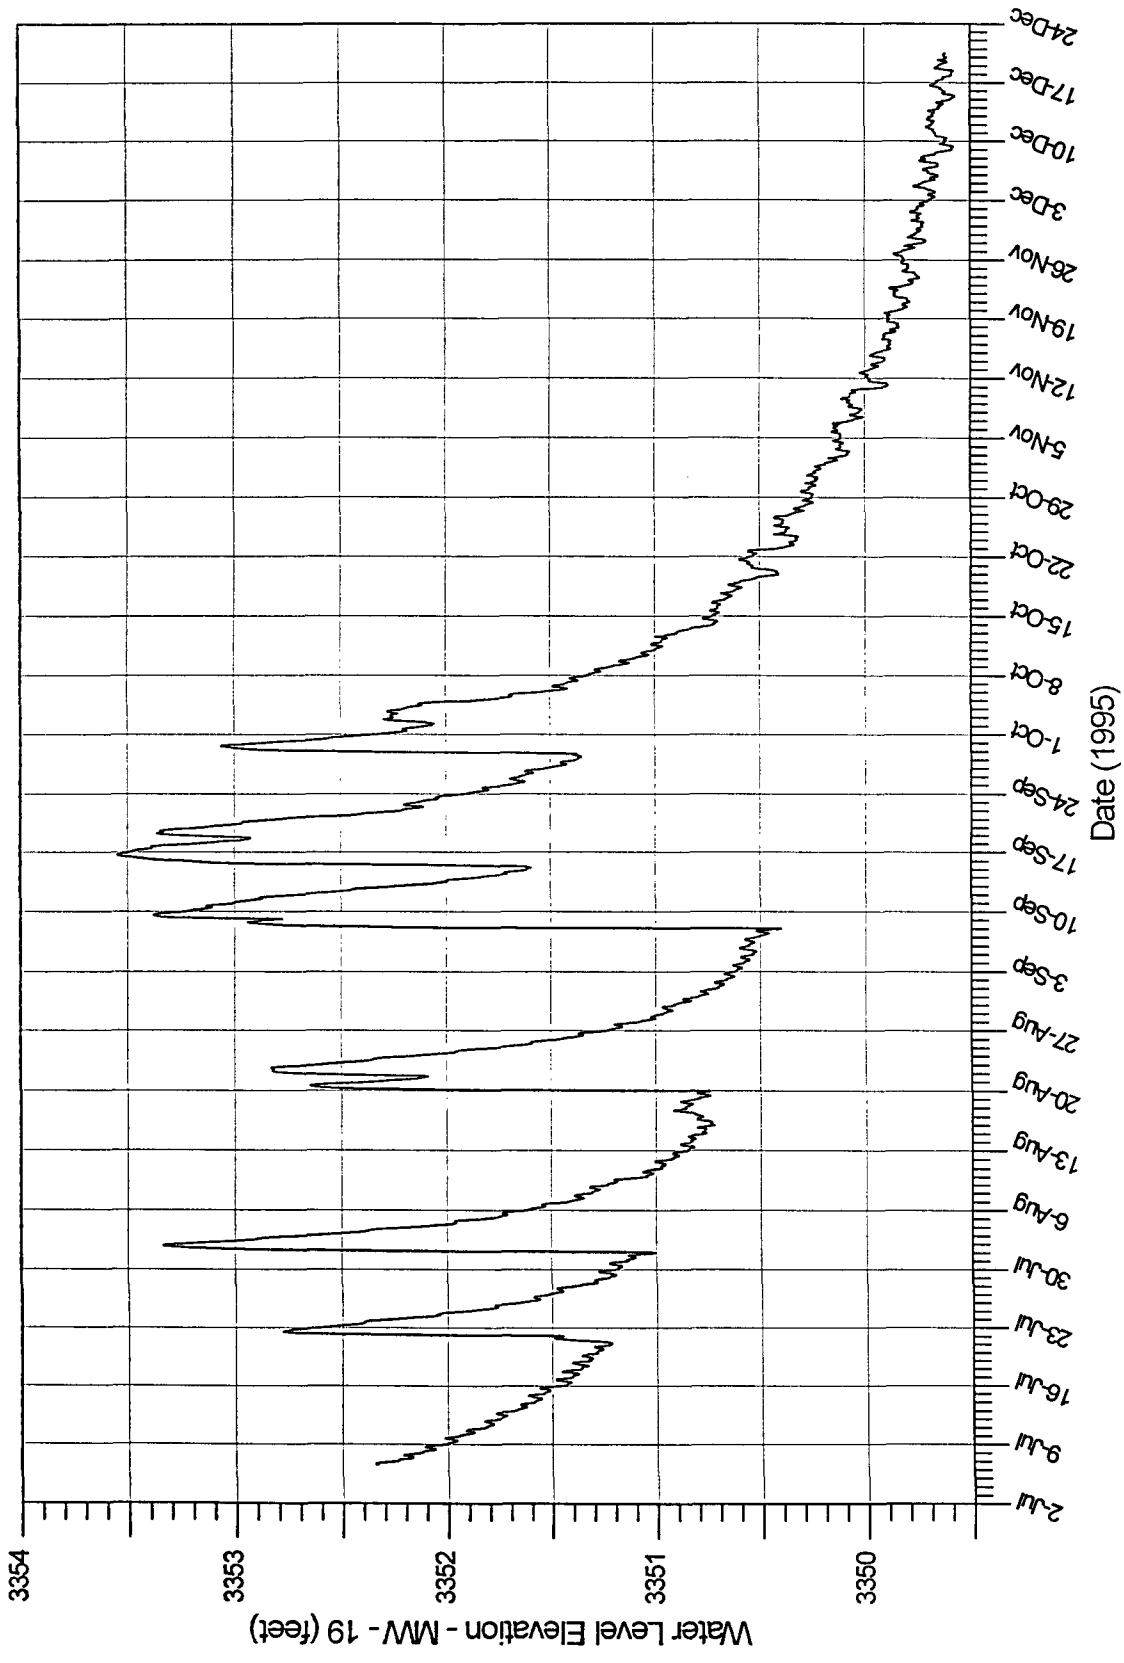
Figure 6-4. Water Level Elevations, MW-19, July-December 1995

The plotted data clearly show highly variable and rapid fluctuations in water levels over the period of investigation. Water levels declined approximately 3 feet from early July through late December. Of greater importance are the dramatic rises in water levels that were observed on at least six occasions during this period. Water level rises of 1 to 2 feet in a 12-hour period were common. The most spectacular response occurred on September 8, when water levels rose about 3 feet in one day. The return to initial conditions (defined as water level elevations existing at a time immediately preceding the increase), typically took about 10 days (provided no additional stimulus occurred).

Two alternative hypotheses were proposed that could account for the changes in water levels. The first was a response to local precipitation, and the second was a response to irrigation of City of Artesia parks by treated city wastewater effluent. Initial data from mid-July to mid-August tentatively supported the irrigation scenario since the rise in water levels could be interpreted to be a response to periodic irrigation on a schedule from 10 days to 2 weeks apart. However, inquiry found the city irrigates on almost a daily basis and no unusually large applications of the effluent are applied on a schedule which reflects the observed response in MW-19.

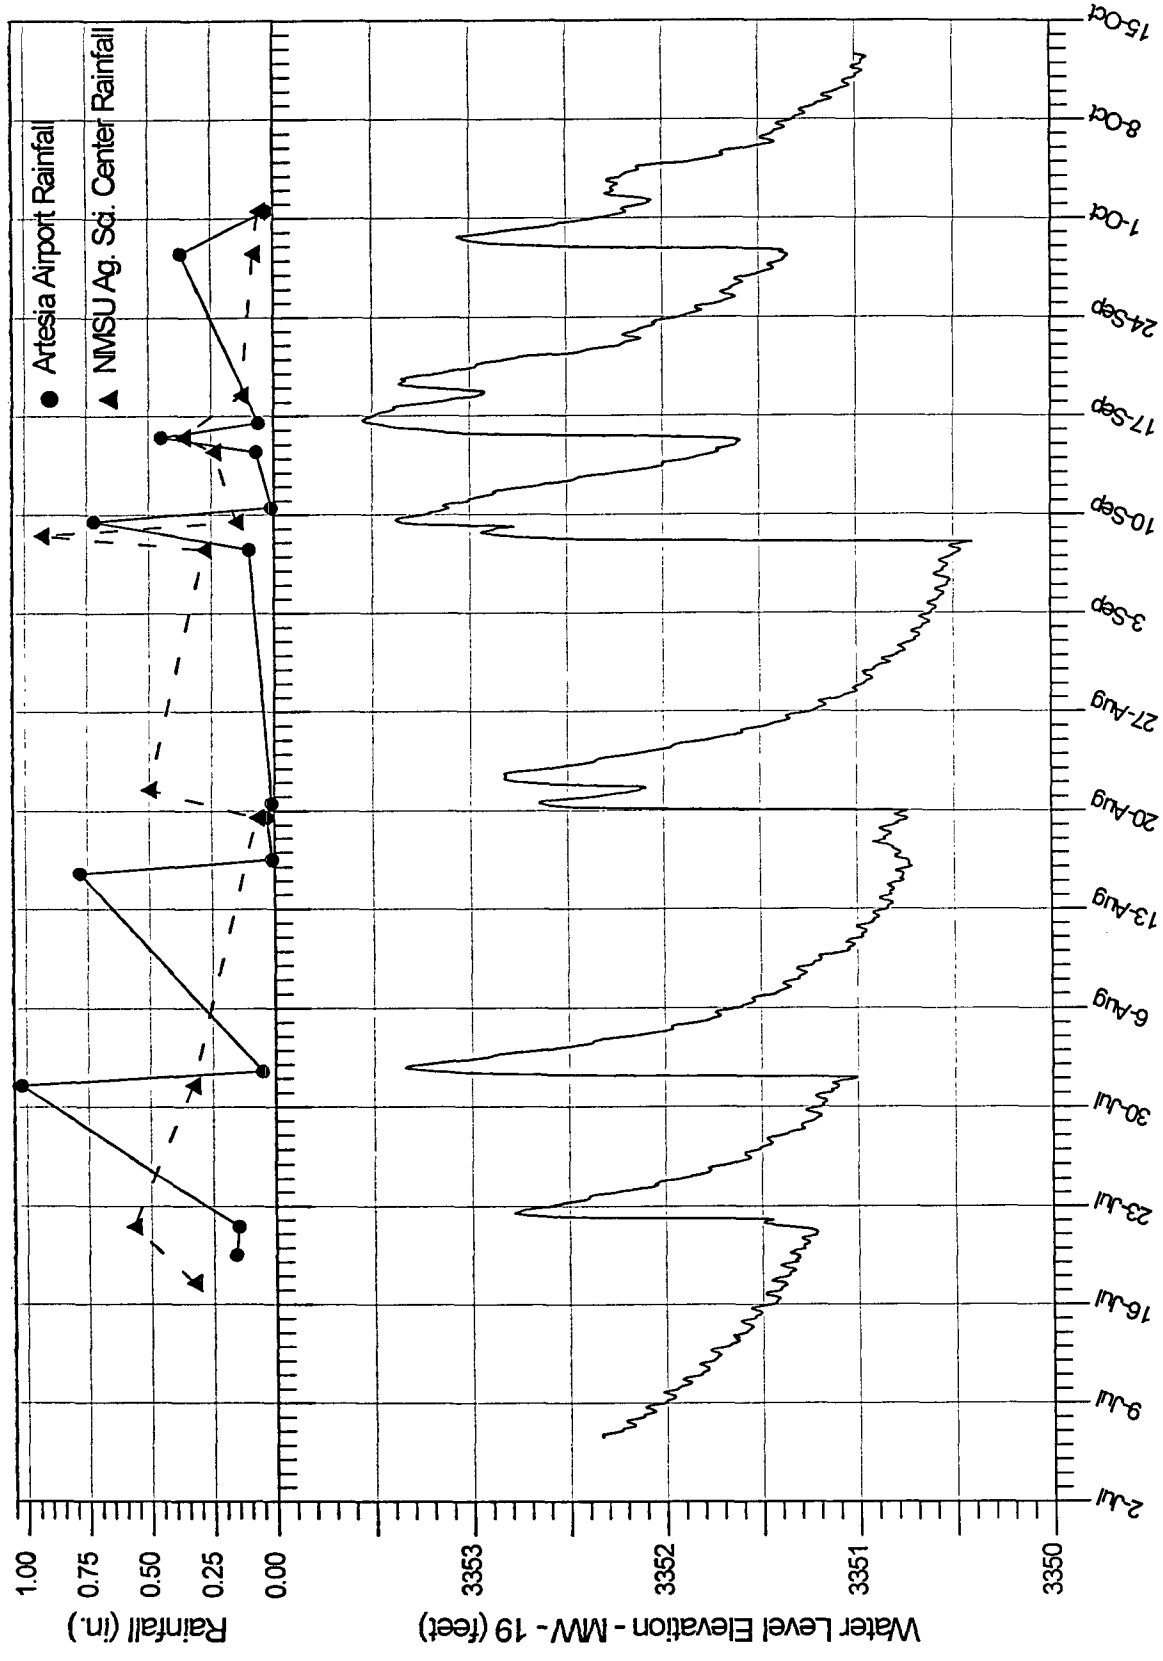
Figure 6-5. Water Level-Rainfall Relationship, MW-19, July-October 1995

The resultant graph of water levels and precipitation is shown in Figure 6-5. An obvious correlation can be seen between precipitation events and water level increases. Because summer precipitation in the Southwestern United States is primarily convective in nature, rainfall occurs from finite-diameter storm cells that commonly drop the majority of their moisture close to the cell. This effect often produces heavy rainfall in one location while very little is deposited a few miles away. Therefore, while neither the Artesia airport or university station records correlate completely with the increases seen in the monitor well, the combination of both produces excellent correlation of precipitation and water level increases.

However, the exact location of the source of infiltration to the subsurface remains unknown. The City of Artesia is directly upgradient from the NCL and no obvious nearby infiltration source, such as a retention basin or city park pond was identified. A shallow unlined city stormwater drainage ditch is located adjacent to NCL, but limited trenching performed along the ditch during the NCL Phase I investigation and reported in Appendix E of that report found that clay overburden present in the ditch location was similar to that observed directly under the landfarm. However, since the ditch is concreted in the city and concentrates rainfall runoff, it is possible that a relatively small permeable recharge area may exist at the juncture of the lined and unlined portion of the ditch. This is given some credence by the fact that both highway and railroad structures occur at the same location and the ditch was no doubt excavated at that locale to remove the overlying clay and provide foundation structural stability. This, combined with stormwater scouring at the exit point of the concreted ditch, may provide a permeable temporary storage site and serve as a source of subsurface infiltration. If this location is not the source of the water, the next possible upgradient source is Eagle Creek in an area in the city where it has been modified from an incised channel into a broad swale that serves as a park planted with grass, landscaped, and irrigated with wastewater effluent. If the recharge is from Eagle Creek and the direction of flow remains constant, the closest upgradient location for such infiltration to occur is at distance of about 4,000 feet in the vicinity of the 10th Street crossing of Eagle Creek.

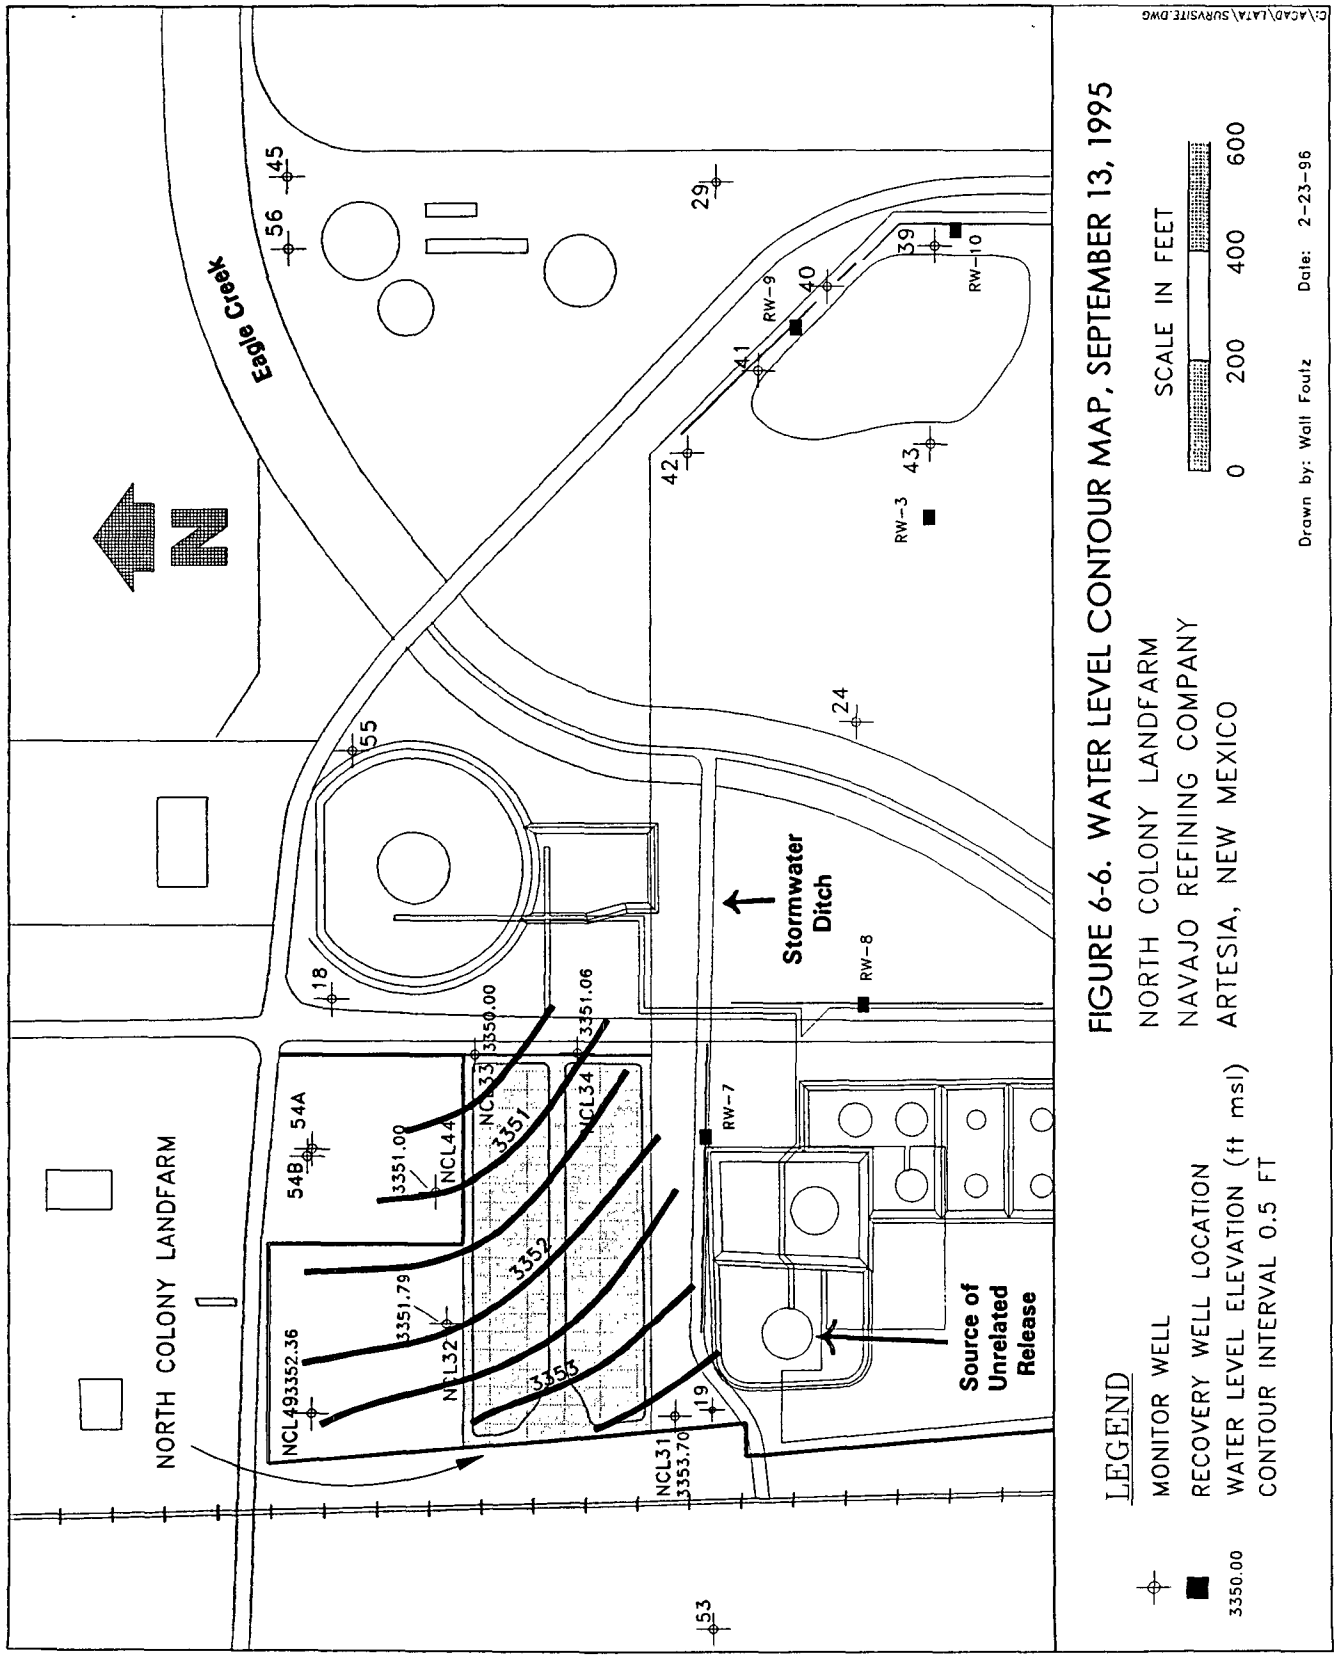
Water level contour maps for September 13 and December 23, 1995, were constructed using the groundwater elevation information shown in Table 6-3. The resultant maps are shown in Figures 6-6 and 6-7, respectively. Water flow is generally northeasterly on both maps, although contours at the north end of the maps show movement to be more easterly. The northeasterly direction of flow in this area of the refinery follows the orientation of Eagle Creek in the vicinity of the landfarm. Groundwater movement in other areas of the refinery has been shown to flow in a more easterly direction.

The groundwater contour maps presented in Figures 6-6 and 6-7 show several features which are critical to understanding the groundwater system in the vicinity of the NCL. The water level map for September 13 shows potentiometric surface elevations under the NCL ranging from 3350.5 to 3353.5 feet while the range for December 23 is from 3348 to 3349.5 ft. On September 13, water level elevations under the NCL decrease by 3 feet over a horizontal distance of approximately 620 feet from the vicinity of the southwest corner of the landfarm to the northeast corner. This results in an average hydraulic gradient of about 0.0048 feet/feet across the landfarm. On December 23, water levels under the landfarm decrease by 1.5 feet from southwest to northeast across a distance of approximately 720 feet, which produces a gradient of about 0.0021 feet/feet.

C:\ACAD\LATA\SURVSITE.DWG
N
Eagle Creek
NORTH COLONY LANDFARM
Stormwater Ditch
Source of Unrelated Release
RW-3
RW-7
RW-8
RW-9
RW-10
NCL49 3352.36
NCL32 3351.79
NCL44 3351.00
NCL33 3350.00
NCL34 3351.06
NCL31 3353.70
3350
3351
3352
3353
18
19
24
29
39
40
41
42
43
45
53
54A
54B
55
56
FIGURE 6-6. WATER LEVEL CONTOUR MAP, SEPTEMBER 13, 1995
NORTH COLONY LANDFARM
NAVAJO REFINING COMPANY
ARTESIA, NEW MEXICO
SCALE IN FEET
0 200 400 600
Drawn by: Wall Foutz
Date: 2-23-96
LEGEND
MONITOR WELL
RECOVERY WELL LOCATION
3350.00 WATER LEVEL ELEVATION (ft msl)
CONTOUR INTERVAL 0.5 FT

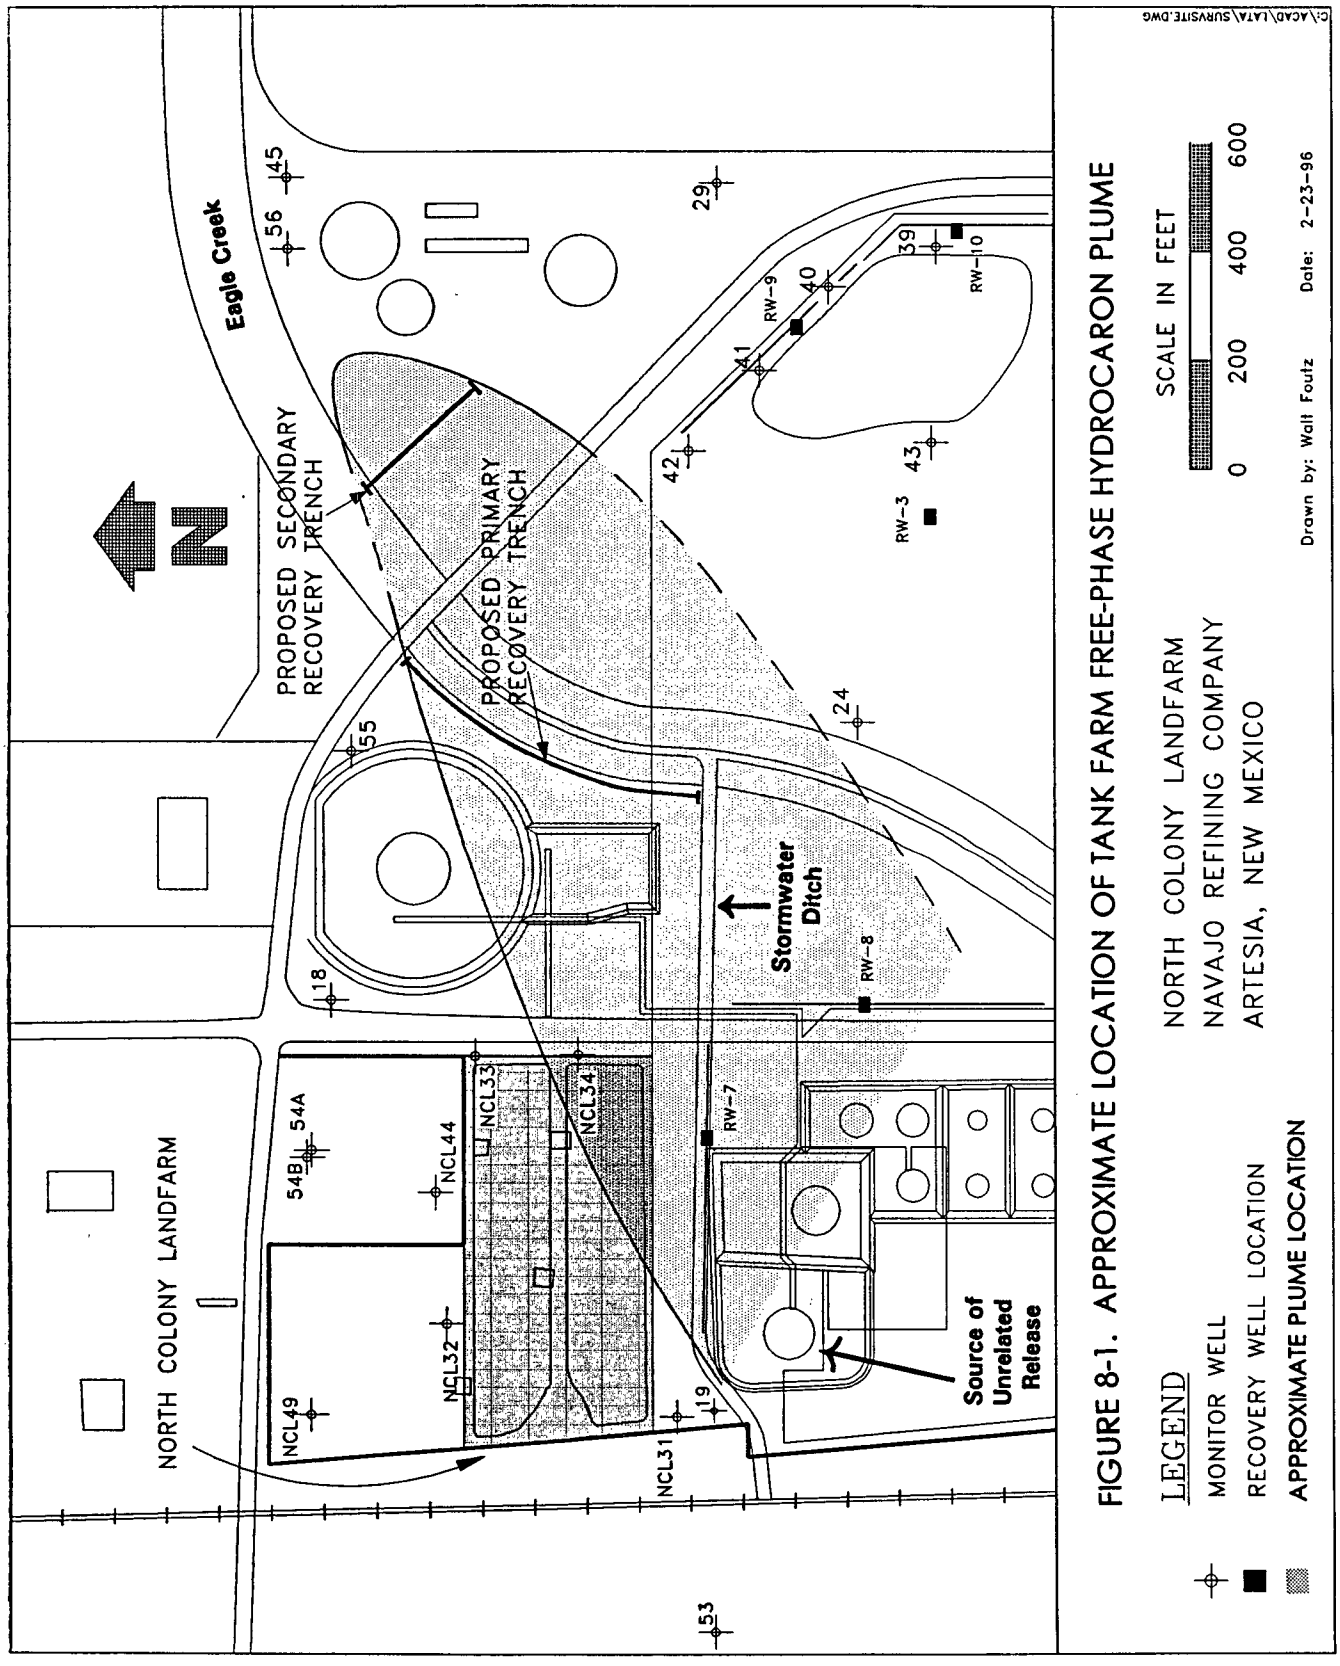
The secondary trench will be located near the leading tip of the plume and is expected to recover lesser amounts of hydrocarbon and contaminated water since not all borings in that area were found to have been impacted by the product. The location of this trench is also dictated by existing refinery structures and pipeline and utility considerations. However, by cutting off the source of product and water, the trench is expected to cause downgradient fluid movement to

greatly decrease and it should significantly diminish hydrocarbon movement. The presence of new monitor well MW-56 will provide timely notice of imminent approach of any hydrocarbon constituents.

Based on the location of free-phase product within the NSSZ, and physical constraints imposed by Eagle Creek and various surface and subsurface refinery installations, two separate trench installations are recommended for the interception and recovery of the hydrocarbon product. A primary trench located immediately west of Eagle Creek would recover product and contaminated groundwater. In addition, a secondary trench located east of the creek would serve as a recovery system to collect contamination which migrated beyond the point of the primary trench prior to its installation.

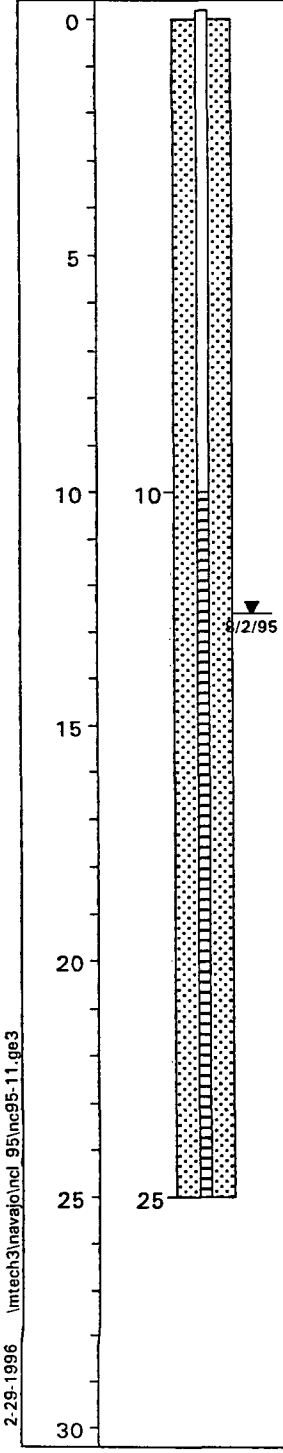
Depth in Feet	NCL 95-11 ELEV:	DESCRIPTION

NCL 95-11 located 200 ft. southeast of NCL 95-06. Cored to 25 ft. Hole was not logged but cuttings observed. Discolored clay soil about 15 - 18 ft. Clay with H/C odor but no fluid at 20 ft. Clean, damp clay at total depth. Installed 15 ft. of screen and 10 ft. of temporary PVC casing for H/C product search.

Depth to water 12.6 ft. BLS on 8/2/95; no product but H/C odor on water level probe.

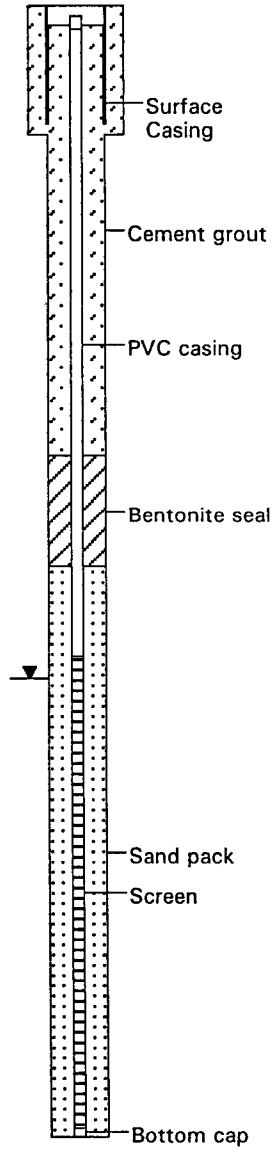
Well: MW-53
ELEV: 3367.67

Notes:
Completed hydraulic push at 1000, began auger drilling at 1015. Water on bit at 20 ft, none seen in hole. Auger hole drilled to 24 ft. No PID measurements. Depth to water at 14.24 ft. BLS @ 0915 6/29.

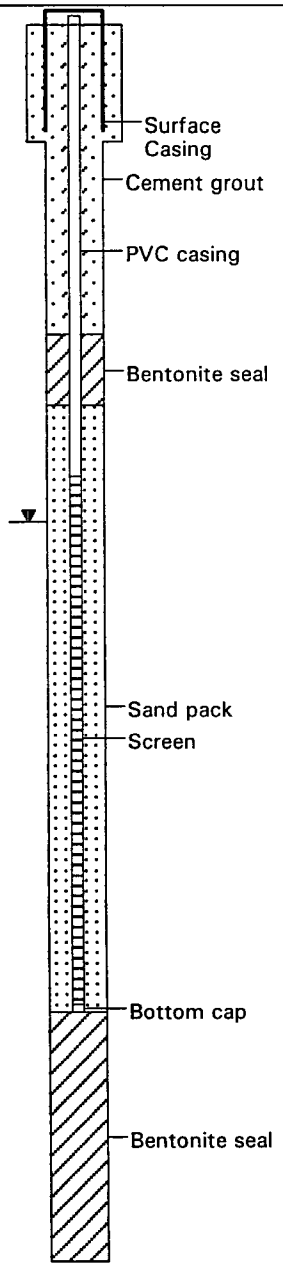
Well: MW-54A
ELEV: 3365.38

30.4-31 ft. Silty gravel		GM
		31-33 ft. Silty sand, light brown, very fine grained with some clay and gravel, saturated. 33-35 ft. Sand increasing with gravels. River gravels at 35 ft., flat to 3 in. 5 ft. sample recovery		SM
35		Notes: 6 in. smear of product on auger when retreived. Backfilled hole to 27.5 ft. with medium bentonite chips. Depth to water at 14.1 ft. BLS @1130 12/15 Photoionization Detector (PID) readings are from jar headspace analysis of grab samples taken from drill cuttings at designated intervals.		
40
