BURLINGTON RESOURCES

July 30, 1997

RE: Hampton 4M - Groundwater Contamination
Unit Letter N, Section 13, Township 30N, Range 11W

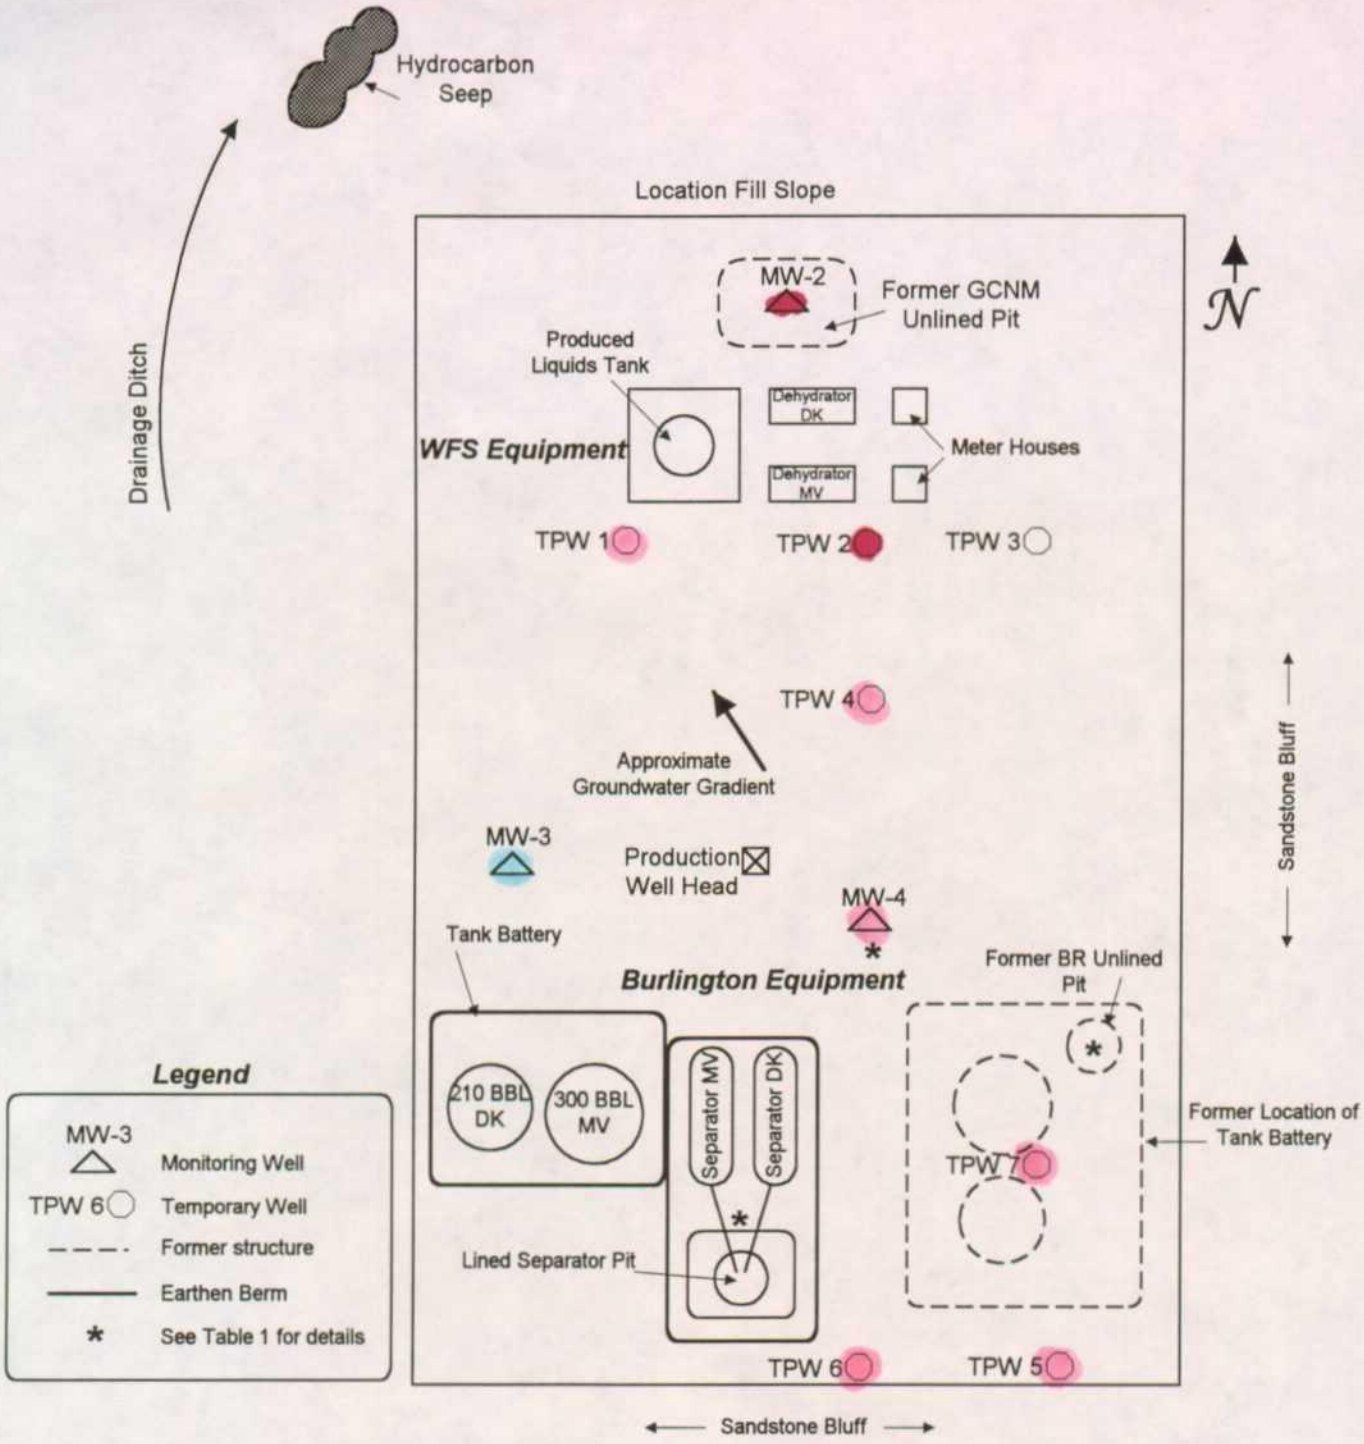
Figure 2: Hampton 4M Site Diagram

The Hampton 4M gas production location is located approximately 3 miles East of Aztec, NM (Figure 1). Figure 2 illustrates all equipment and the orientation of that equipment on the pad surface. Burlington owns and operates the location and PNM Gas Services owns and operates two dehydrators with associated equipment on the Northern end of the location. Burlington's equipment is all situated to the South of the well head.

June 5, 1997 ***Soil Boring***	Three holes were bored on the site just to the south of PNM's dehydrators and discharge tank. Figure 2 shows the location of each borehole and the results of groundwater and soil samples. Information gathered during the boring was soil characteristics and soil vapor analysis every five feet to groundwater. A soil sample, for laboratory analysis, was taken just above the water level and a groundwater sample will be taken. .
June 6, 1997 ***Soil Boring***	Burlington continued soil boring on the location. A total of four more points were bored. These points are shown in Figure 2.
June 10, 199 ***Meeting - Discussion of Boring Results***	Burlington and PNM met to discuss costs for other groundwater sites and to discuss the results of the soil boring at the Hampton 4M.

Three permanent groundwater monitoring wells were installed on location (Figure 2). Monitoring Well 2 (MW-2) was installed in the center of the former gas dehydrator discharge pit operated by PNM. MW-3 and MW-4 were installed to establish the groundwater gradient under the location. A contour map of the groundwater was developed from water level information in the monitoring wells (Figure 3). The contour surface map shows the groundwater flows northwest across the location.

TPW 1 through 3 were drilled in an east to west transect just to the south of PNM's gas dehydration equipment. TPW 4 was drilled midway between TPW 2 and MW-4. The remainder of the temporary wells were drilled to the south of MW-4 to locate the source of dissolved phase BTEX contamination. TPW 5 and 6 were drilled on the southern most boundary of the production location. The seventh temporary well (TPW 7) was drilled directly under the former location of the produced hydrocarbon storage tanks. Relative locations of the temporary wells can be seen in Figure 2.

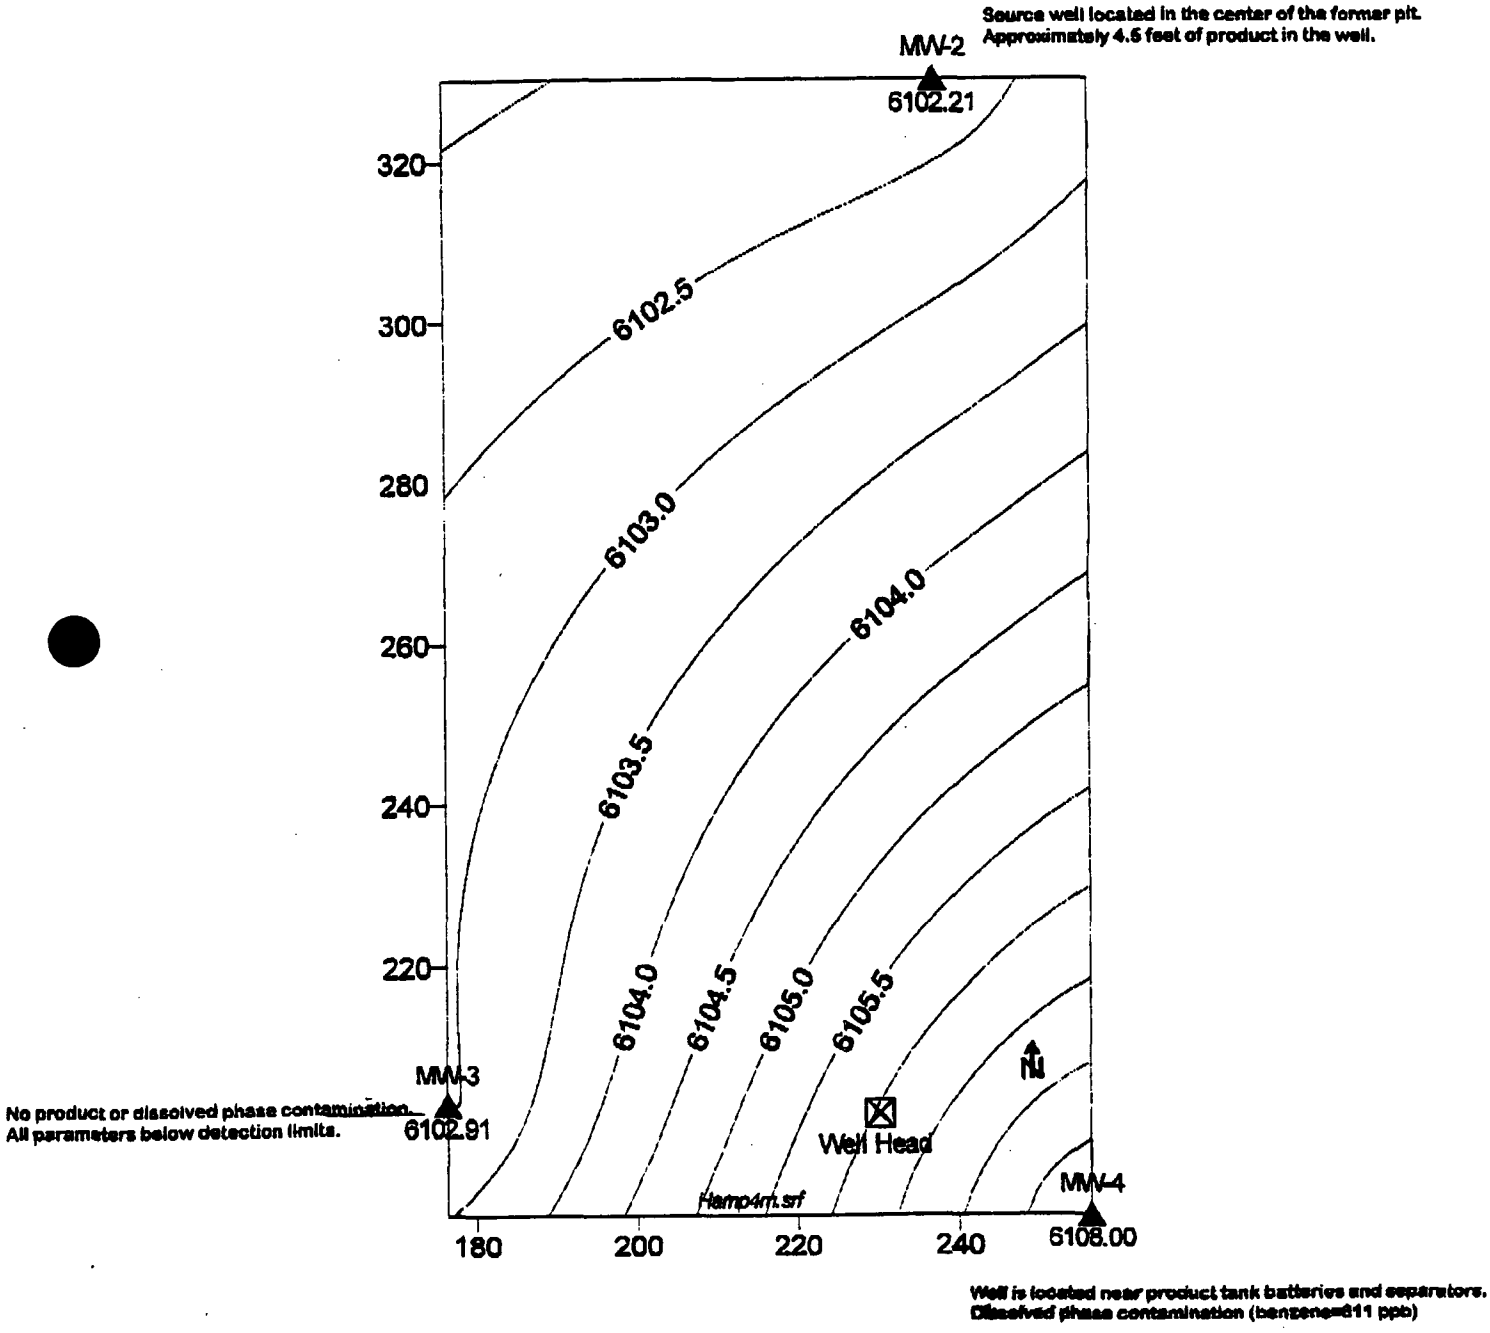
Figure 3: Hampton 4M Groundwater Contour Map (January 1997)

Results of groundwater sampling over the location indicates a significant amount of NAPL on the top of the groundwater under the gas dehydration equipment operated by PNM. NAPL from the area under the dehydration equipment has migrated to the northwest and is the source of hydrocarbons surfacing in the seep.

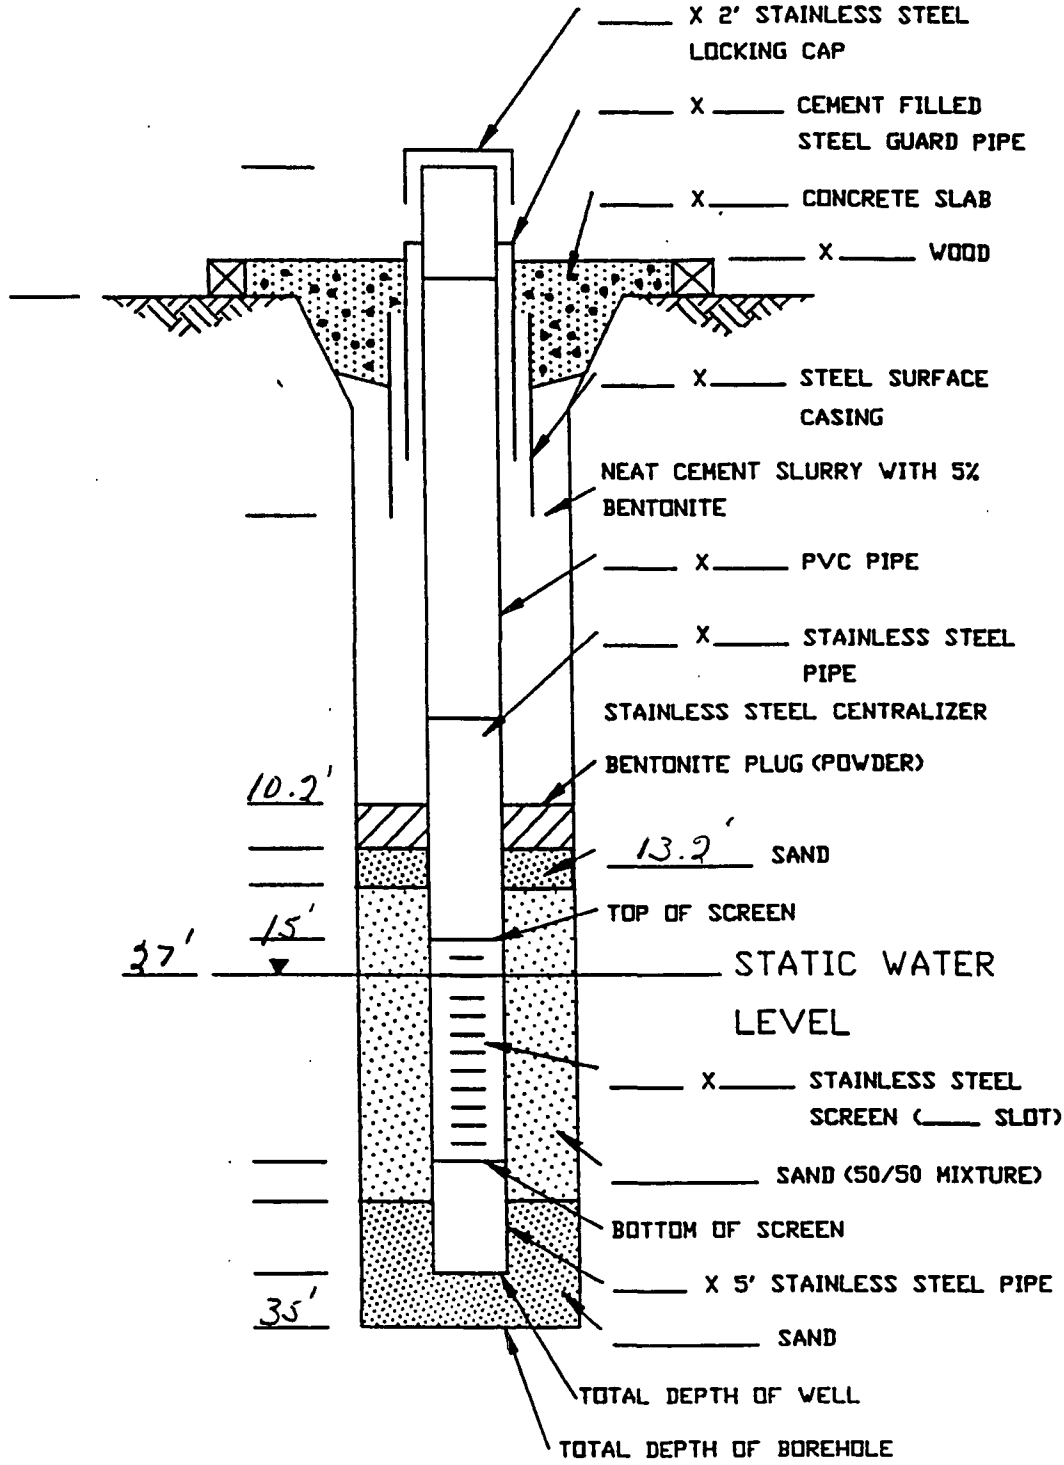
Hampton #4m . MW #4

It is thought that there are two separate sources of groundwater contamination at the Hampton 4M location. One source is the former discharge pit for the gas dehydrators operated by PNM and the second source being upgradient of MW-4 supplying a dissolved phase BTEX component. This is supported by the fact that a NAPL on the groundwater has only been found in the area directly around the dehydration equipment.
