Release Notification

Site Name Graham State #1 Battery	Site Type Tank Battery
Date Release Discovered 7/29/2020	API# *(if applicable)* 30-025-21842

Graham State #1 Battery

NRM2030337321

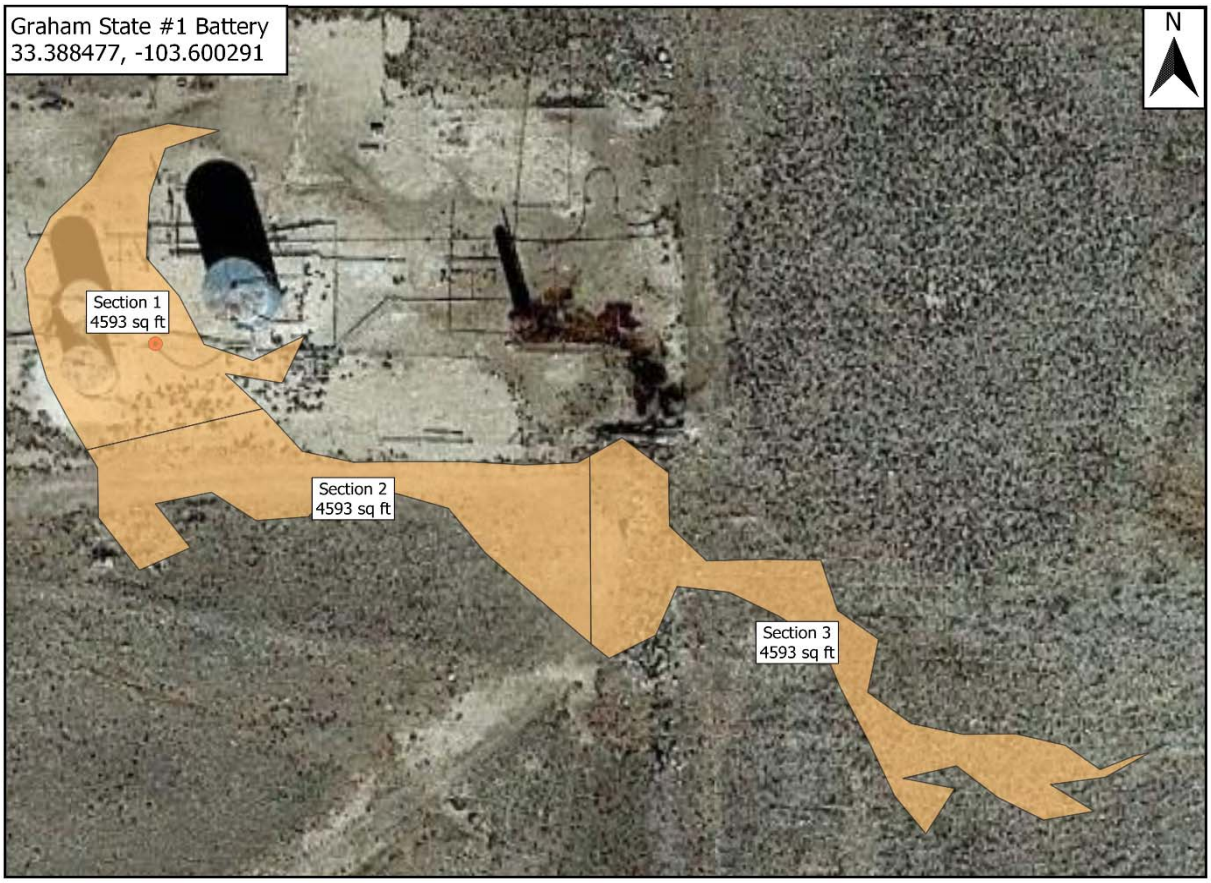
The release was caused by tanks overflowing.

Volume Calculation — Graham State #1 Battery

Volume of Liquid Remaining in Soil:	204.5	bbls
Volume Recovered:	20.0	bbls
Total Volume:	224.5	bbls
Oil (Approximate)	25.0	%

Volume of Oil Released:	56.1	bbls
Volume of Water Released:	168.4	bbls
Volume of Oil Recovered:	~10	bbls
Volume of Water Recovered:	~10	bbls
