PHILIP SERVICES CORP.

Project 19099

RE: Report for sampling of the reserve pits at the Westland Development Corp. #1 located west of Albuquerque, New Mexico

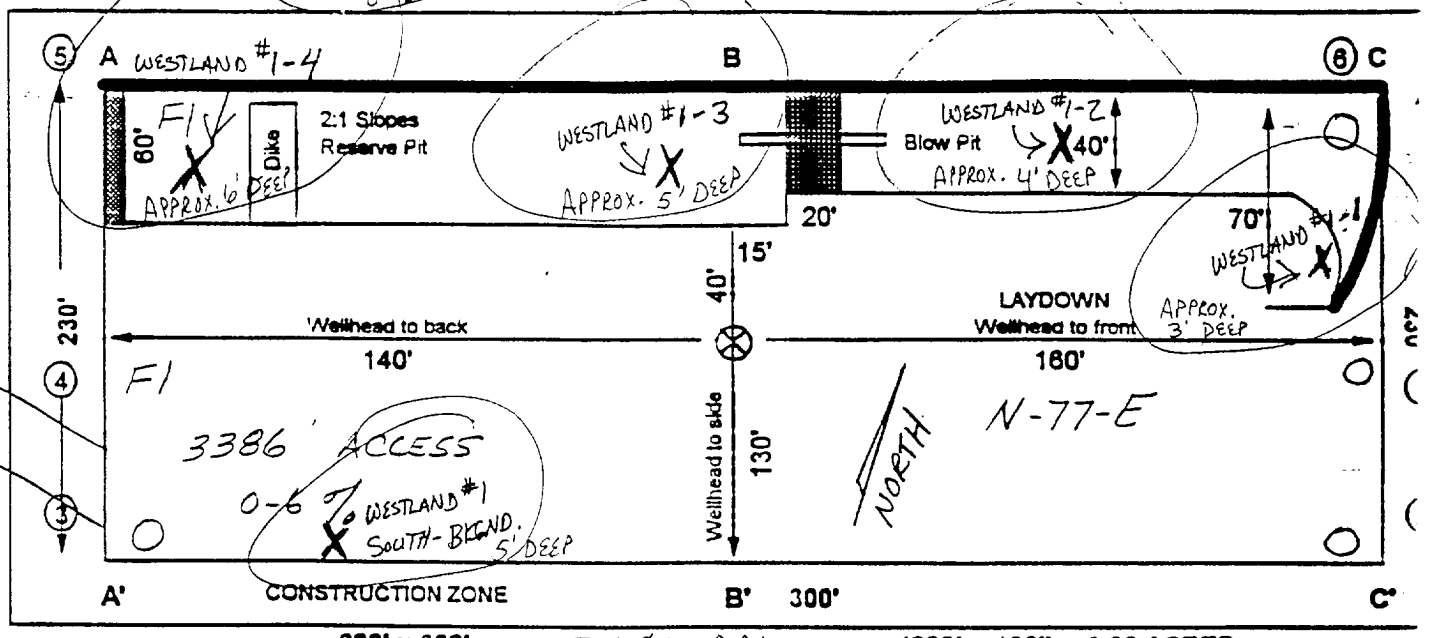
Site Diagram of Sample Locations

All samples collected were sent to SPL Laboratory located in Farmington, New Mexico. Results of laboratory analysis are included in Attachment A. A site diagram outlining the sample locations is included as Attachment B.
