Souder, Miller & Associates♦201 S. Halagueno St.♦Carlsbad, NM 88220
(575) 689-8801

December 28, 2018

SUBJECT: Amended Remediation Closure Report for the Riser #4 Release (2RP-5113) Eddy County, New Mexico

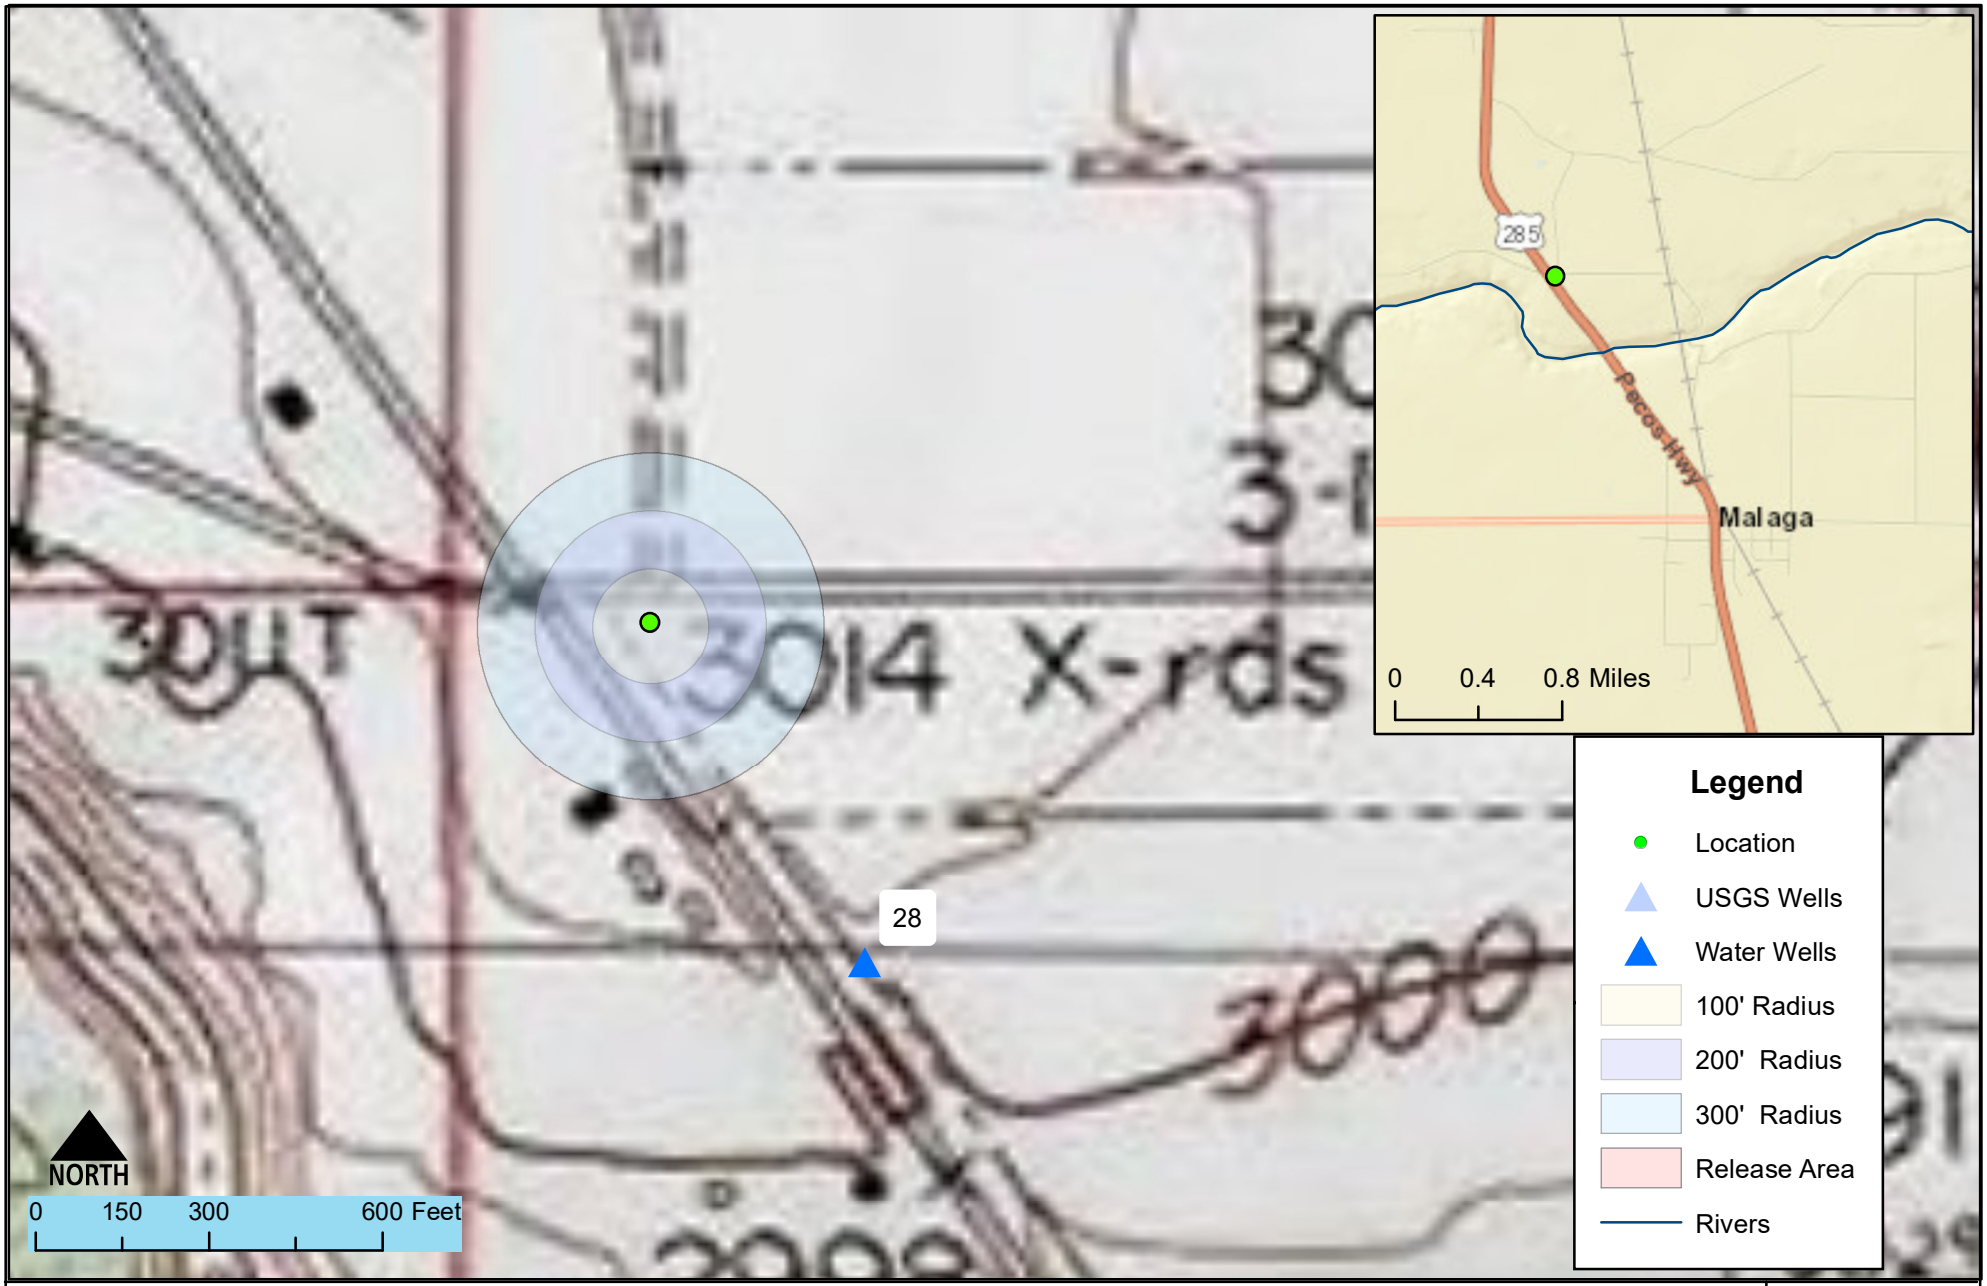
Figure 2

SMA then conducted confirmation sampling of the walls and base of the excavation, which measured approximately 25 by 30 feet. The area was excavated to a depth of 17 feet bgs, 2 feet underneath the pipelines. Confirmation samples were comprised of five-point composites of the base (BH1) and walls (SW1-SW4) and sent for laboratory analysis. A deferral is being requested for SW4 as it borders the concrete canal that runs northwest to southeast and further delineation or excavation would cause damage to the infrastructure. This canal can also be seen on Figure 2.

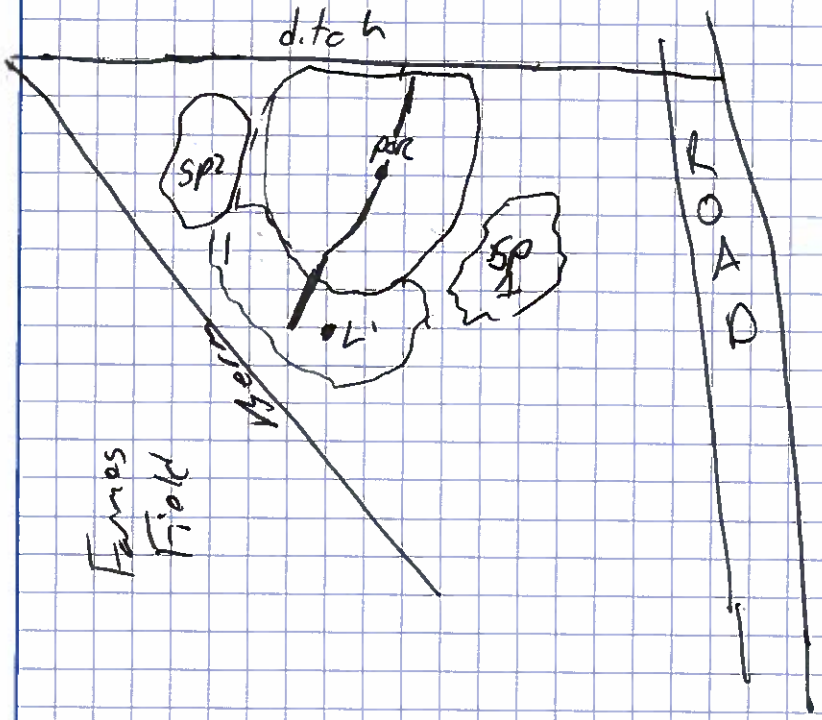
excavation has occur up to 15' BGS

pipe exposed bore by elbow

Does not show visual that displaced moved on surface to field to the east

~ 20' depth

From excavation
