Release Notification

Site Name Denton No. 2 SWD well	Site Type: SWD wellhead
Date Release Discovered 11/5/18	API# 30-025-05270

Work Plan: 1RP-5270– Denton No.2 SWD Wellhead spill

1RP-5270 Denton No.2 SWD Sample Analysis

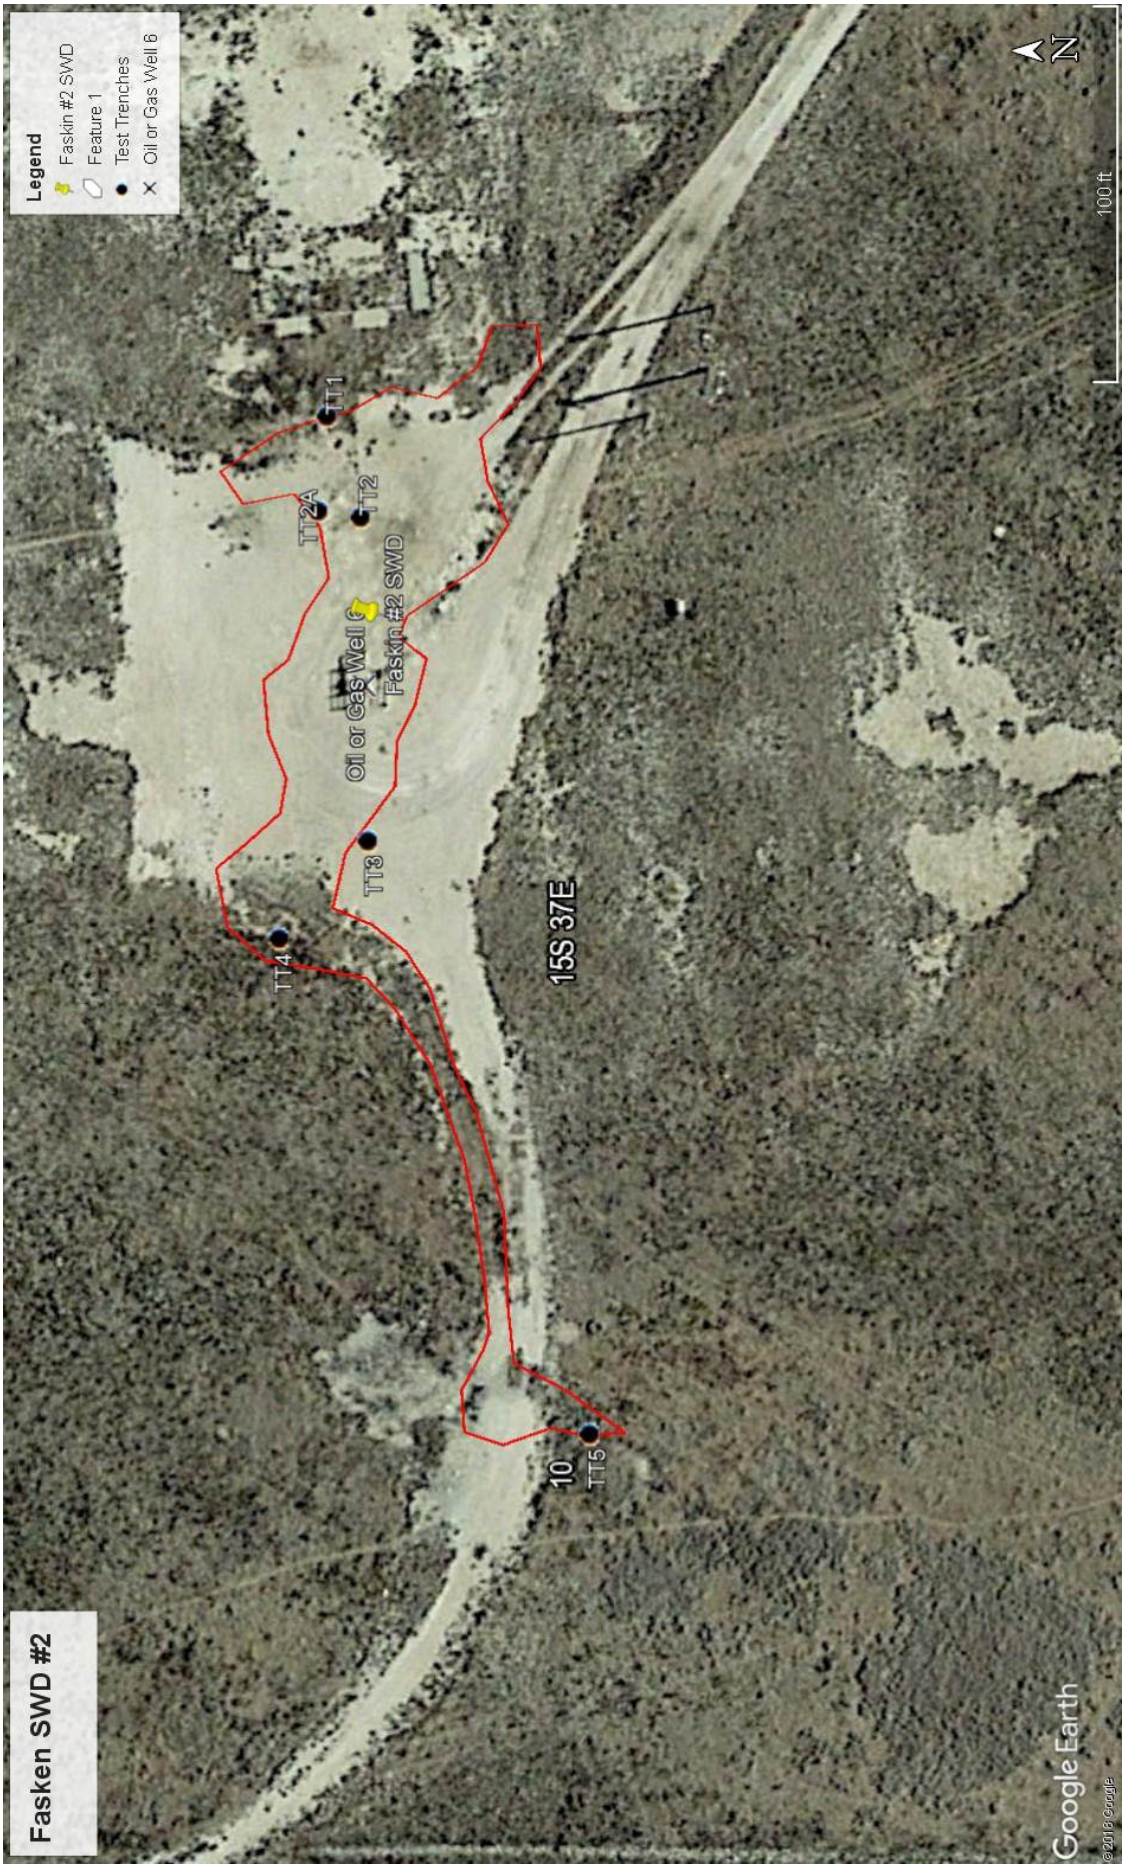
Fasken SWD #2
Legend
Faskin #2 SWD
Feature 1
Test Trenches
Oil or Gas Well 6
TT1
TT2
TT2A
TT3
TT4
TT5
Oil or Gas Well 6
Faskin #2 SWD
15S 37E
10
N
100 ft
Google Earth
©2018 Google

On January 30, 2019, five trenches were opened with a backhoe and three samples from each trench were collected: surface, one foot, and the top of caliche. The surface of the caliche at this location varies from 2 to three below the surface. Laboratory analysis of the samples shows that chloride concentrations are high in the surface samples at TT-1, TT-2, and TT-3. All other sample concentrations are below 2,000 mg/kg chloride. A site plan showing these sample locations is included as an attachment.

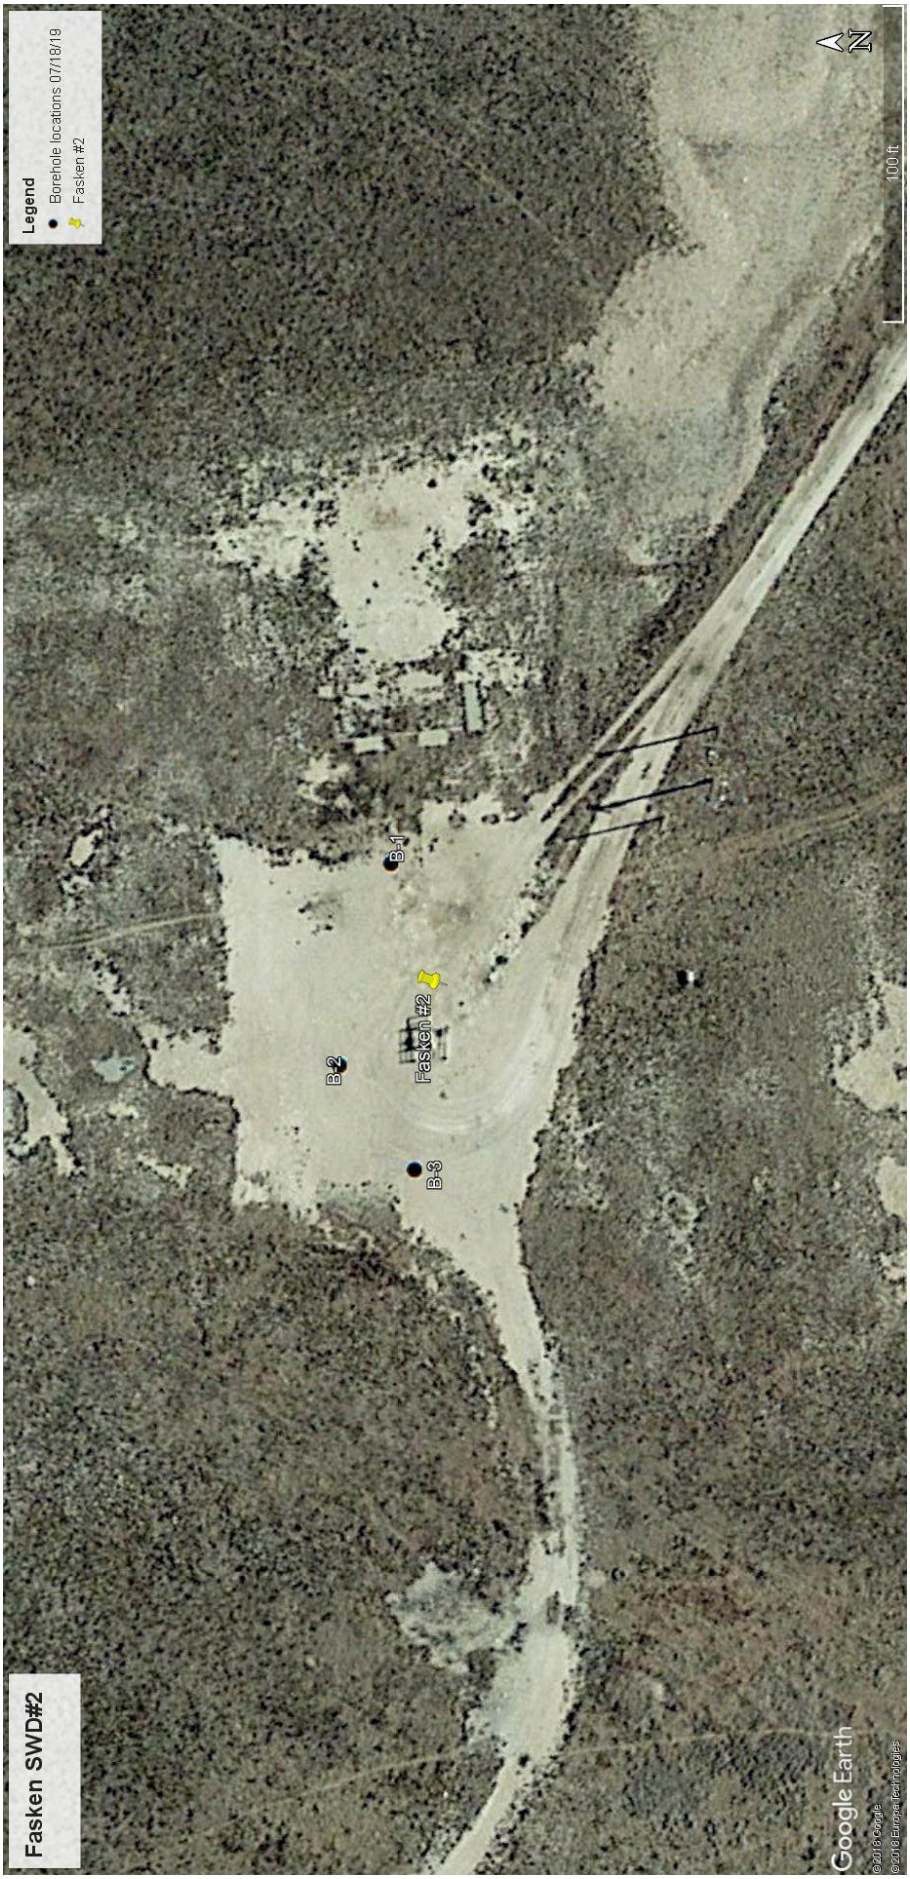
Fasken SWD#2
Legend
Borehole locations 07/18/19
Fasken #2
B-1
B-2
B-3
Fasken #2
N
100 ft
Google Earth
©2018 Google
©2018 Europa Technologies

On July 18, 2019, three borings were advanced with a hollow stem auger mobile drilling machine. Samples were continuously collected by hollow stem auger in two-foot increments. Four samples from each boring were submitted for laboratory analysis. The maximum concentration for these samples was 1,410 mg/kg chloride in B-2 at 0-2'. All other concentrations were low, and the deepest samples collect from each boring were 320 (B-1), 128 (B-2), and 112 (B-3) mg/kg chloride. A site plan showing these sample locations is included as an attachment.

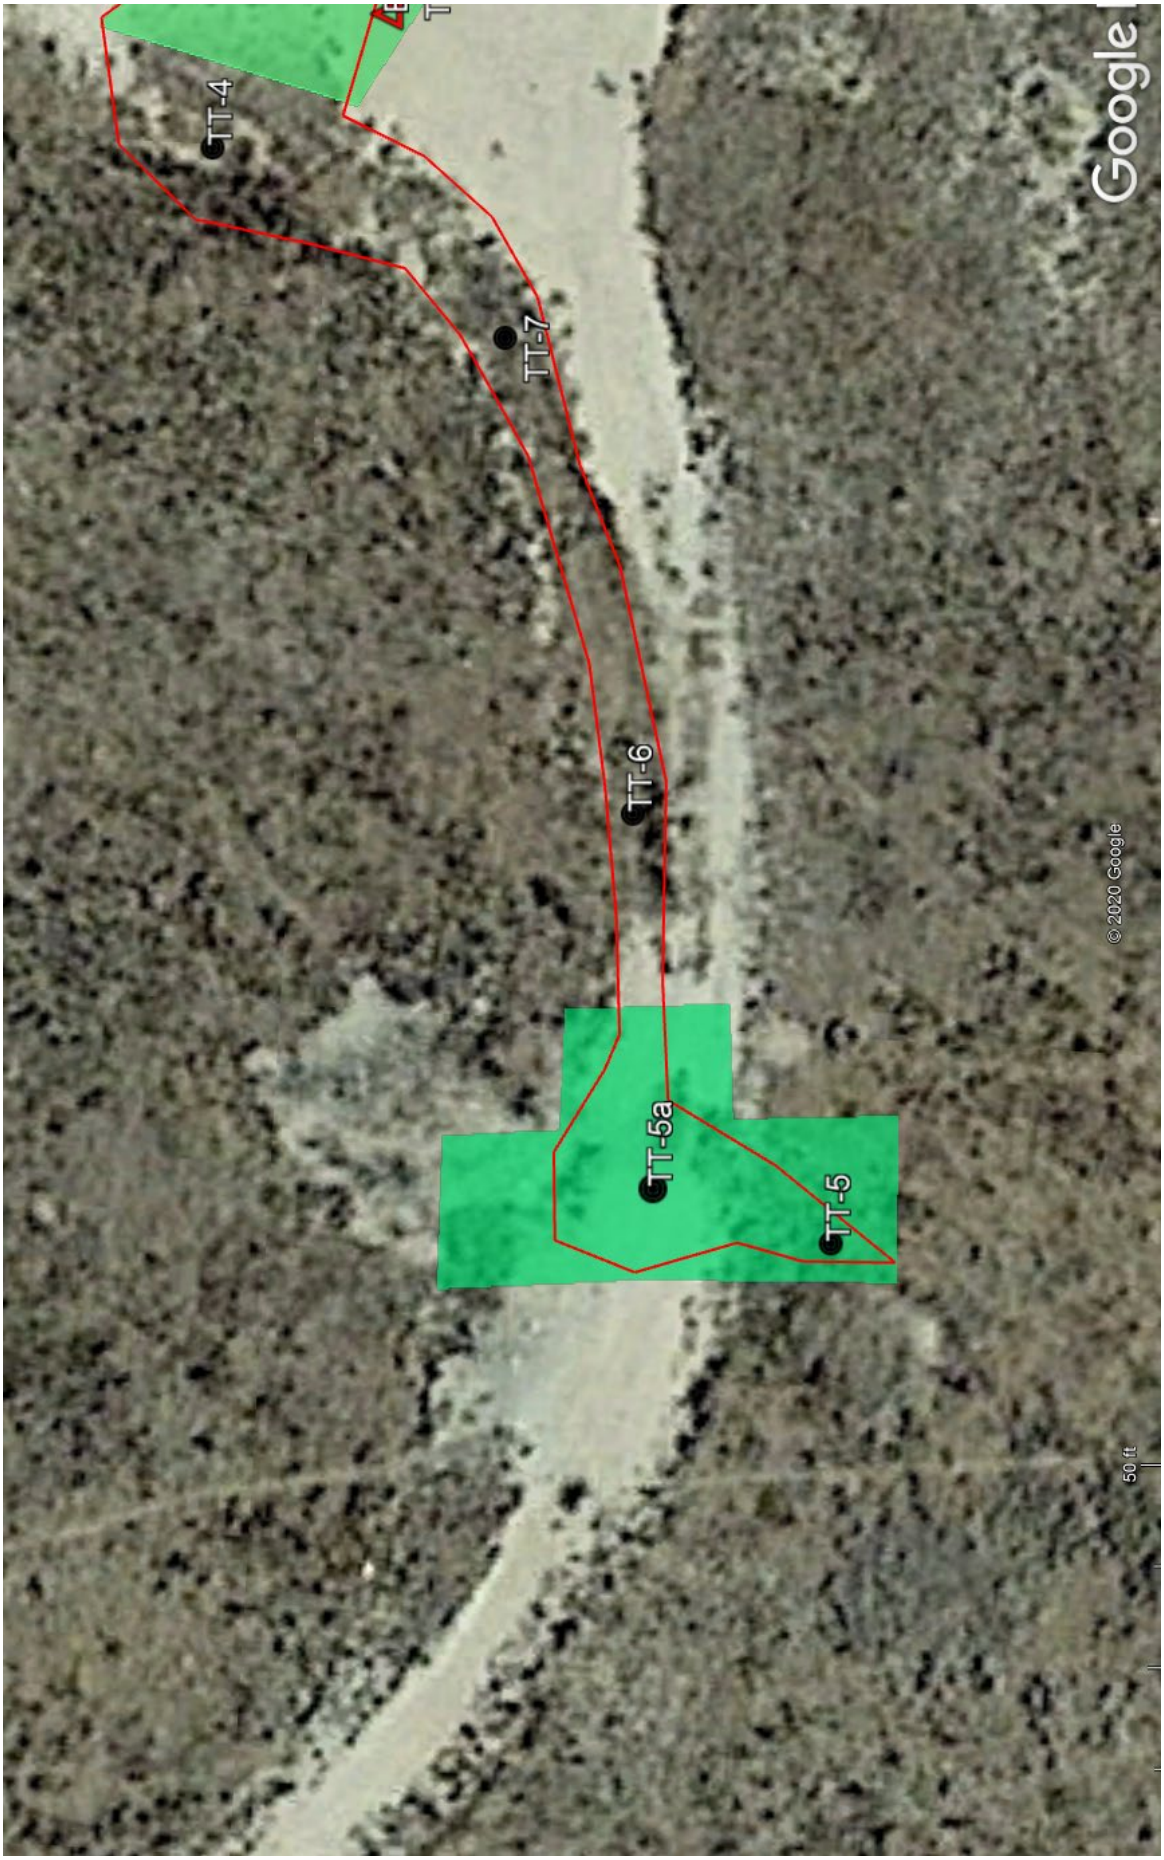
TT-4
TT-7
TT-6
TT-5a
TT-5
Google
© 2020 Google
50 ft

On October 31, 2019, SESI INC of Hobbs, New Mexico performed additional delineation of the release on behalf of Fasken Oil and Ranch. Additional delineation was performed at the request of OCD. TT-3 and TT-5 were re-sampled below the caliche in order to delineate at these locations. Please note that the depths these samples were mislabeled on the laboratory chain of custody by the SESI technician: the field notes from the technician indicate that samples were obtained after he 'busted out the rocks'. The depth to caliche at the location was previously recorded at approximately three feet below ground surface. Also note that the TT-3 data correlates very well with shallow sample results from adjacent B-3 that was previously advanced. Three new delineation locations were also opened with a backhoe and sampled at the request of the OCD: TT-6, TT-7, and TT-8. These locations were sampled at the surface and at 1 foot below ground surface. All sample locations were field screened prior laboratory analysis. All field screen results were less than 600 mg/kg, according to SESI personnel. Laboratory results for all samples collected ranged from 'not detected' to 370 mg/kg.

After closure was requested on January 15th, NM OCD Specialist Robert Hamlet denied closure, noting that additional excavation of material was needed at TT-5.
On April 2, 2020, the area that TT-5 was excavated to approximately 9 inches to 1 foot below ground surface. Sample TT-5a was collected, with a result of 499 mg/kg chloride. Excavated soils are stockpiled pending disposal.
