PIT REMEDIATION AND CLOSURE REPORT

Facility or Well Name: GCU # 222E

Blow Pit B1058

FIELD REPORT: PIT CLOSURE VERIFICATION

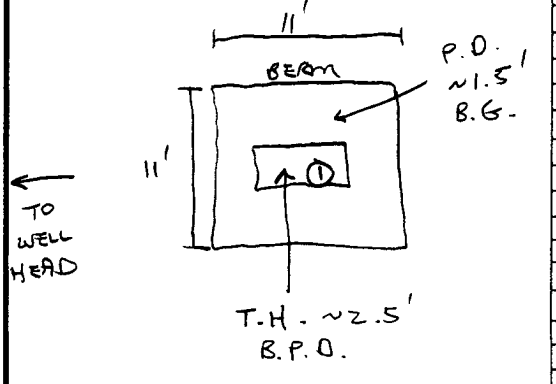
PIT PERIMETER

FIELD NOTES & REMARKS: PIT LOCATED APPROXIMATELY 72 FT. N90E FROM WELLHEAD.
DEPTH TO GROUNDWATER: >100' NEAREST WATER SOURCE: >1000' NEAREST SURFACE WATER: >1000'
NMOCD RANKING SCORE: 0 NMOCD TPH CLOSURE STD: 5000 PPM

SOIL TYPE: (SAND) / SILTY SAND / SILT / SILTY CLAY / CLAY / GRAVEL / OTHER BEDROCK (SANDSTONE)
SOIL COLOR: GRAYISH ORANGE BEDROCK - SAME AS SOIL
COHESION (ALL OTHERS): (NON COHESIVE) SLIGHTLY COHESIVE / COHESIVE / HIGHLY COHESIVE
CONSISTENCY (NON COHESIVE SOILS): ~~LOOSE~~ ~~FIRM~~ / DENSE / VERY DENSE
~~PLASTICITY (CLAYS)~~: NON PLASTIC / SLIGHTLY PLASTIC / COHESIVE / MEDIUM PLASTIC / HIGHLY PLASTIC
~~DENSITY (COHESIVE CLAYS & SILTS)~~: SOFT / FIRM / STIFF / VERY STIFF / HARD
MOISTURE: DRY / (SLIGHTLY MOIST) / MOIST / WET / SATURATED / SUPER SATURATED
DISCOLORATION/STAINING OBSERVED: (YES) / NO EXPLANATION - 4" OK. GRAY/BLACK ~ 1 FT. ABOVE BEDROCK.
HC ODOR DETECTED: (YES) NO EXPLANATION - WITHIN TEST HOLE & OVM SAMPLE.
SAMPLE TYPE: (GRAB) / COMPOSITE - # OF PTS. —
ADDITIONAL COMMENTS: COLLECTED SAMPLE FROM BEDROCK SURFACE. BEDROCK - VERY HARD, SLIGHTLY FRIABLE.
BEDROCK BOTTOM
