PIT REMEDIATION AND CLOSURE REPORT
30-045-28331

Facility or Well Name: GCU # 507

Blow Pit B0994

FIELD REPORT: PIT CLOSURE VERIFICATION

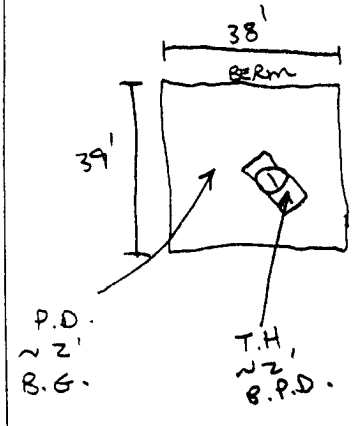
PIT PERIMETER

FIELD NOTES & REMARKS: PIT LOCATED APPROXIMATELY 110 FT. N5W FROM WELLHEAD.
DEPTH TO GROUNDWATER: >100' NEAREST WATER SOURCE: >1000' NEAREST SURFACE WATER: >1000'
NMOCD RANKING SCORE: 0 NMOCD TPH CLOSURE STD: 5000 PPM

SOIL TYPE: SAND / SILTY SAND / SILT / SILTY CLAY / CLAY / GRAVEL / OTHER BEDROCK (SANDSTONE)
SOIL COLOR: PALE YELL. ORANGE TO BROWN
COHESION (ALL OTHERS): NON COHESIVE / SLIGHTLY COHESIVE / COHESIVE / HIGHLY COHESIVE
CONSISTENCY (NON COHESIVE SOILS): LOOSE / FIRM / (DENSE) / (VERY DENSE)
~~PLASTICITY (CLAYS)~~: NON PLASTIC / SLIGHTLY PLASTIC / COHESIVE / MEDIUM PLASTIC / HIGHLY PLASTIC
~~DENSITY (COHESIVE CLAYS & SILTS)~~: SOFT / FIRM / STIFF / VERY STIFF / HARD
MOISTURE: DRY / (SLIGHTLY MOIST) / MOIST / WET / SATURATED / SUPER SATURATED
DISCOLORATION/STAINING OBSERVED: YES / (NO) EXPLANATION -
HC ODOR DETECTED: YES / (NO) EXPLANATION -
SAMPLE TYPE: (GRAB) / COMPOSITE - # OF PTS. -
ADDITIONAL COMMENTS: 4" COMPACT SILTY SAND ~ 6" BELOW PIT DEPRESSION, REMAINING PORTION OF TEST HOLE CONSISTED OF BEDROCK. SAMPLE COLLECTED FROM BEDROCK.

(CLOSED)
(MOSTLY BEDROCK)
(PIT CONSTRUCTED AFTER 98 PIT INVENTORY)
