State of New Mexico
Energy, Minerals and Natural Resources Department

PIT REMEDIATION AND CLOSURE REPORT

Facility or Well Name: Florance D LS #13

FIELD REPORT: PIT CLOSURE VERIFICATION

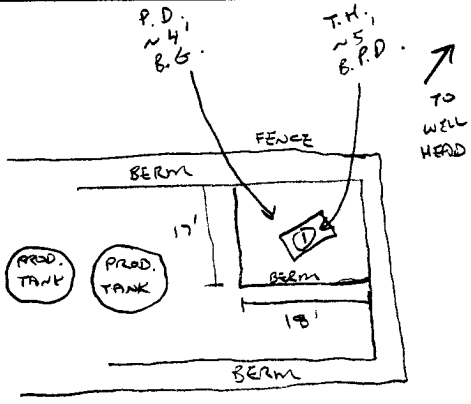
PIT PERIMETER

FIELD NOTES & REMARKS: PIT LOCATED APPROXIMATELY 102 FT. S39W FROM WELLHEAD.
DEPTH TO GROUNDWATER: >100' NEAREST WATER SOURCE: >1000' NEAREST SURFACE WATER: >1000'
NMOCD RANKING SCORE: 0 NMOCD TPH CLOSURE STD: 5000 PPM
ELEV 6778'

SAMPLE ID	FIELD HEADSPACE PID (ppm)
1 @ 9'	432
2 @	
3 @	
4 @	
5 @

SAMPLE ID	ANALYSIS	TIME
(1) @ 9'	TPH (8015B)	1340
"	BTEX (8021B)	"
	BOTH PASSED

SOIL TYPE: SAND / (SILTY SAND) / SILT / (SILTY CLAY) / CLAY / GRAVEL / OTHER
SOIL COLOR: DK. YELL. BROWN - OLIVE GRAY
COHESION (ALL OTHERS): (NON COHESIVE) / SLIGHTLY COHESIVE / COHESIVE / HIGHLY COHESIVE
CONSISTENCY (NON COHESIVE SOILS): LOOSE / (FIRM) / DENSE / VERY DENSE
PLASTICITY (CLAYS): (NON PLASTIC) / SLIGHTLY PLASTIC / COHESIVE / MEDIUM PLASTIC / HIGHLY PLASTIC
~~DENSITY (COHESIVE CLAYS & SILTS)~~: SOFT / FIRM / STIFF / VERY STIFF / HARD
MOISTURE: DRY / (SLIGHTLY MOIST) / MOIST / WET / SATURATED / SUPER SATURATED
DISCOLORATION/STAINING OBSERVED: (YES) / NO EXPLANATION - ENTIRE TEST HOLE INTERVAL.
HC ODOR DETECTED: (YES) / NO EXPLANATION - TEST HOLE & OVM SAMPLE
SAMPLE TYPE: (GRAB) / COMPOSITE - # OF PTS. —
ADDITIONAL COMMENTS: INSTRUCTED OPERATOR TO DILUTE/AERATE SOIL IN PIT AREA DOWN TO 7-8' BELOW PIT BOTTOM.
