Pit, Below-Grade Tank, or Proposed Alternative Method Permit or Closure Plan Application

Burlington Resources Oil & Gas Company, LP
San Juan Basin
Below Grade Tank Closure Report

Lease Name: Huerfano Unit 287
API No.: 30-045-26849

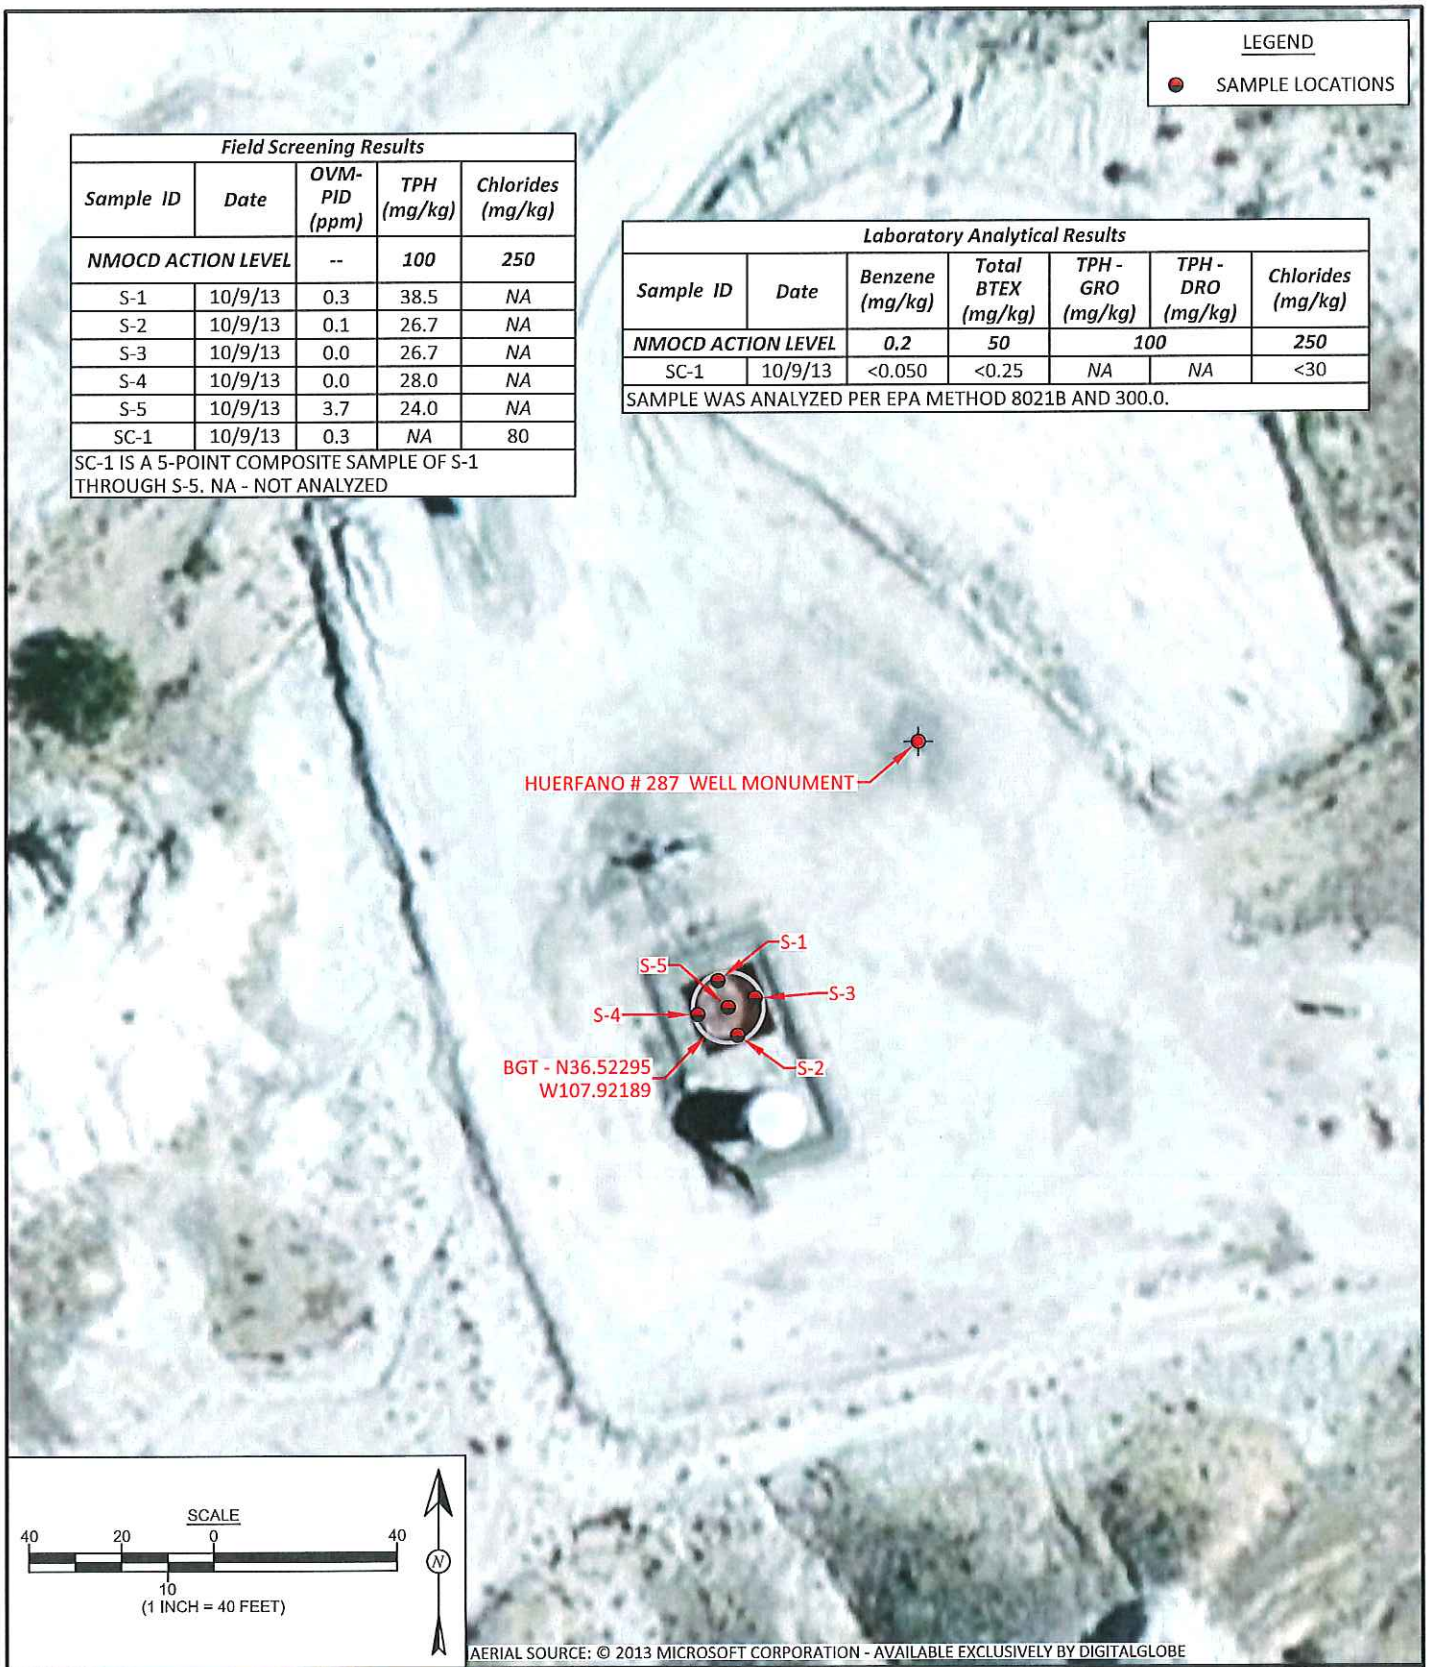
NMOCD action levels for BGT closures are specified in New Mexico Administrative Code (NMAC) 19.15.17.13E. Field TPH concentrations were below the NMOCD action level of 100 mg/kg, with the highest concentration reported in S-1 with 38.5 mg/kg. Benzene and total BTEX concentrations in SC-1 were below the NMOCD action levels of 0.2 mg/kg and 50 mg/kg, respectively. Chloride concentrations in SC-1 were below the NMOCD action level of 250 mg/kg. Based on field screening and laboratory analytical results for benzene, total BTEX, TPH, and chlorides, no further work is recommended at Huerfano #287.

Field Screening Results				
Sample ID	Date	OVM-PID (ppm)	TPH (mg/kg)	Chlorides (mg/kg)
NMOCD ACTION LEVEL		--	100	250
S-1	10/9/13	0.3	38.5	NA
S-2	10/9/13	0.1	26.7	NA
S-3	10/9/13	0.0	26.7	NA
S-4	10/9/13	0.0	28.0	NA
S-5	10/9/13	3.7	24.0	NA
SC-1	10/9/13	0.3	NA	80
SC-1 IS A 5-POINT COMPOSITE SAMPLE OF S-1 THROUGH S-5. NA - NOT ANALYZED

Laboratory Analytical Results						
Sample ID	Date	Benzene (mg/kg)	Total BTEX (mg/kg)	TPH - GRO (mg/kg)	TPH - DRO (mg/kg)	Chlorides (mg/kg)
NMOCD ACTION LEVEL		0.2	50	100		250
SC-1	10/9/13	<0.050	<0.25	NA	NA	<30
SAMPLE WAS ANALYZED PER EPA METHOD 8021B AND 300.0.
