Pit or Below-Grade Tank Registration or Closure

Operator: Burlington Resources Telephone: (505) 326-9841 e-mail address: LHasely@br-inc.com
Address: 3401 East 30th Street, Farmington, New Mexico, 87402
Facility or well name: Huerfano Unit Well No. 158 API #: 30045200280000 U/L or Qtr/Qtr E Sec 8 T 26N R 9W
County: San Juan Latitude 36.50498 Longitude -107.8169 NAD: 1927 ☒ 1983 ☐
Surface Owner: Federal ☒ State ☐ Private ☐ Indian ☐

FIELD REPORT: CLOSURE VERIFICATION

LOCATION: NAME: Huerfano Unit WELL #: 158 PIT:
QUAD/UNIT: SEC: 8 TWP: 26N RNG: 9W PM: NMPM CNTY: SJ ST: NM
QTR/FOOTAGE: CONTRACTOR: L&R

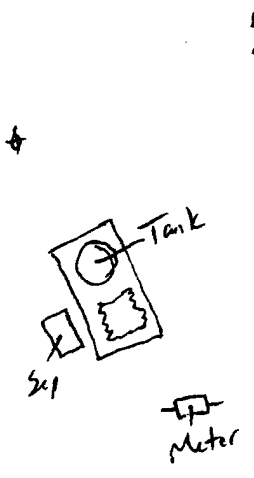
PIT PERIMETER

Soil does have greyish color but very little odor. Changed pit closure from Burlingtons 5000 ppm to 1000 ppm due to ephemeral wash to the north within 1000 ft.

o = 3' Below
x = 5 Pt Comp
