Release Notification and Corrective Action

Name of Company **Williams Production**	Contact **Michael K. Lane**
Address **PO Box 640**	Telephone No. **505-634-4219**
Facility Name **Cox Canyon #200 (API: 30-045-27878)**	Facility Type **Well Site**

Cox Canyon #200

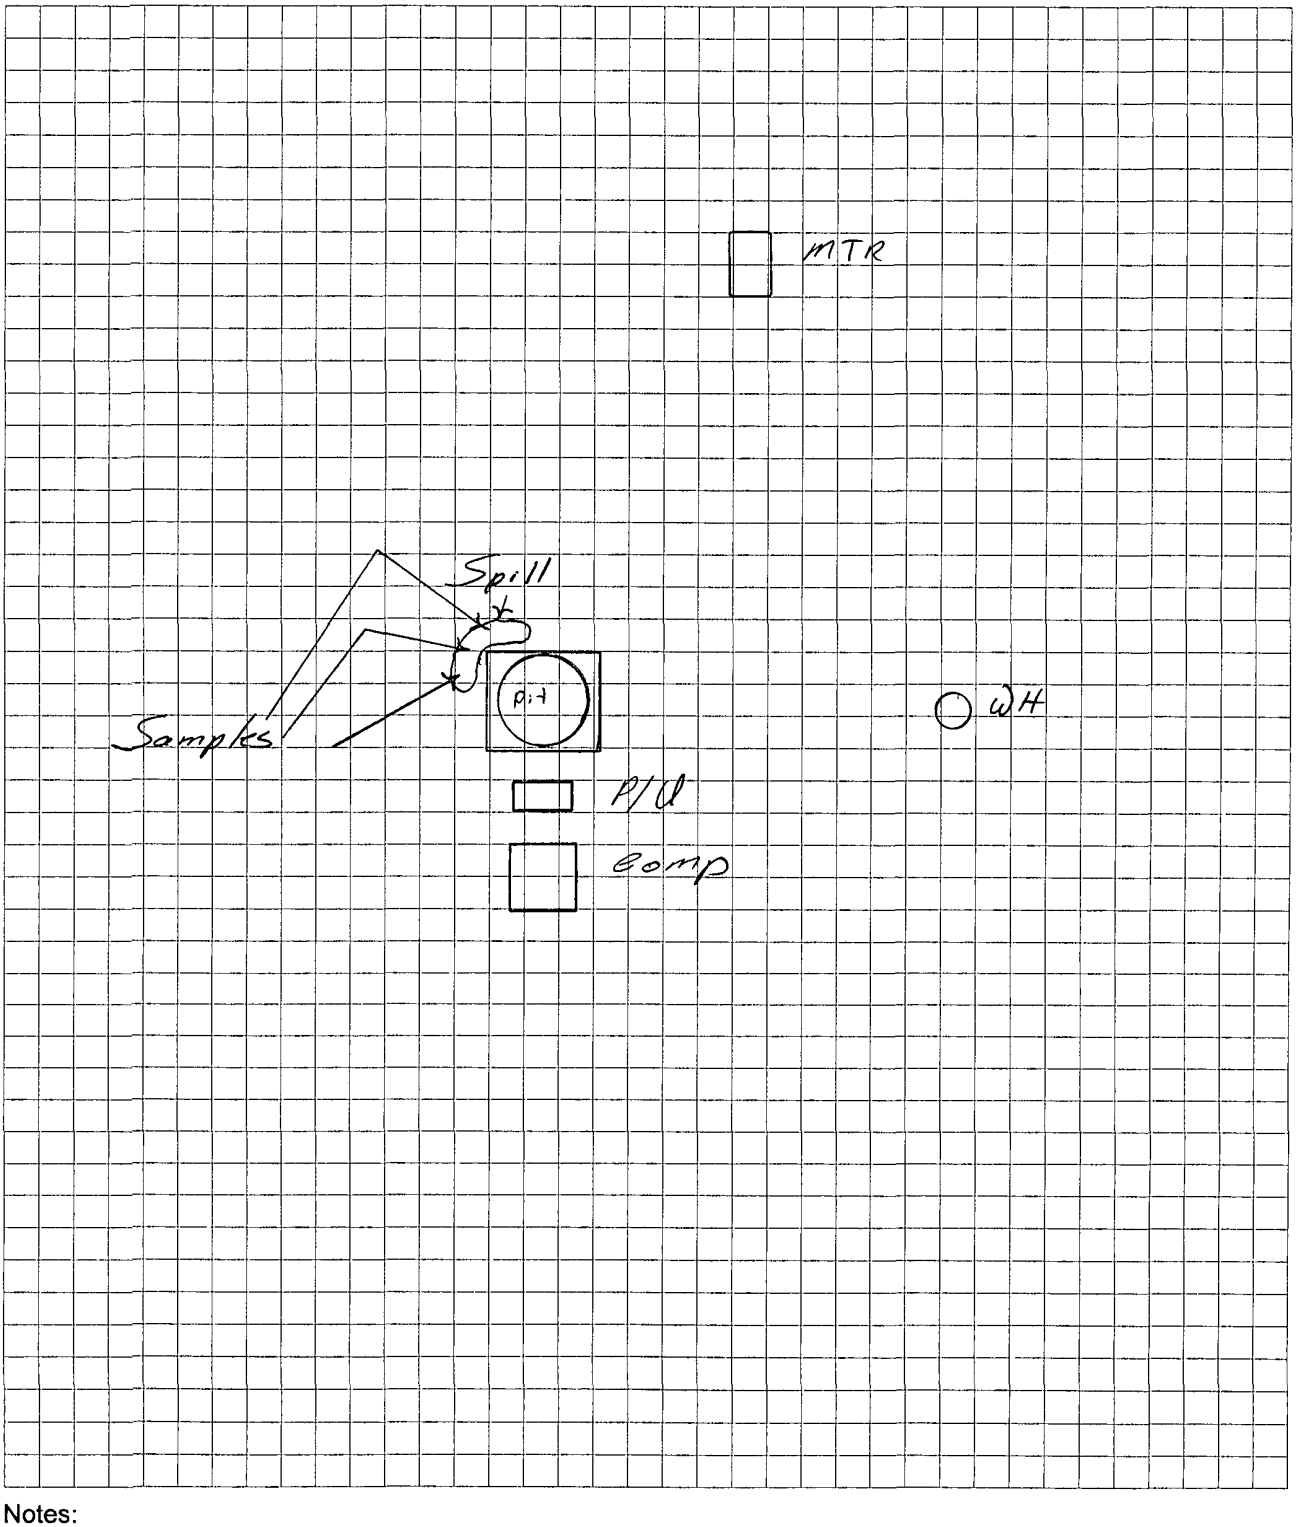
Site Sketch

Heavy rainfall during a thunderstorm wash out berm and overfilled BGT. Produced water and oil skim spread over a 100sf area. Well shut-in, BGT drained with vac truck Impacted soil and residual liquids recovered with hydrovac truck. Sampling indicates no residual contamination Berms rebuilt and site drainage modified to prevent stormwater run-on. Composite sample results and site map attached.
