Pit, Closed-Loop System, Below-Grade Tank, or Proposed Alternative Method Permit or Closure Plan Application

1
Operator **ConocoPhillips Company** OGRID#: **217817**
Address **P.O. Box 4289, Farmington, NM 87499**
Facility or well name: **SAN JUAN 29-5 UNIT 235**
API Number **30-039-30879** OCD Permit Number
U/L or Qtr/Qtr. **L(NW/SW)** Section **15** Township: **29** Range **5** County: **Rio Arriba**
Center of Proposed Design Latitude. **36.72311** °N Longitude. **107.35016** °W NAD: [ ] 1927 [X] 1983
Surface Owner. [ ] Federal [ ] State [X] Private [ ] Tribal Trust or Indian Allotment

Closure Report (required within 60 days of closure completion): Subsection K of 19 15 17 13 NMAC

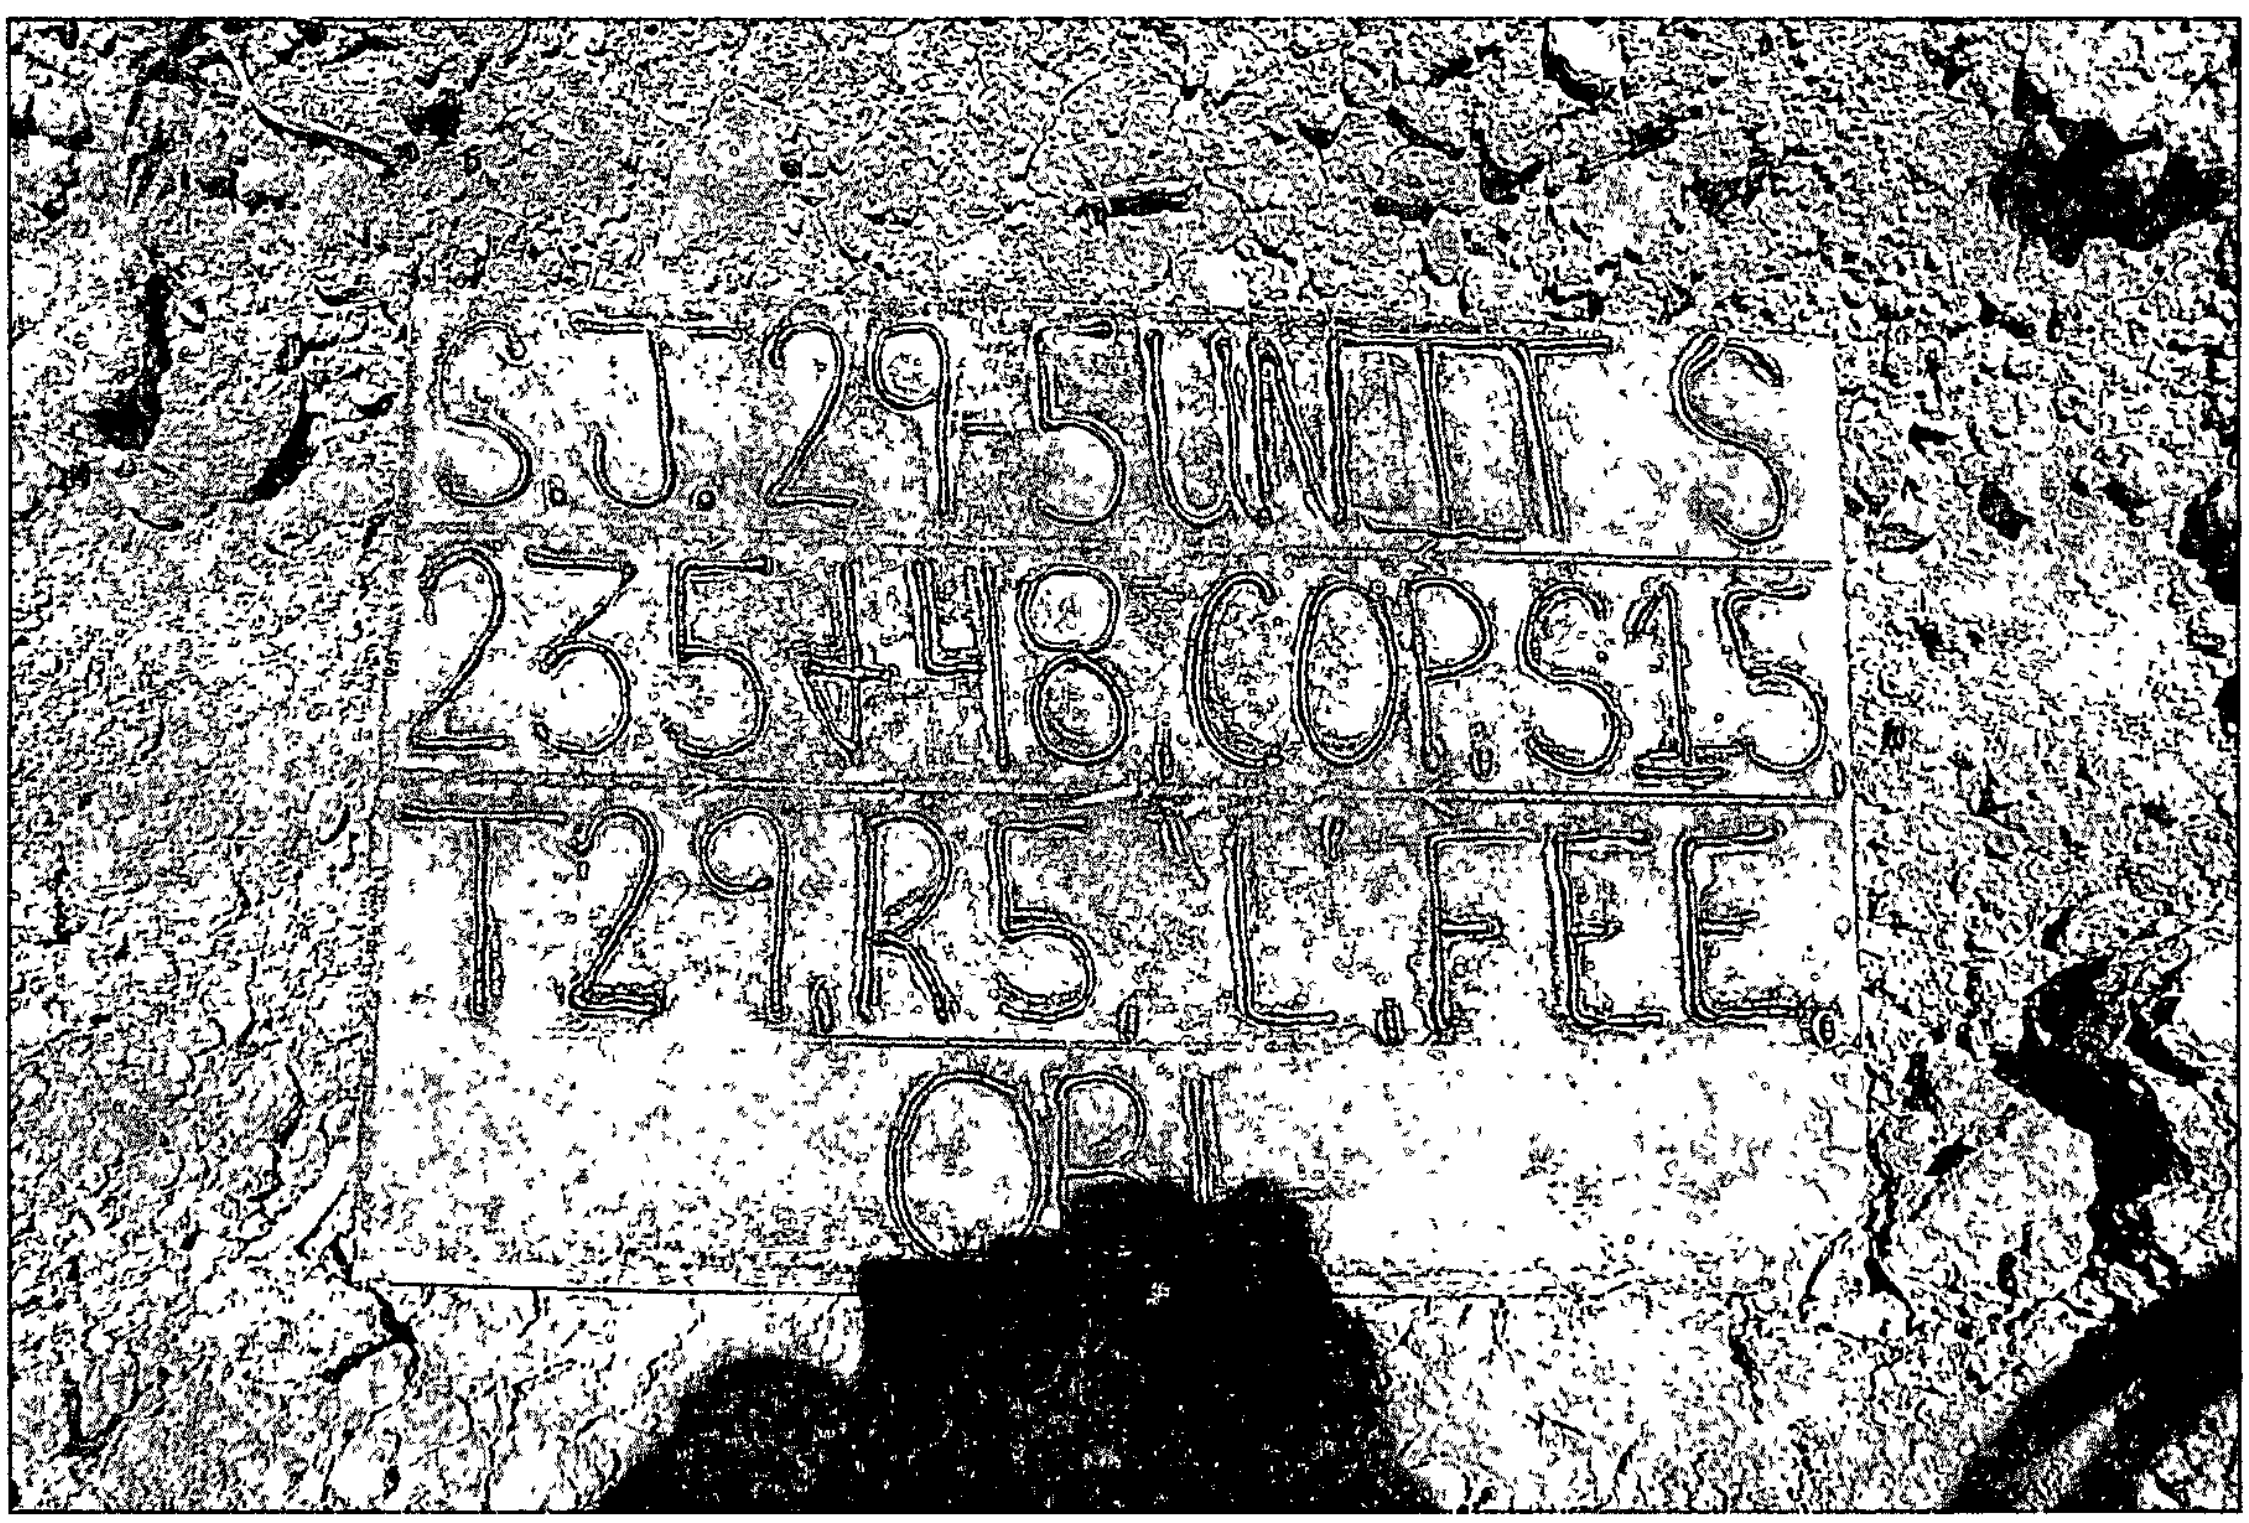
CONOCOPHILLIPS COMPANY
SAN JUAN 29-5 UNIT #235
LATITUDE 36° 43' 23' N (NAD83)
LONGITUDE 107° 21' 00' W (NAD83)
UNIT L SEC 15 T29N R05W
1750' FSL 1045' FWL
API # 30-039-30879
LEASE # SF-080069 ELEV.6774'
RIO ARRIBA COUNTY, NEW MEXICO
EMERGENCY CONTACT: 1-505-324-5170
