Pit or Below-Grade Tank Registration or Closure

Operator: Burlington Resources Telephone: (505) 326-9841 e-mail address: LHasely@br-inc.com
Address: 3401 East 30th Street, Farmington, New Mexico, 87402
Facility or well name: Culpepper Martin # 18 API #: 30045223360000 U/L or Qtr/Qtr K Sec 28 T 32N R 12W
County: San Juan Latitude 36.95328 Longitude -108.10332 NAD: 1927 ☒ 1983 ☐
Surface Owner: Federal ☐ State ☐ Private ☒ Indian ☐

FIELD REPORT: CLOSURE VERIFICATION

LOCATION: NAME: Culpepper Martin WELL #: 18 PIT:
QUAD/UNIT: SEC: 28 TWP: 32N RNG: 12W PM: NMPM CNTY: SJ ST: NM
QTR/FOOTAGE: CONTRACTOR: L&R

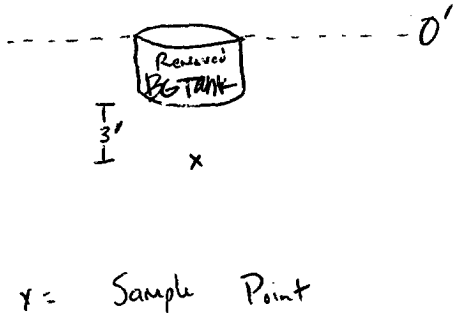
PIT PERIMETER

FIELD NOTES & REMARKS: PIT LOCATED APPROXIMATELY 82 FT. 125° FROM WELLHEAD.
DEPTH TO GROUNDWATER: 0 NEAREST WATER SOURCE: 0 NEAREST SURFACE WATER: 10
NMOCD RANKING SCORE: 10 NMOCD TPH CLOSURE STD: 1000 PPM

Pit already removed. No visible signs of contamination or odors present.
Gave O.K to set up new steel tank.

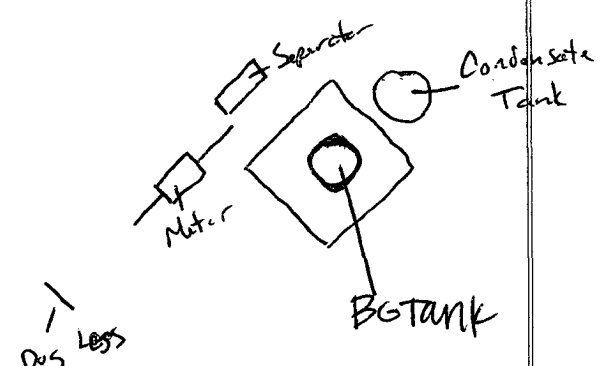
PIT PROFILE

EXCAVATION APPROX 11 FT. x 10 FT. x 8 FT. DEEP CUBIC YARDAGE: 0
DISPOSAL FACILITY: N/A REMEDIATION METHOD:
LAND USE: LEASE: FORMATION:

No Soil Removed from site.
