# Pit or Below-Grade Tank Registration or Closure

Operator: Burlington Resources Telephone: (505) 326-9841 e-mail address: LHasely@br-inc.com
Address: 3401 East 30th Street, Farmington, New Mexico, 87402
Facility or well name: Hanks # 14 API #: 30045066160000 U/L or Qtr/Qtr M Sec 12 T 27N R 10W
County: San Juan Latitude 36.58497 Longitude -107.8537 NAD: 1927 ☒ 1983 ☐
Surface Owner: Federal ☒ State ☐ Private ☐ Indian ☐

# FIELD REPORT: CLOSURE VERIFICATION

LOCATION: NAME: Hanks WELL #: 14 PIT: A
QUAD/UNIT: M SEC: 12 TWP: 27N RNG: 10W PM: NMPM CNTY: SJ ST: NM
QTR/FOOTAGE: _____ CONTRACTOR: _____

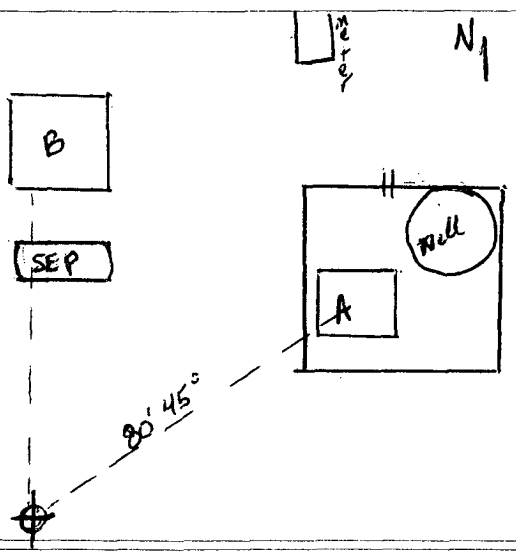
## PIT PERIMETER

FIELD NOTES & REMARKS: PIT LOCATED APPROXIMATELY 80' FT 45° FROM WELLHEAD.
DEPTH TO GROUNDWATER: <50' NEAREST WATER SOURCE: — NEAREST SURFACE WATER: 300'
NMOCD RANKING SCORE: 30 NMOCD TPH CLOSURE STD: 100 PPM

SOIL AND EXCAVATION DESCRIPTION:
BGT (A) seemed very clean. Soil underneath and walls tested < 100ppm and pit was backfilled. Steel ~~tank~~ BGT will be installed a few feet from original location

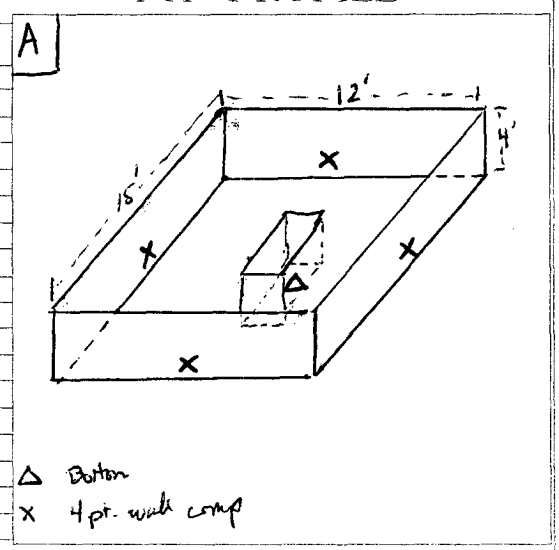
## PIT PROFILE

△ Bottom
X 4pt. wall comp
