Pit, Closed-Loop System, Below-Grade Tank, or Proposed Alternative Method Permit or Closure Plan Application

1
Operator: **ConocoPhillips Company** OGRID#: **217817**
Address: **P.O. Box 4289, Farmington, NM 87499**
Facility or well name: **HODGES 13F**
API Number: **30-045-35185** OCD Permit Number:
U/L or Qtr/Qtr: **I(NE/SE)** Section: **34** Township: **26N** Range: **8W** County: **SAN JUAN**
Center of Proposed Design: Latitude: **36.44155** °N Longitude: **107.66221** °W NAD: [ ] 1927 [X] 1983
Surface Owner: [X] Federal [ ] State [ ] Private [ ] Tribal Trust or Indian Allotment

ConocoPhillips Company
San Juan Basin
Closure Report

Lease Name: HODGES 13F
API No.: 30-045-35185

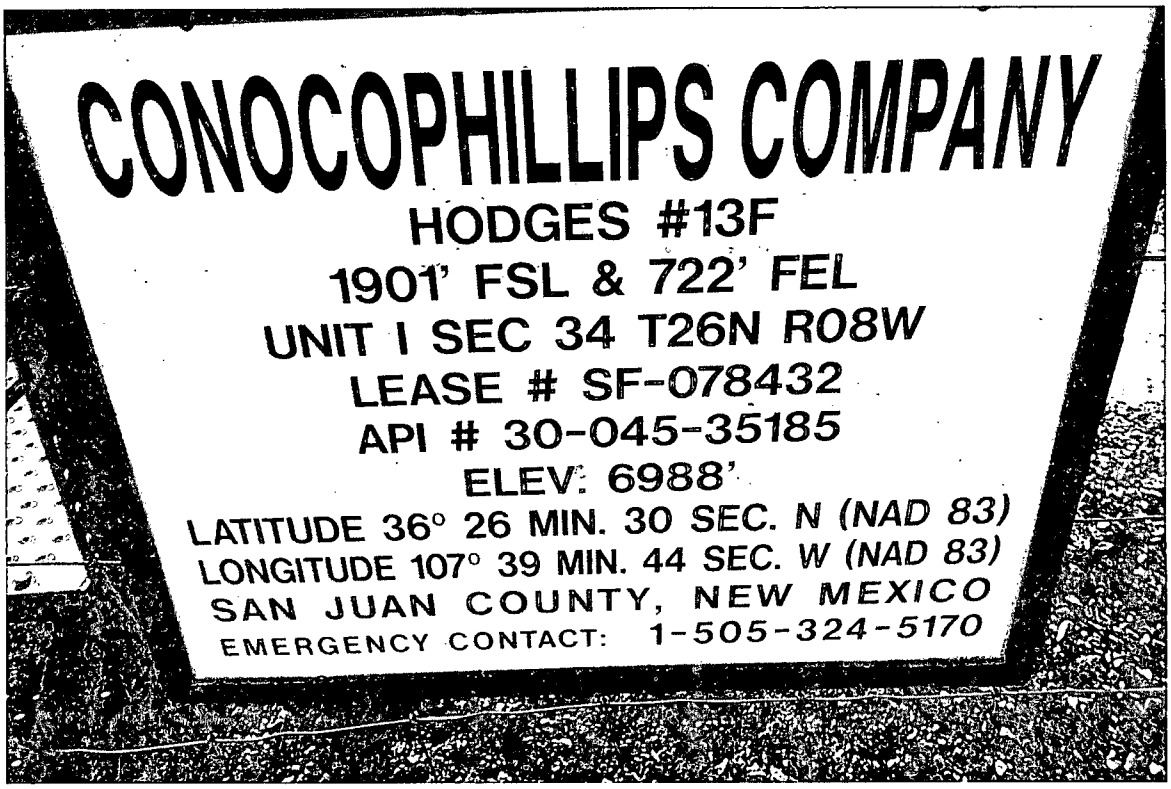
CONOCOPHILLIPS COMPANY
HODGES #13F
1901' FSL & 722' FEL
UNIT I SEC 34 T26N R08W
LEASE # SF-078432
API # 30-045-35185
ELEV: 6988'
LATITUDE 36° 26 MIN. 30 SEC. N (NAD 83)
LONGITUDE 107° 39 MIN. 44 SEC. W (NAD 83)
SAN JUAN COUNTY, NEW MEXICO
EMERGENCY CONTACT: 1-505-324-5170
