Pit or Below-Grade Tank Registration or Closure

Operator: Burlington Resources Telephone: (505) 326-9841 e-mail address: LHasely@br-inc.com
Address: 3401 East 30th Street, Farmington, New Mexico, 87402
Facility or well name: San Juan 30-6 Unit 434 API #: 30039242600000 U/L or Qtr/Qtr M Sec 12 T 30N R 6W
County: Rio Arriba Latitude 36.82240 Longitude -107.42052 NAD: 1927 ☒ 1983 ☐
Surface Owner: Federal ☒ State ☐ Private ☐ Indian ☐

FIELD REPORT: CLOSURE VERIFICATION

LOCATION: NAME: San Juan 30-6 WELL #: 434 PIT:
QUAD/UNIT: M SEC: 12 TWP: 30N RNG: 6W PM: NMPM CNTY: Rio Arriba ST: NM
QTR/FOOTAGE: 900'S 790'W CONTRACTOR: LOR

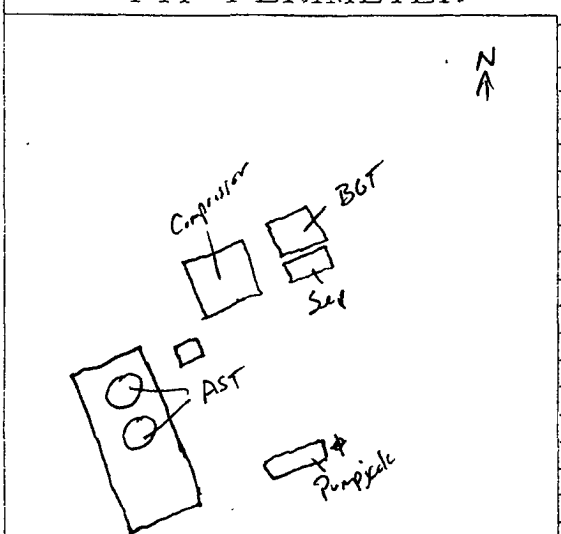
PIT PERIMETER

FIELD NOTES & REMARKS: PIT LOCATED APPROXIMATELY 92' FT. 345° FROM WELLHEAD.
DEPTH TO GROUNDWATER: 20 NEAREST WATER SOURCE: 0 NEAREST SURFACE WATER: 10
NMOCD RANKING SCORE: 30 NMOCD TPH CLOSURE STD: 100 PPM

No visible signs of contamination present. No soil removed from site.
To the east approx. 150' is another site.
