Pit or Below-Grade Tank Registration or Closure

Operator: Dugan Production Corp Telephone: (505)325-1821 e-mail address:
Address: P.O. Box 420, Farmington, New Mexico 87401
Facility or well name: Goodman 2 API #: 30-045-29191 U/L or Qtr/Qtr L Sec 23 T 22N R 8W
County: San Juan Latitude 36.12289 Longitude 107.65767 NAD: 1927 ☐ 1983 ☐ Surface Owner Federal ☐ State ☐ Private ☐ Indian ☐

FIELD REPORT: PIT CLOSURE VERIFICATION

LOCATION: NAME: GOODMAN WELL #: 2 TYPE: SEP
QUAD/UNIT: L SEC: 23 TWP: 22N RNG: 8W PM: NM CNTY: SJ ST: NM
QTR/FOOTAGE: 1850 FSL x 810 FWL CONTRACTOR: DPC

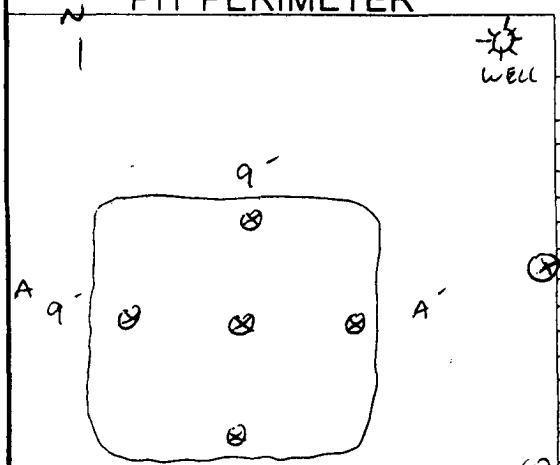
PIT PERIMETER

FIELD NOTES & REMARKS: PIT LOCATED APPROXIMATELY 33 FT. 543W FROM WELLHEAD.

SOIL TYPE: (SAND) / SILTY SAND / SILT / SILTY CLAY / CLAY / GRAVEL / OTHER
SOIL COLOR: Lt Tan
COHESION (ALL OTHERS): (NON COHESIVE) / SLIGHTLY COHESIVE / COHESIVE / HIGHLY COHESIVE
CONSISTENCY (NON COHESIVE SOILS): (LOOSE) / FIRM / DENSE / VERY DENSE
PLASTICITY (CLAYS): NON PLASTIC / SLIGHTLY PLASTIC / COHESIVE / MEDIUM PLASTIC / HIGHLY PLASTIC
DENSITY (COHESIVE CLAYS & SILTS): SOFT / FIRM / STIFF / VERY STIFF / HARD
MOISTURE: DRY / (SLIGHTLY MOIST) / MOIST / WET / SATURATED / SUPER SATURATED
DISCOLORATION/STAINING OBSERVED: YES / (NO) EXPLANATION -
HC ODOR DETECTED: YES / (NO) EXPLANATION -
SAMPLE TYPE: GRAB / (COMPOSITE) # OF PTS. 5
ADDITIONAL COMMENTS: 9'x9'x4' Earthen Pit w/ Vegetation. Use Backhoe to Dig into Pit & collect Sample. No evidence of Prior Pit use

DISPOSAL FACILITY: NA REMEDIATION METHOD: CLOSE AS IS

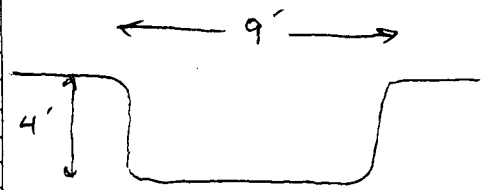
PIT PROFILE

SAMPLE ID	FIELD HEADSPACE (ppm)
1 @	
2 @	
3 @	
4 @	
5 @	
(X) 5-Point Composite @ 7'	0.0
